3<sup>rd</sup> May 2017

***Bat survey results and mitigation plan for the farmhouse on Brook Lane, Rustington, West Sussex.***

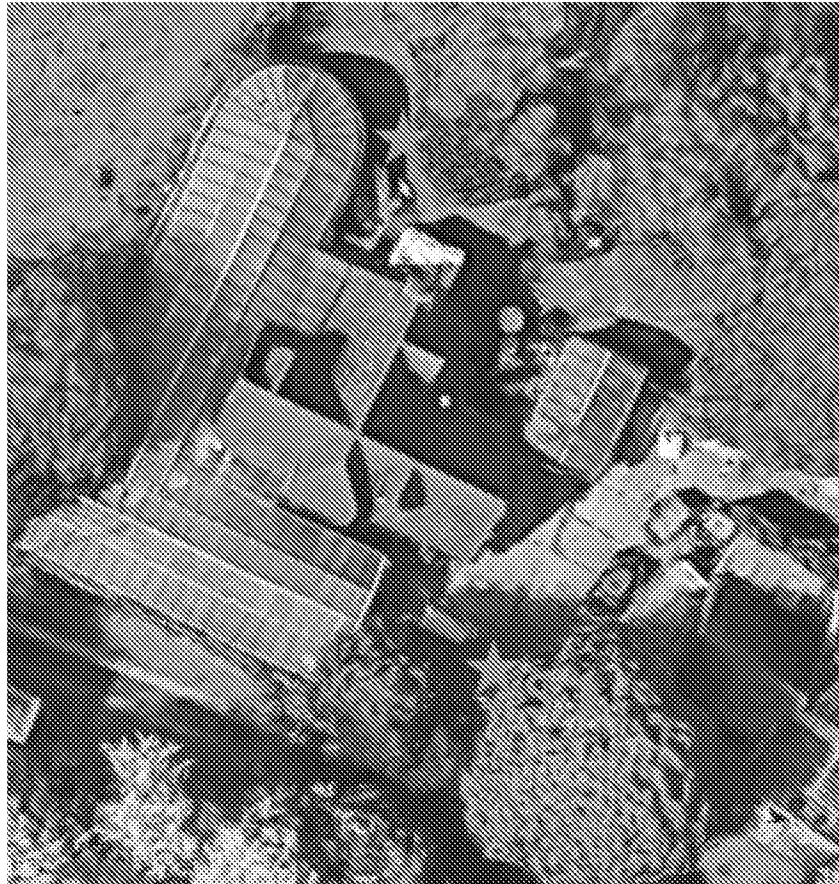
The surveyors were positioned around the house as shown below in Figure 1.

*Figure 1: Locations of the surveyors on the 2nd May 2017 emergence survey*

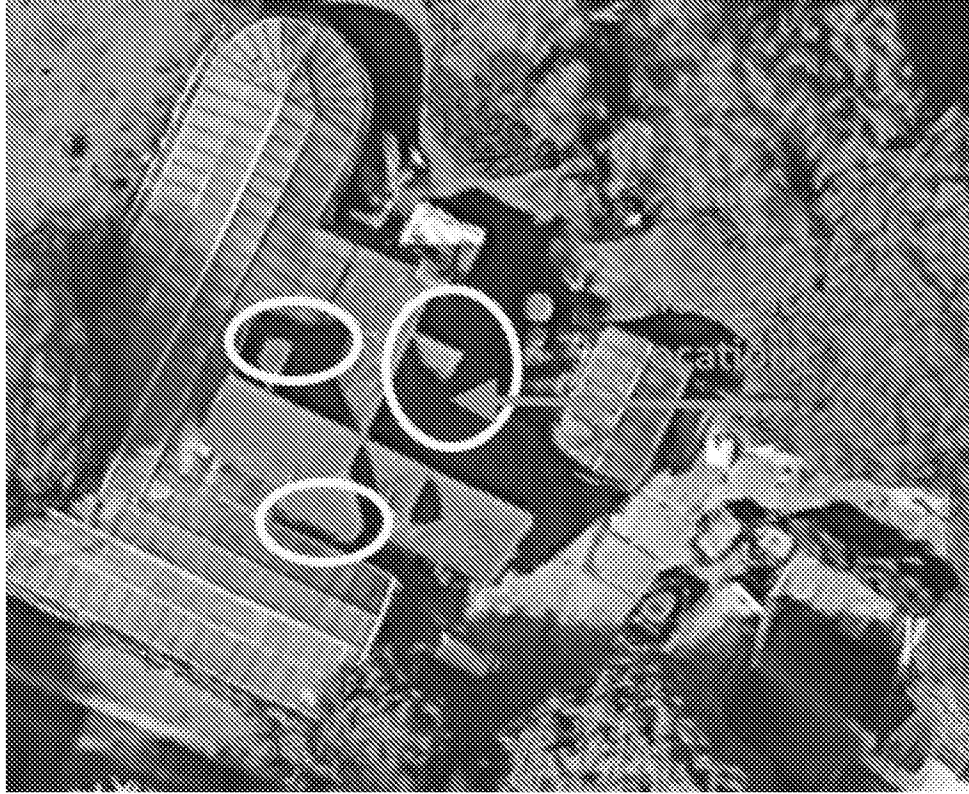
An internal inspection of the roof void on the 22<sup>nd</sup> June 2016 revealed no evidence of bat activity within the void. Loose and lifted weatherboarding around the windows of the house were considered to offer some opportunities for roosting bats.

*Figure 2: Yellow circles indicate areas of lifted weatherboarding.  
Red arrow indicates where the bat was seen to emerge from on the 2nd May 2017*

Internal inspection of the roof void above the farmhouse in June 2016 revealed no evidence of bat activity with the void. It is considered that bats are not roosting within the void. Externally the loose and lifted weatherboarding around the dormer windows of the farmhouse were considered to create opportunities for roosting bats.

Demolition works to the roof should be undertaken under Ecological Clerk of Works by the Registered Consultant (RC) during times where bats are less likely to be roosting under the roof / hanging tiles or within the void (October – November).

Pipistrelle bats are a crevice dwelling species; the erection of bat boxes can mitigate for the loss of roosting opportunities caused by the demolition of the farmhouse. Schwegler 1FS and 2FS boxes are recommended, both general purpose boxes utilised by a range of smaller UK bat species. In the event of further survey work indicating larger species such as serotines or species with more specific roosting requirements, then other bat boxes may be required. Ideally the bat boxes should be situated on the southern or western aspect of a mature tree in close proximity to suitable habitat features such as hedgerows and trees.

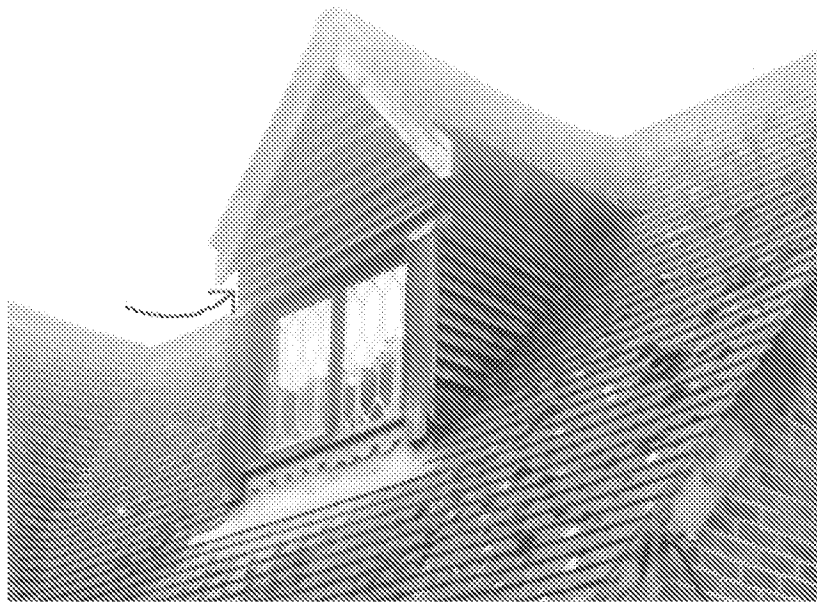
Surveyor two heard predominantly pipistrelle calls from common and sopranos, with a serotine pass at 21.23. Pipistrelles were seen to be foraging within the driveway for a continuous 10 minutes between 21.25 and 21.34. A bat was seen by surveyor 2 to emerge from the corner of the eastern dormer window, from underneath the weatherboarding, three boards up. The bat did not echolocate, however the next call heard was from a soprano pipistrelle. It is considered likely that the bat was a pipistrelle species.

*Figure 3: Photograph of the area where the bat was seen to emerge from on the 2nd May 2017*

A single bat was seen to emerge from the weatherboarding around the eastern dormer window from surveyor position 2 at 20.20. The bat did not echolocate but is considered likely to be a pipistrelle species.

It is recommended that another two bat surveys be carried out this season (May-September 2017). One dusk and one dawn survey are recommended. This will assist in determining the exact location of the roost, the number of bats using the roosting feature and confirmation of the species and if there are any additional bats using crevice features on other aspects of the house.

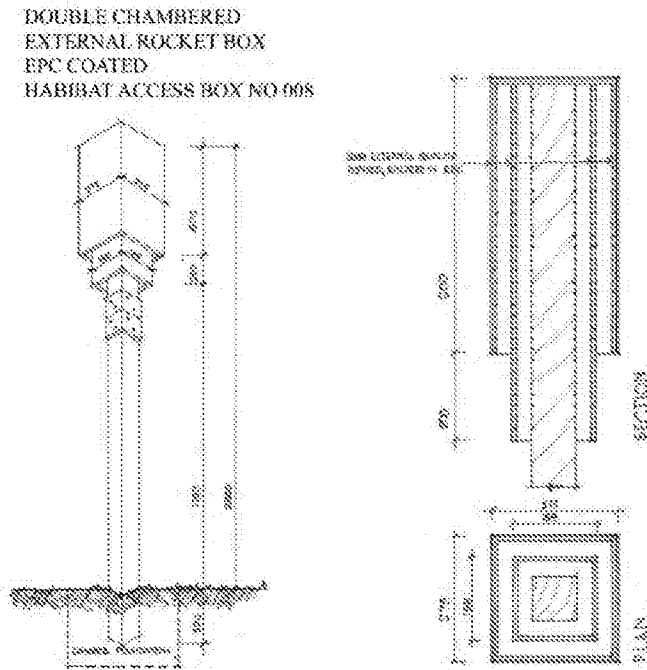
Finally, it is recommended that a Habibat Rocket Box 008 is recommended for the western section of the site. This is a freestanding double-chambered access box and would be considered a suitable box for a range of species which are currently using the site. The wood has an EPC coating for durability and can be delivered in a wood finish or in a colour of the property owner's choice. The box is 2.8m high at its highest point and it is recommended that 30cm of the pole is sunk into a concrete footing.

**Figure 4: A Habibat Rocket Box design**

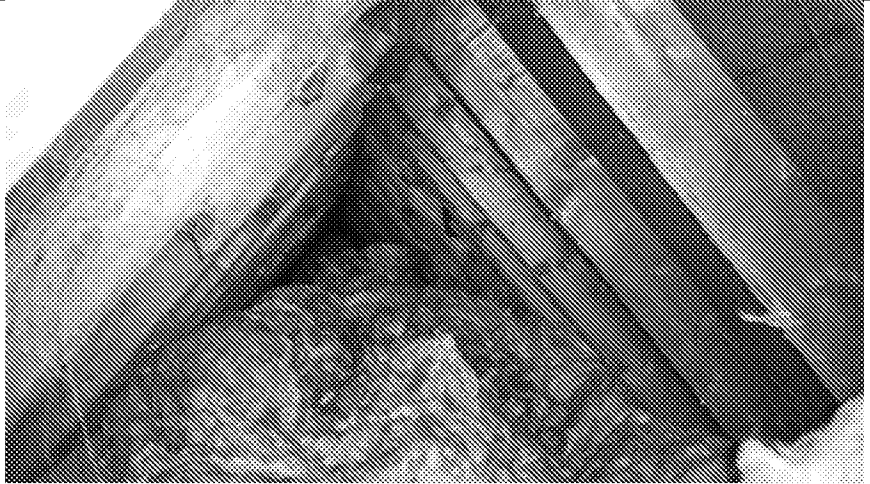
**Photo 1:** Internal void above the farmhouse. Very shallow void. No evidence of bats.

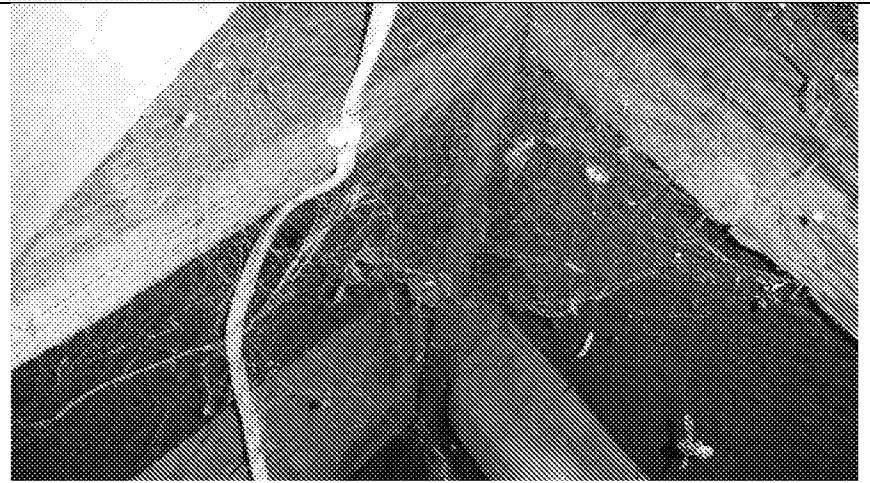
**Photo 2:** Apex covered in cobwebs suggesting little disturbance.

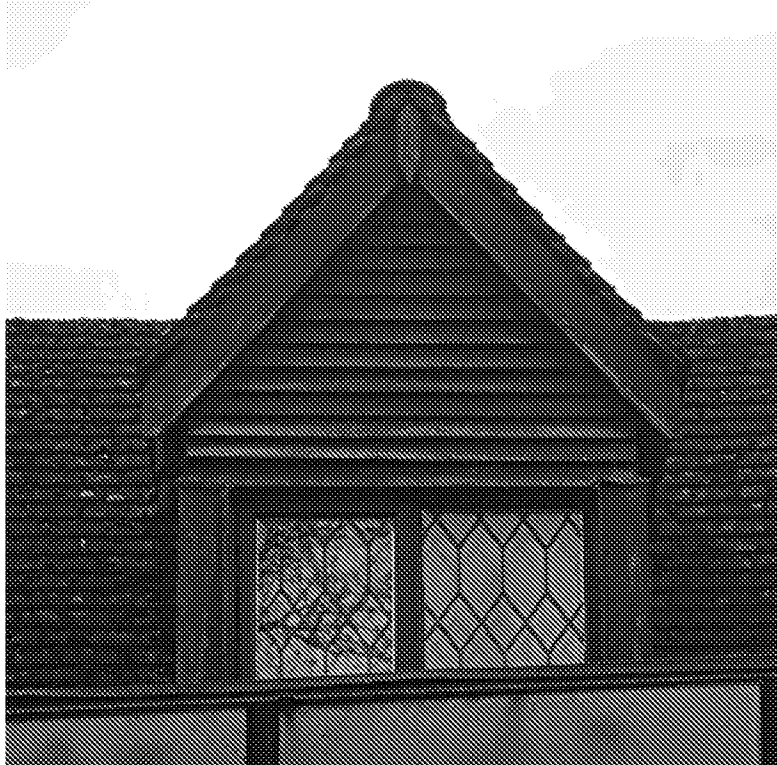
**Photo 3:** Aspect surveyed by surveyor 3 on 03/05/2017. No bats seen to emerge from here.

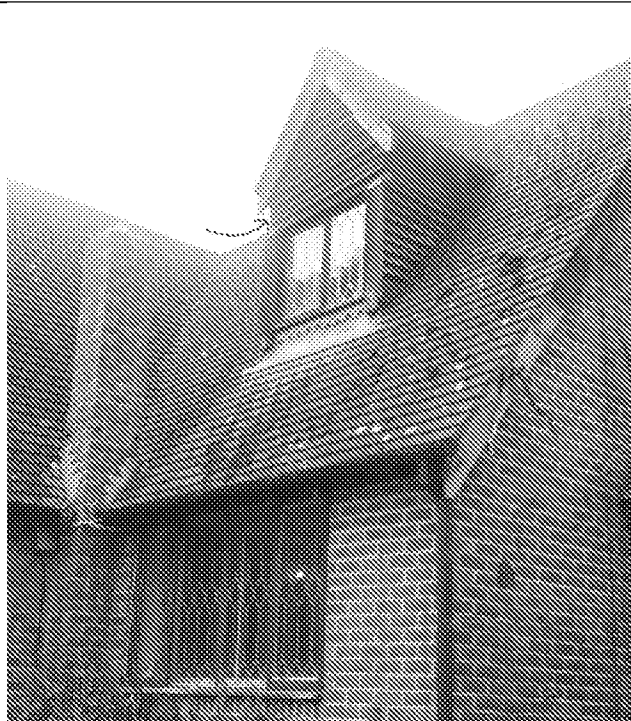
**Photo 4:** Aspect surveyed by surveyor 2 and the emergence location on 03/05/2017
