# Phase I Desk Study, Site Reconnaissance & Phase II Site Investigation Report

at Shrublands Nursery,  
Angmering, BN16 4AT

for Sigma Homes

Report Reference: LP2386

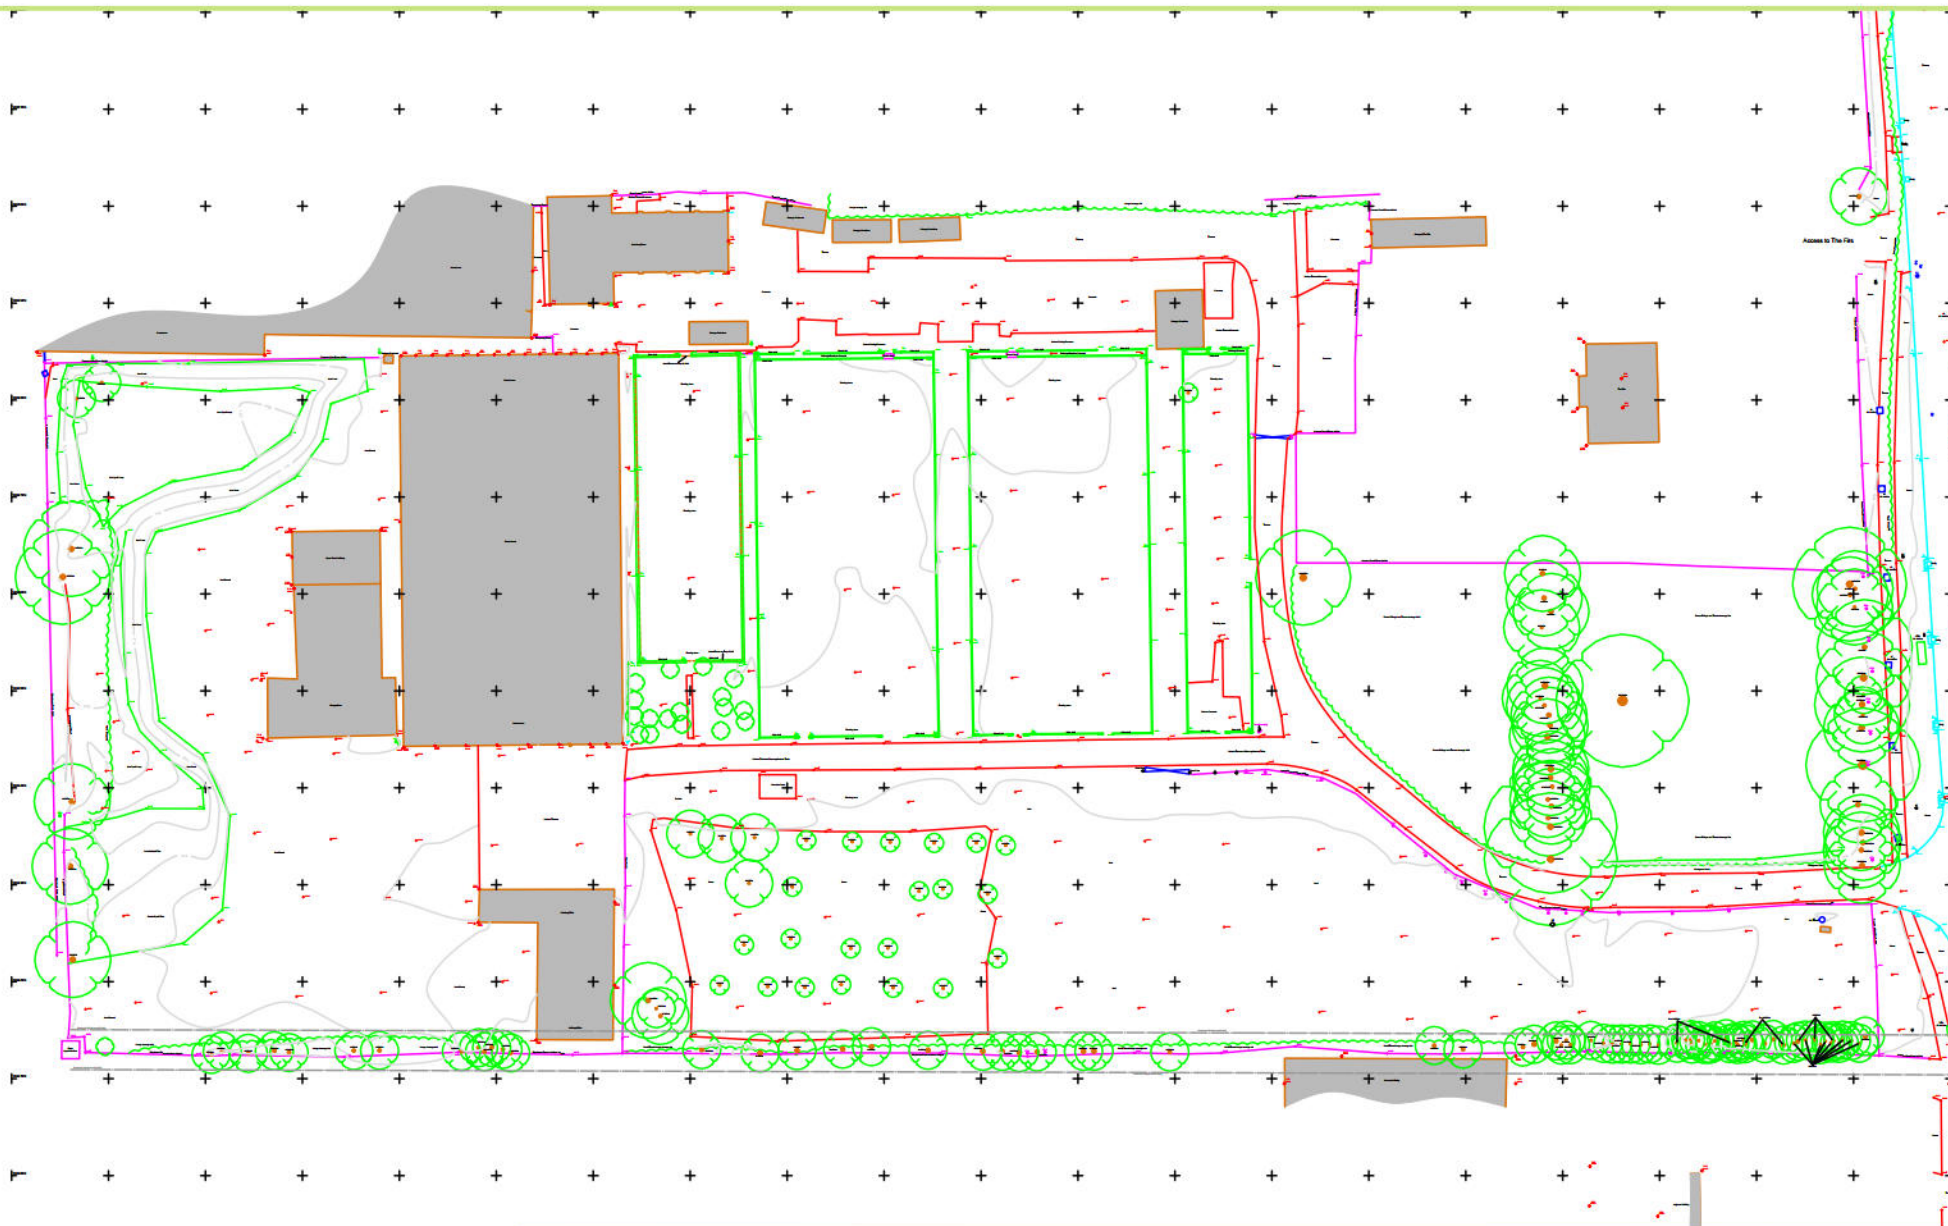
| Project | Shrublands Nursery, Angmering | Scale at A4 | Text | Fig No. | 3 |

The remaining greenhouse is still in use for a variety of crops. To the east of the greenhouses, are several rectangular walled areas (approximately 1.0m high) which from discussion with the current site users are the foundation walls of former greenhouses. The remaining areas were a mixture of sparse grass cover and hardstanding.

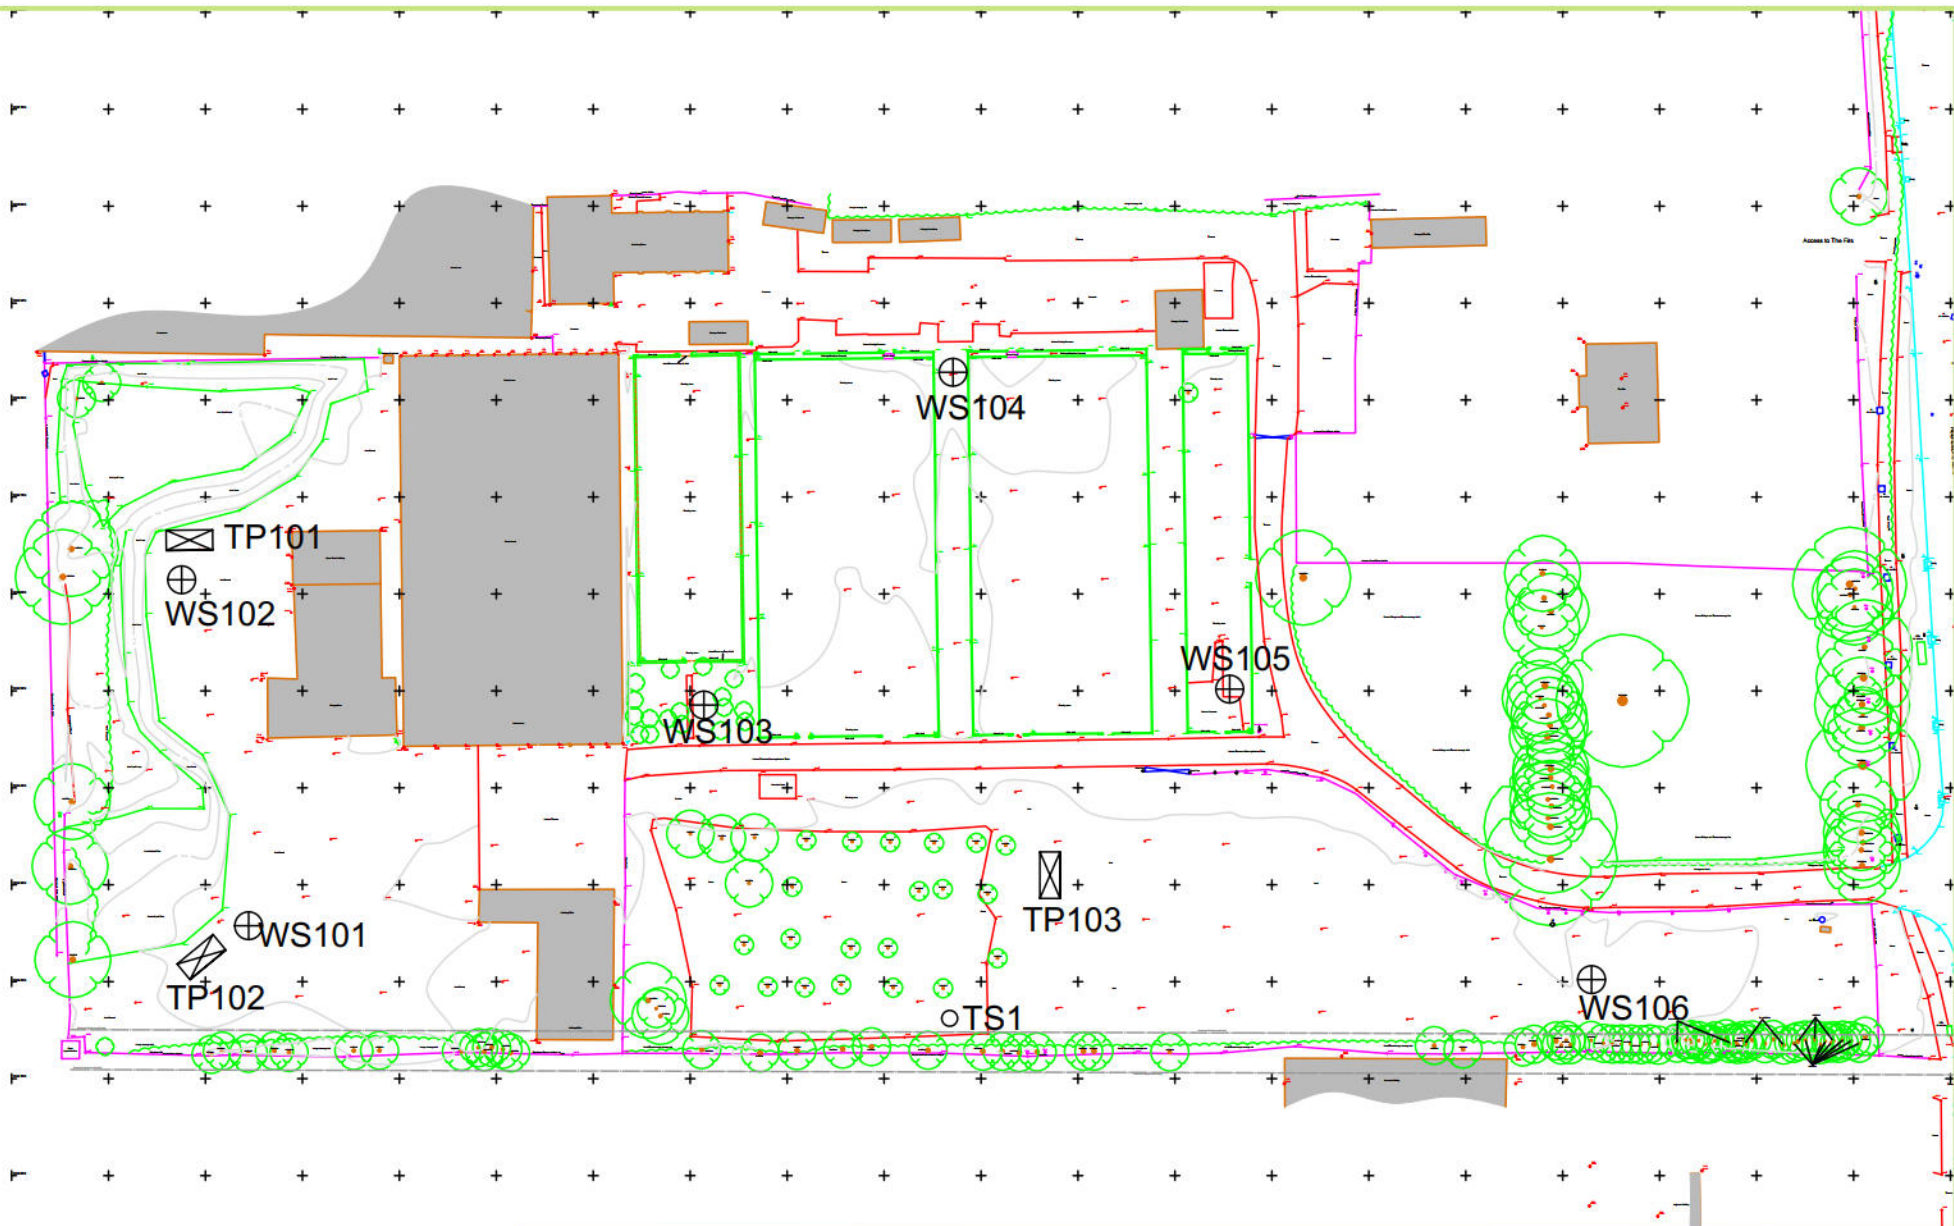
| Title | Investigation Locations | | | | |

The trial holes were located to give general coverage, taking into consideration the proposed development and the potential geoenvironmental and geotechnical risks/hazards highlighted by the CSM in accordance with BS10175.

The trial hole spacing was consistent with the recommended density of 25 to 50m for an exploratory investigation after BS10175 Section 7.7.

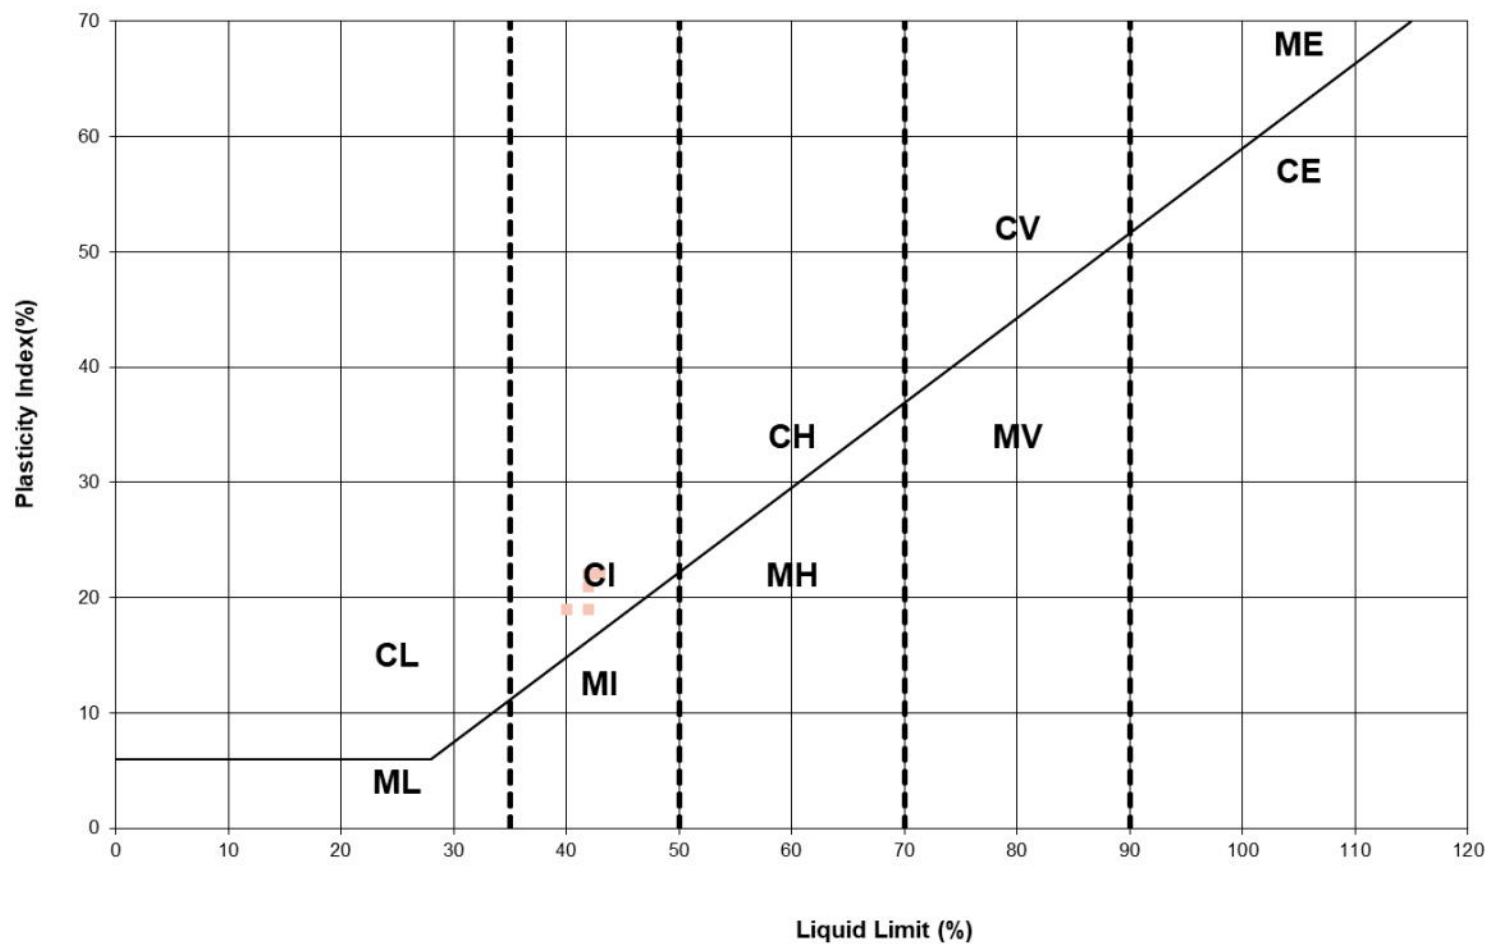
Chart 2 Atterberg Limits A-Line Plot

An allowable bearing capacity of 80kPa is recommended for the firm clays below about 1.0m. Suspended floor slabs are recommended due to the medium volume change potential of the clay soils on site. Soil sulphates fall within BRE design class DS-I and the site conditions fall within the ACEC class AC-I.
