SHRUBLANDS, ROUNDSTONE  
LANE, ANGMERING, BN16 4AT

## APPENDIX D – Qualitative Risk Assessment Model

## APPENDIX E – Site Photographs

## APPENDIX F – Trial Hole and Borehole Logs

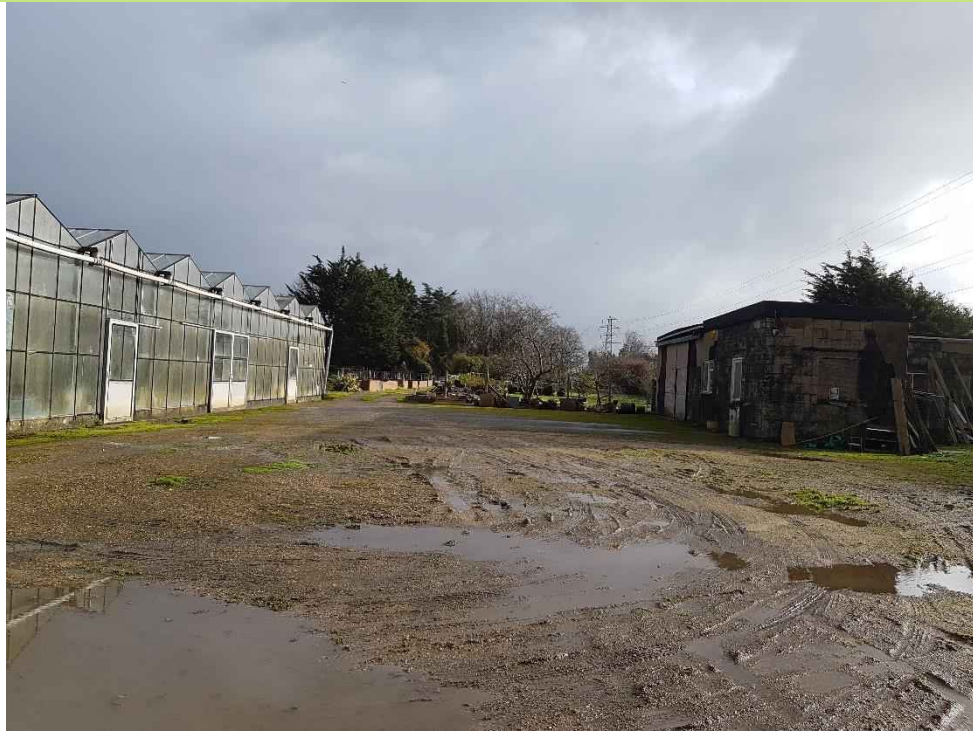
Plate 1 – View looking east across the site with the site office to the south and the greenhouses to the north.

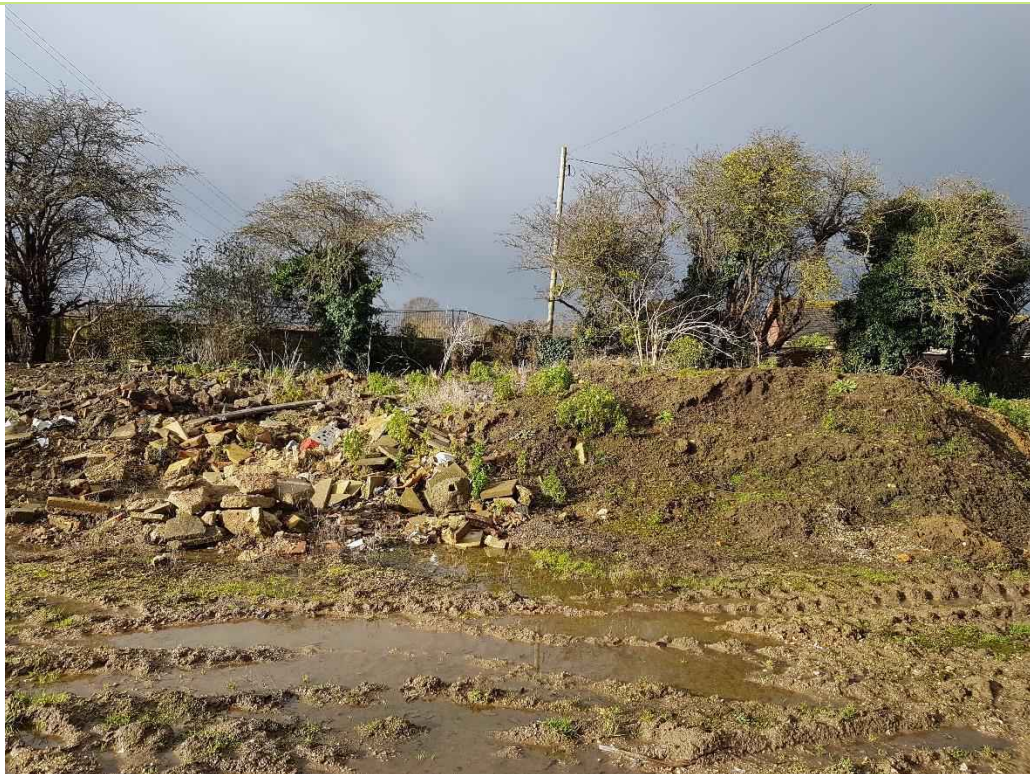
Plate 4 – Building rubble and ear stockpiles along the site's western boundary.

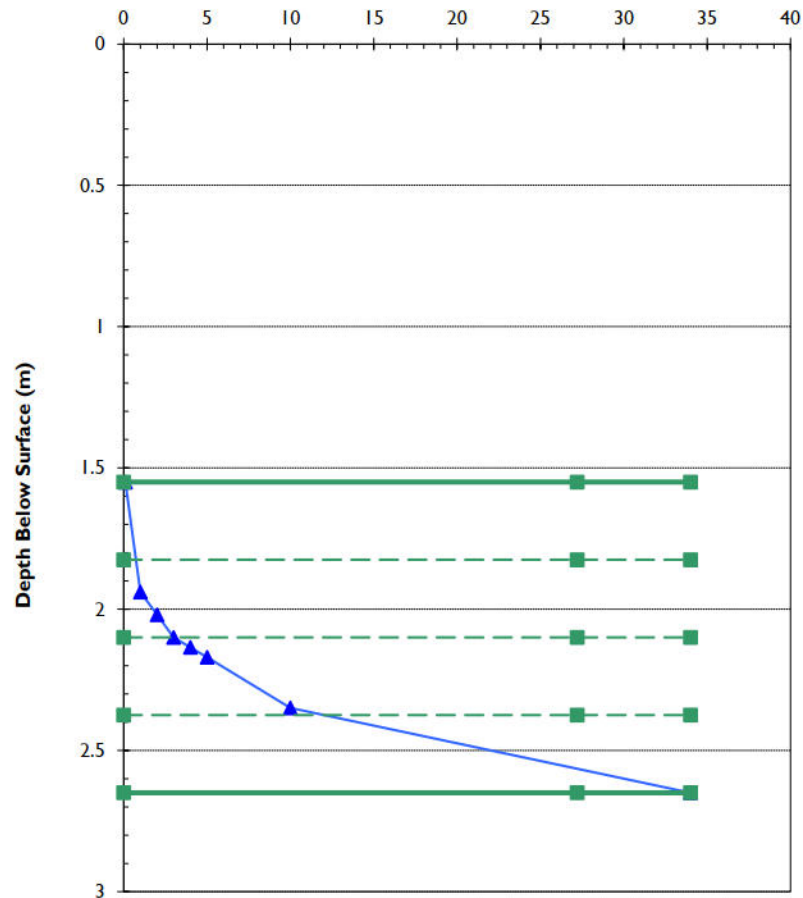
Test Hole No: TP1  
Test No: Test No 1

## BRE Digest 365 - Soakage Test

| BRE Soil Infiltration Rate (m/sec) | 8.62943E-05 |

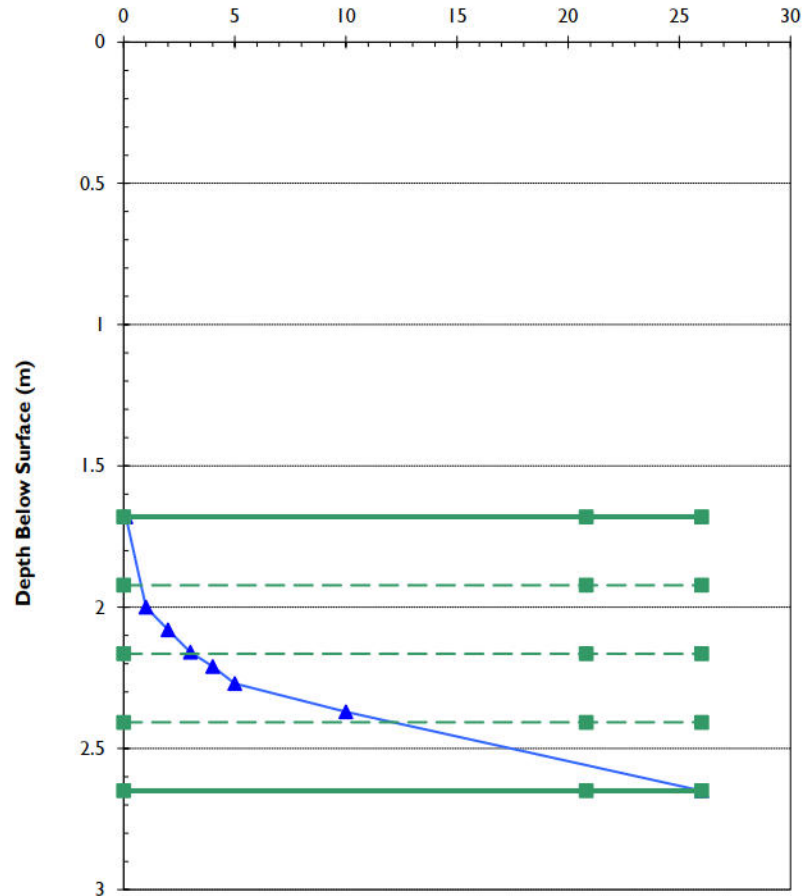
Test Hole No: TP1  
Test No: Test No 2

## BRE Digest 365 - Soakage Test

| BRE Soil Infiltration Rate (m/sec) | 8.22616E-05 |

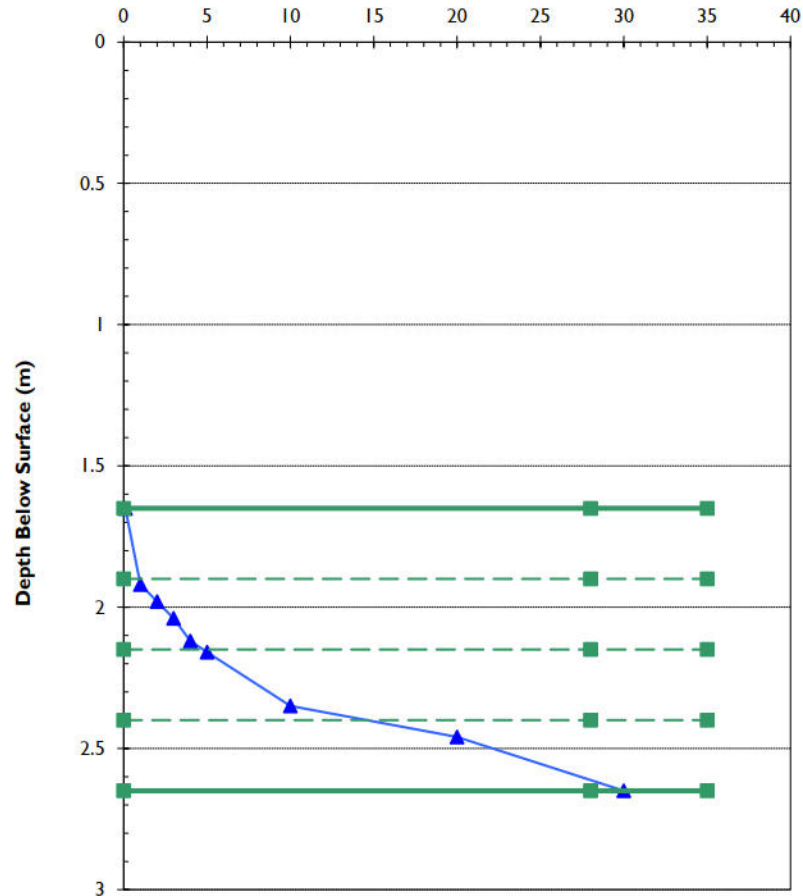
Test Hole No: TP1  
Test No: Test No 3

## BRE Digest 365 - Soakage Test

| BRE Soil Infiltration Rate (m/sec) | 5.0804E-05 |

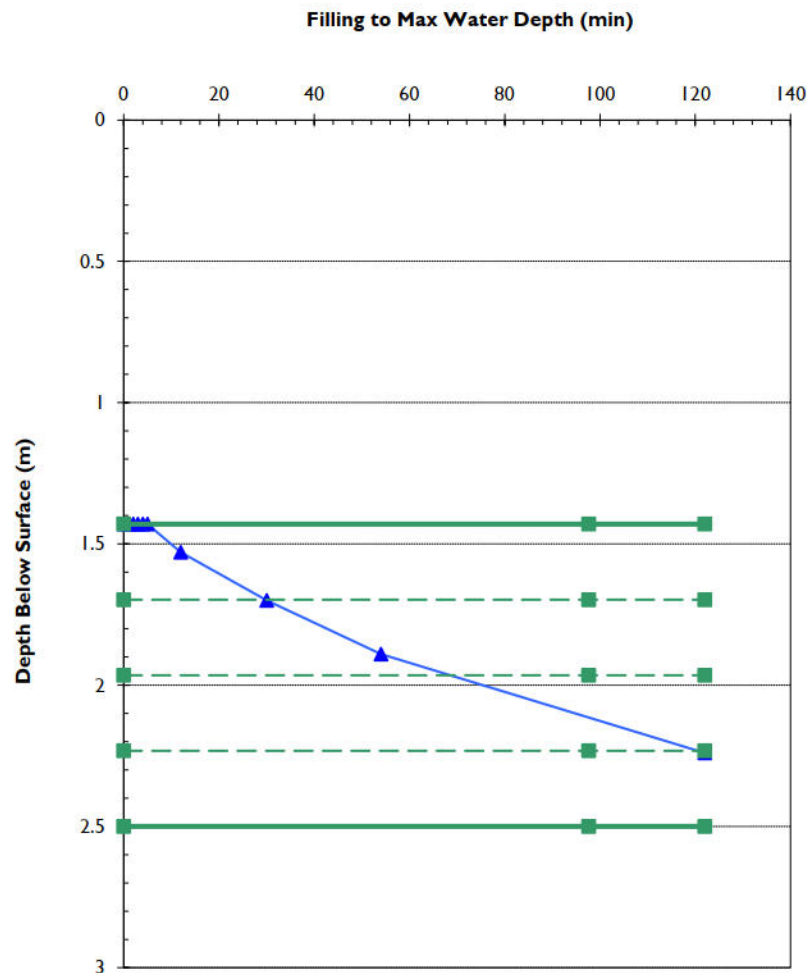
Test Hole No: TP2  
Test No: Test No 1

## BRE Digest 365 - Soakage Test

| BRE Soil Infiltration Rate (m/sec) | 1.05793E-05 |

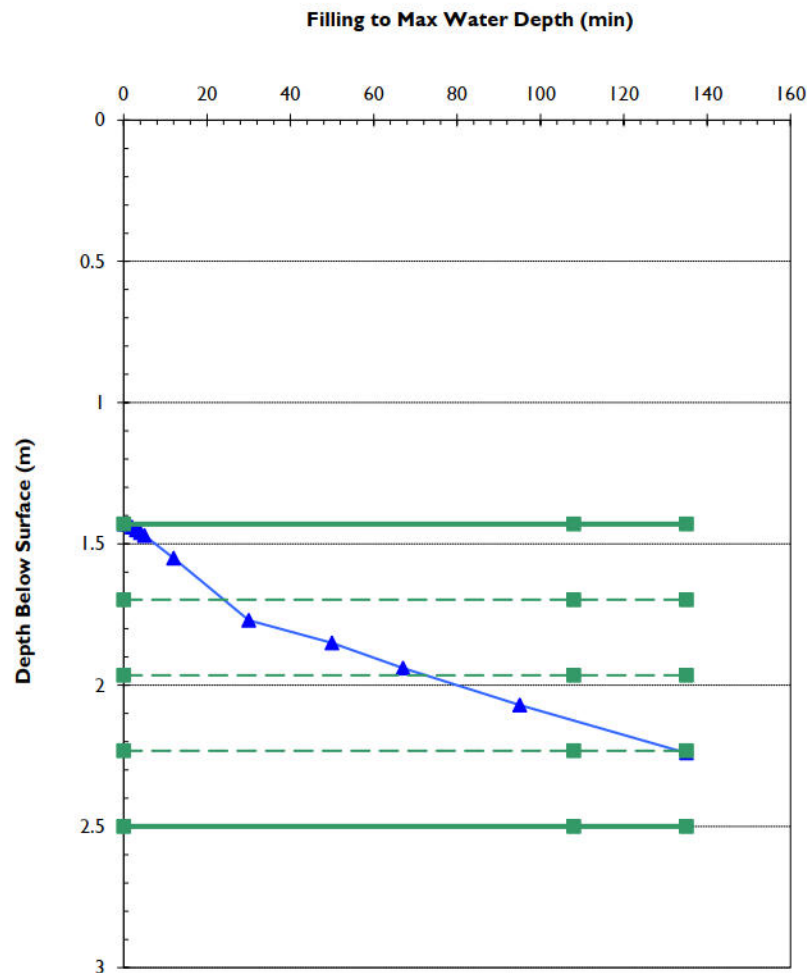
Test Hole No: TP2  
Test No: Test No 2

## BRE Digest 365 - Soakage Test

| BRE Soil Infiltration Rate (m/sec) | 8.80013E-06 |

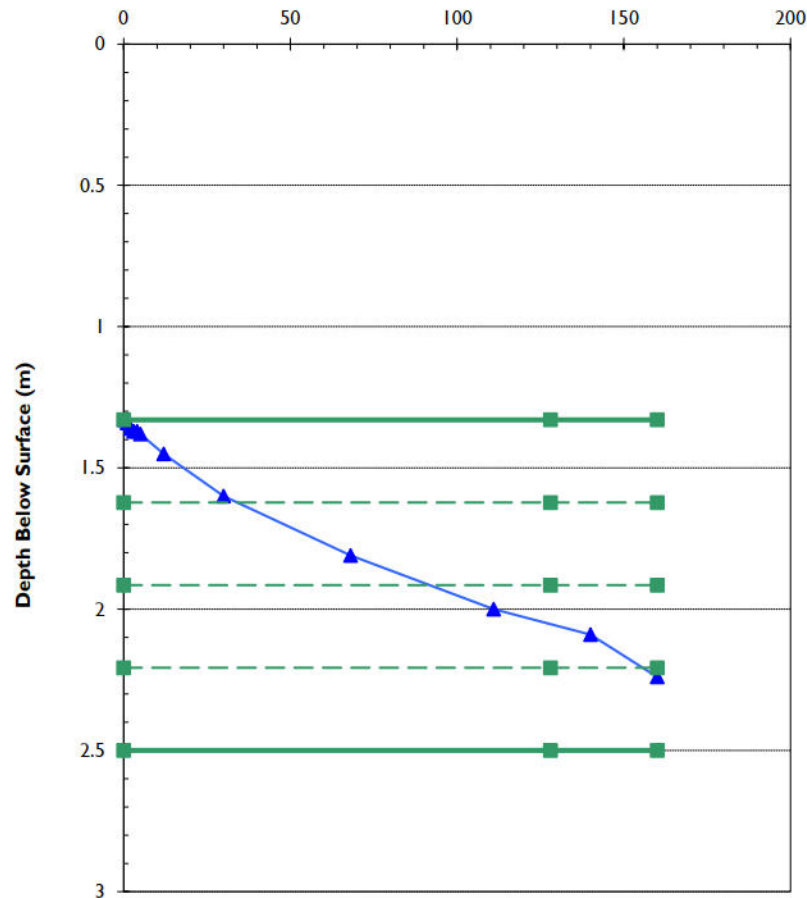
Test Hole No: TP2  
Test No: Test No 3

## BRE Digest 365 - Soakage Test

| BRE Soil Infiltration Rate (m/sec) | 8.11416E-06 |
