## Pigeon House, Angmering

application for planning permission and listed building  
consent for alterations to existing barn and stable

design & access statement and  
supporting documentation

malcolm simmonds architects

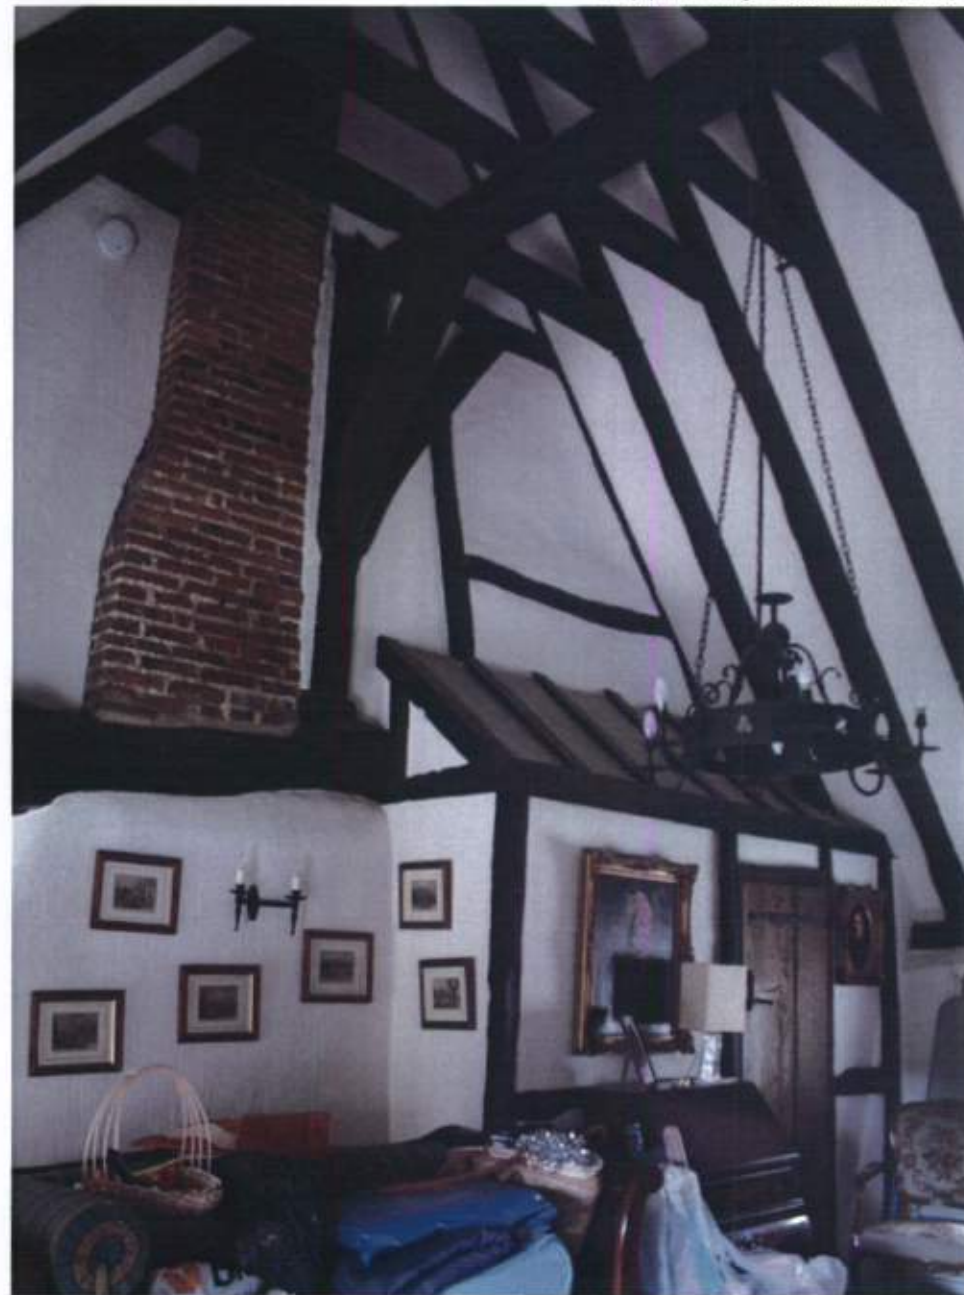
Fig 5: Crown Post roof structure now evident in core of house

This decorated crown post (*Fig.5*) adjacent to the chimney stack sits astride a substantial tie beam (*Fig.6*), once supported upon large arched braces from the, now lost, timber wall framing, these being evidence of a high status open hall house. From the physical evidence, it would appear that the original house was a medieval (pre-1500) two-bay open hall house (forming the core of the present house) with potentially a service range to the north and south ends.

The nature of the detailing of the building does suggest a building of the late 1300's (C.14th). It is noted that the building is narrow in relation to the length of hall and that the loss of all external framing and the fact that wall plates are now underbuilt by later flint walls mean that external form cannot be deduced but the possibility that the house was once aisled is discussed.

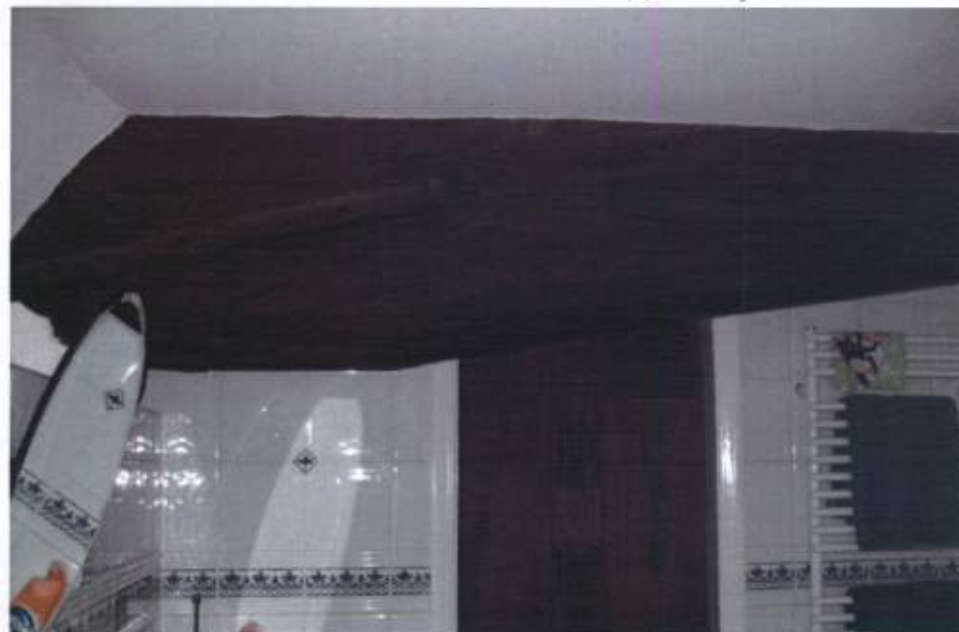
*Fig.6: Base of tie beam to West side of house*

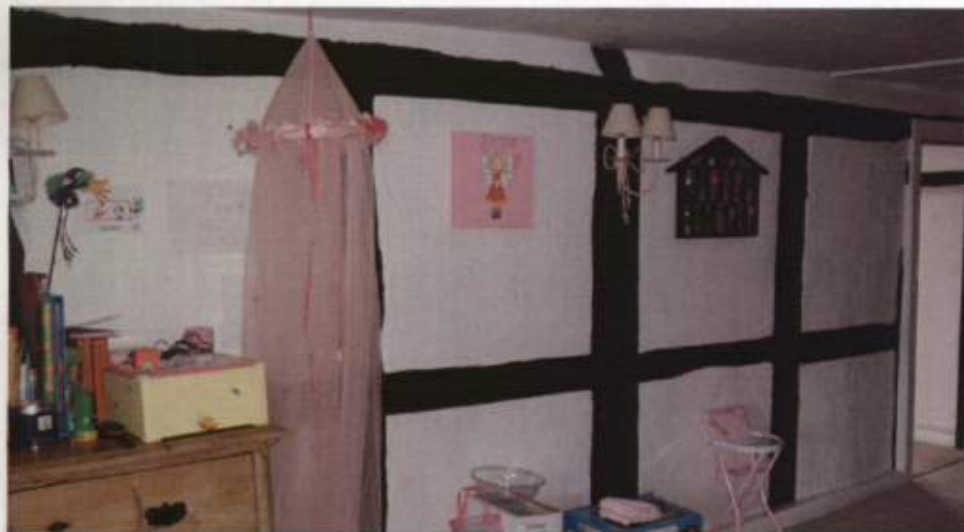
*Fig.7: Former external wall at first floor*

Owing to subsequent alterations, the full extent of the original building is unclear but it appears likely that the timber framed partition to the South of the crown post (*Fig.7*) was (although the timbers have been reset) the original external wall, with a Solar being formed at the northern end, terminating with a hipped roof over. Within the roof, there is evidence of C.16th insertion of a smoke bay (*Fig.8*), probably at the time that the open hall was floored in and possibly the aisles removed (to allow greater light into newly created first floor chambers).

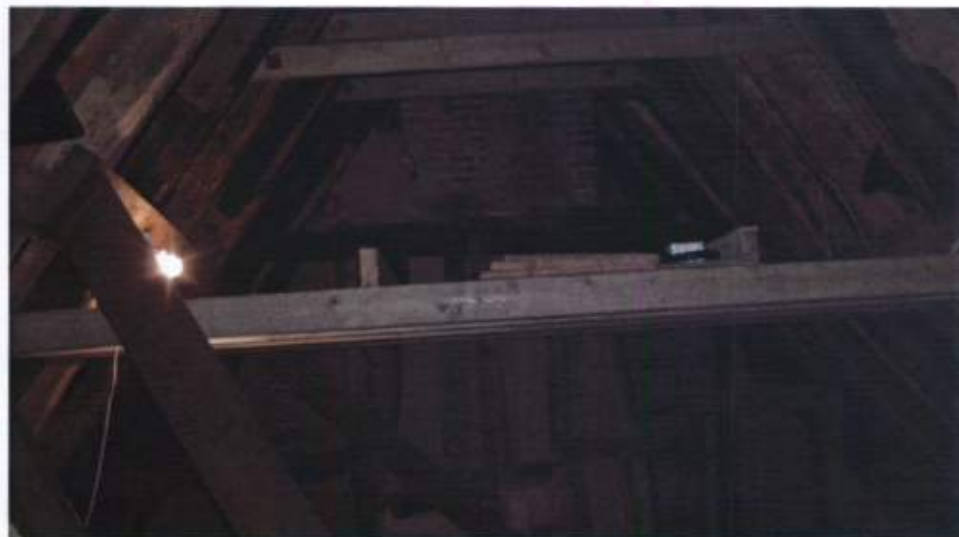
*Fig.8: Remnants of former smoke bay to back of stack*

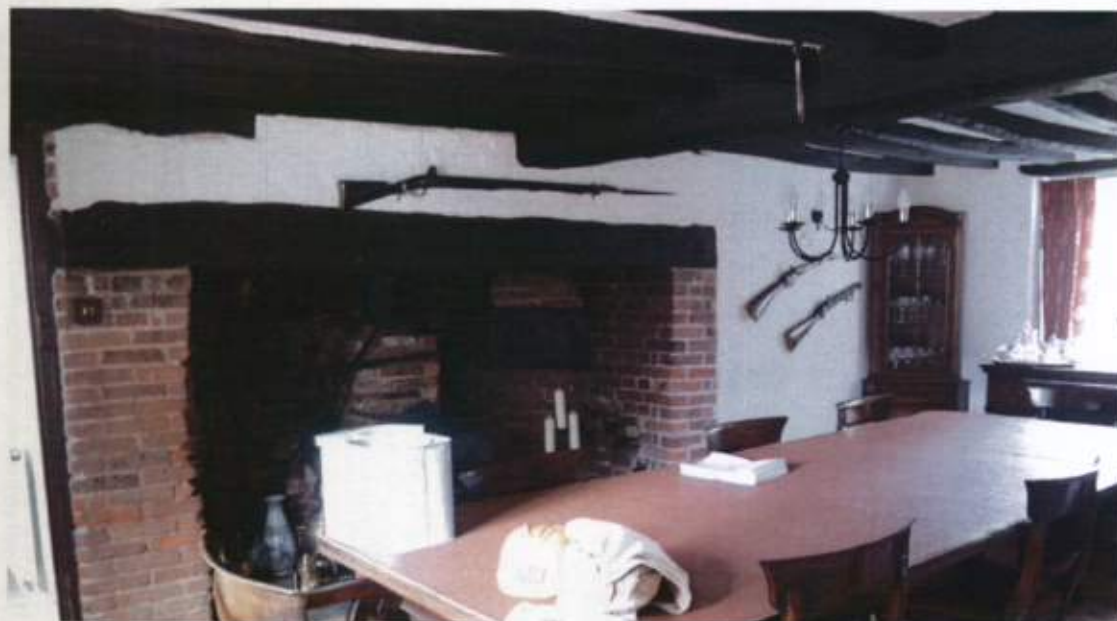
Fig.10: Former cooking hearth within house

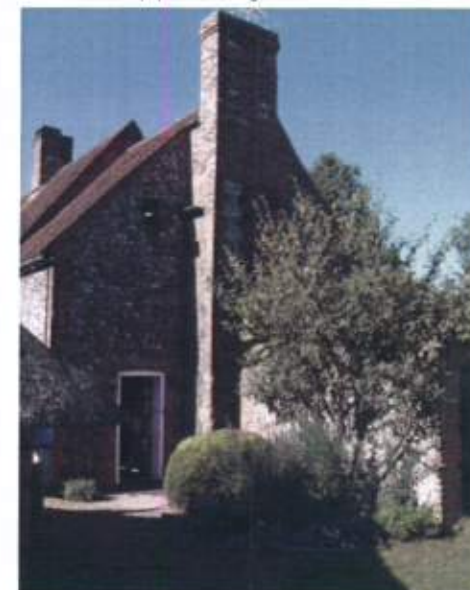
Fig.9: Pigeon House from the North showing different ridge heights

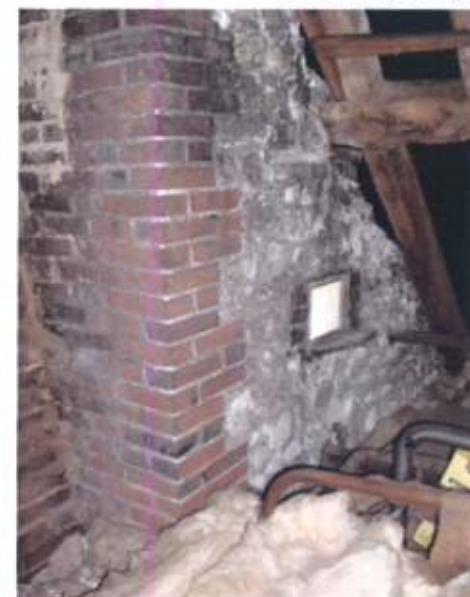
Fig.11: Pigeon loft viewed from within roofspace

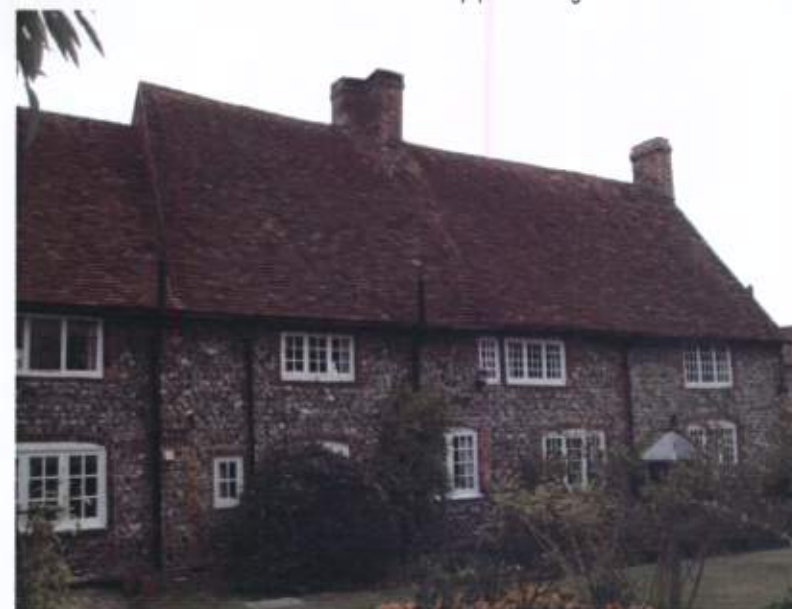
Fig. 13: Rear (West) Elevation; note straight joint to r/h side

The flint refacing of the house is clearly not of one date, that to the North of the stair vyse and to the rear appears earlier until the junction with the southern 'extension', where a straight joint exists (Fig. 13). However the smaller more regular coursing that starts at that point continues around the front elevation to junction with the brick stair (Fig. 14). This may have been some localised refacing to ensure the integrity of the more visual front facade, certainly no other reason presently can be deduced. The fenestration to the house is of differing dates, featuring some earlier leaded lights but generally appearing to be C.18th/19th timber casements with some later replacements. The historical build up of the house is, as presently understood, shown shaded below (Fig. 12).

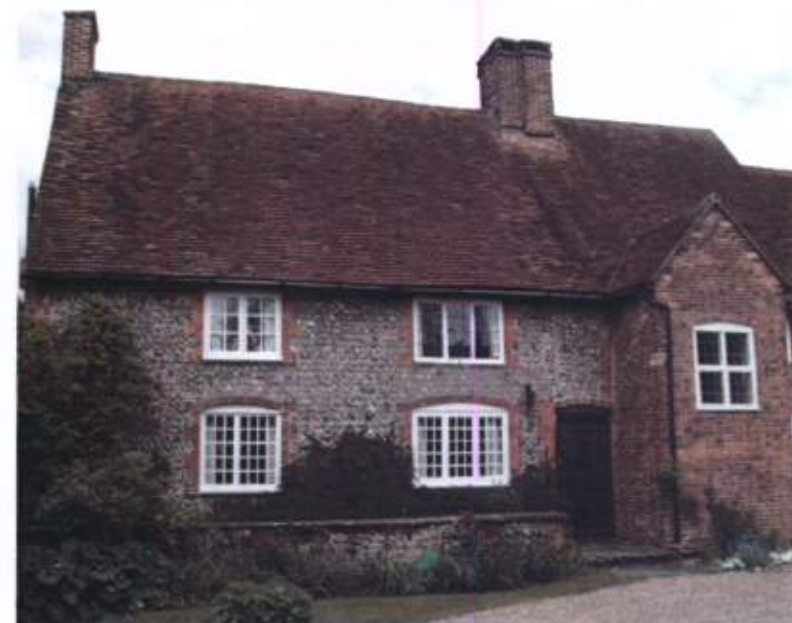
Fig. 14: Front (East) Elevation showing lack of corresponding joint

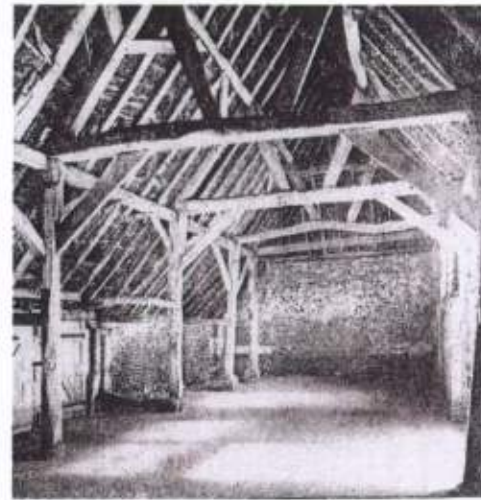
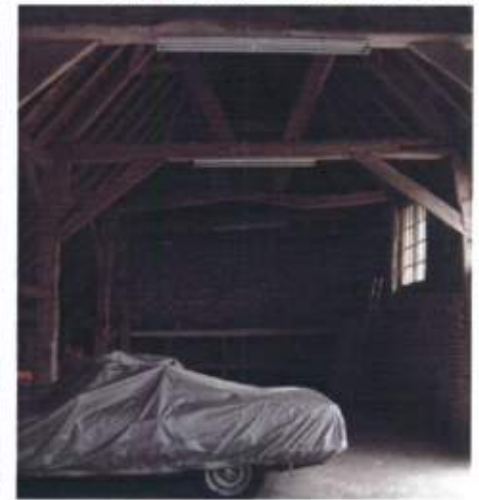
*Fig. 15: Interior of Barn 1937, showing light from large windows still extant on South side.*

*Fig. 16: Interior of Barn*

With regard to the outbuildings, the Barn is listed as being of C.18th date and internally the timber frame (*Fig. 15 and 16*) would support this dating. Parts of the external wall have been rebuilt in flint, possibly coinciding with the first refacing of the main house, being in larger more randomly coursed flints. The front elevation of the barn has two large windows, probably installed when the property ceased to be a working farm and the Barn became ancillary domestic accommodation, they are in evidence in photographs taken in 1937 (*Fig. 15*).

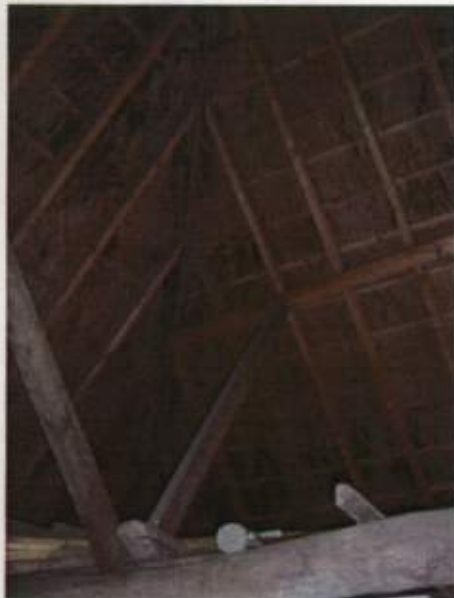
*Fig. 17: Modern roof structure to Workshop*

The Workshop, adjacent to the barn, appears on the 1838 tithe map (*Fig. 22*) to be a separate structure however the flint rear wall and present spine beam appear older than this date although the roof structure is all clearly modern (*Fig. 17*).

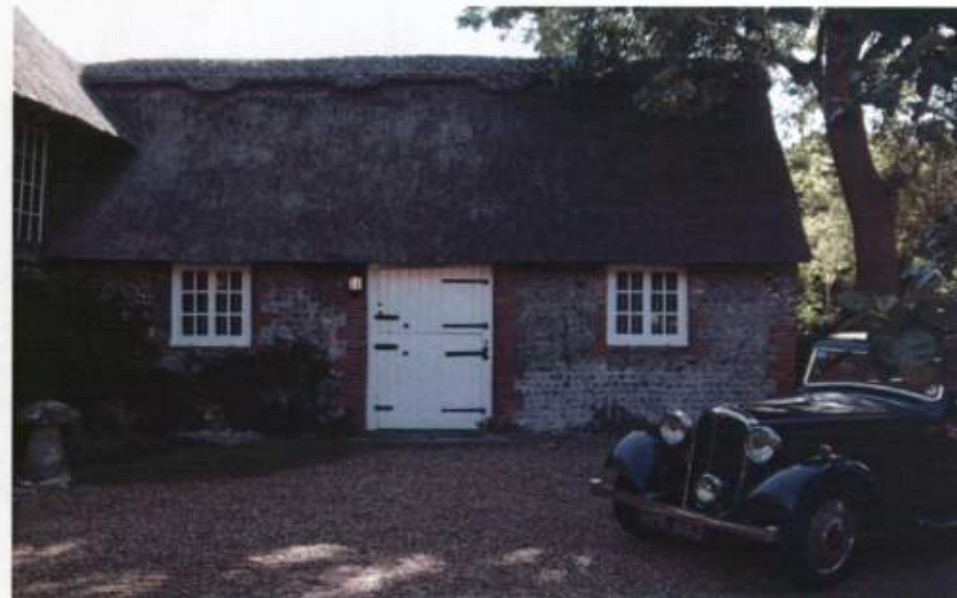
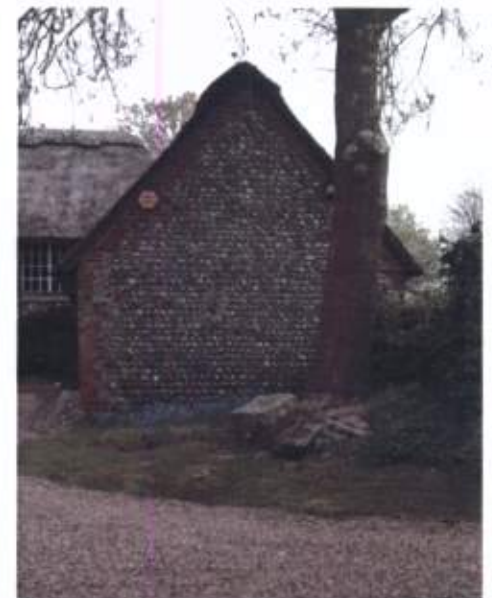
*Fig. 18: Front elevation of Stables*

*Fig. 19: Gable elevation to Stables*

The date of the Stables is less clear, the flint work is generally well coursed small cobbles which match the southern end of the house suggesting that it was built concurrently (*Fig. 18 and 19*). The Cottage is outside of this application but again appears to be a C.19th refacing of a possibly earlier ancillary structure, at the time of the 1937 article (*Fig. 26*) it appears to have been in use as a garage.

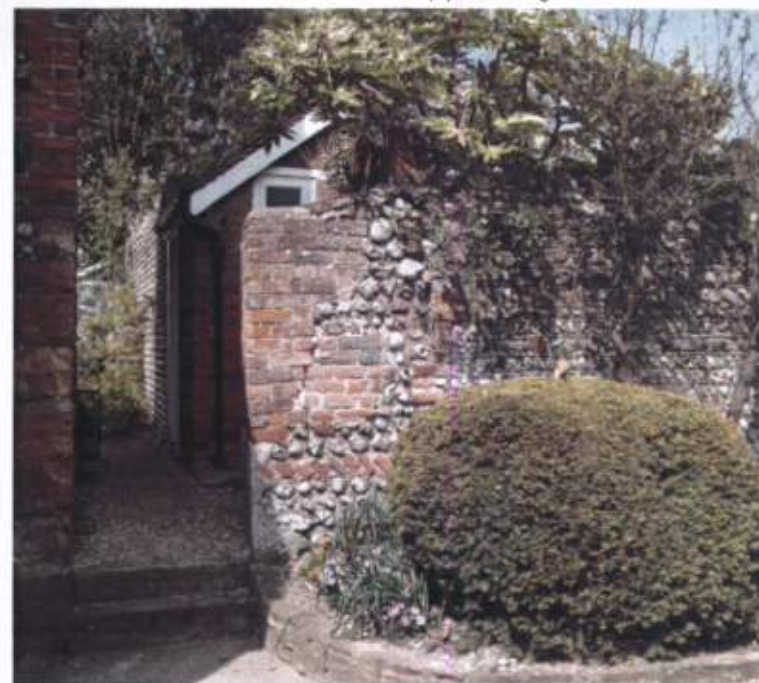
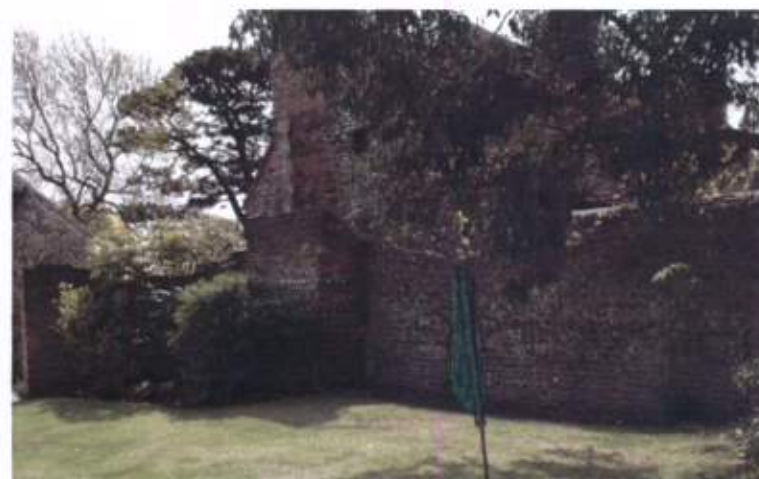
*Fig 20: Garden wall from East showing anomalous returns now forming an outdoor privy*

*Fig.21: Garden wall from North showing anomalous returns now forming an outdoor privy*

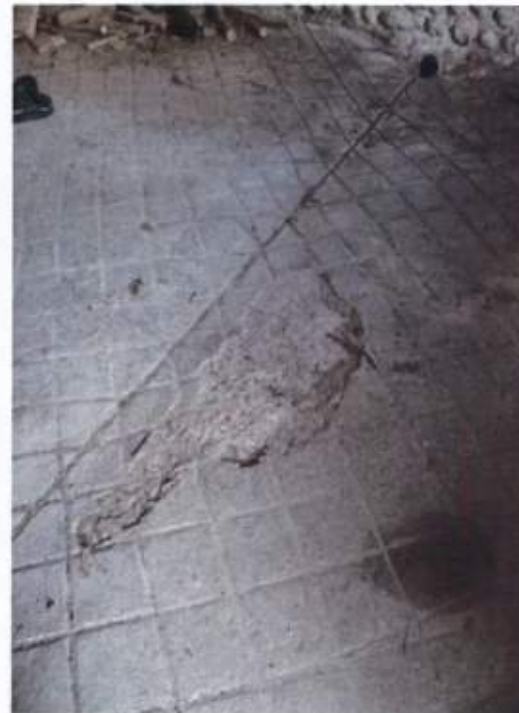
Fig.33: Existing grooved concrete floor to Stable showing deterioration

It is proposed to convert this to a Home Office / Library. Again, the plan form of the space would remain as is and the walls be insulated & dry-lined. The retention of the Stable's 'pavours' was discussed with Arun District Council and West Sussex County Council however on closer inspection these are actually grooves cast into a concrete screed, probably only of mid C.20th date (Commander Molson owner 1934 - 1939 was an Equine enthusiast and it is likely that these date from this time.) and as the screed is in poor condition it's removal and replacement with a new insulated slab and quarry tiles would be preferable.

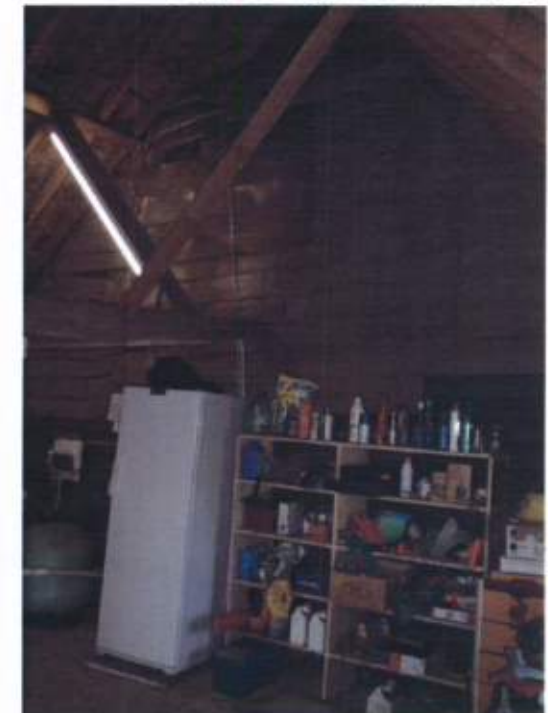
Fig.34: Timber clad adjoining wall of Workshop to Barn  
Note C.20th roof structure

The existing C.20th roof structure would remain unaffected with a new ceiling located above the existing tie beam to enclose the space. (See Fig. 34)

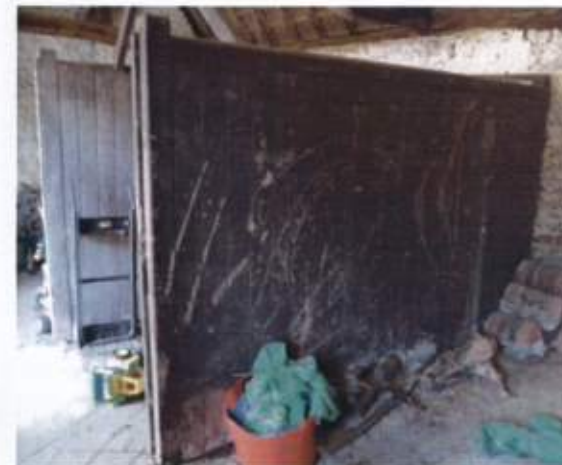
Fig.35: C.20th softwood stall within Stable

It was agreed with Arun District Council and West Sussex County Council that the existing stalls would be carefully set aside & relocated as a form of panelling within the room. (See Fig. 35)

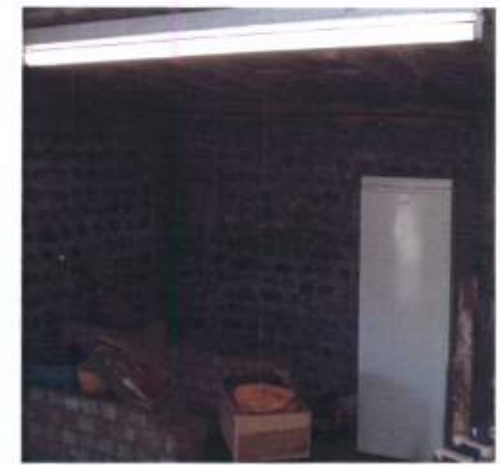
Fig.36: Northwest corner of Workshop, note  
C.20th low levels walls

It is proposed to convert this to a Utility room and the plan form of this space would remain unaltered, however the low C.20th walls in the NW corner (See Fig. 36) would be removed. The present C.20th concrete floor would be removed and an insulated slab laid. The walls would be dry-lined and insulated, a new wall to the barn (East) side of the room built inboard to avoid affecting the barn.
