Pound Place, Angmering

Extended Phase I Habitat Survey, Bat Building Assessment and  
Bat Emergence Survey

Hallmark Healthcare

March 2018

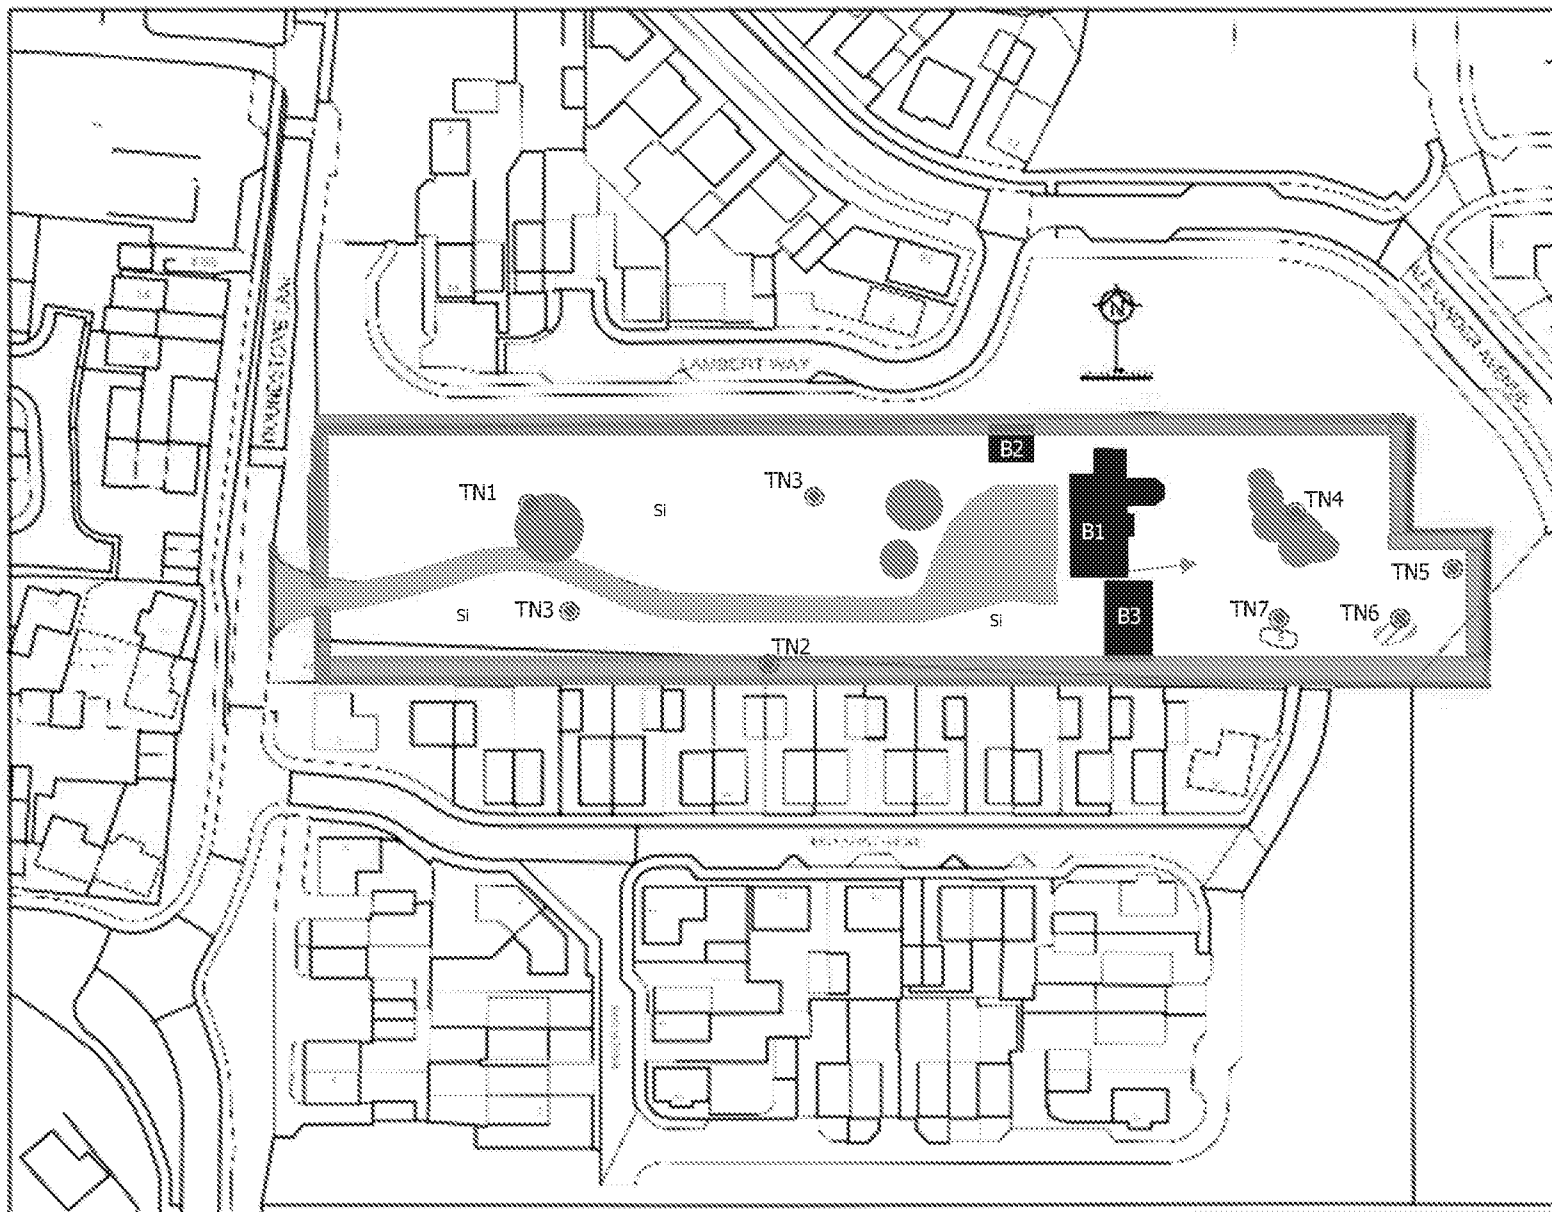
- TN4 Target note
- Scattered trees
- SI Semi-improved grassland
- Tall ruderal
- Access drive
- Spoil/log pile
- Hedgerow
- B1 Building number
- Pipistrelle emergence

3.2.2 The habitats present are shown within Figure 1 with further details provided by way of specific Target Notes, denoted by the letters TN.

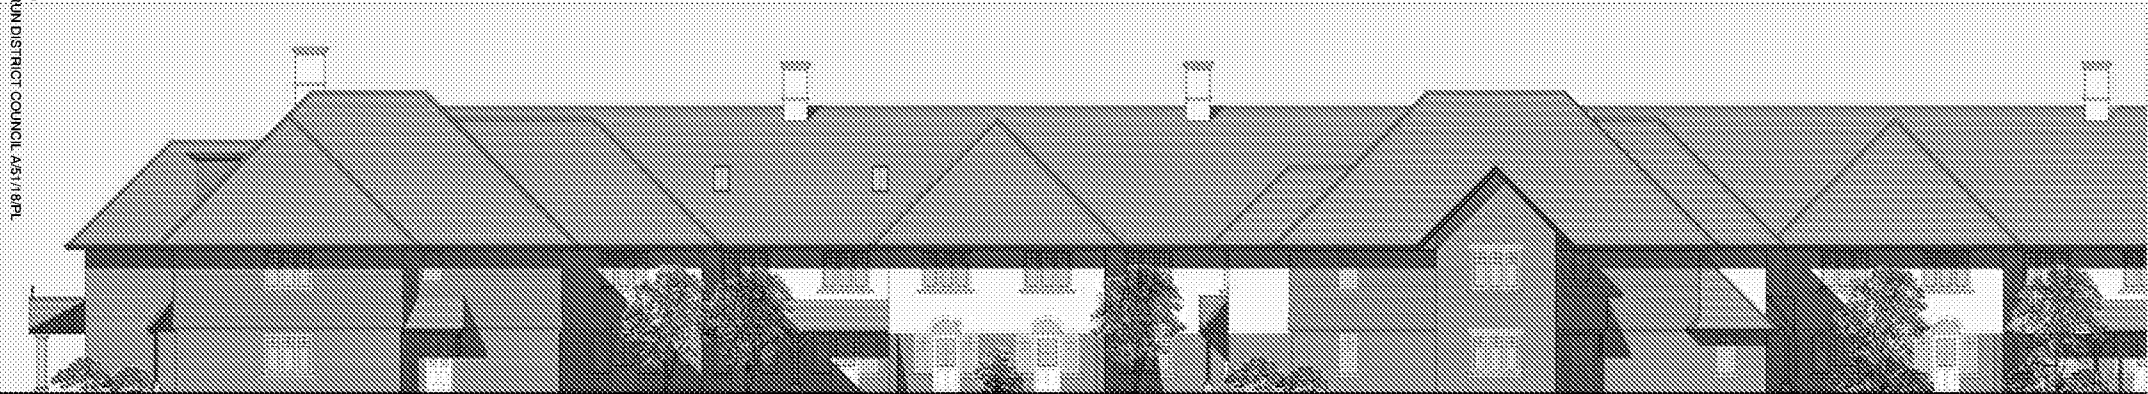
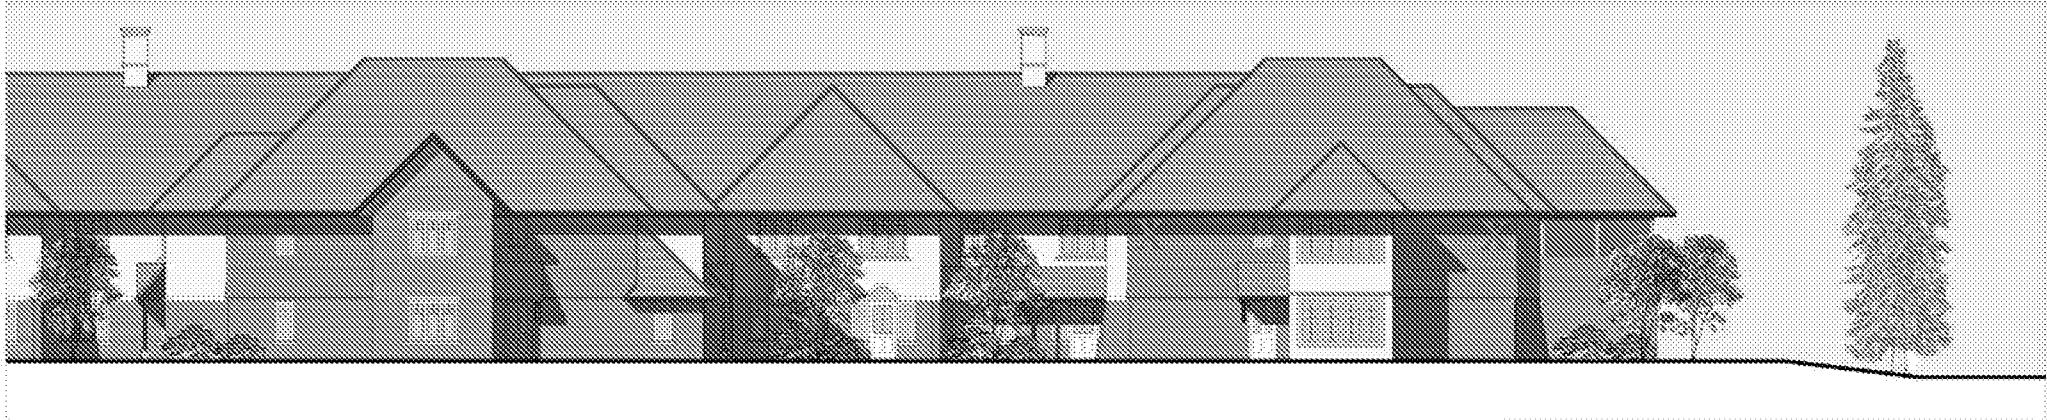
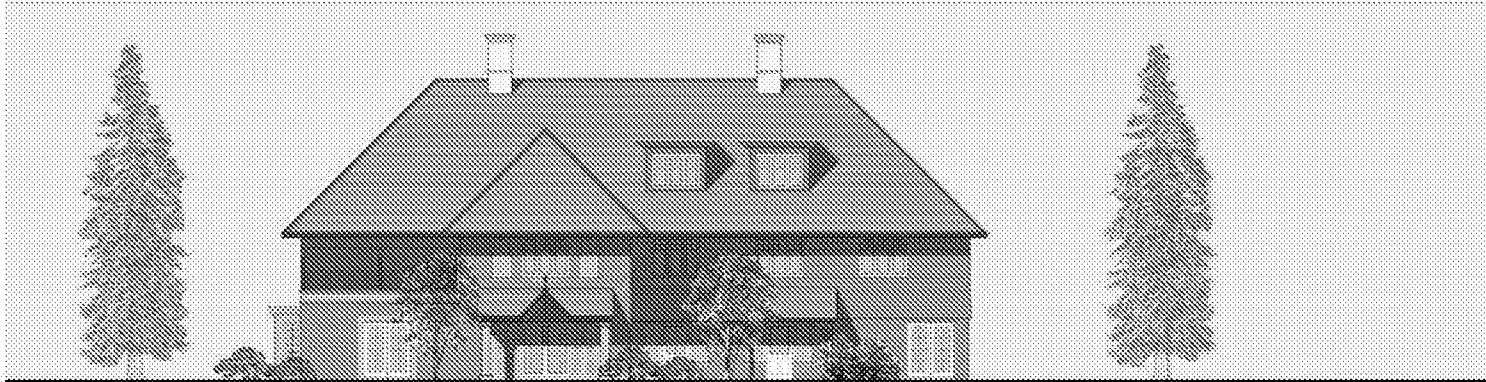
Figure 2 - Location of bat boxes

**SOUTH ELEVATION to Brougham Grove**

Two Schwegler 1FR Bat Tube. To be positioned on the southern elevation as close to the eaves as possible.

**WEST ELEVATION to Roundstone Lane**

7. Two cavity bat boxes (Schwegler 1FR bat tube) are proposed on the southern elevation (recommended locations are shown on Figure 2), one as compensation and one as an enhancement measure. The roost compensation and enhancement will be checked by the project ecologist prior to submitting the licence return.

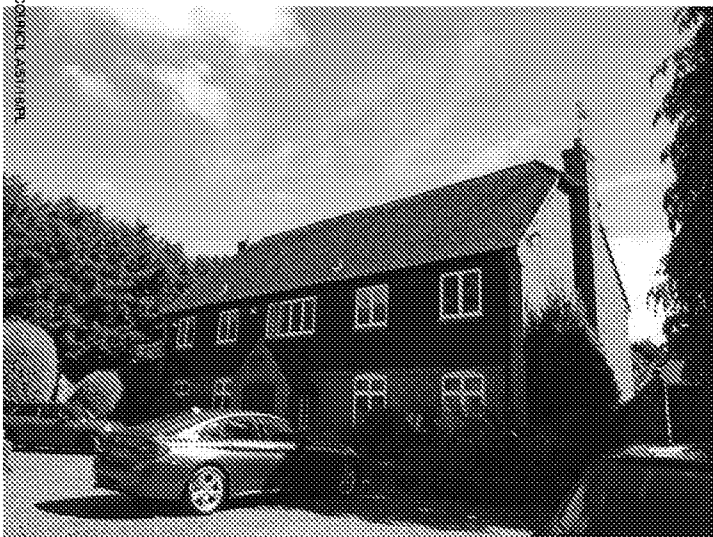
Building B1 - main house

- 3.4.2 The main house is constructed of brick, with a half-hipped pitched roof. The main roof has a north to south axis. The house has weatherboarding on the first floor; many of these boards are lifted and raised on all elevations. The roof has traditional clay tiles throughout, some of which are missing, raised or slipped. There are two single-storey extensions, on the eastern elevation and the northern elevation. *Pipistrellus Pipistrellus* spp. and long-eared bat *Plecotus* spp. droppings were found on the window frame on the eastern elevation.
- 3.4.3 Internally, there are no roof voids and any attic rooms have been converted into living spaces. No evidence of bats was found.
- 3.4.4 The main house is considered to offer 'Moderate' potential to support bats under the Bat Conservation Trust Survey Guidelines (Collins 2016).

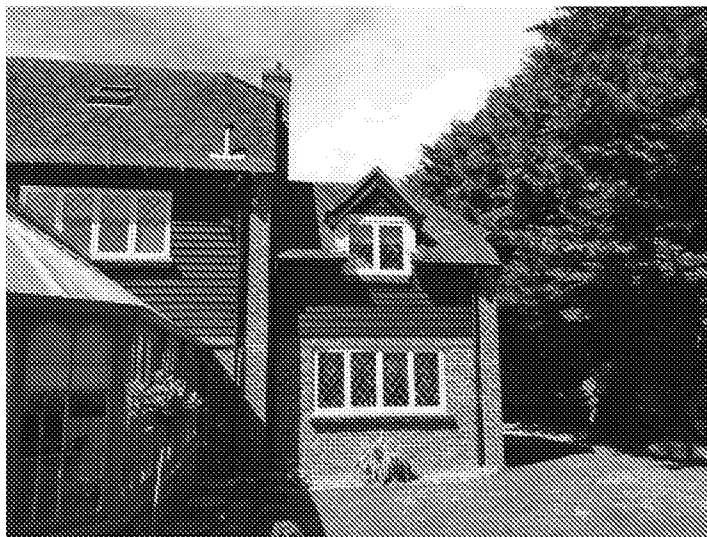
Building B1 - main house

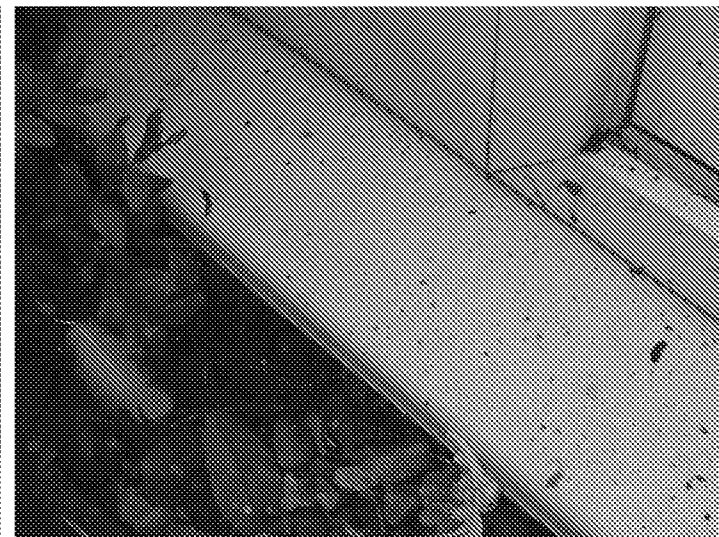
Bat droppings - building B1

4.2.1 During the bat building survey evidence of pipistrelle and long-eared bats were found along with potential roosting features. As no roof spaces are present then there are no features suitable for void dwelling species and the potential is for crevice species only. The surrounding habitat is poor for bats and therefore the building was awarded 'Medium' potential under the BCT guidelines and this would equate to two surveys being undertaken between May and August.

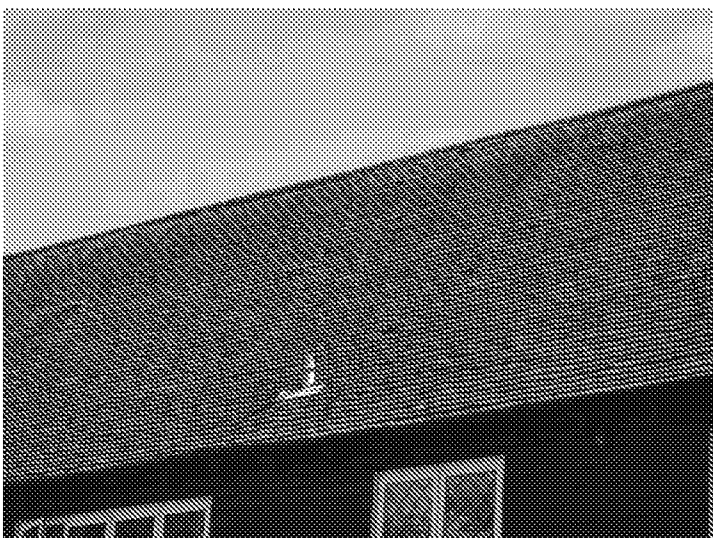
Building B1 - roof tile with gaps

4.2.2 Emergence surveys have confirmed the presence of a small roost of pipistrelle bats recorded under the roof tiles but this was only recorded during the second survey and therefore the roost is considered to be infrequently used. As the building will be demolished under the Site proposals then the Site would need to be registered under the Low Impact Bat Licensing scheme.

4. The stripping of roof tiles will be supervised by the project ecologist. Once the tiles have been removed works to remove and replace the building can continue without interruption.

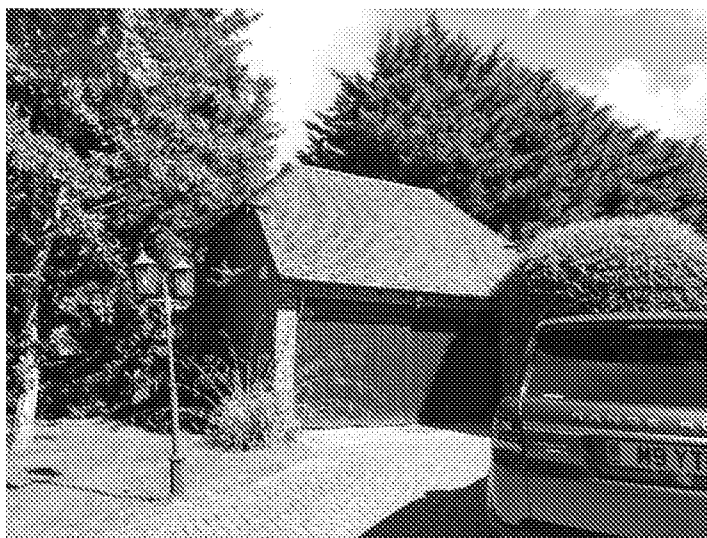
Garage building - B3

- 3.4.5 To the north west of the main house lies a detached single-storey detached garage constructed of brick. The roof is half-hipped and pitched, with an east to west axis. The roof has clay tiles, some of which are missing or raised. Along the northern side of the property there is dense hedgerow which restricted access during the survey. Internally, there is no roof space and no evidence of bats was found.
- 3.4.6 This building is considered to have 'Moderate' potential to support crevice dwelling bats.

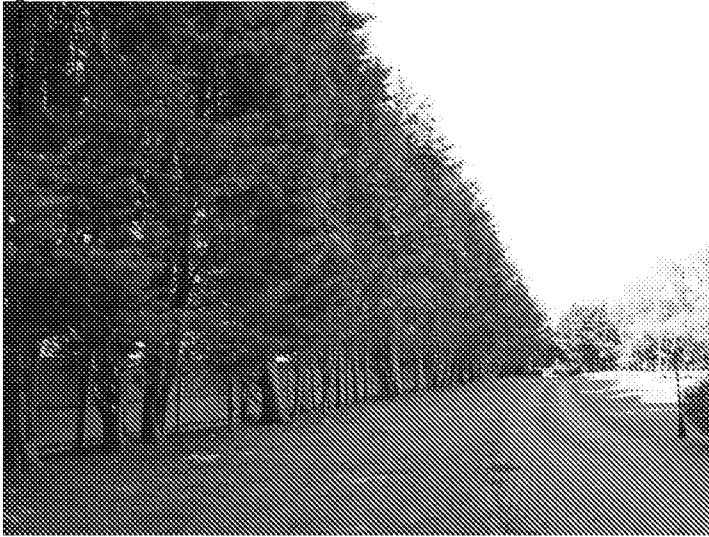
Hedgerow - southern boundary TN2

- 3.2.8 Running around all four sides of the Site are semi-mature non-native hedgerows of western red-cedar *Thuja plicata* (TN2).

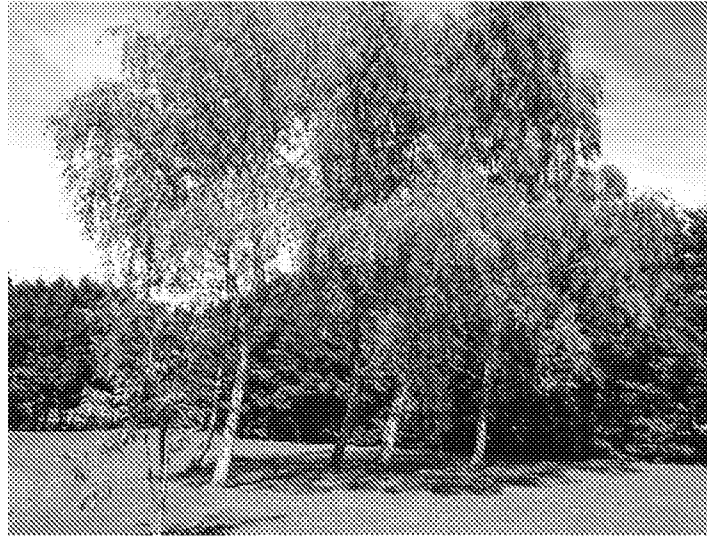
Scattered trees - TN1

- 3.3.2 The Site contains a number of scattered trees which have been assessed for their potential to support bats. The silver birch trees of TN1 are semi-mature but no features suitable for roosting bats were evident. These trees have 'Negligible' potential to support bats.
- 3.3.3 The hedgerows surrounding the Site (TN2) are lines of semi-mature western red-cedar, all of which are multi-stemmed and not large enough to support bat roosting features. These boundary hedgerows are considered to have 'Negligible' potential for roosting bats.

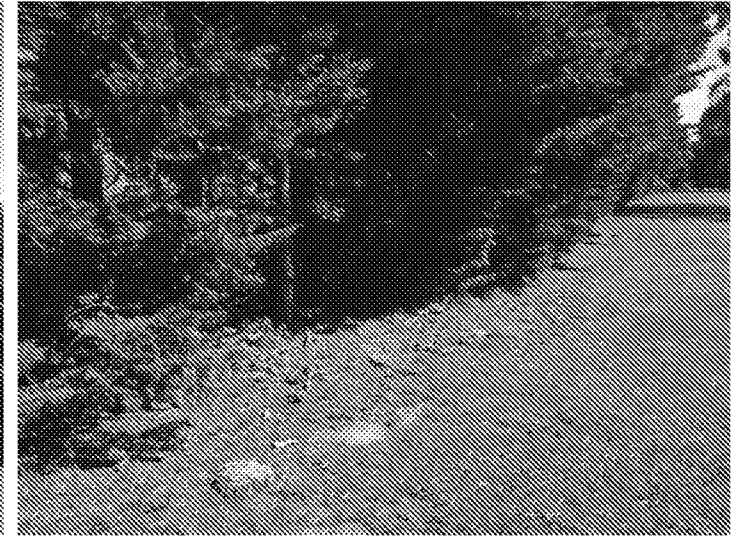
Sparse ground cover beneath boundary hedgerows

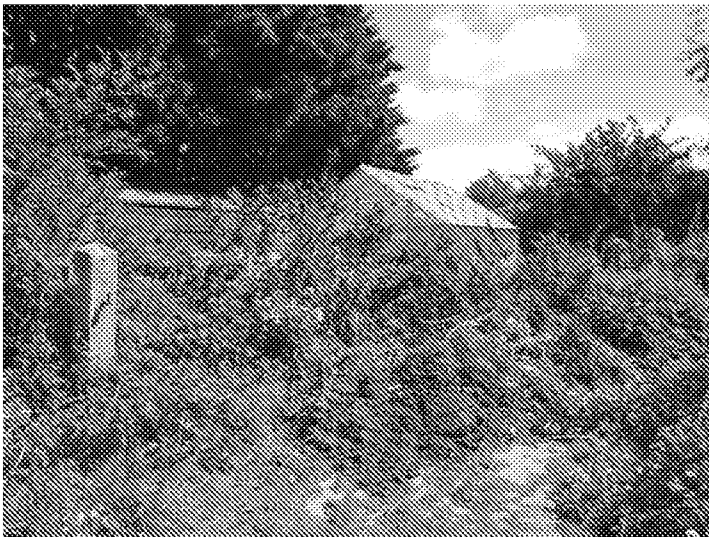
Overgrown tall ruderal vegetation TN5

3.2.3 The Site contains an overgrown area (TN5 on Figure 1), located at the eastern boundary of the Site. This area is dominated by common nettle *Urtica dioica* with bristly oxtongue *Helminthotheca echioides*, pendulous sedge *Carex pendula*, butterfly-bush *Buddleja davidii*, red dead nettle *Lamium purpureum*, bramble *Rubus fruticosus*, spear thistle *Cirsium vulgare* and Yorkshire fog *Holcus lanatus*. This area also includes spoil piles, a compost heap and log piles, with some open areas of unmanaged grass dominated by Yorkshire fog.

- 3.3.4 The area of overgrown vegetation (TN5) has margins of unmanaged grassland and contains bramble scrub with spoil piles, a compost heap and log piles. Such areas could provide cover for common species of reptiles, such as slow worm, with grassland margins suitable for basking. However, the majority of the Site is comprised of closely mown lawn areas and, in addition, the Site is isolated from any other areas of suitable habitat for reptiles and is surrounded by a construction Site. Therefore, the potential of reptiles being present within the Site is considered low.

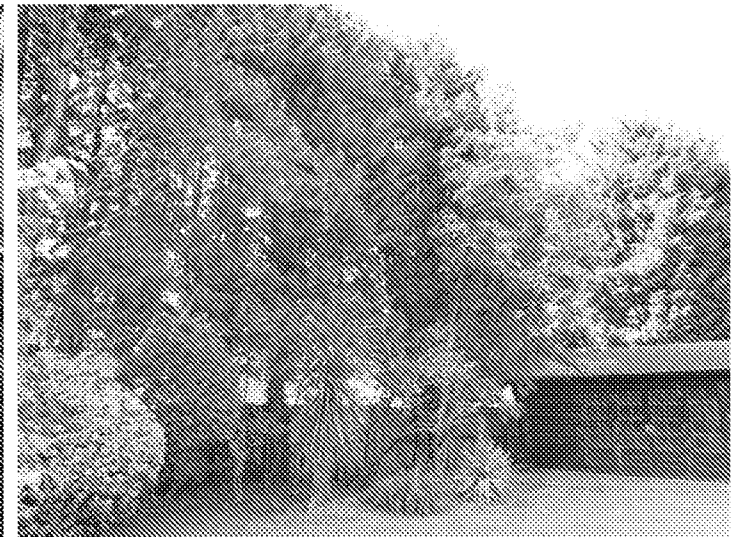
Boundary trees close to pool house - B2
