**The Laurels  
Dappers Lane  
Angmering  
West Sussex**

**Ground Contamination  
Risk Assessment Report**

| Document Control | | | |
|---|---|---|---|
| R18-13291 | 14 <sup>th</sup> Nov 2018 | Final for issue | |

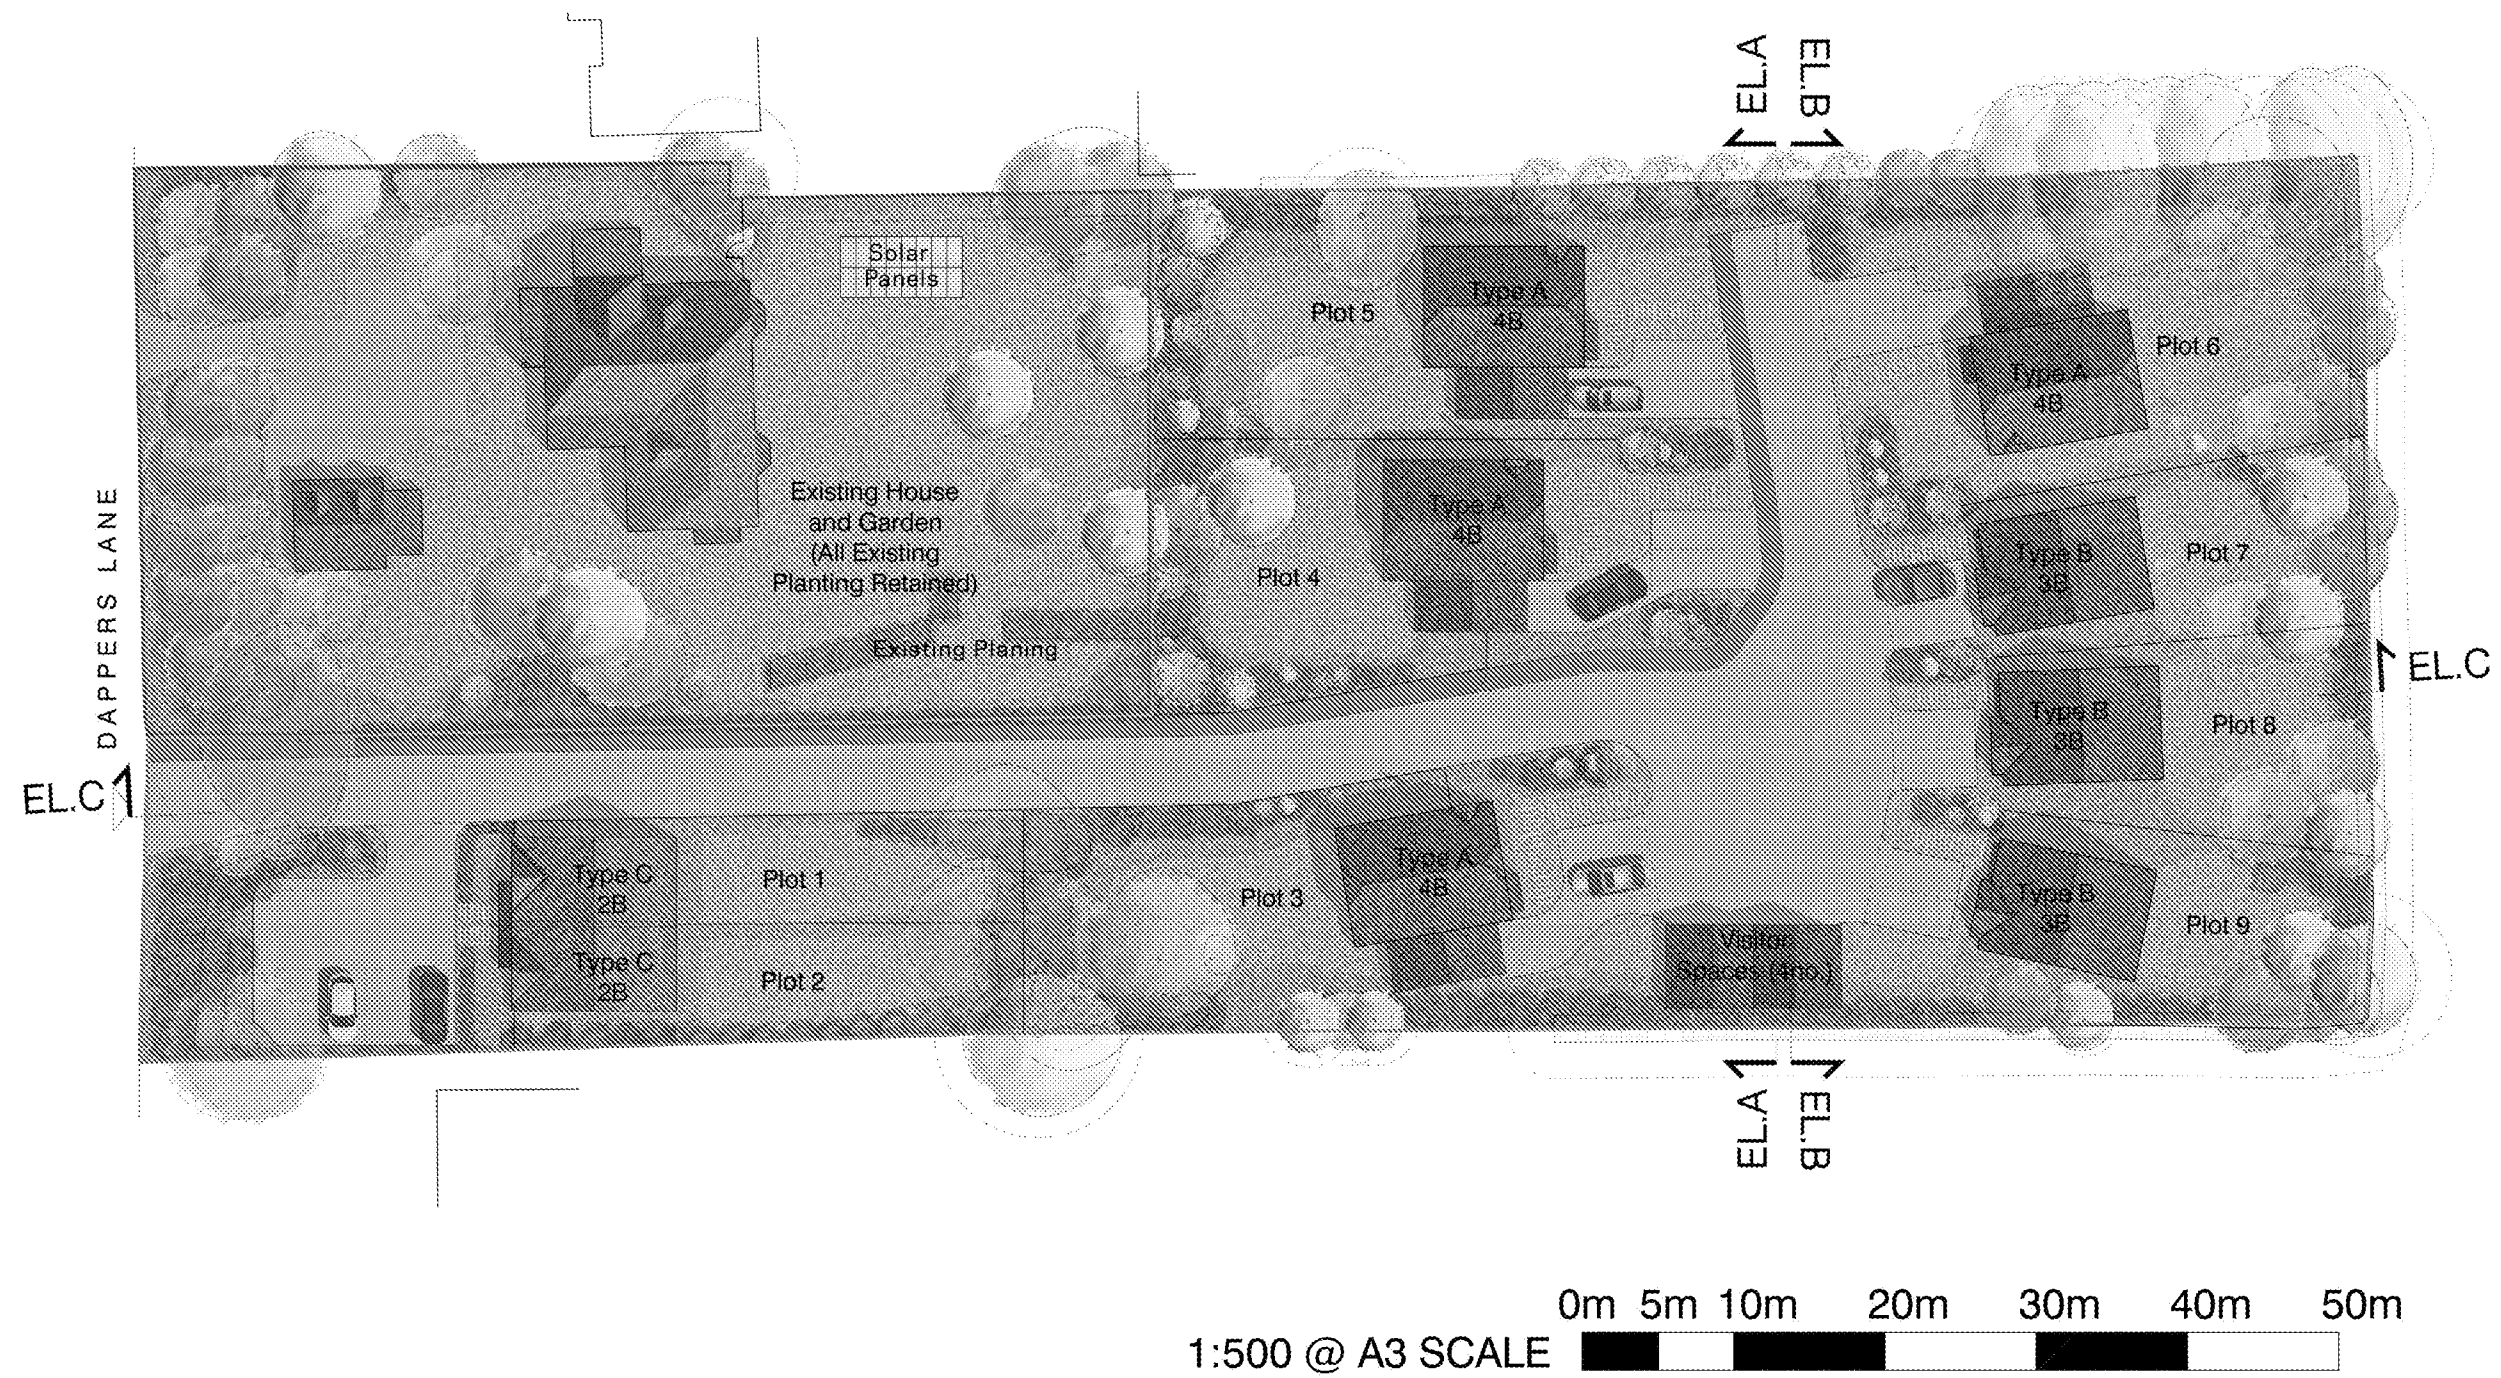
Drawing number:  
0242/P009

Drawing name:  
Master Plan For 9 Units

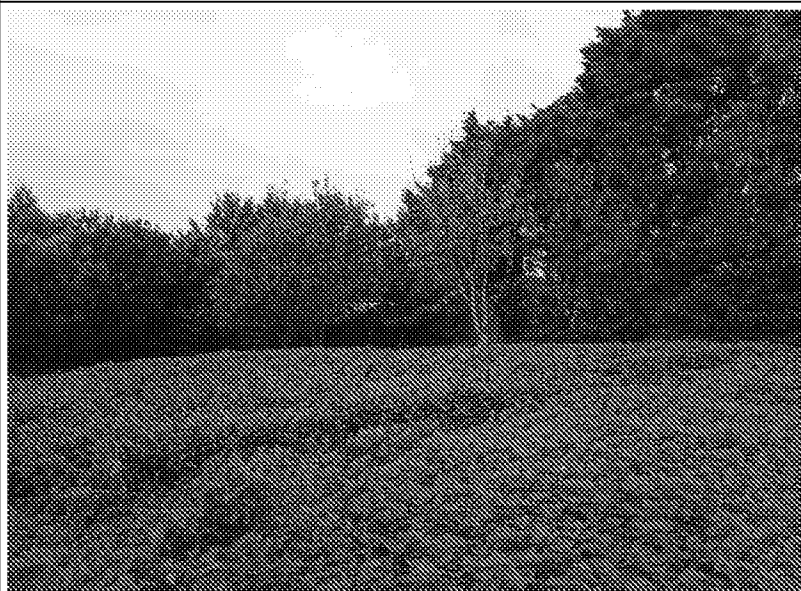
The larger, eastern portion of the site was found to be overgrown with vegetation and some small trees. No existing structures were evident in this part of the site. An above ground storage tank was observed approximately 2-3m beyond the boundary of the northeast corner of the site.

Looking north-eastwards across eastern portion of site.

Due to the presence of numerous mature trees within areas of proposed soft landscaping it is recommended that the local Tree Protection Officer should be consulted at an early stage to ascertain whether any of these trees are subject to tree protection orders, as remedial measures

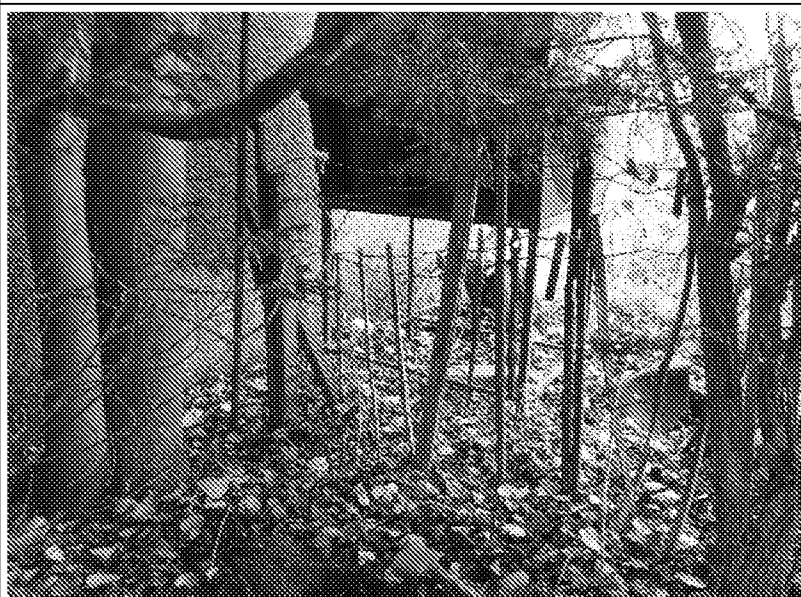
It is noted that the made ground sample from trial pit TP02 at 0.50m depth recorded a total hydrocarbon concentration in excess of 1000mg/kg, although no suspected fuel odours and/or visual indications of hydrocarbon contamination were observed at this location. In addition, no suspected fuel odours and/or visual indications of hydrocarbon contamination were noted at exploratory hole HA1, which was positioned close to an above ground storage tank located off-site to the northeast.

Above ground storage tank observed adjacent to northeast of site.
