## Desk Study, Site Investigation & Risk Assessment Report

Site: Land South of Mayflower Way, Angmering

Client: Angmering Community Land Trust

Project Reference: J13227

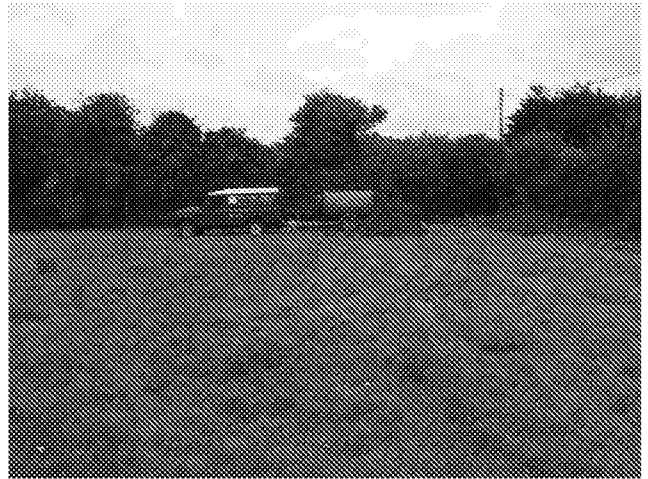
BRE365 test in progress

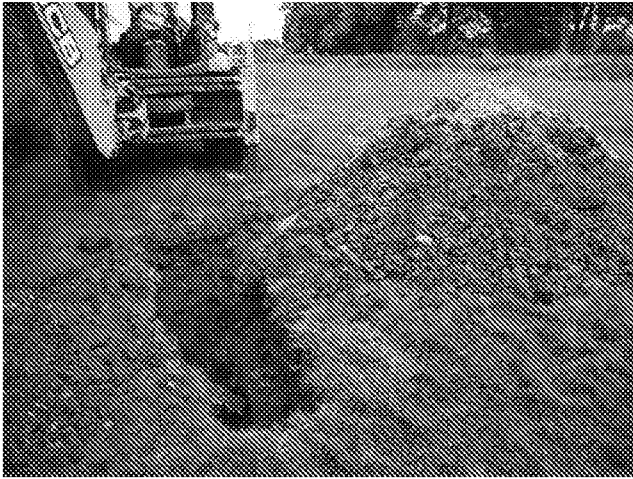
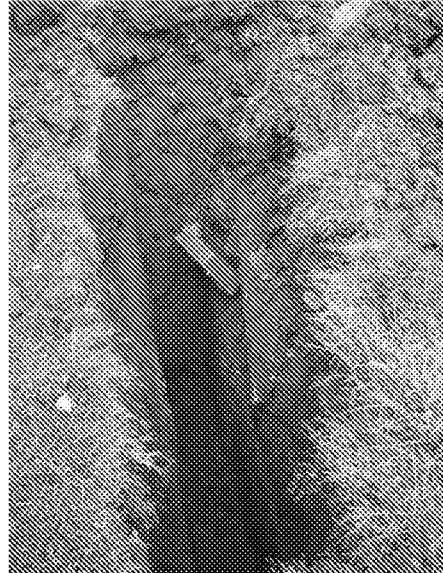
Asbestos containing materials in the form of suspected asbestos cement fragments were observed in the made ground soils at the location of TP101 and TP105.

| | | | | <b>Start - End Date:</b><br>24/07/2017 | | <b>Project ID:</b><br>J13227 | | <b>Machine Type:</b><br>JCB 3CX | | <b>TP105</b><br>Sheet 1 of 1 | | |
|---|---|---|---|---|---|---|---|---|---|---|---|--|
| 0.40 | ES | | | (0.75) | | 0.75 | Grass over MADE GROUND comprising grey-brown mottled black silty sandy CLAY with abundant re-inforced concrete posts, metal fragments, rubber tyres, glass, timber and plastic.<br>Fragments of asbestos containing materials in the form of cement sheeting were observed. | | | | | |

Both fragments of asbestos containing materials and loose fibres of chrysotile asbestos were detected in the made ground samples tested to date. These material are not considered suitable to remain on site and will require further delineation and removal from site.

At this stage, without any further works, we would recommend that the shallow soils from across the subject site be stripped down onto natural soils and removed from site. In areas where made ground soils are in excess of 600mm thick, these soils, in areas of private gardens, should be stripped down to 600mm below finished levels and a detor to dig layer installed, with levels made up with site won clean soils and imported clean, certified topsoil.
