# Land west of Arundel Road, Angmering

Preliminary risk assessment

Project no. 301954 R01 (00)

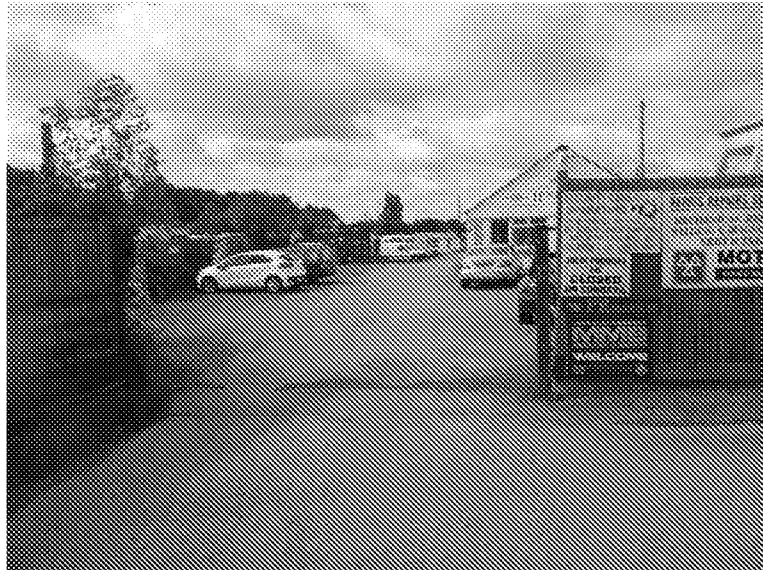
| PHOTOGRAPHIC LOG | | |
|---|---|---|
| Photo no.<br>1 | Date:<br>14/09/2017 | |

| PHOTOGRAPHIC LOG | | |
|---|---|---|
| Description:<br>An entry to a section of the small commercial and light industrial area off the road accessed via Arundel Road. | | |

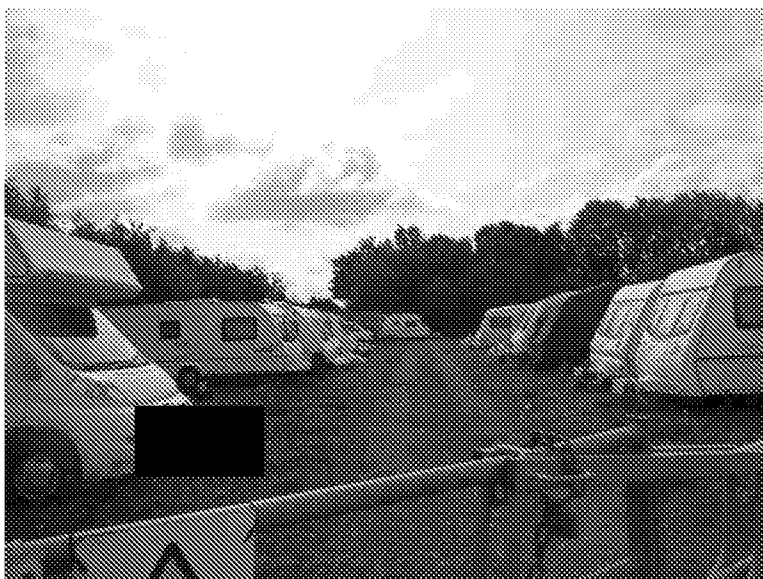
| Photo No.<br>2 | Date:<br>14/09/2017 | |

| Description:<br>Caravan storage park in the small commercial and light industrial area. | | |

The south-east of the site comprises a mixture of land uses, including a caravan, coach and minibus storage area (see photograph 2 in Appendix C), printing facilities (Va Signs and The Design Studio), auto repair garages (VW Spares, Angmering Auto Services and Parris Repairs Service) and a door, window and conservatory manufacturing and installation business (Horizon Windows). Some of the buildings are in a state of disrepair with the majority of the buildings having roofs which are considered likely to comprise asbestos containing materials (ACM), illustrated in photograph 7 in Appendix C.

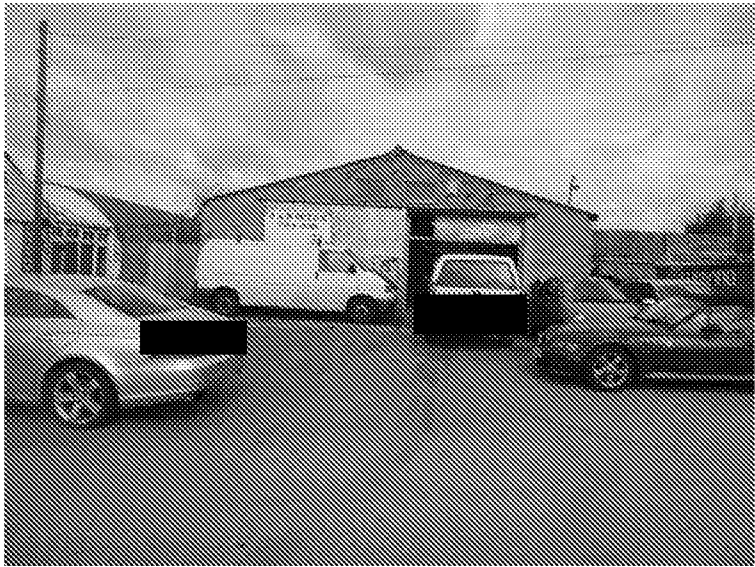
| <b>Photo No.</b><br>3 | <b>Date:</b><br>14/09/2017 | |

| <b>Description:</b><br>A & B Autos service, repair and MOT garage. | | |

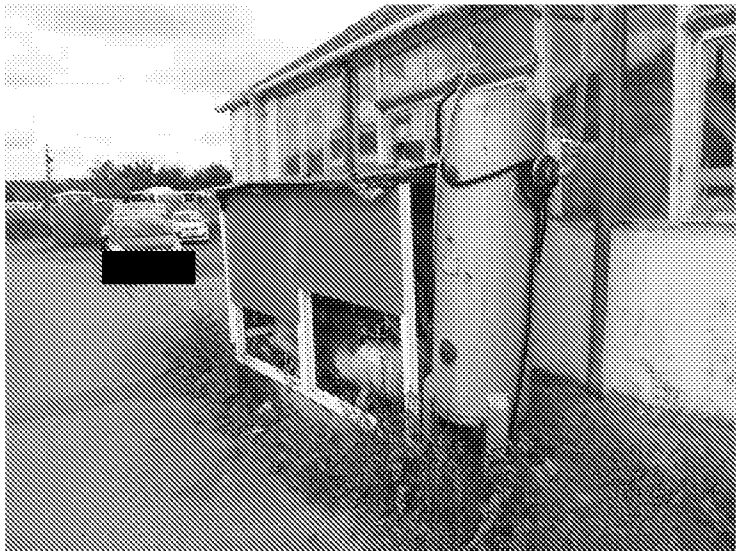
| <b>Photo No.</b><br>5 | <b>Date:</b><br>14/09/2017 | |

| <b>Description:</b><br>Small above ground storage tanks. | | |

Oil and fuel storage tanks are present associated with the auto repair garages. The tanks appear to be unbunded and evidence of some oil spillage is present within their immediate vicinity. Containers with unknown contents are situated near the stored caravans (see photograph 8 in Appendix C). To the immediate north of this area there is a residential property called New Place Bungalow (see photographs 11 and 12 in Appendix C) with a small grassland area to the south-west which appears to be used for camping.

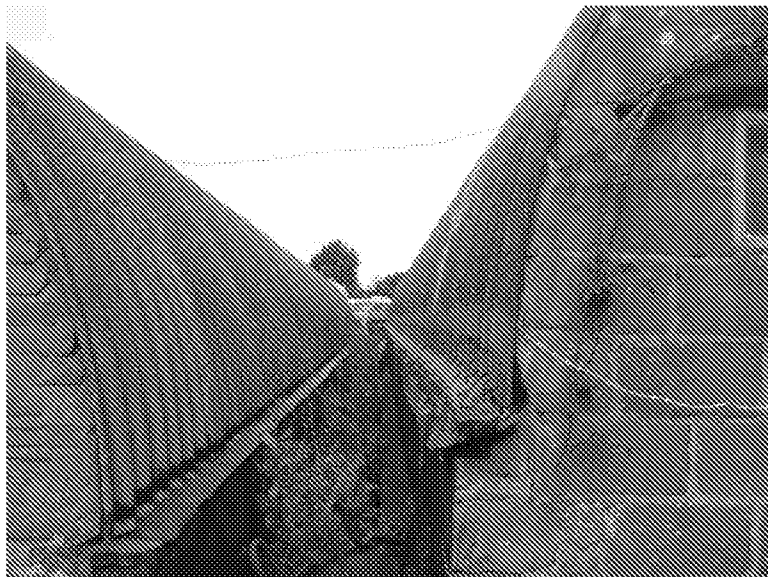
| <b>Photo No.</b><br>7 | <b>Date:</b><br>14/09/2017 | |

| <b>Description:</b><br>The roofs of on-site buildings with the potential presence of ACM. | | |

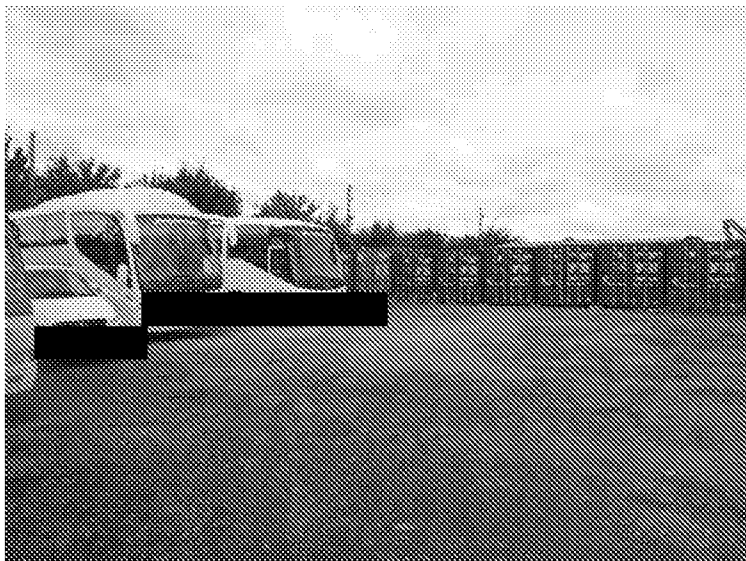
| <b>Photo No.</b><br>8 | <b>Date:</b><br>14/09/2017 | |

| <b>Description:</b><br>Storage containers adjacent to the coach and minibus parking area. | | |

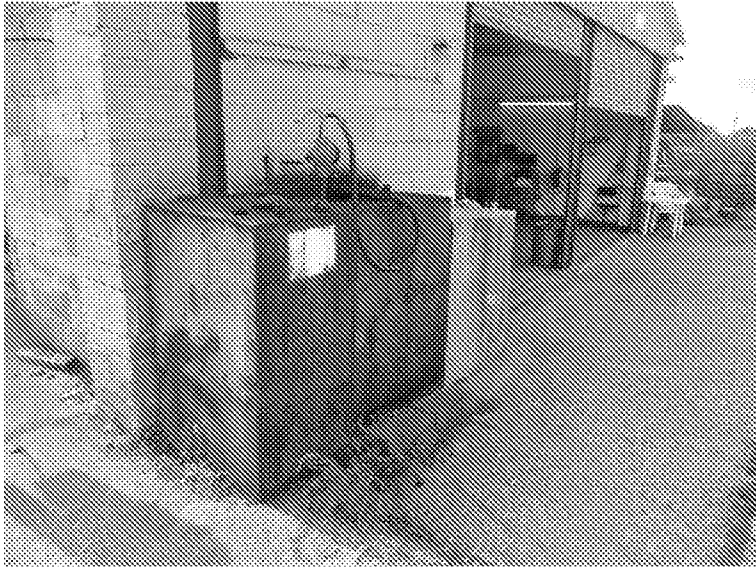
| <b>Photo No.</b><br>9 | <b>Date:</b><br>14/09/2017 | |

| <b>Description:</b><br>Small above ground storage tanks. | | |

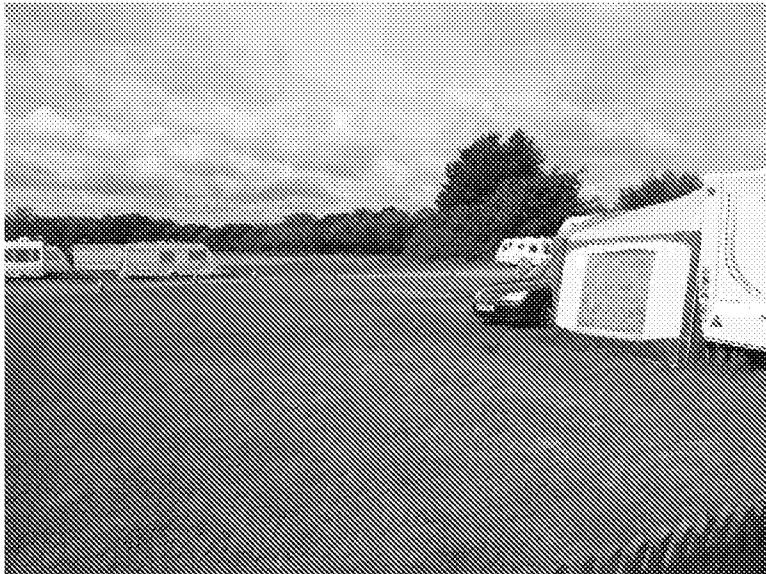
| <b>Photo No.</b><br>10 | <b>Date:</b><br>14/09/2017 | |

| <b>Description:</b><br>Camping area to the north of the small commercial and light industrial area. | | |

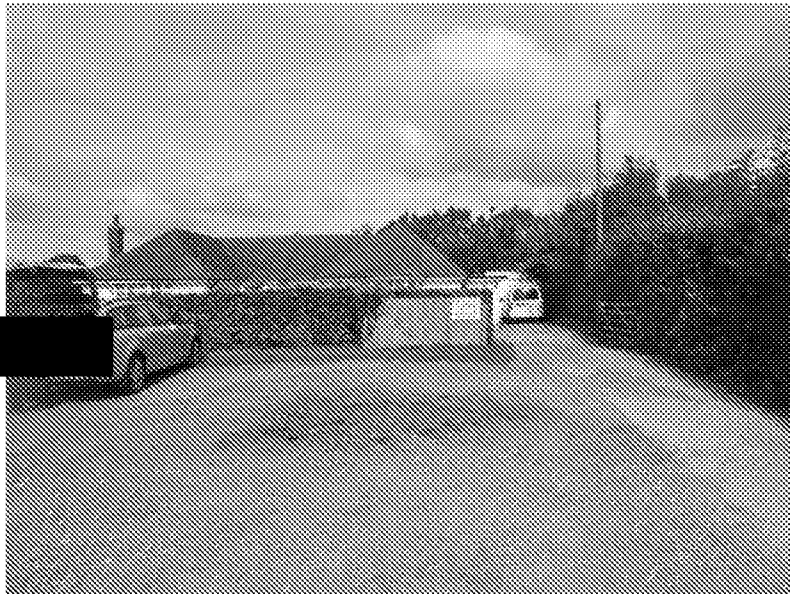
| <b>Description:</b><br>New Place Bungalow to the north of the small commercial and light industrial area. | |

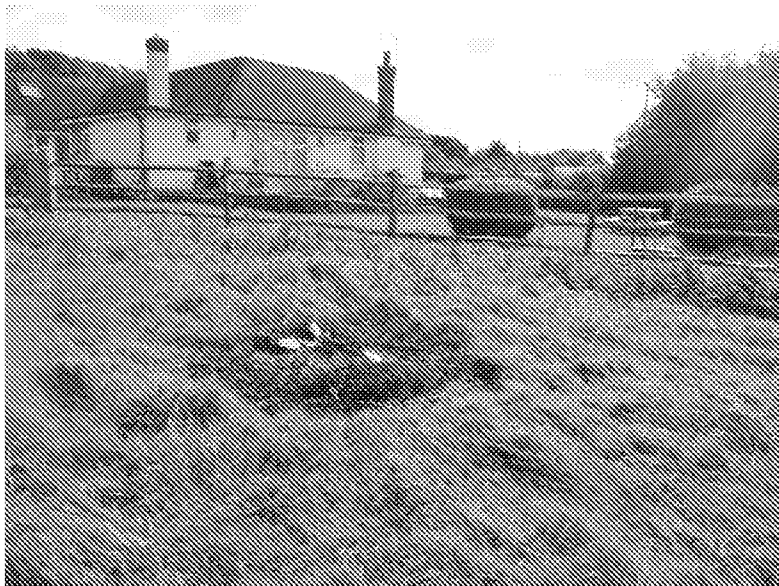
| <b>Photo No.</b><br>12 | <b>Date:</b><br>14/09/2017 | |

| <b>Description:</b><br>The rear of New Place Bungalow with evidence of a bonfire in the adjacent field. | | |

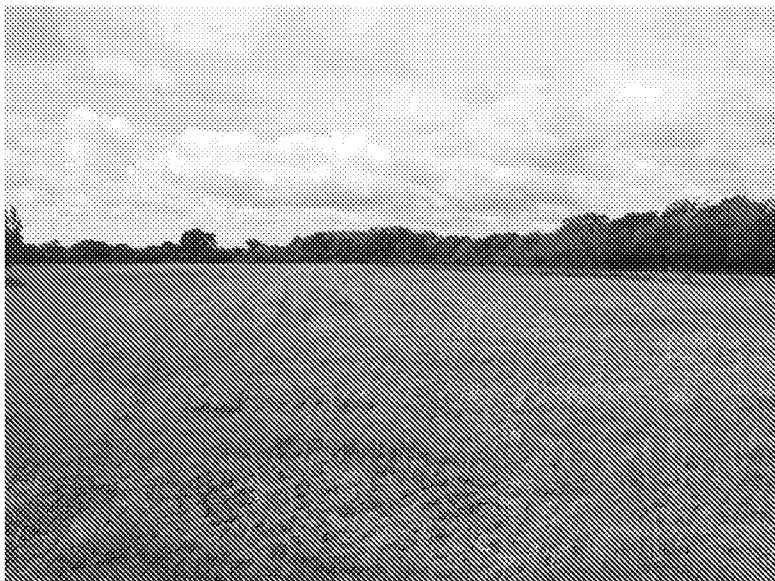
| <b>Photo No.</b><br>13 | <b>Date:</b><br>14/09/2017 | |

| <b>Description:</b><br>General overview of the agricultural field to the west of the small commercial and light industrial area. | | |

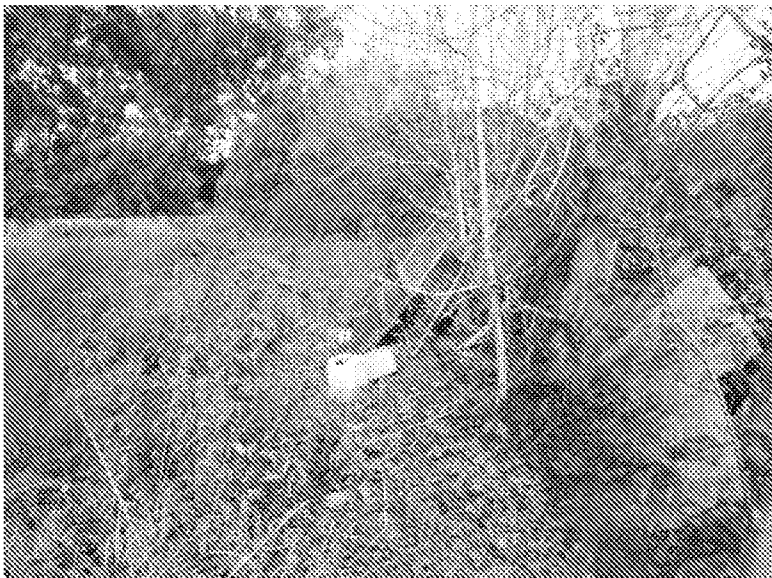
| <b>Photo No.</b><br>14 | <b>Date:</b><br>14/09/2017 | |

| <b>Description:</b><br>An area of scrubland in the north-east of the site. | | |

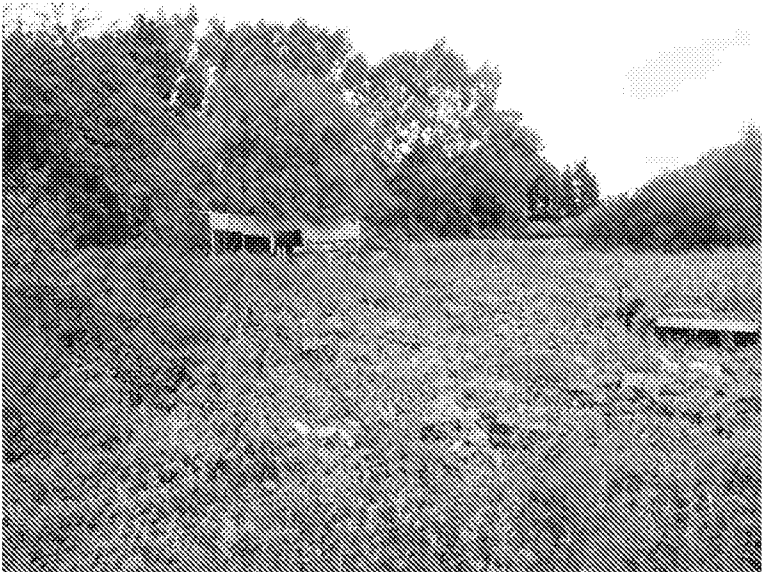
| <b>Photo No.</b><br>15 | <b>Date:</b><br>14/09/2017 | |

| <b>Description:</b><br>Disused building in the scrubland in the north-east of the site. | | |

The north of the site comprises grassland and with scrubland and some evidence of past industrial land use in the north-east including, a disused building, loose asphalt surfacing, plastic containers containing red diesel and old machinery (see photograph 15 in Appendix C). The remaining area of the site in the south-west comprises an agricultural field. There was no obvious evidence encountered during the reconnaissance of an infilled pit / quarry as possibly shown by the 1974 Historical Map (see section 3.2).

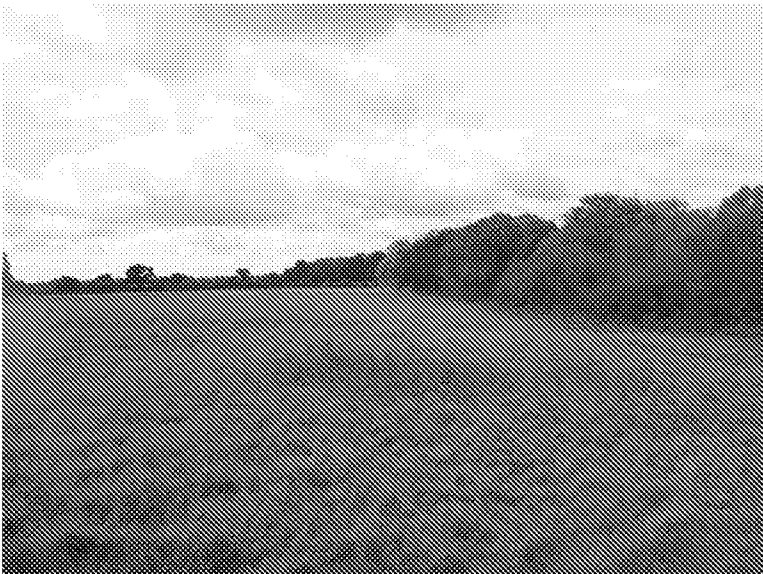
| <b>Photo No.</b><br>16 | <b>Date:</b><br>14/09/2017 | |

| <b>Description:</b><br>Grassland in the north of the site, showing the wooded area beyond | | |

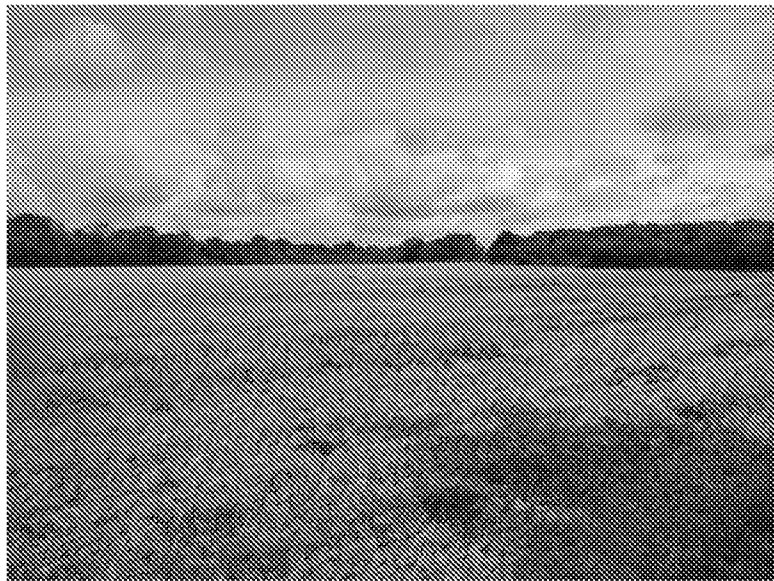
| <b>Description:</b><br>General overview of the agricultural field to the west of the small commercial and light industrial area. | |
