SHRUBLANDS, ROUNDSTONE  
LANE, ANGMERING, BN16 4AT

## APPENDIX D – Qualitative Risk Assessment Model

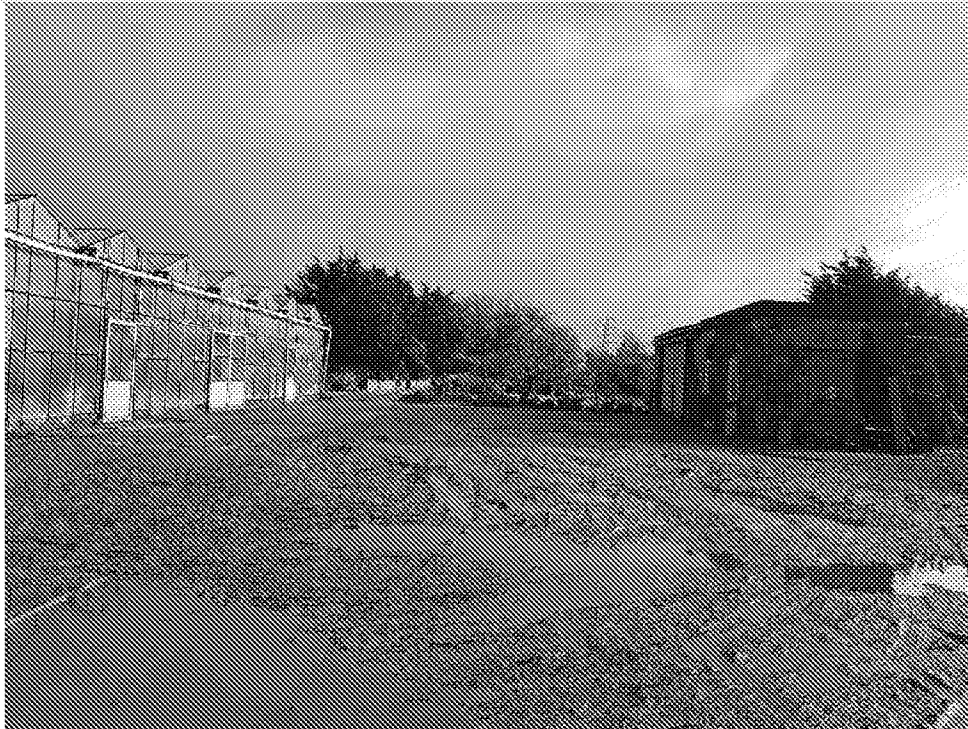
Plate 1 – View looking east across the site with the site office to the south and the greenhouses to the north.

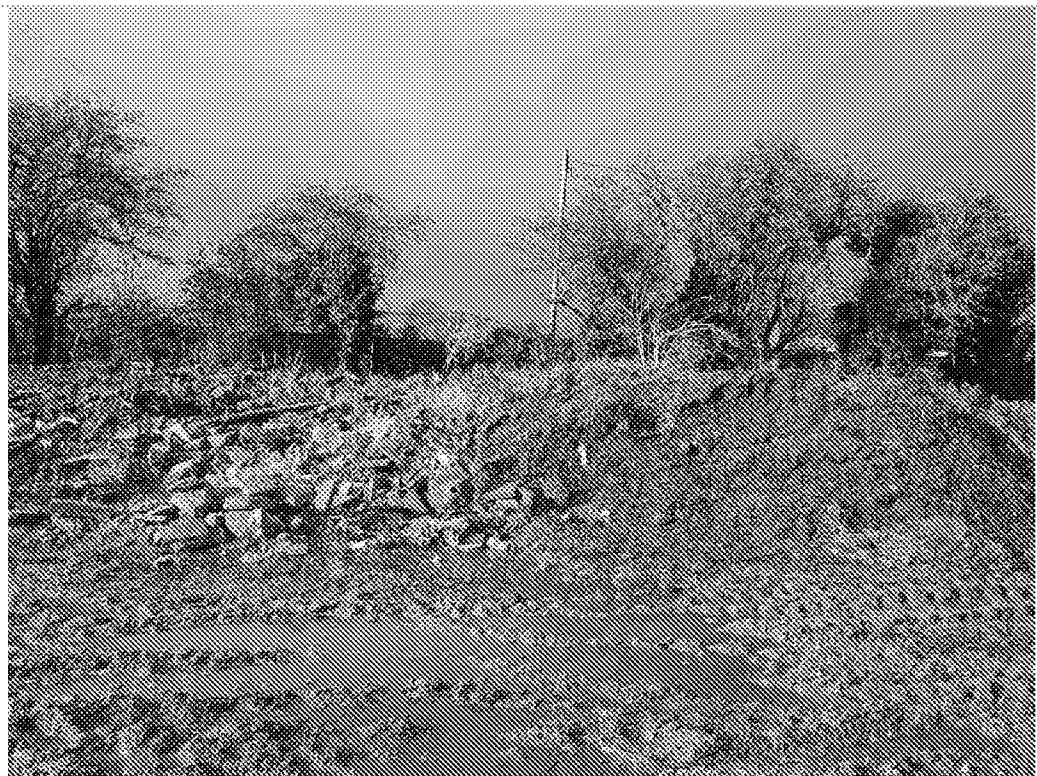
Plate 4 -- Building rubble and ear stockpiles along the site's western boundary.

| Contaminant | Receptor | Pathway <sup>1</sup> | Likelihood of Exposure | Severity of Exposure | Risk Classification | Notes |
|---|---|---|---|---|---|---|
| All contaminants in soils | Future Residents | Dermal contact, ingestion and inhalation of soil particles | Likely | Mild | Moderate/low risk | Given that portions of the site have undergone development and subsequent demolition there is the potential for contaminants such as heavy metals and to have impacted the soils. An historic tank with associated chimneys is shown on the northern part of the site with a second shown on the sites western boundary. There, is therefore the potential for localised hydrocarbon contamination to occur on site. There is also the potential for heavy metals to be present within any made ground which occurs on site as well as within the stockpiles along the sites western boundary. |

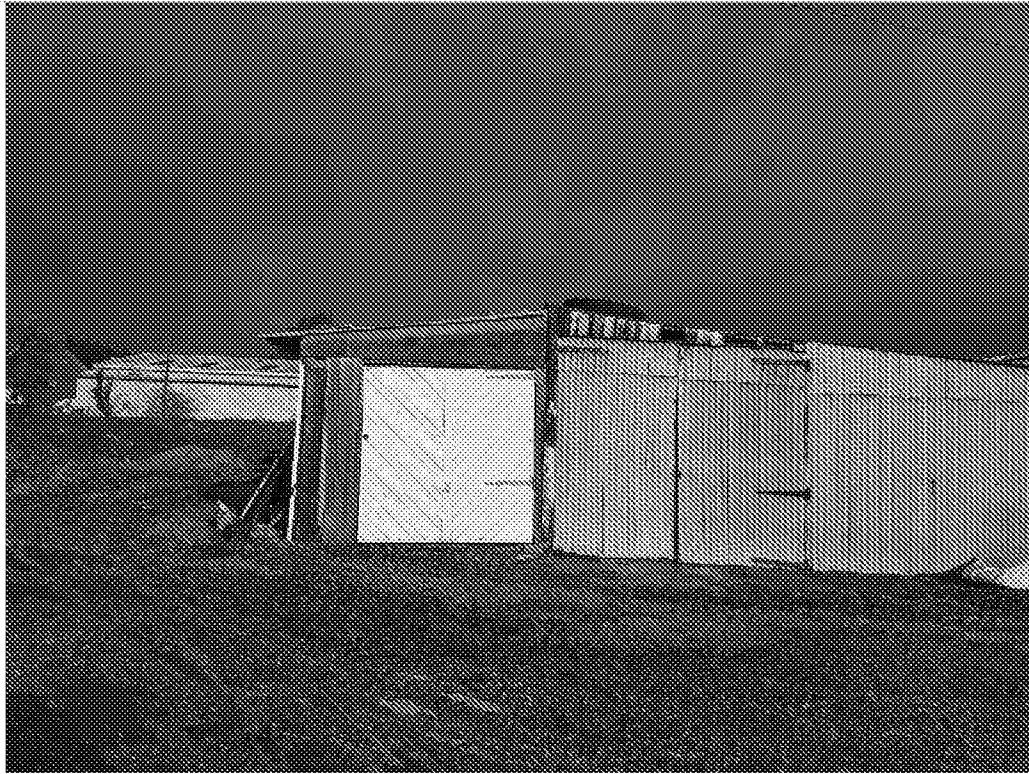
Plate 5 -- Sheds in the north western corner of the site.

| Contaminant | Receptor | Pathway <sup>1</sup> | Likelihood of Exposure | Severity of Exposure | Risk Classification | Notes |
|---|---|---|---|---|---|---|
| Asbestos fibres in soils | Future Residents | Inhalation of asbestos fibres | Likely | Severe | High risk | Potential ACM was noted in the north western portion of the site. Furthermore, asbestos was often utilised in the construction of agricultural buildings and used for lagging heating pipes within greenhouses. Given the age of the structures on site there is the potential that ACM was utilised during their construction and may therefore have impacted the soils on site. |

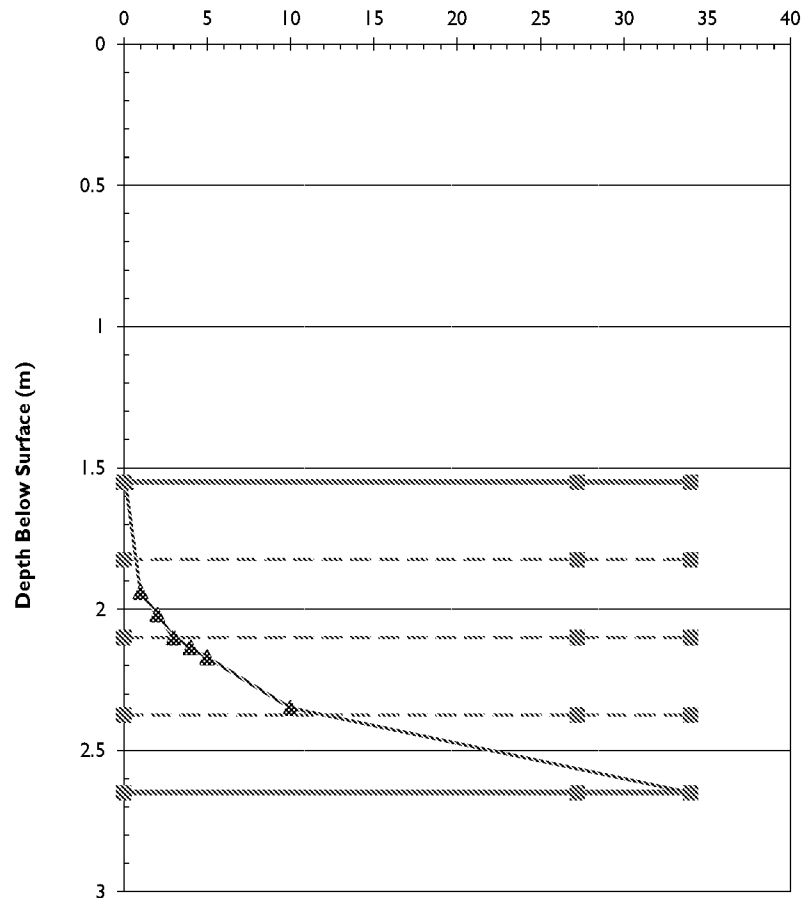
## BRE Digest 365 - Soakage Test

Test Hole No: TP1  
Test No: Test No 1

| BRE Soil Infiltration Rate (m/sec) | 8.62943E-05 |

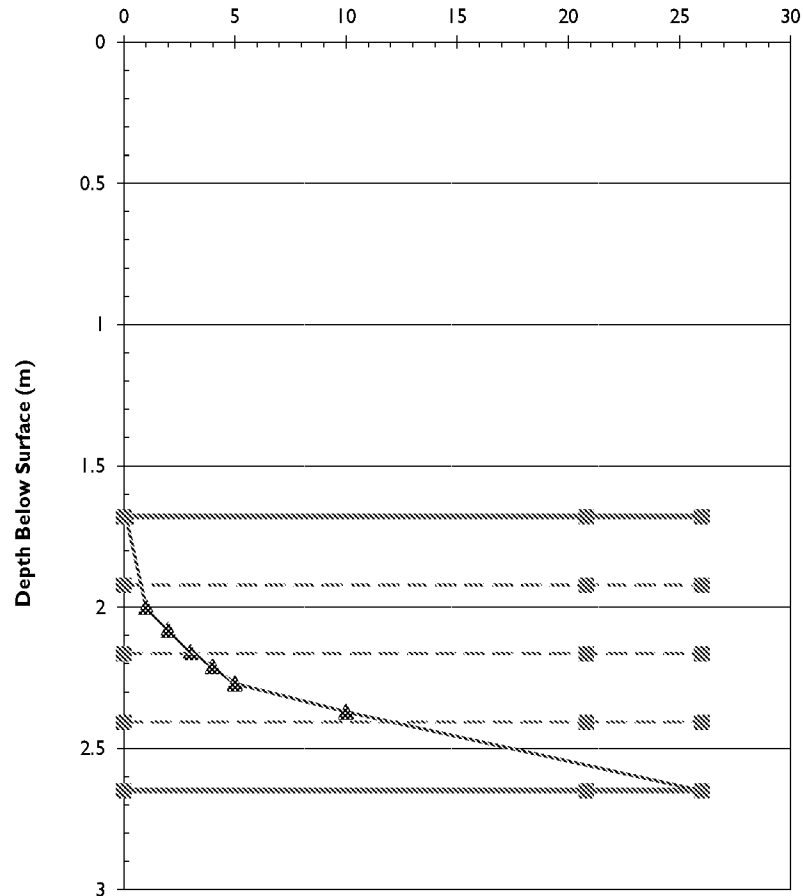
## BRE Digest 365 - Soakage Test

Test Hole No: TP1  
Test No: Test No 2

| BRE Soil Infiltration Rate (m/sec) | 8.22616E-05 |

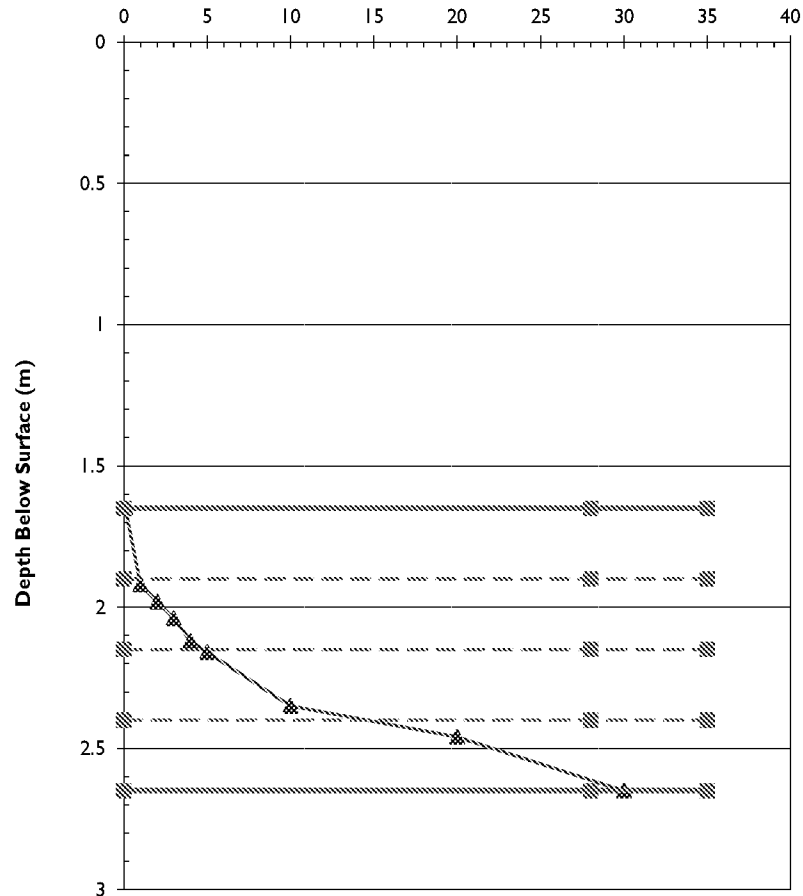
## BRE Digest 365 - Soakage Test

Test Hole No: TP1  
Test No: Test No 3

| BRE Soil Infiltration Rate (m/sec) | 5.0804E-05 |

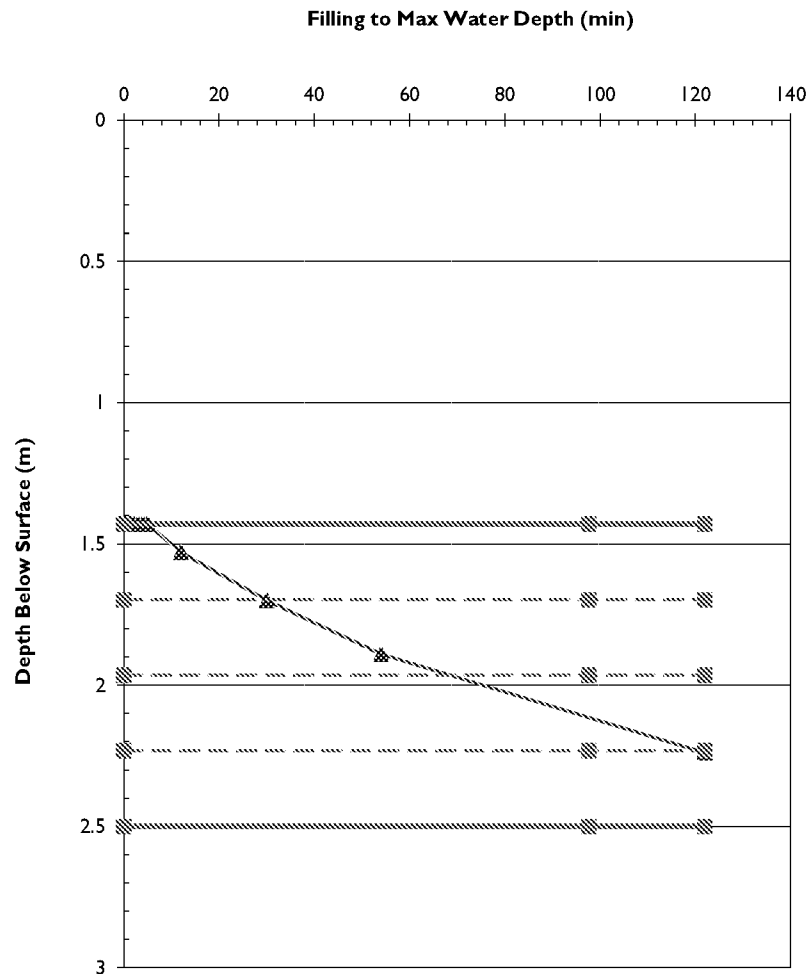
## BRE Digest 365 - Soakage Test

Test Hole No: TP2  
Test No: Test No 1

| BRE Soil Infiltration Rate (m/sec) | 1.05793E-05 |

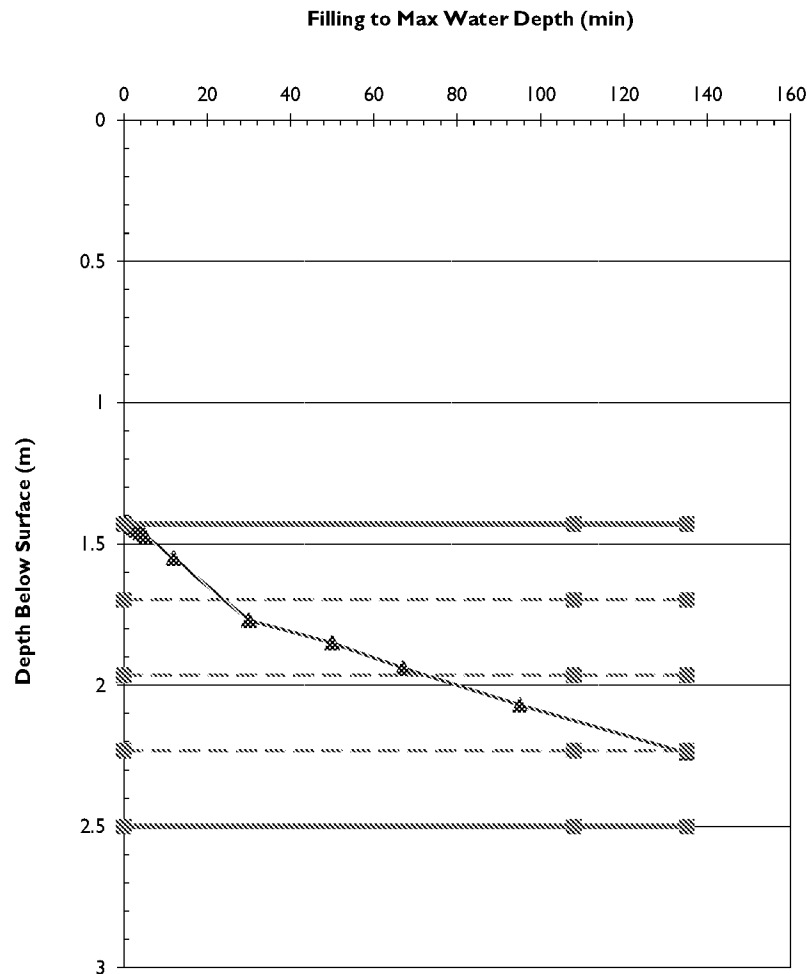
## BRE Digest 365 - Soakage Test

Test Hole No: TP2  
Test No: Test No 2

| BRE Soil Infiltration Rate (m/sec) | 8.80013E-06 |

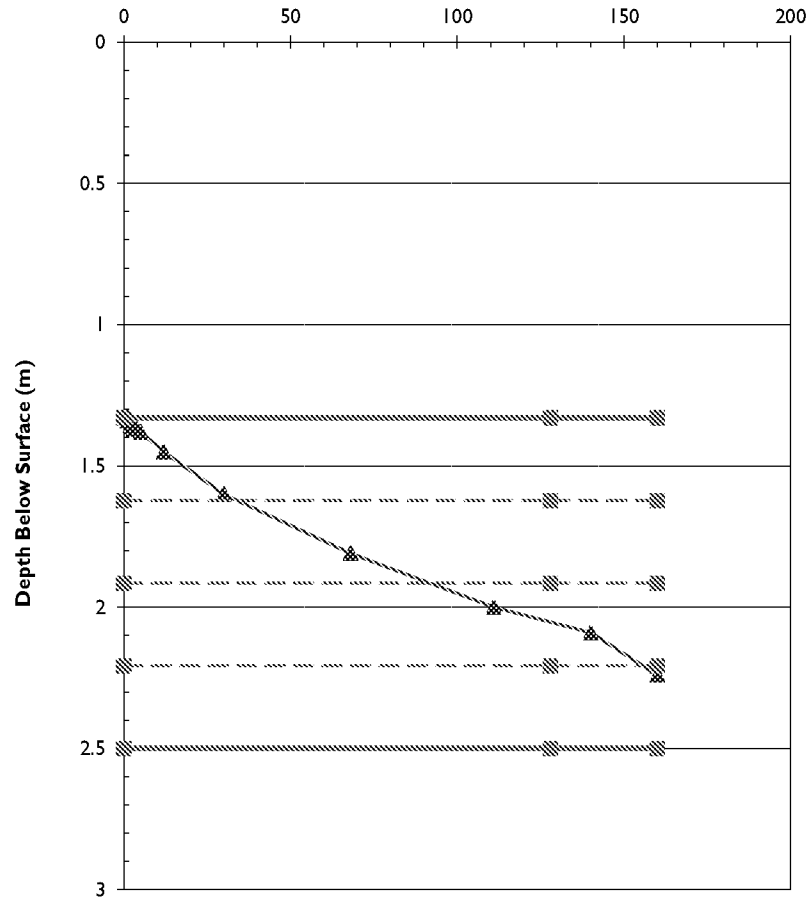
## BRE Digest 365 - Soakage Test

Test Hole No: TP2  
Test No: Test No 3

| BRE Soil Infiltration Rate (m/sec) | 8.11416E-06 |

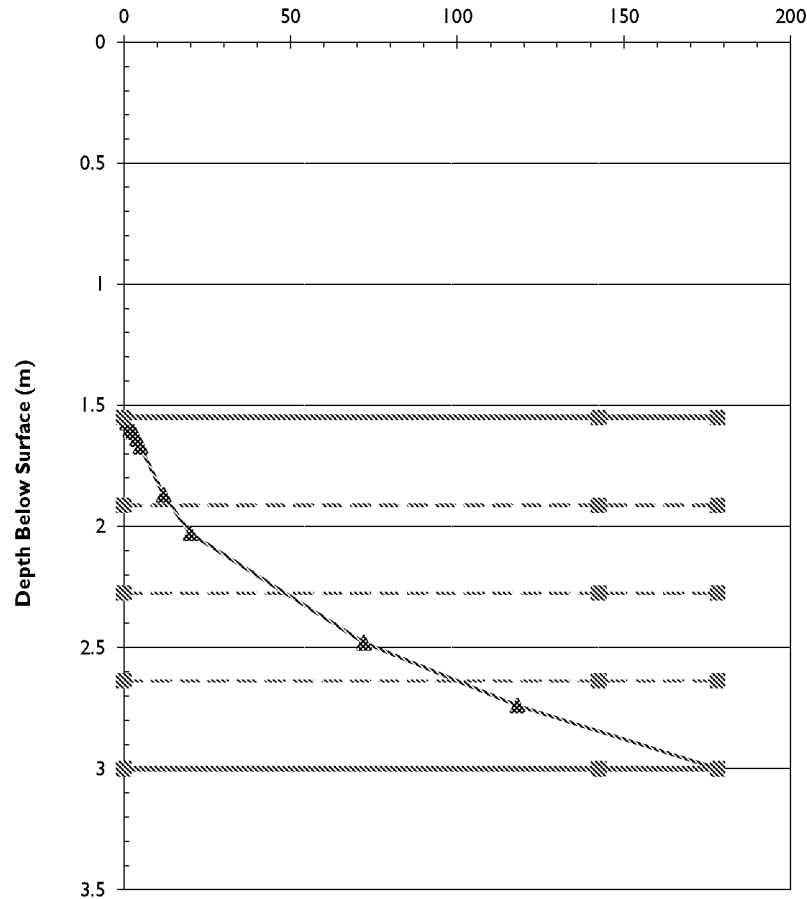
## BRE Digest 365 - Soakage Test

Test Hole No: TP3  
Test No: Test No 1

| BRE Soil Infiltration Rate (m/sec) | 1.24109E-05 |

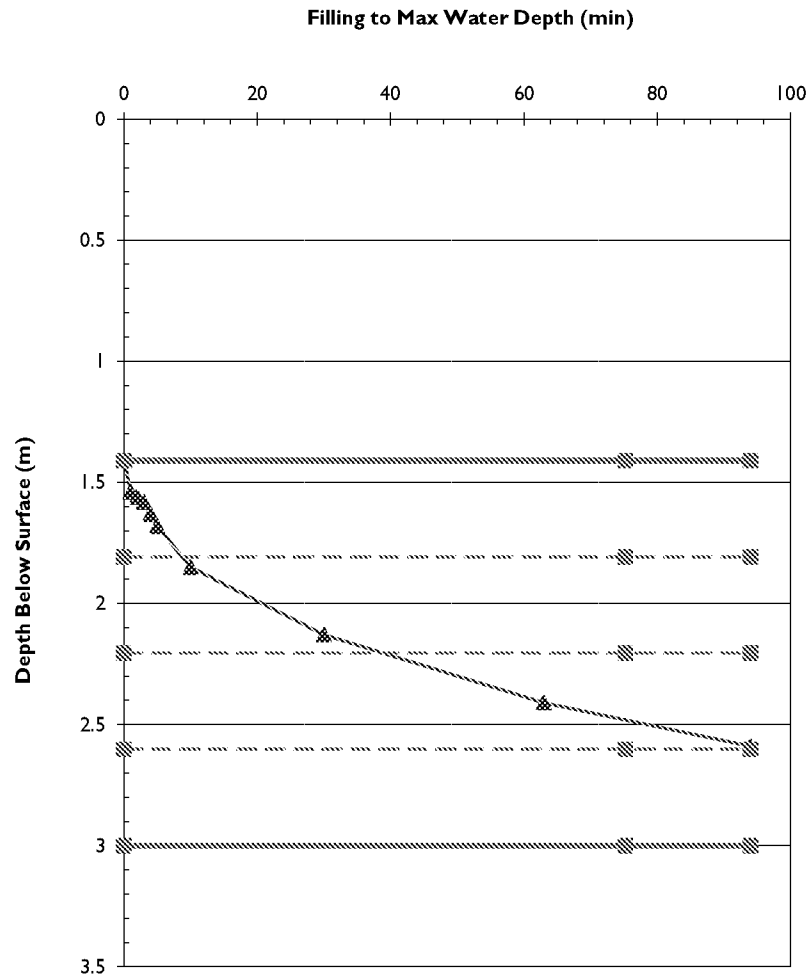
## BRE Digest 365 - Soakage Test

Test Hole No: TP3  
Test No: Test No 2

| BRE Soil Infiltration Rate (m/sec) | 1.24892E-05 |

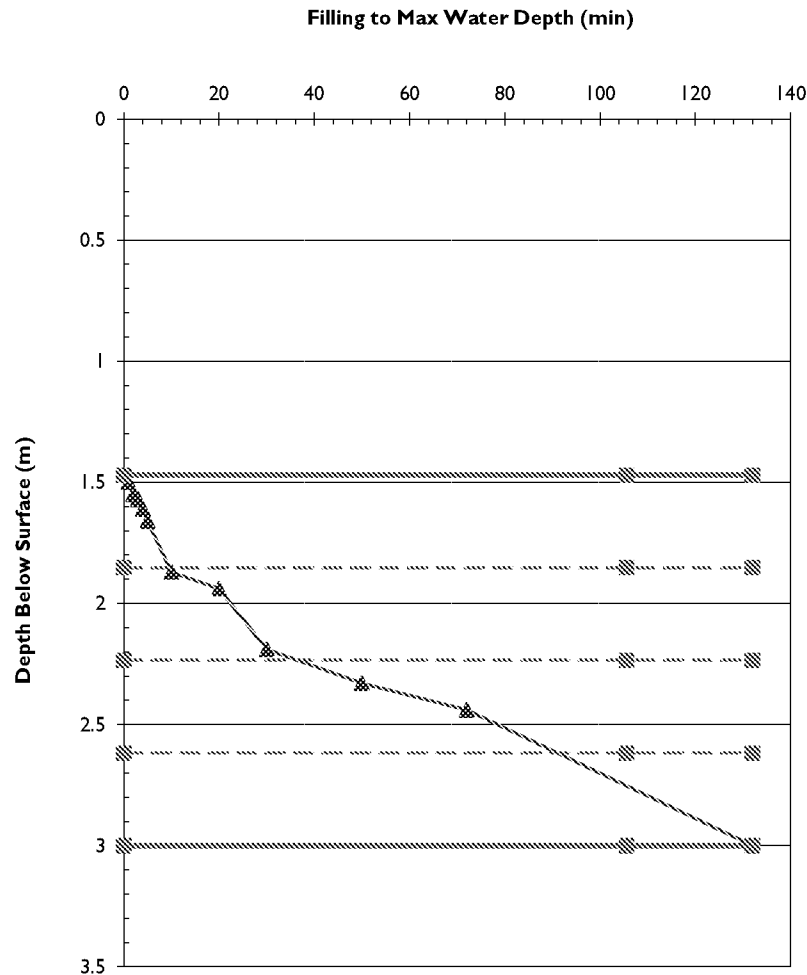
## BRE Digest 365 - Soakage Test

Test Hole No: TP3  
Test No: Test No 3

| BRE Soil Infiltration Rate (m/sec) | 1.32413E-05 |
