THE OLD COTTAGE, STATION ROAD, ANGMERING, BN16 4HY

PHOTOGRAPHIC RECORD rev A

Date - 12.12.19

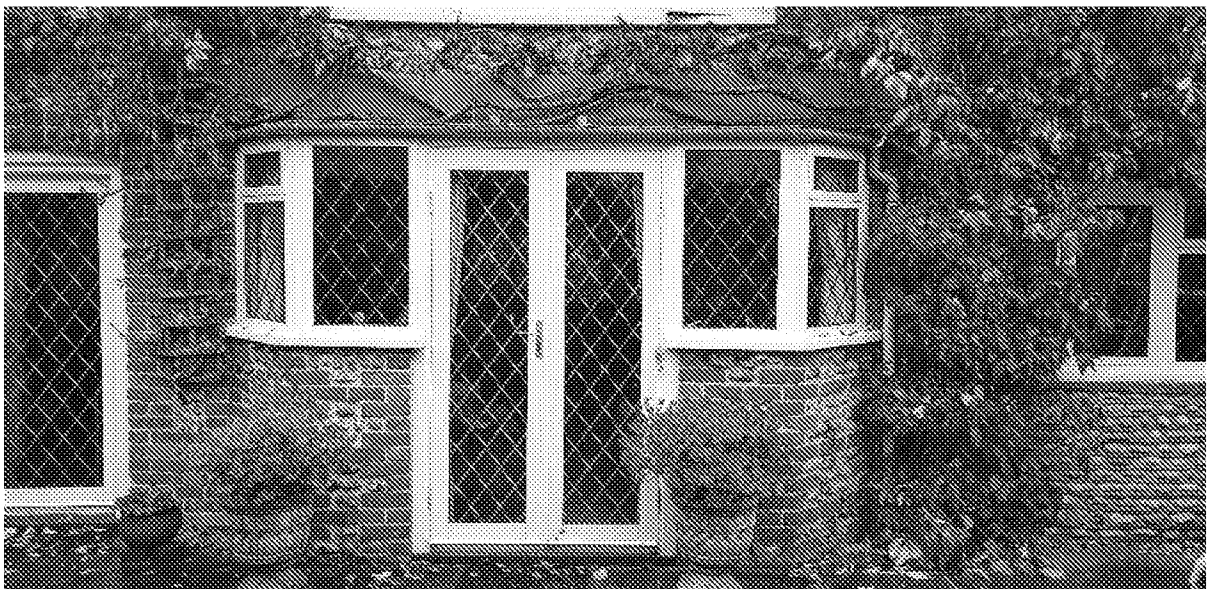
Photograph showing the rear bay window. The lead roof is proposed to be replaced as it currently falls the wrong way towards the house. See Note 07 on drawing 19068 2.01.
