**THE VINERY  
POLING  
WEST SUSSEX**

**PHASE 1 CONTAMINATION  
ASSESSMENT REPORT**

**Report No. LW23270/ds November 2012**

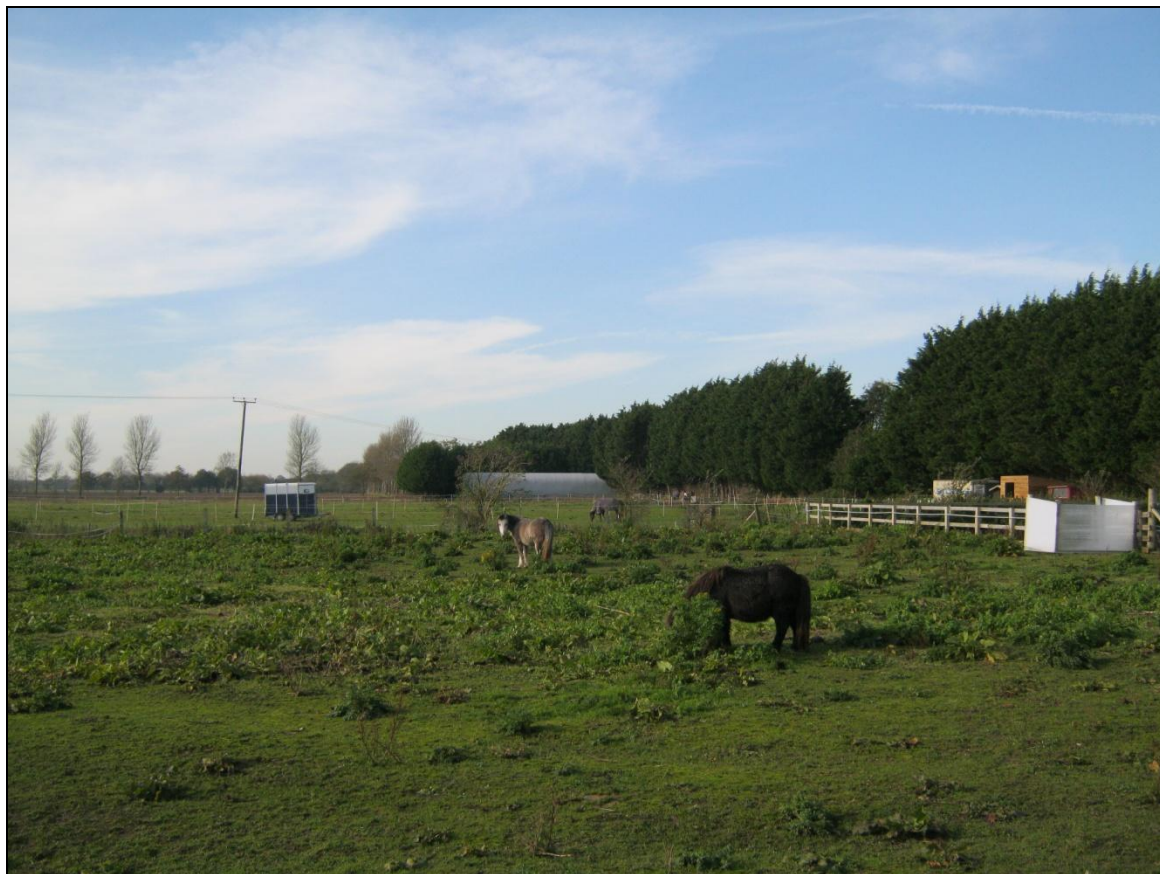
At the time of the walkover survey the majority of the site comprised a grass field used for horse grazing and divided into paddocks with temporary electric fences. Several sheds and small buildings associated with the paddocks were located in the north eastern corner of the field. A drainage ditch ran along the northern boundary and turned southwards through ninety degrees to cross the eastern side of the site in a north to south direction. The ditch was noted to be overgrown with shrubs and several trees were located along its length. Numerous mature trees and shrubs were also located along the site boundaries. Two poly tunnels were present in the north western corner of the field.

Paddocks and Poly Tunnels in Northern part of Site

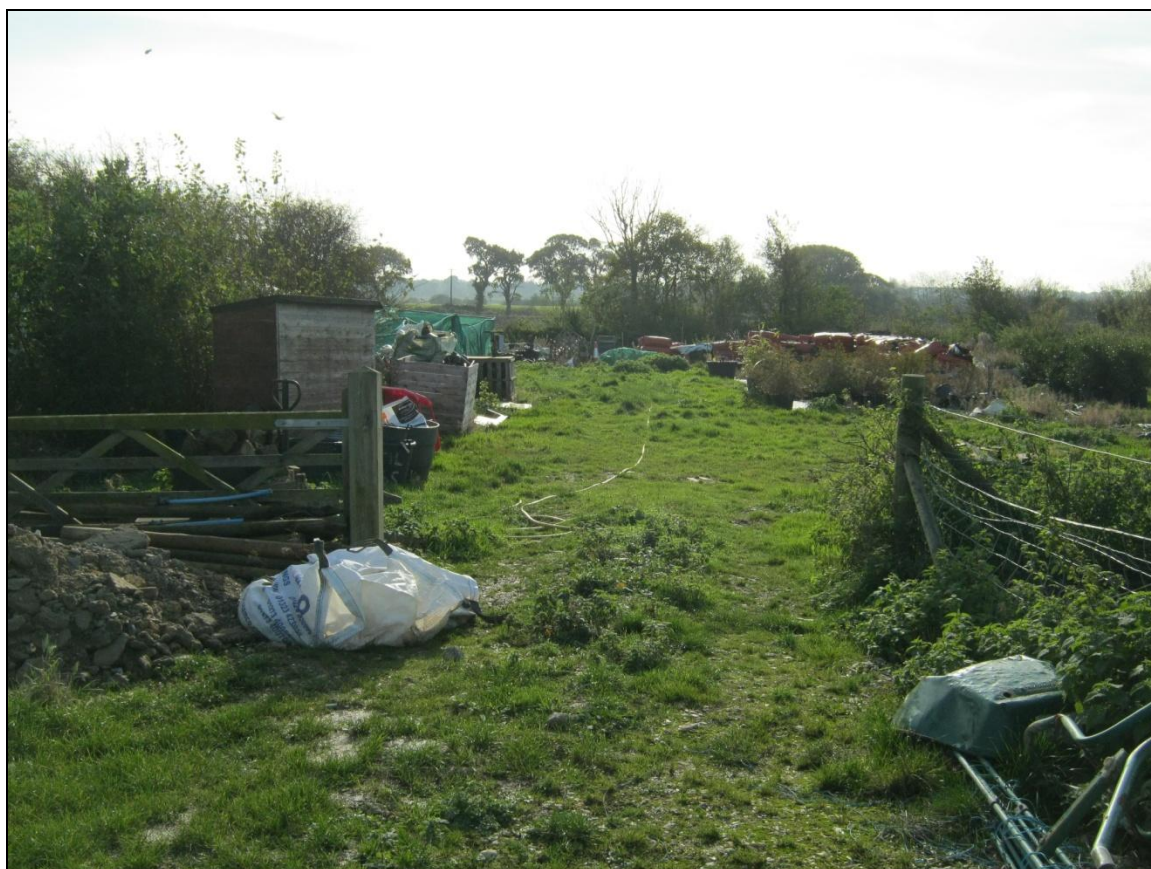
The site to the east of the ditch comprised an area of rough open ground used partly as a paddock and partly as a storage area. In the south eastern corner the site was in use as a plant nursery storing plants in pots, bags of compost, old pots, plastic tubing, timber pallets, stakes and metal posts. Several stockpiles of soil and topsoil were located in this area along with a large telecoms mast.

Eastern Part of Site used for Storing Plants, Compost, Timber, Pots etc..

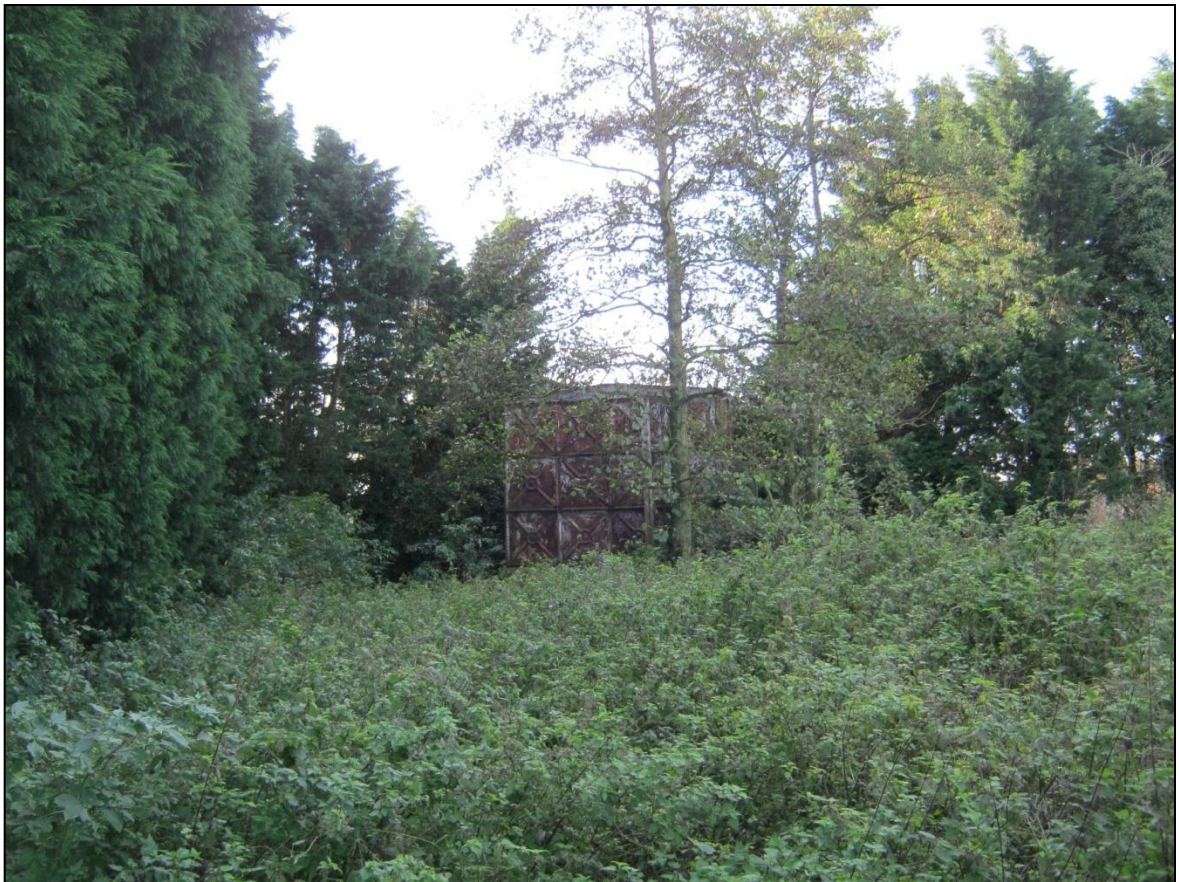
Beyond the north-western corner of the site was a large metal tank which was rusting and no longer appeared to be in use. From its appearance and very large size and given the context that the site was used as a vinery and a mushroom farm it is considered likely that the tank was used for water storage.

Large Metal Tank to North West of Site

Similarly the old tank located some distance from the north-western boundary of the site is not considered likely to represent a significant risk to the site.

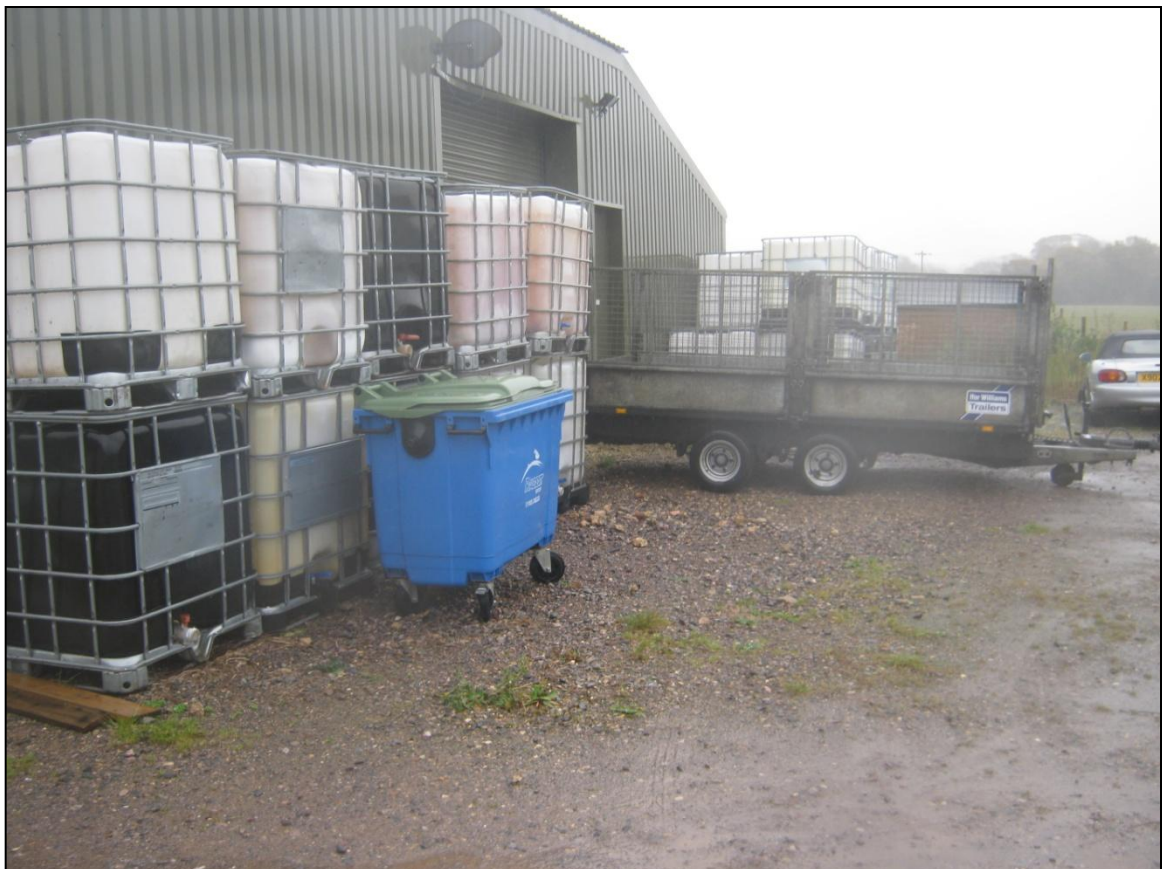
Warehouse Building used to Store Stage Props and Empty Plastic Containers
