**LAND AT DAPPERS LANE, ANGMERING,  
WEST SUSSEX BN16 4EW**

**PROPOSED RESIDENTIAL DEVELOPMENT**

Flood Risk Assessment

D1260/FRA 1.4

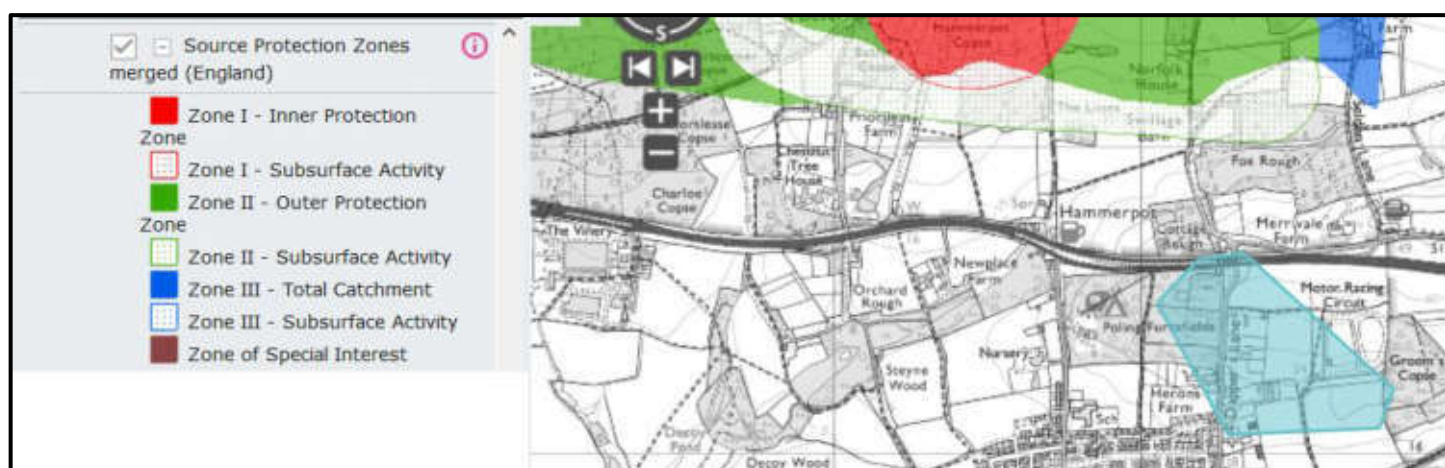
1.4.14 The site is not indicated as falling within any classified Groundwater Source Protection Zones, as demonstrated by **Figure 6**, below.

Figure 6. Groundwater Source Protection Zones
