**Manor Nursery  
Angmering  
West Sussex**

**Revised Ground Contamination  
Risk Assessment Report**

**Project Reference: P14618**

**Report Reference: R14233**

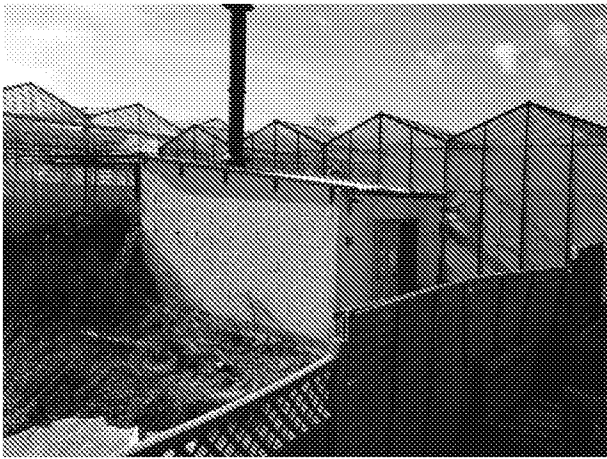
A small brick built plant room with a suspected asbestos panel roof was located adjacent to the north eastern corner of the nursery.

| Plant room in the east of the site | Inside the plant room showing the staining on the floor slab |

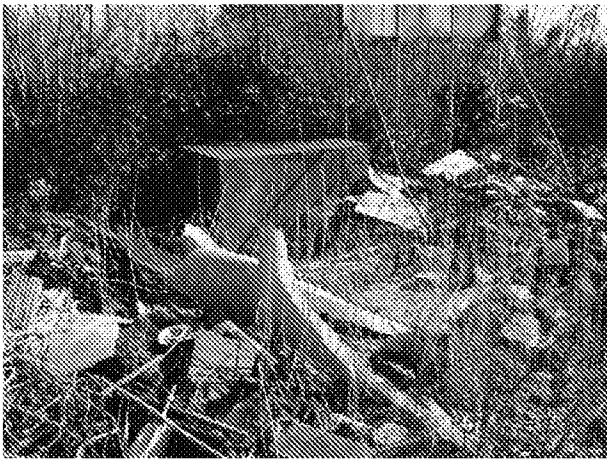
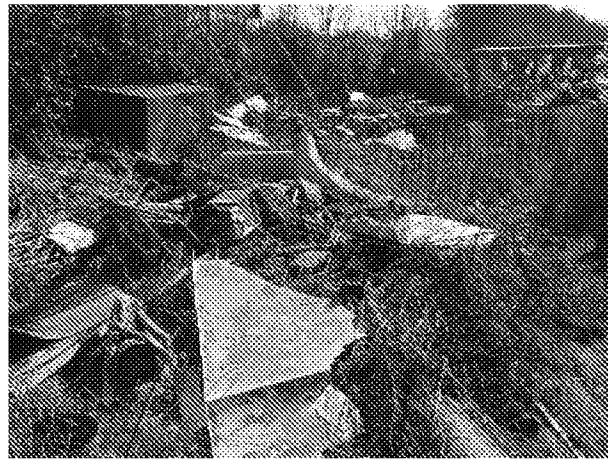
The plant room contained a boiler that was formerly oil fired. The oil tank had been removed from the room and had been placed on the eastern boundary of the site along with a pile of other demolition spoil and waste materials.

| Demolition spoil and above ground oil tank formerly located in the plant room | Demolition spoil and above ground oil tank formerly located in the plant room |

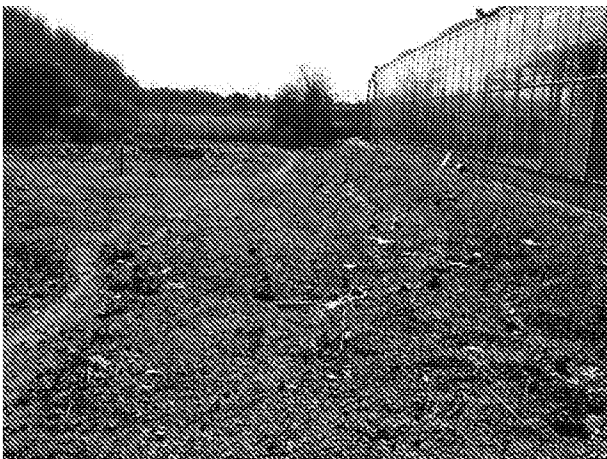
In the south eastern corner of the site was an open area of ground where the remains of a large bonfire, including various pieces of scrap metal, was noted.

| Bonfire Mound in the south eastern corner of the site. | View to the south along the western part of the site towards the bonfire mound |
