**Manor Nursery  
Angmering  
West Sussex**

**Combined Geotechnical and  
Ground Contamination Risk Assessment**

**Report No. LW26073**

**April 2015**

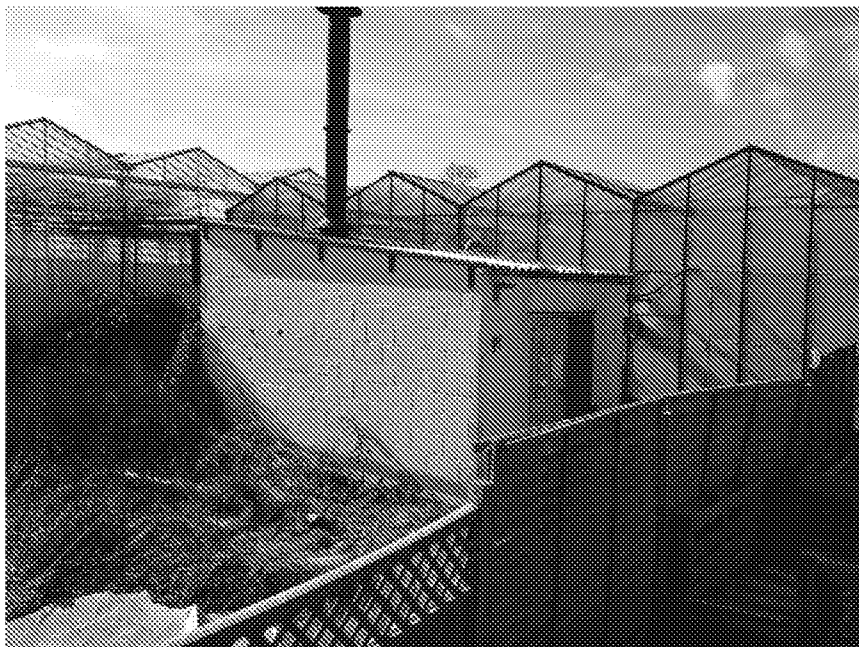
Plant room on the east of the site.

As discussed in section 6.6.2 it is recommended that following the removal of the plant room that the underlying soils are inspected to determine if there is any visual or olfactory evidence of petroleum hydrocarbon contamination. In the event that suspected contamination is identified then further testing and assessment should be carried out.

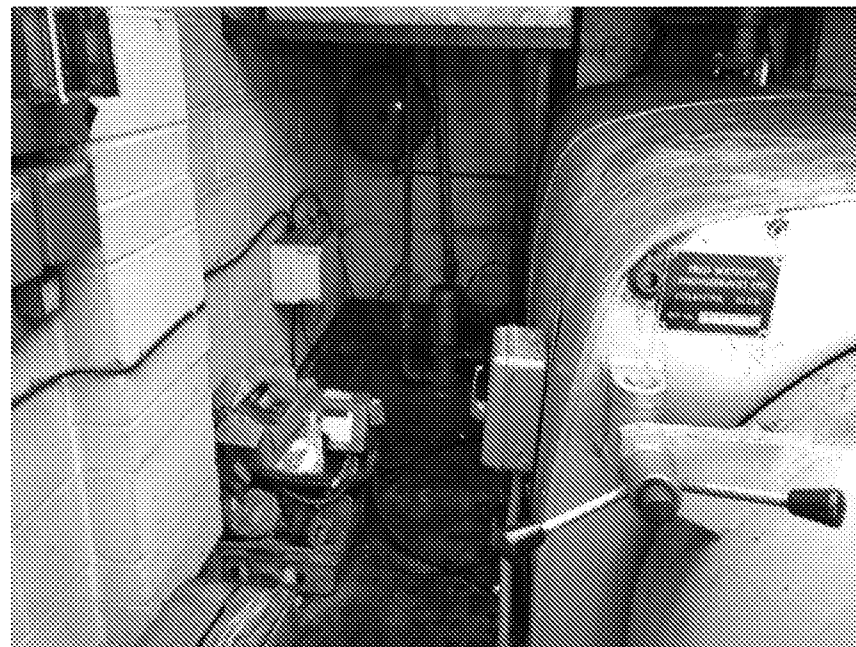
Inside the plant room showing the staining on the floor slab.

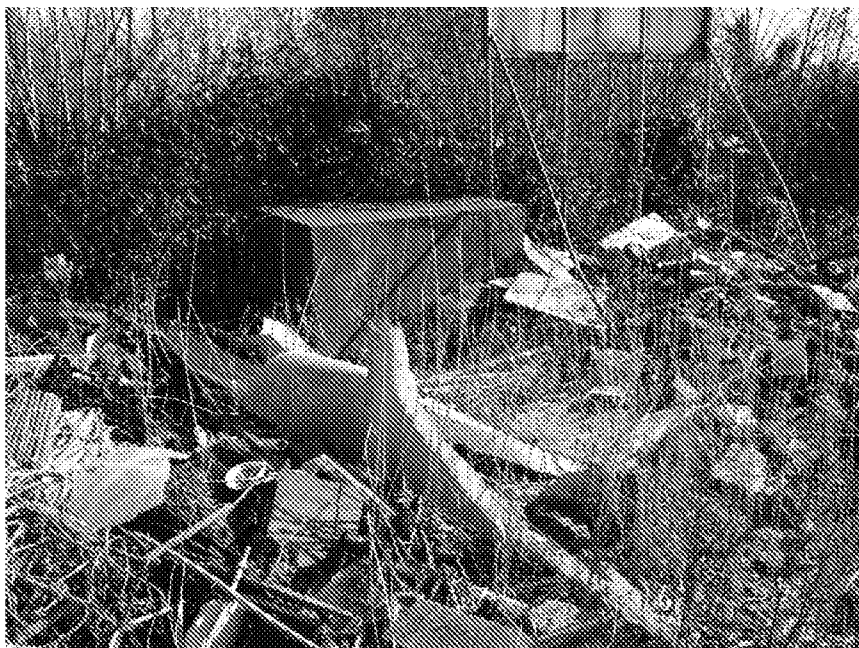
Demolition spoil and above ground oil tank formerly located in the plant room.

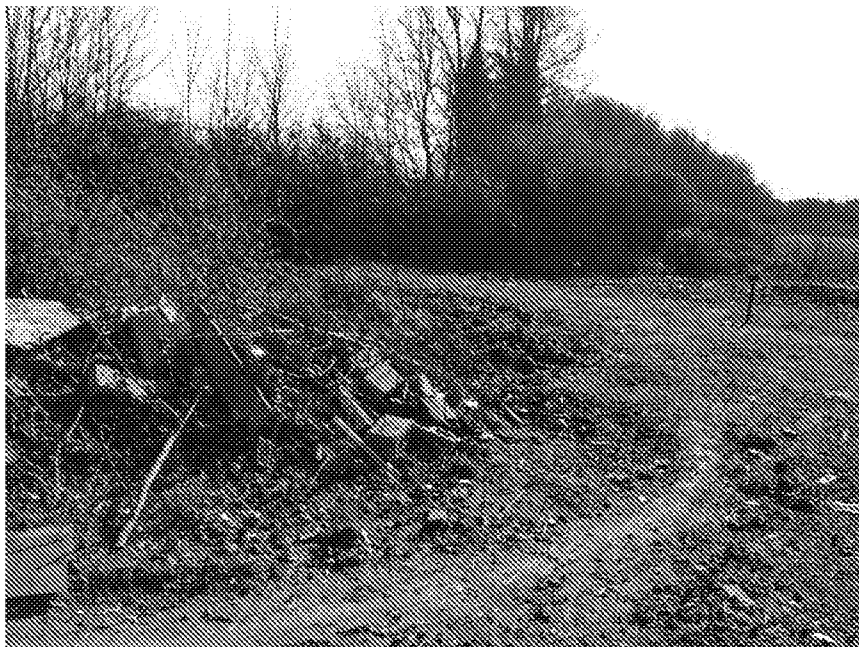
In the south eastern corner of the site was an open area of ground where the remains of a large bonfire, including various pieces of scrap metal, was noted.

Bonfire Mound in the south eastern corner of the site.

It is recommended that the complete removal of the bonfire material from the south eastern part of the site will sever the pollutant linkage by the removal of the source and that this will remove the risk to end users of the development.
