GEO-ENVIRONMENTAL ASSESSMENT  
LAND TO THE NORTH OF WATER LANE  
ANGMERING  
RYDON HOMES / GLEESON STRATEGIC LAND  
GEA-19495B-17-318 REV A  
FEBRUARY 2018

GEO-ENVIRONMENTAL ASSESSMENT  
LAND TO THE NORTH OF WATER LANE  
ANGMERING  
RYDON HOMES / GLEESON STRATEGIC LAND  
GEA-19495B-17-318  
FEBRUARY 2018

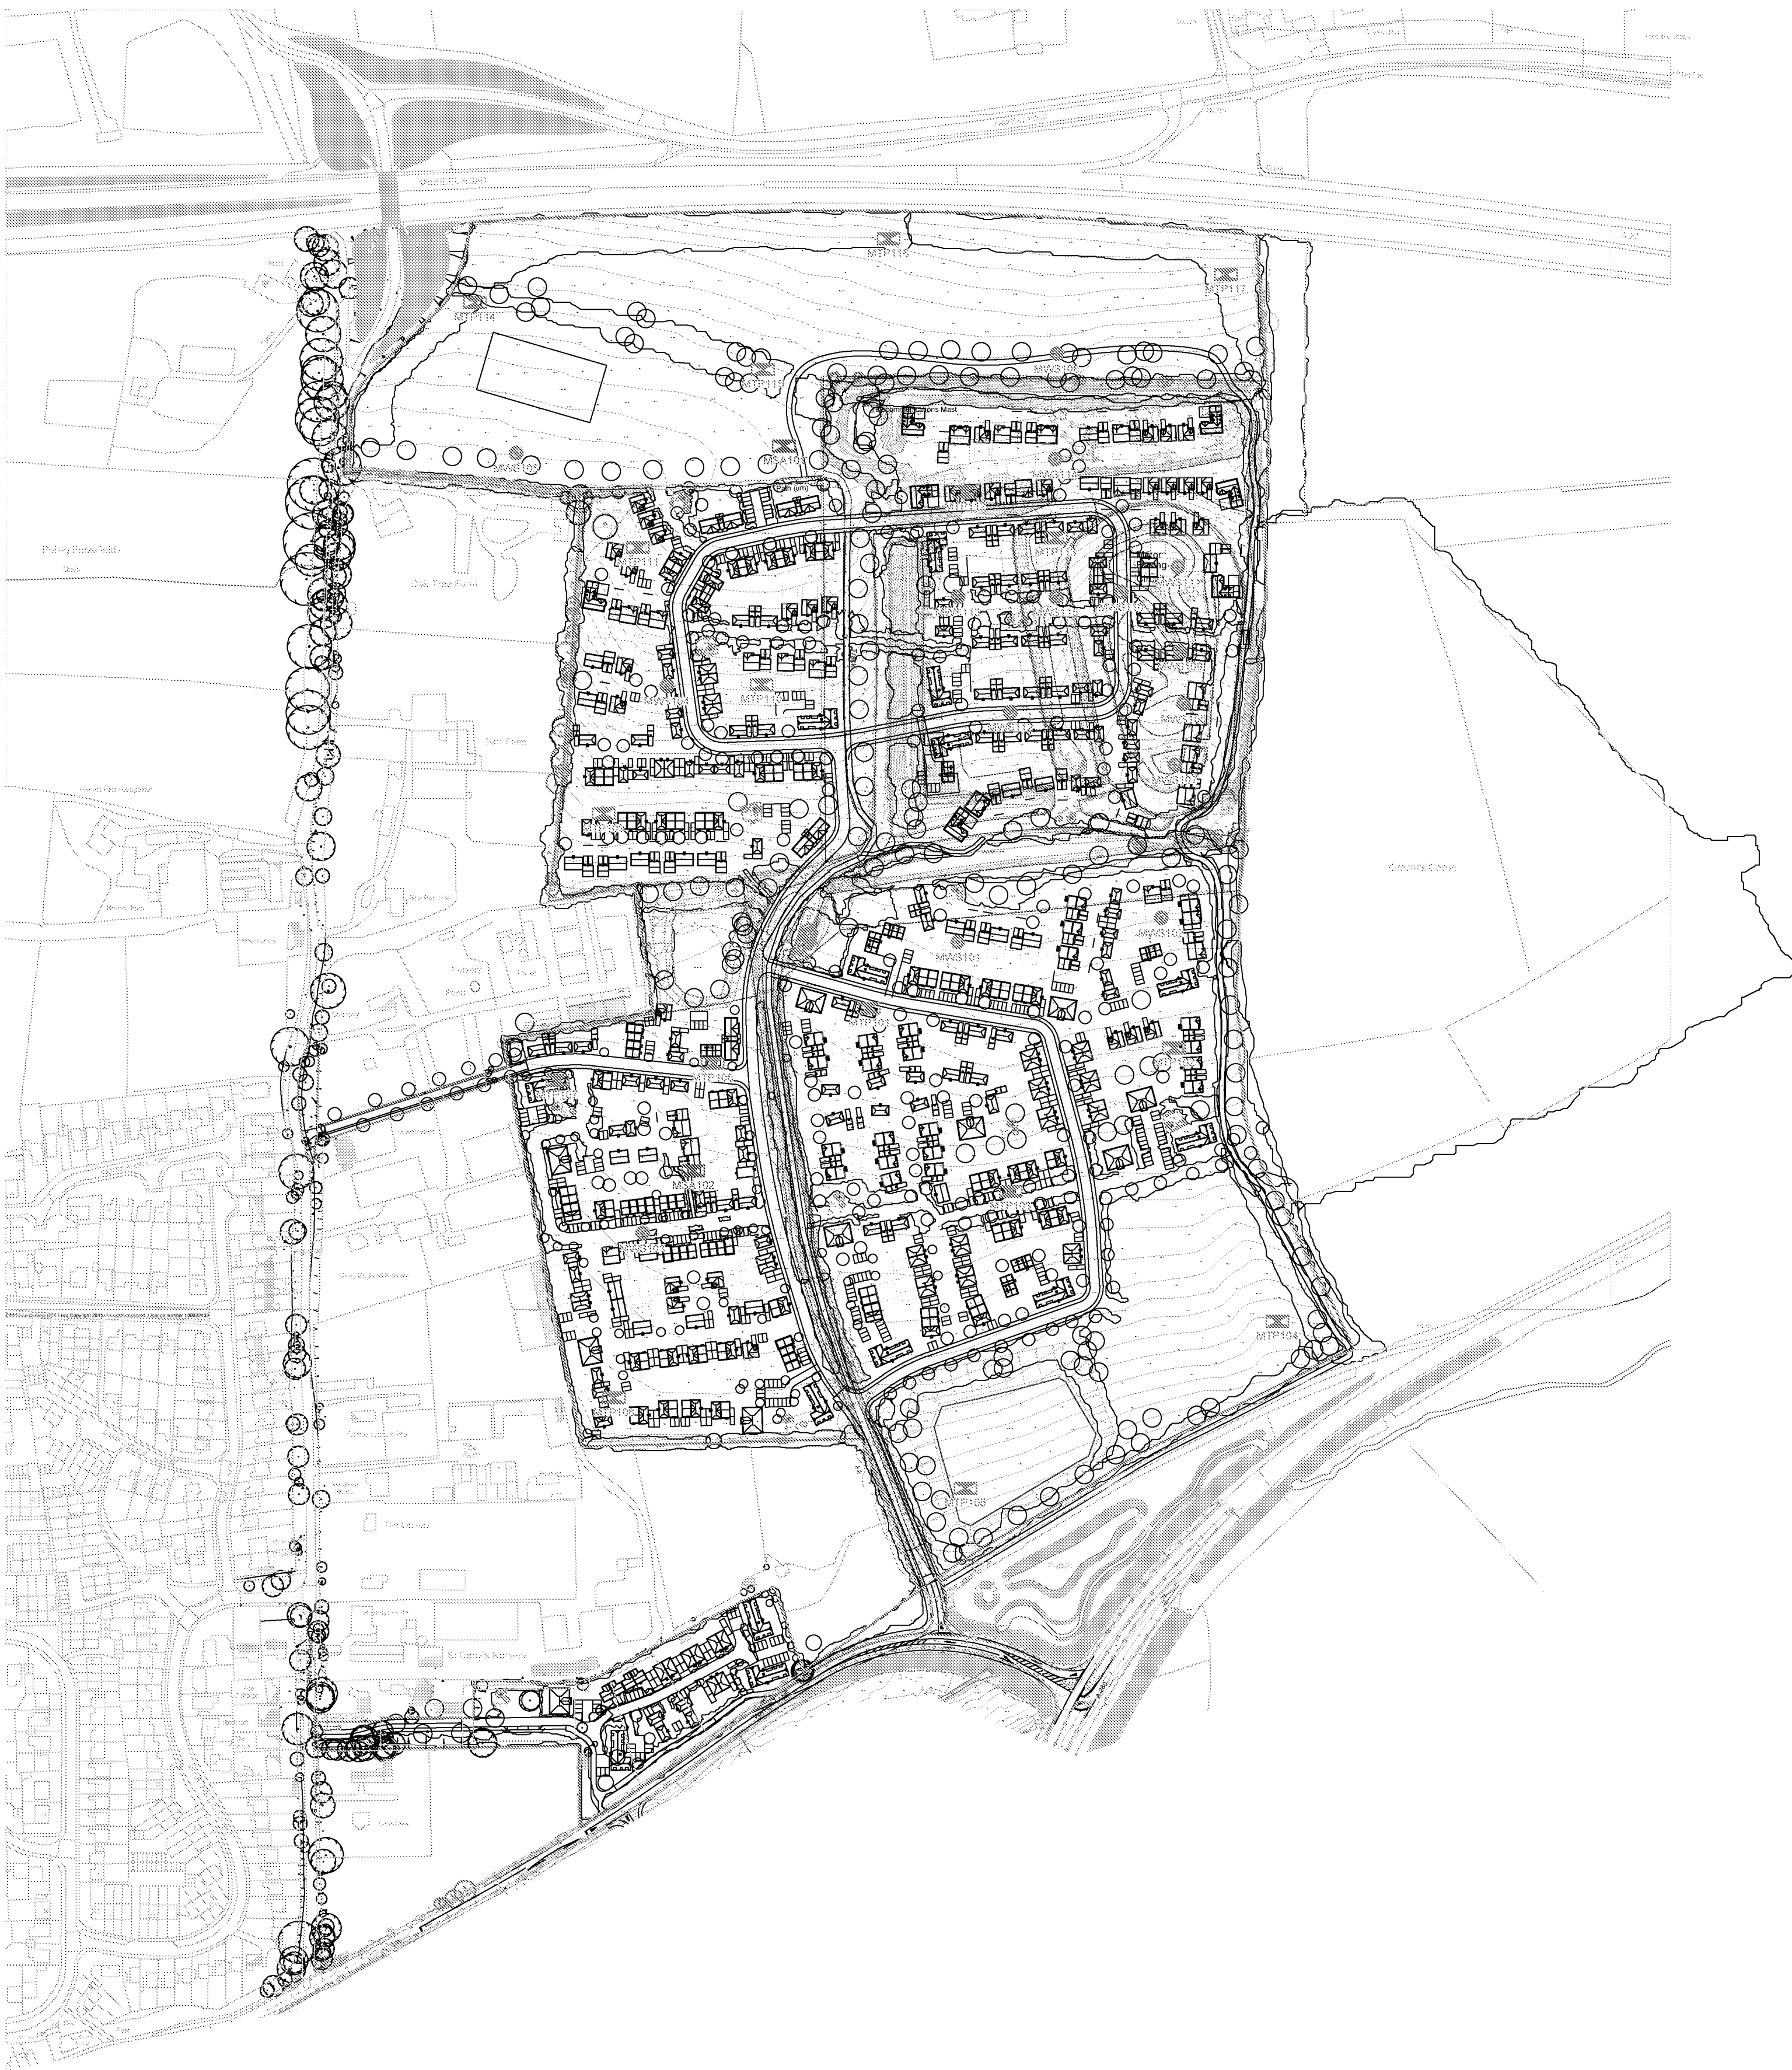
- Legend
- Site boundary
  - Merebrook trial pit with location reference
  - Merebrook window sample with location reference
  - Merebrook soakage test pit with location reference

- 4.1.1 The intrusive locations were positioned to provide sufficient site coverage with specific locations altered to target areas of potential concern, which included the Motorsports Centre. As such, the ground investigation was designed for a detailed coverage within the Motorsports Centre (MTP112 – MTP113 and MWS107 – MWS114). The remainder of the intrusive locations were utilised to gain coverage across the agricultural land and the remainder of the site.
- 4.1.2 The surface ground conditions encountered were consistent in composition and comprised grazing and agricultural field space covered by grass. A crop cover was

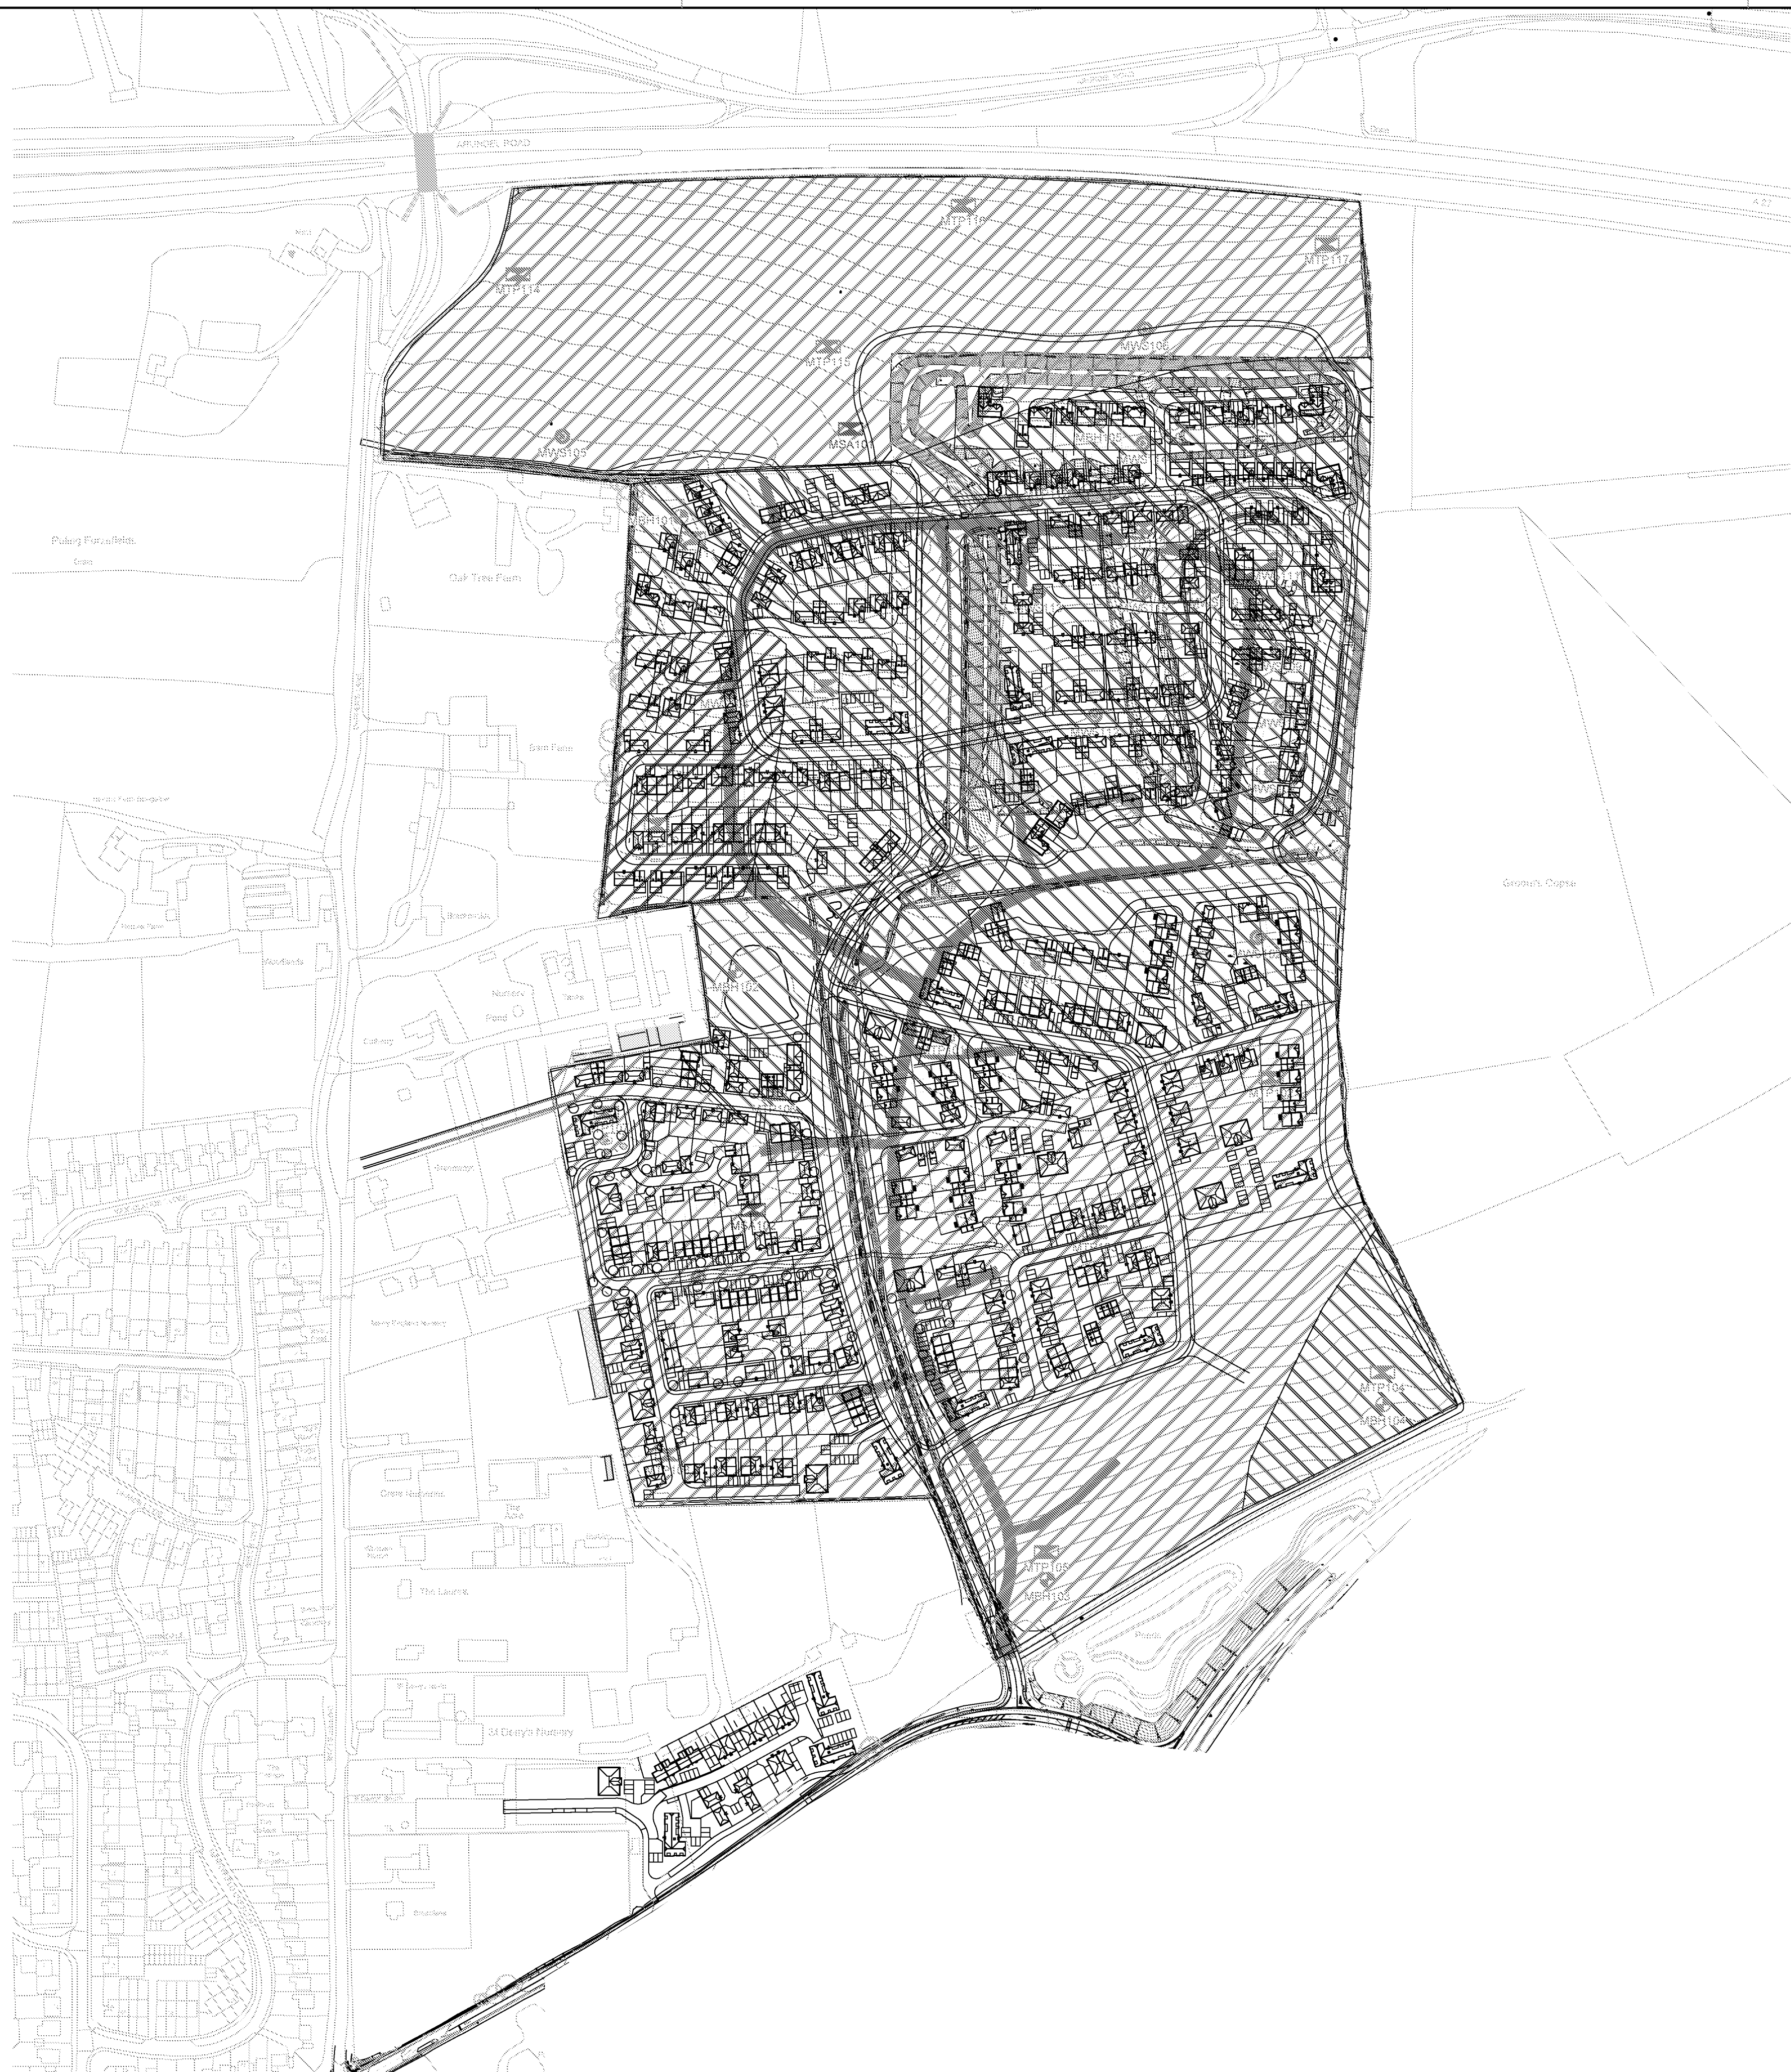
# Preliminary Foundation Zoning Plan

| | Strip footings at minimum depth of 1.0m founded in firm/stiff clay |
| | Strip footings at minimum depth of 0.75m founded in sand/gravel |

- 5.1.3 Based on the ground conditions revealed, it is envisaged that traditional strip or trench footings will be feasible across the majority of this area. Strip footings founded at a minimum depth of 1.0 m within firm / stiff (medium / high strength) clays are considered acceptable in the northern and southern portions, whilst trench footings at a minimum depth of 2.0 m (locally 2.5 m) will be required in the central portion and the south-eastern corner. Footing depths could possibly be reduced locally if firm / stiff is encountered at shallow depth.

- 5.1.6 Vertically persistent soft (low strength) clays have been encountered in a relatively small area situated in the central portion of the site and on the western boundary. It is considered unlikely that strip / trench footings will be feasible in this area, therefore it is recommended that an alternative foundation solution, such as ground improvement (vibro stone columns or concrete columns) or piles, is adopted.

- 5.1.13 A preliminary foundation zoning plan, drawing 19495-311-003 is provided in Appendix 1.
