# **LAND NORTH OF WATER LANE, ANGMERING WATER LEVEL MONITORING – WINTER 2017**

Approximate Site Investigation Location

Land to the North of Water Lane

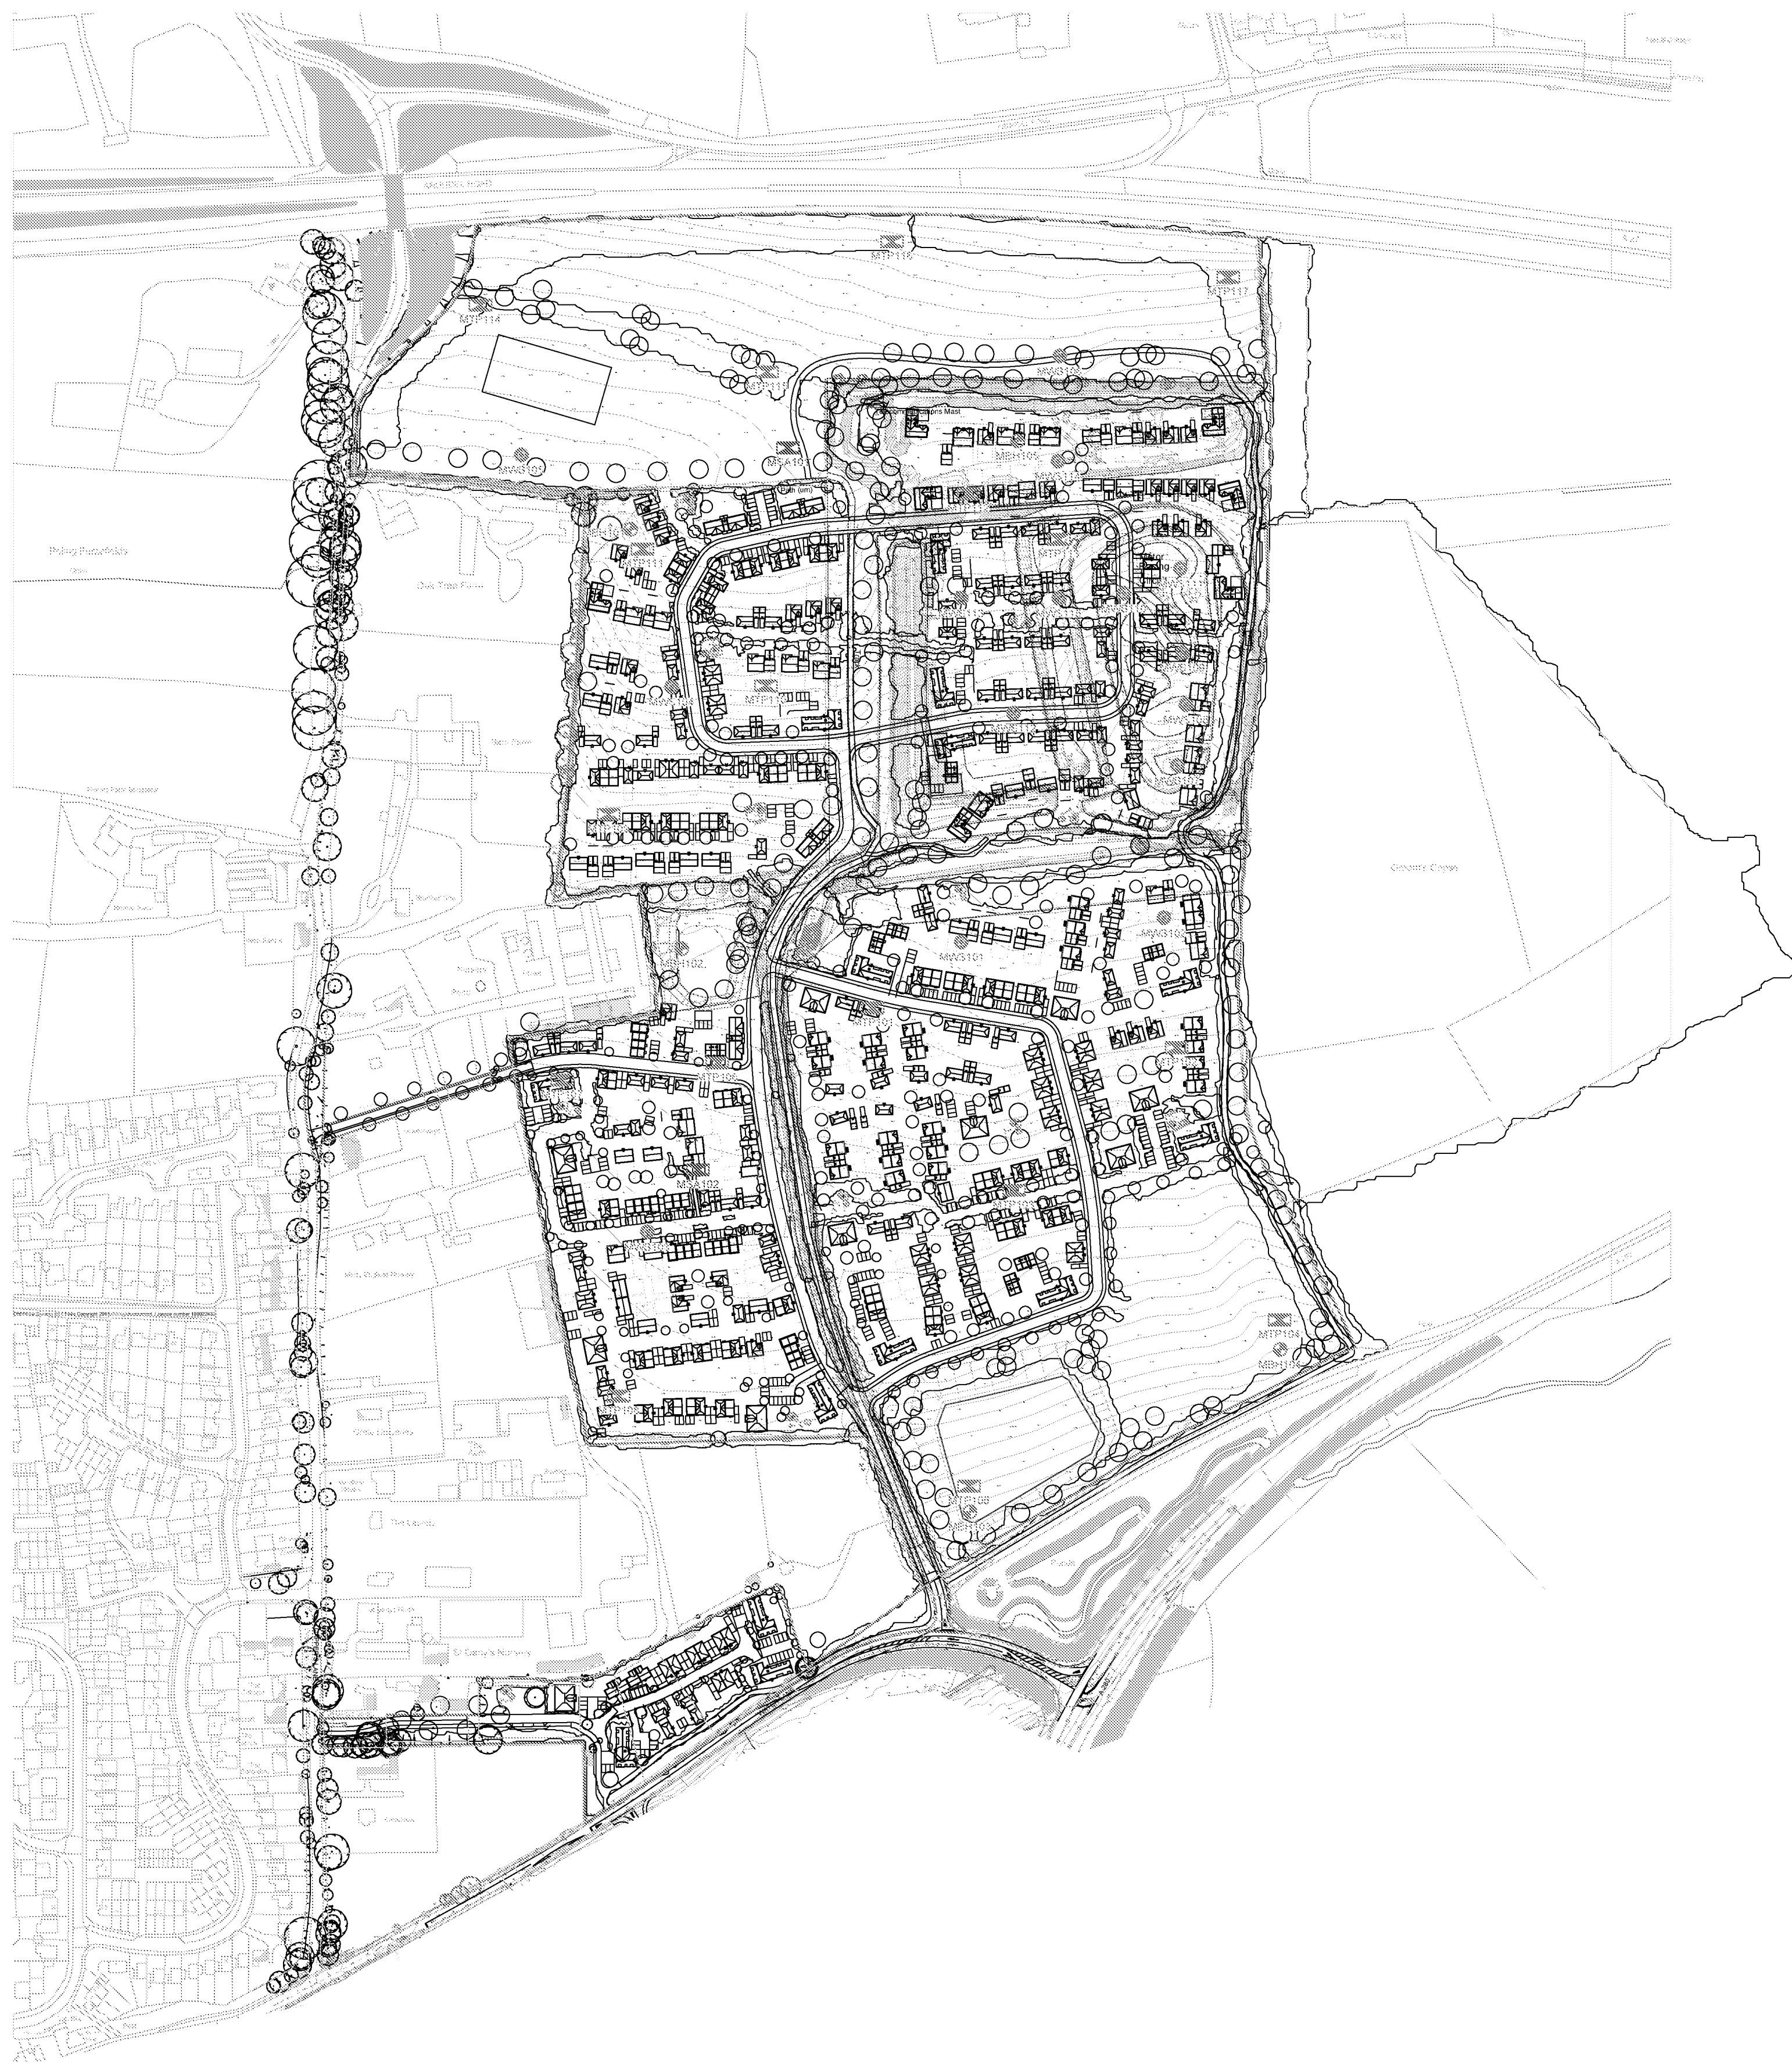
| Job No.<br>19495 | Dwg No.<br>304-004 | Revision<br>- |

| | Merebrook cable percussion borehole installed for water level monitoring |

enc Drawing 19495-304-004  
Exploratory hole records
