GEO-ENVIRONMENTAL ASSESSMENT  
LAND TO THE SOUTH OF WATER LANE  
ANGMERING  
RYDON HOMES & GLEESON STRATEGIC LAND  
GEA-19495-16-306REVB  
MAY 2017

A Geo-Environmental Assessment was requested by Rydon Homes and Gleeson Strategic Land at Water Lane, Angmering. The purpose of the assessment was to identify any contaminative or geotechnical issues associated with former land use at *Land South of Water Lane, Angmering, Littlehampton, West Sussex* which might impact on the site's redevelopment.

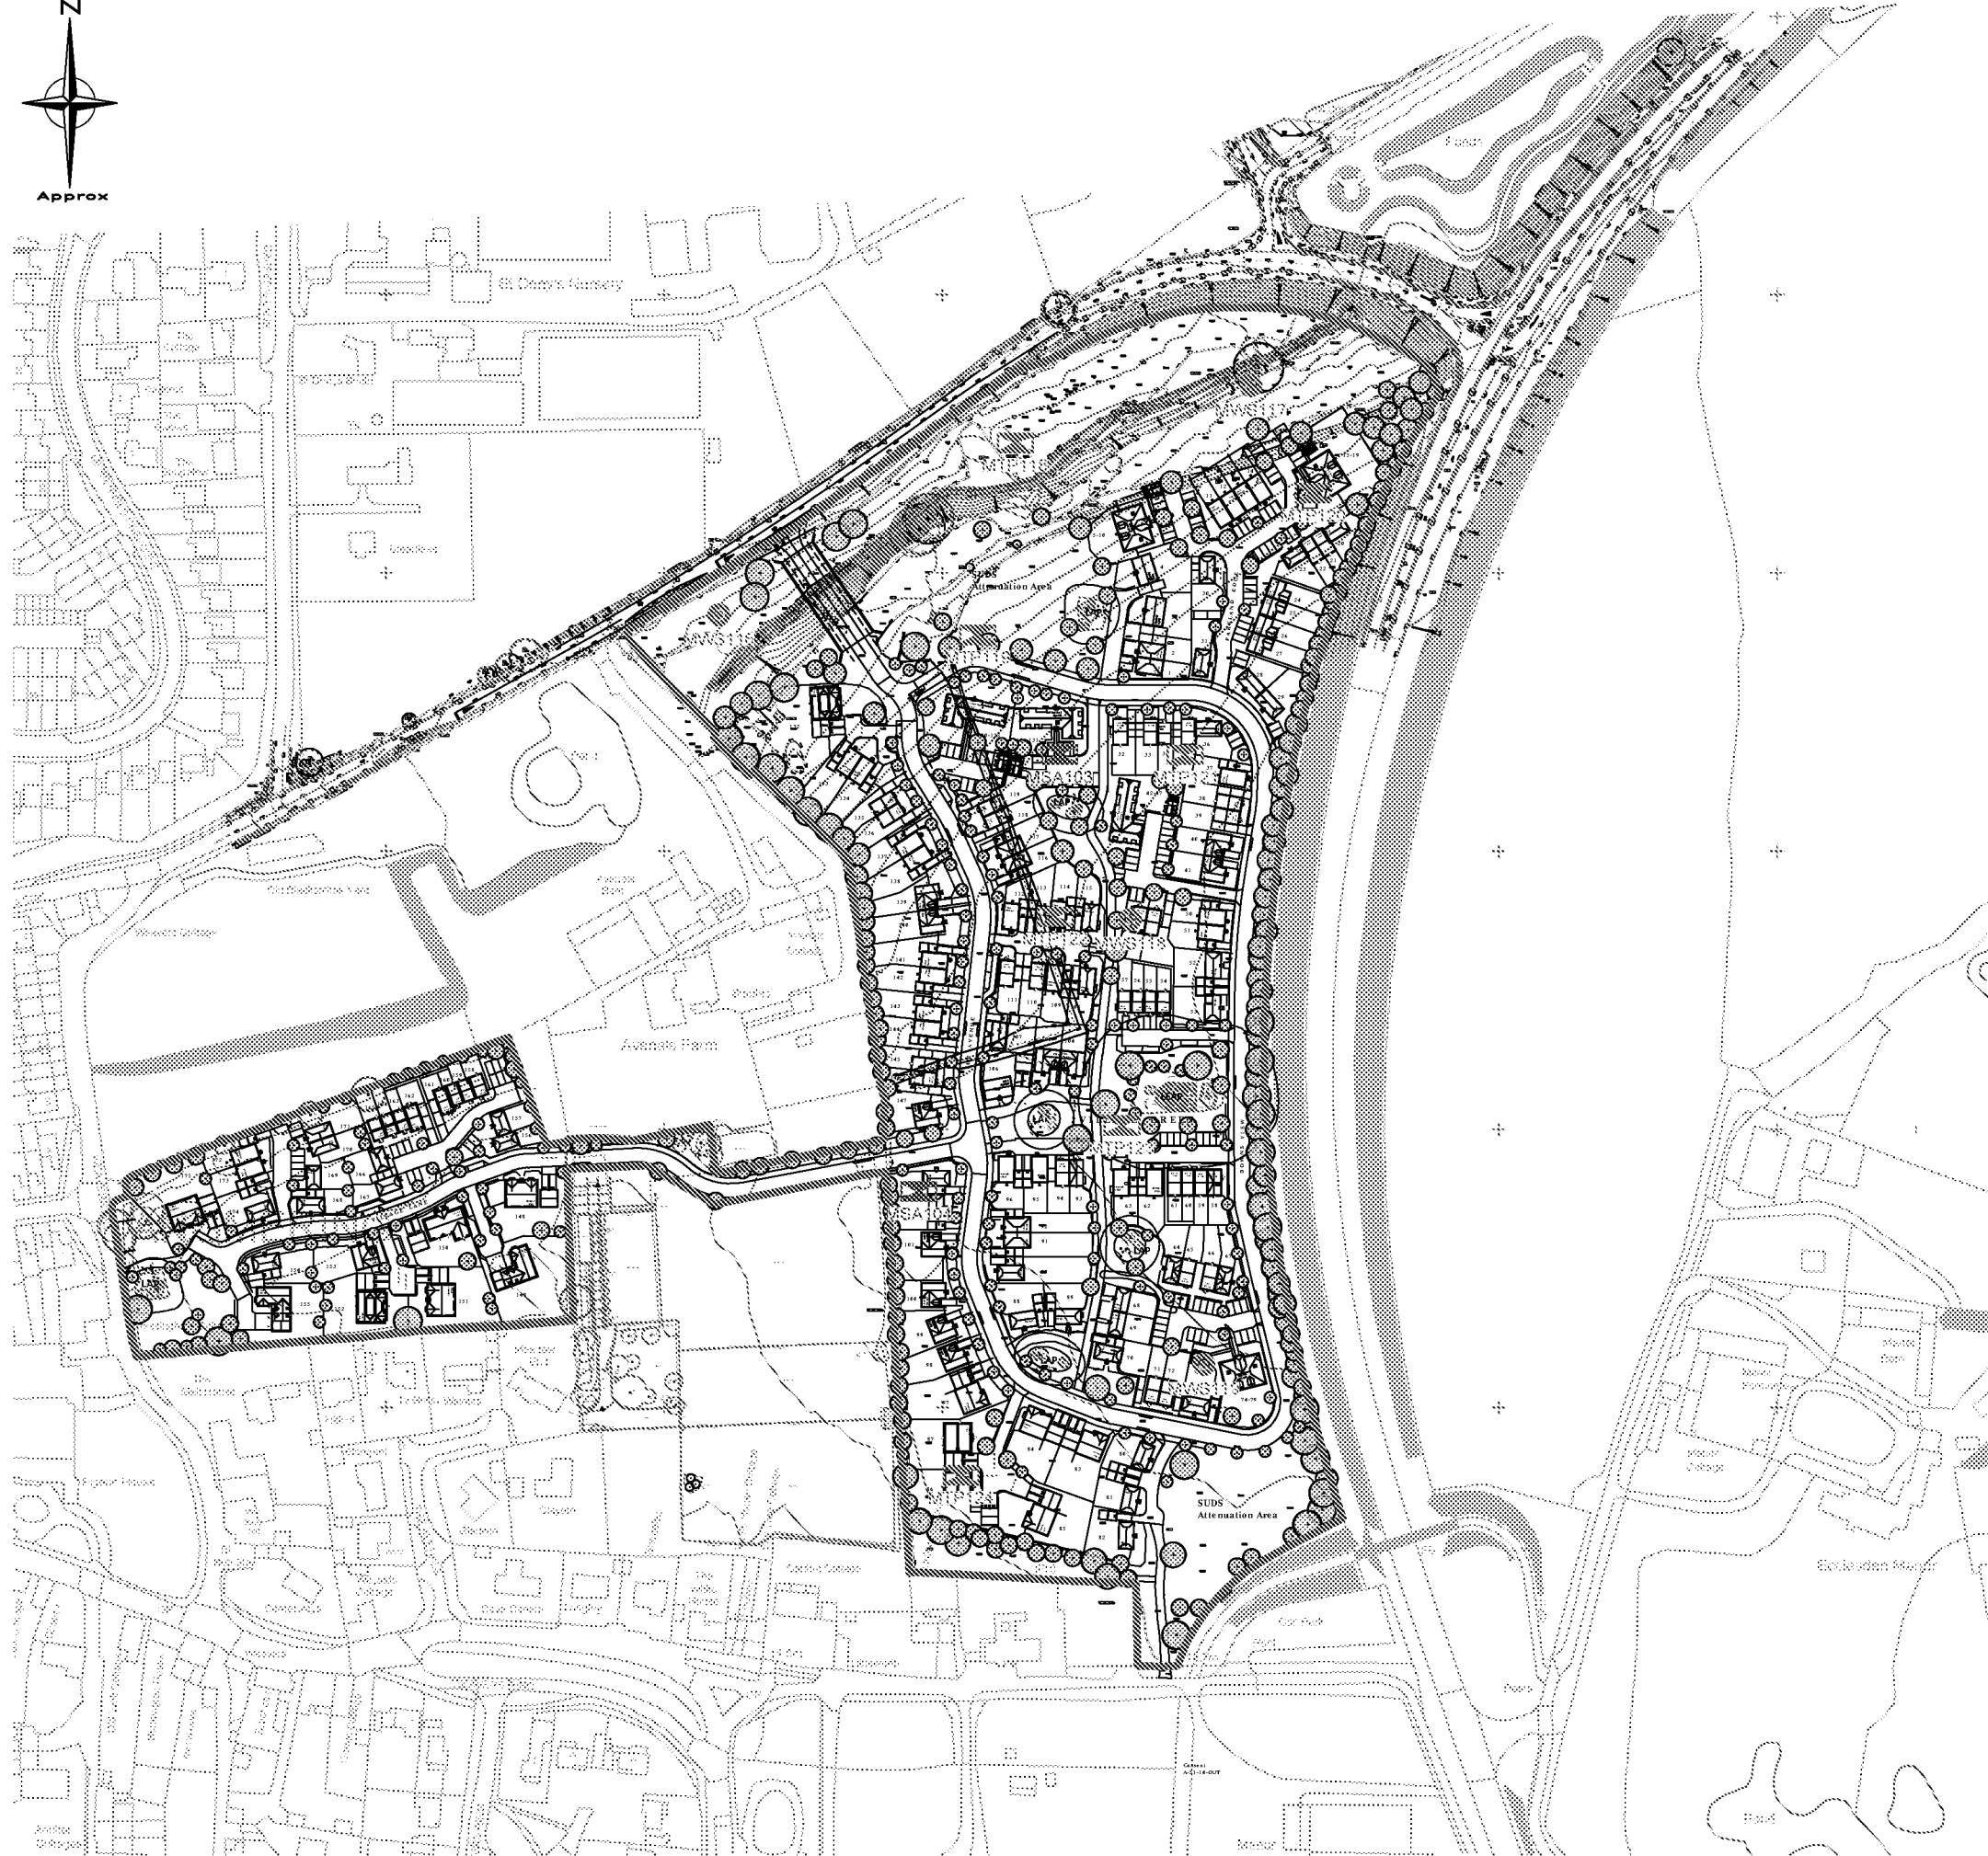
- Southern parcel boundary
- MTPref Merebrook trial pit with location reference
- MWSref Merebrook window sample with location reference
- MSAref Merebrook soakage test pit with location reference
