# **TECHNICAL NOTE**

Surface & Foul Water Drainage

**PROJECT NO. 70061643**

WSP has been appointed by Bellway Homes (Wessex) Ltd to provide engineering support and to assist in the discharge of planning conditions and reserved matters for the New Barn Lane development, North Bersted.

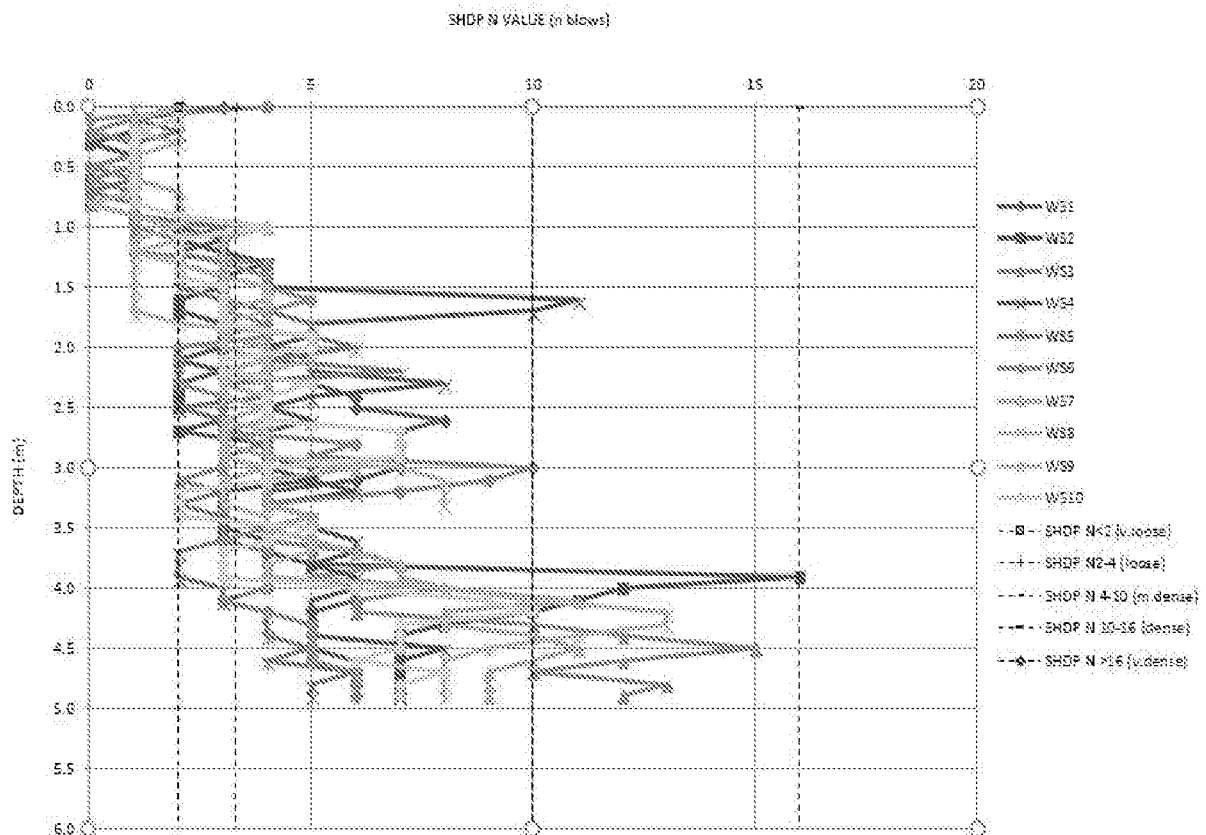
A super heavy dynamic probe (SHDP) was undertaken at all positions. The test is used as a measure of the relative density of granular soils (as defined in BS5930:1999). The test provides limited data in cohesive soils but may be used to illustrate changes in consistency with depth. The test may be used in Chalk to assess the density grade. A typical range of results is summarised below.

Figure 10 is a line graph titled "estimated shear strength kN/m²" on the x-axis and depth in meters on the y-axis. The x-axis ranges from 0 to 120 with major grid lines every 20 units. The y-axis ranges from 0.00 to 2.00 with major grid lines every 0.50 units. The graph displays five data series representing different soil types, each with a unique line style and markers. The series are: silty clay (dotted line with open circles), silty clay with sand (dashed line with open squares), silty sand (solid line with open triangles), sand (solid line with open diamonds), and sand with gravel (dashed line with open circles). The graph shows that shear strength generally increases with depth for all soil types. Silty sand and sand with gravel show the highest shear strength values, while silty clay shows the lowest.

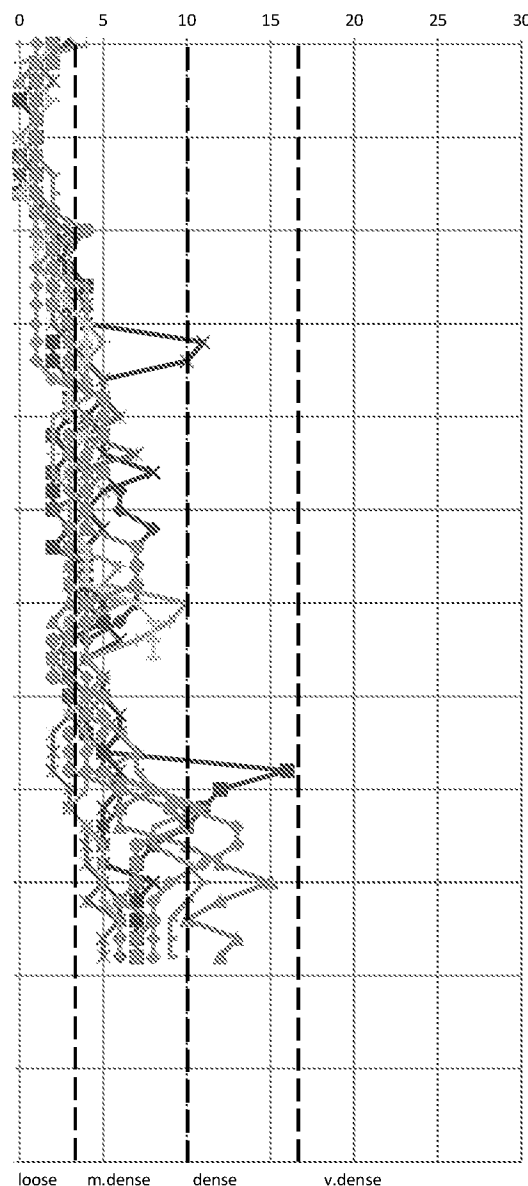
| SUPER HEAVY DYNAMIC PROBE RESULTS | | | | | | | | | | | Drilled 23/04/2018 - 24/04/2018 | | | | | |

| SUPER HEAVY DYNAMIC PROBE RESULTS | | | | | | | | | | | Drilled 23/04/2018 - 24/04/2018 | | | | | |
|---|---|---|---|---|---|---|---|---|---|---|---|--|---|--|--|--|
| Project: New Barn Lane, Bersted, Bognor Regis, PO21 5DL | | | | | | | | | | | Ref LS 3463 | | | | | |

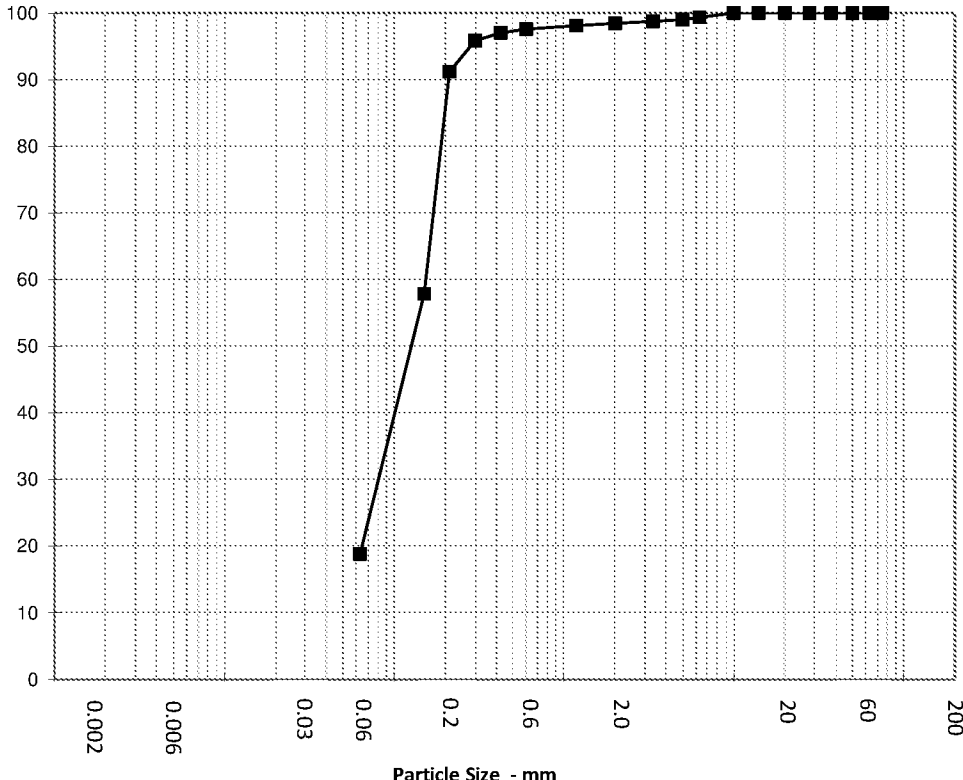
<table><tr><th>Particle Size - mm</th><th>Percentage Passing - %</th></tr><tr><td>0.075</td><td>18.8</td></tr></table>

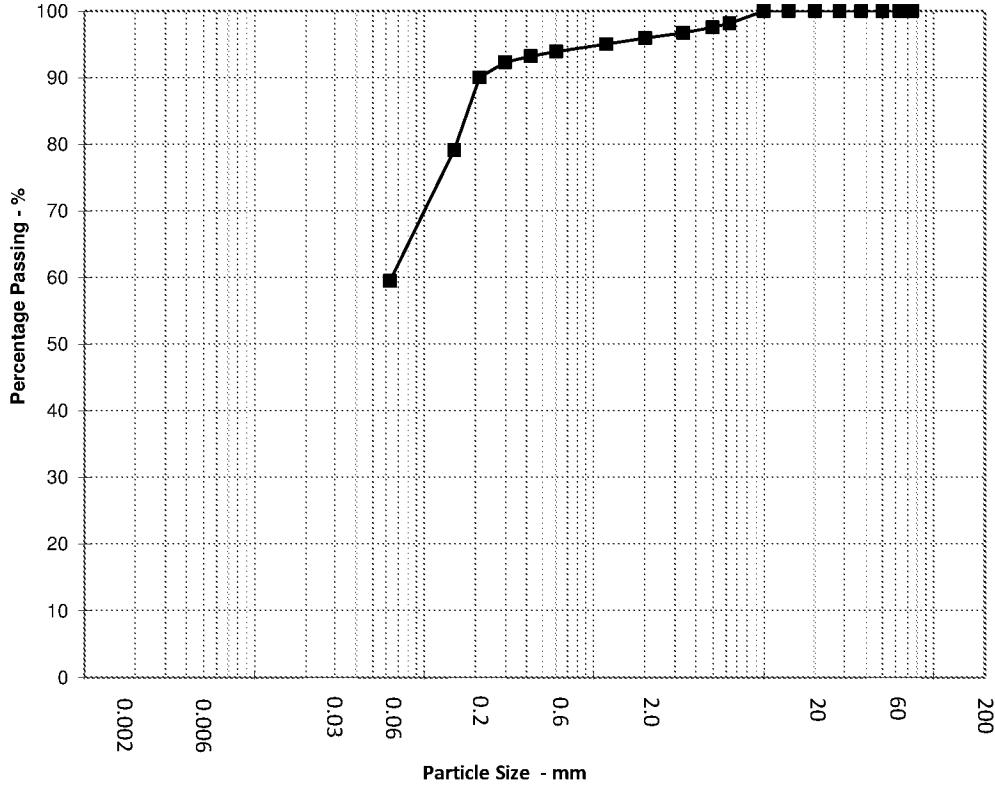
<table><tr><th colspan="2">Sample Proportions</th><th colspan="2">Grading Analysis</th></tr><tr><td>Cobbles</td><td>0.0</td><td>D100</td><td>10</td></tr></table>
