# Road Safety Audit – A29 Shripney Road

| <b>Stage:</b> | <b>1</b> |
| <b>Location:</b> | <b>A29 Shripney Road, Shripney, West Sussex</b> |
| <b>Site:</b> | <b>Proposed right turn lane and new site access (Audit of proposed modifications to informal pedestrian crossings)</b> |

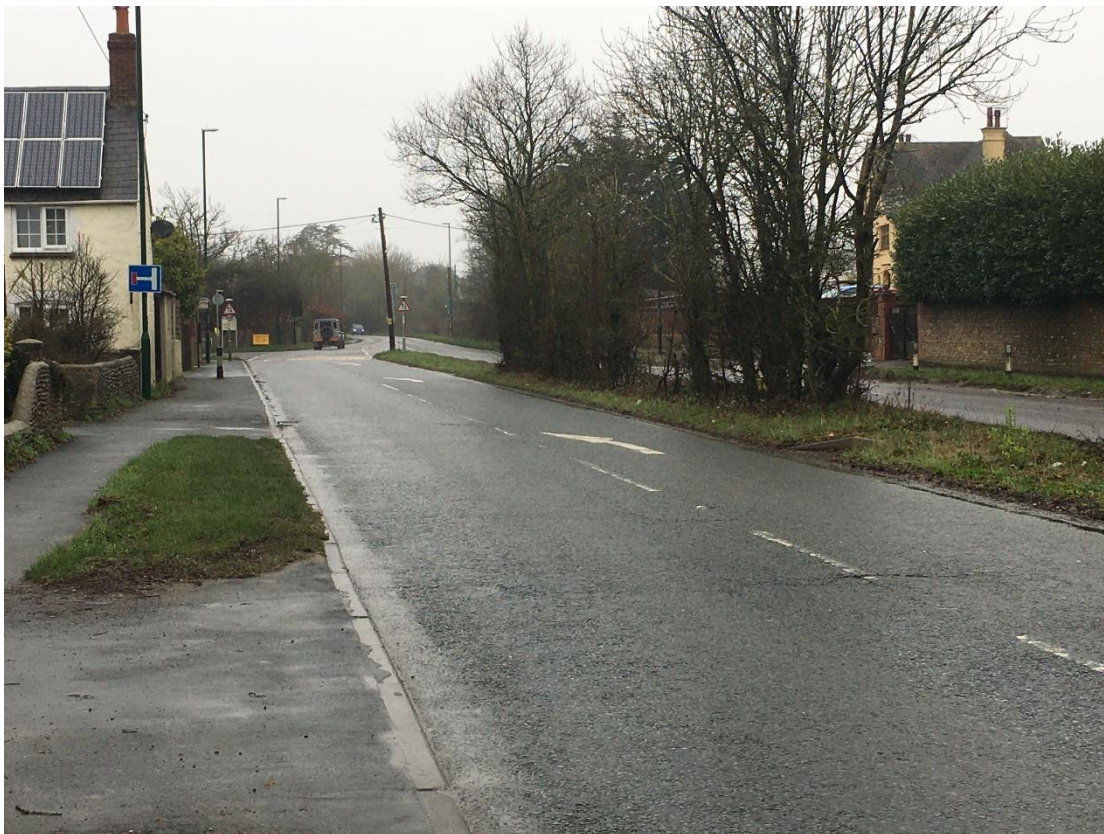
*Northbound approach to the A29/Shripney Lane junction where new informal pedestrian facilities are proposed*

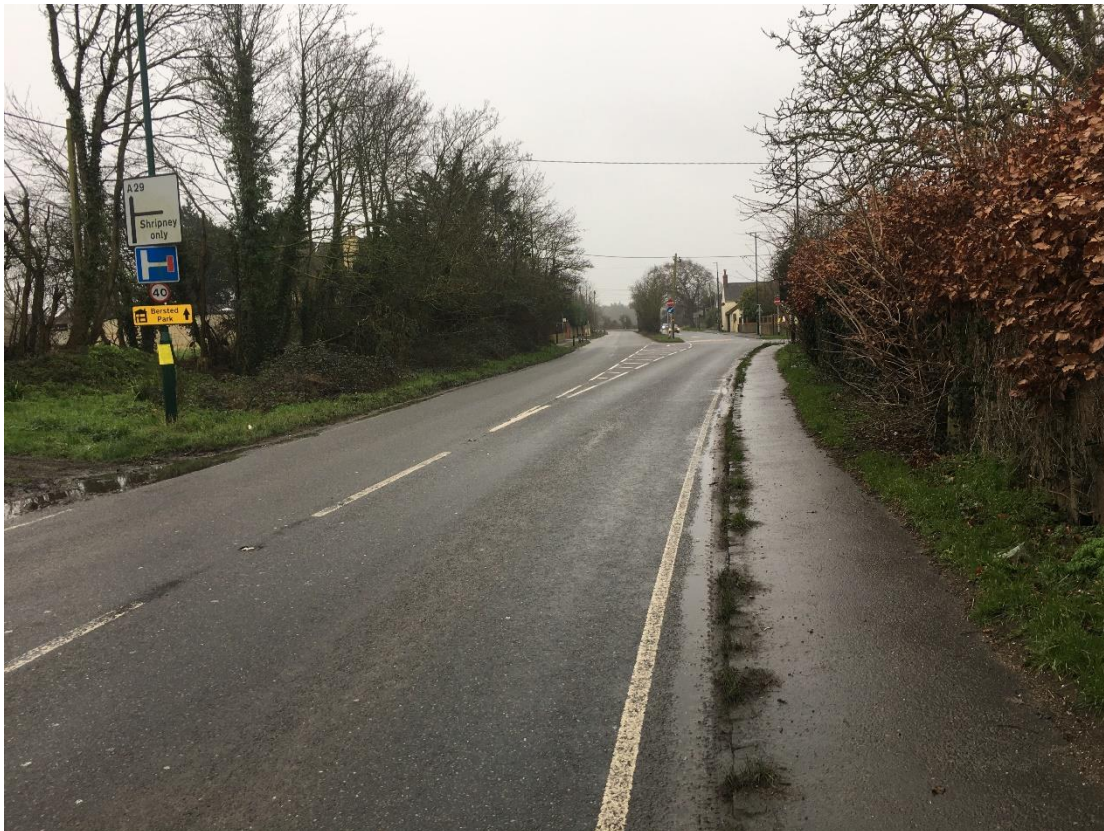
*Southbound approach along the A29 to the proposed informal pedestrian crossing*

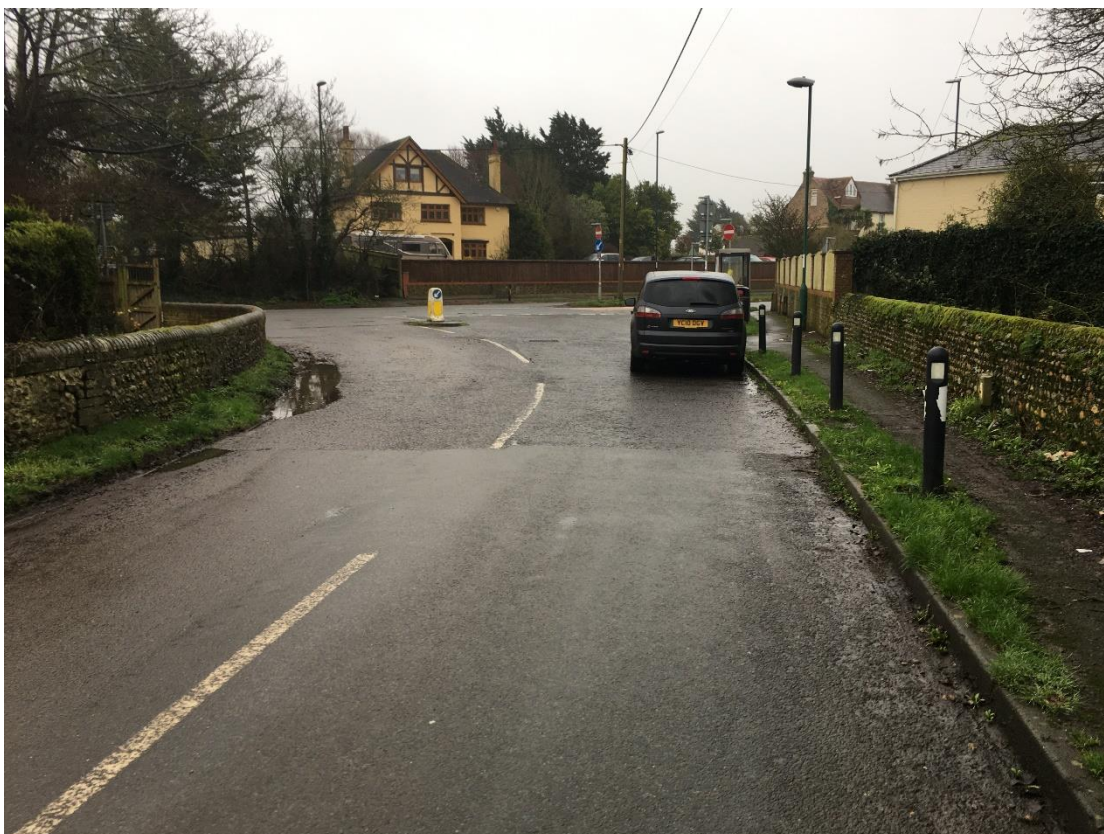
*Eastbound approach to the A29 along Shripney Lane*

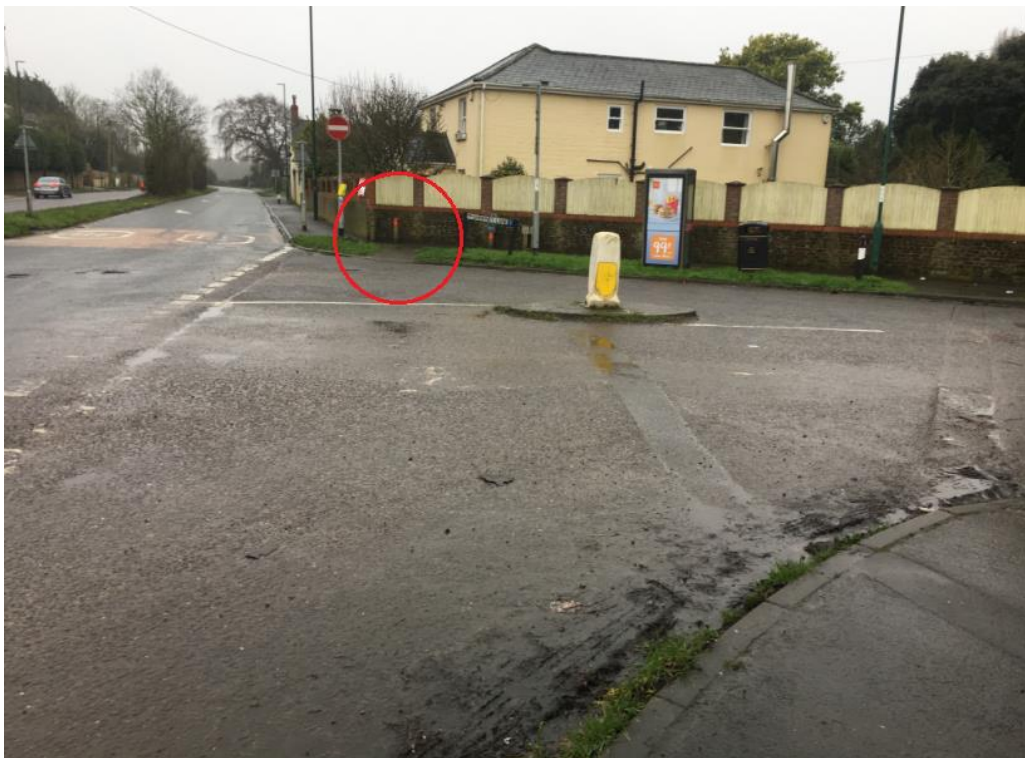
**Location** – Shripney Lane - Proposed pedestrian crossing point on south side

**Summary** – Risk of pedestrian/vehicle conflict due to lack of visibility and inappropriate vehicle approaching speeds

The existing informal pedestrian crossing at this location is proposed to be upgraded so that it is realigned and incorporates an area of tactile paving. The boundary wall and fence of an adjacent residential property inhibits visibility to the proposed crossing of those approaching from the south along the dual carriageway. This increases the likelihood of pedestrian/vehicle conflict particularly for vulnerable groups such as older users and those with mobility and visual impairment. The high approaching speeds observed on site together with the lack of any deflection for vehicles turning in to Shripney Lane will increase the risk of such collisions (see photo 2.1).

*Photo 2.1 - Visibility to the proposed crossing is inhibited by the existing boundary wall and fence*

**Recommendation** – Realign and build out the existing kerblines at this corner to increase visibility to and from the crossing. The resulting increased deflection together with the reduced entry radius at this corner will influence entry vehicle speeds and minimise the risk of conflict with those crossing.

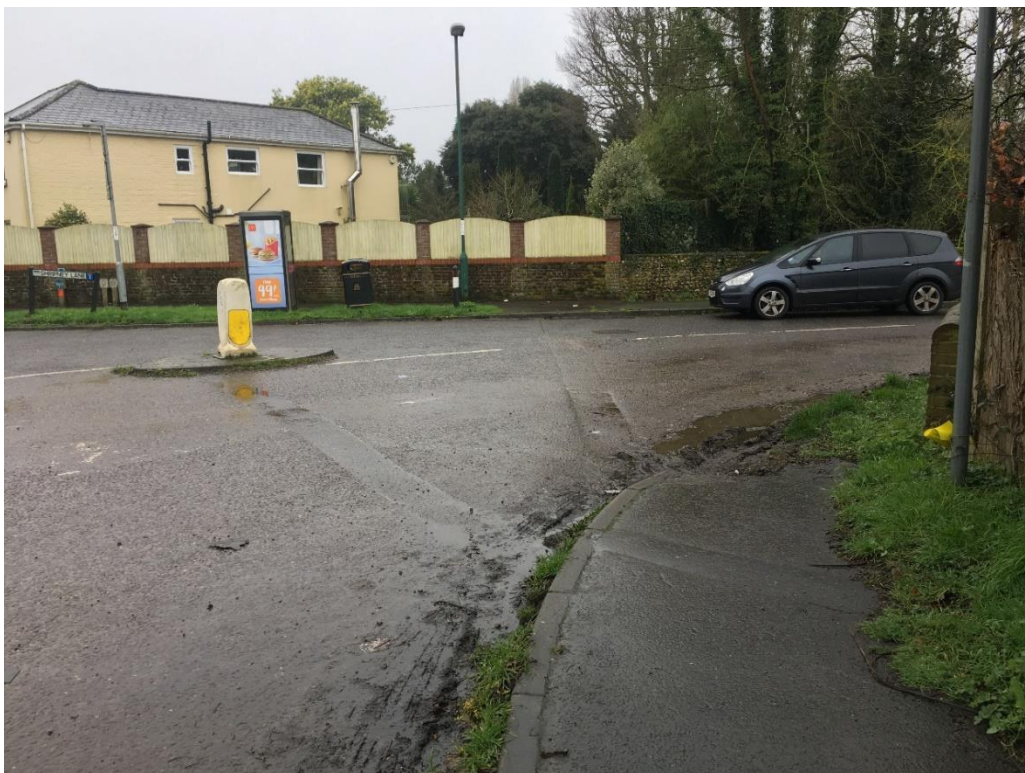
**Location** – Shripney Lane - Proposed pedestrian crossing point on north side

**Summary** – Risk of pedestrian/vehicle conflict due to lack of visibility

The existing boundary fence and wall inhibits visibility to the proposed pedestrian crossing point and increases the risk of vehicle/pedestrian conflict. Evidence on site also indicates that drivers turning left out of Shripney Lane mount the kerb as their attention is drawn to vehicles approaching from the south (often at speed), along the dual carriageway (see photo 2.2).

*Photo 2.2 - Site observations suggest vehicles mounting the existing footway at the point where pedestrians will be encouraged to cross*

**Recommendation** – Increase visibility at this point by building the kerb further out into the carriageway. If the existing kerblines were realigned on both sides of the junction and the refuge island was omitted visibility would be improved on both sides of this junction (see problem 2.1).

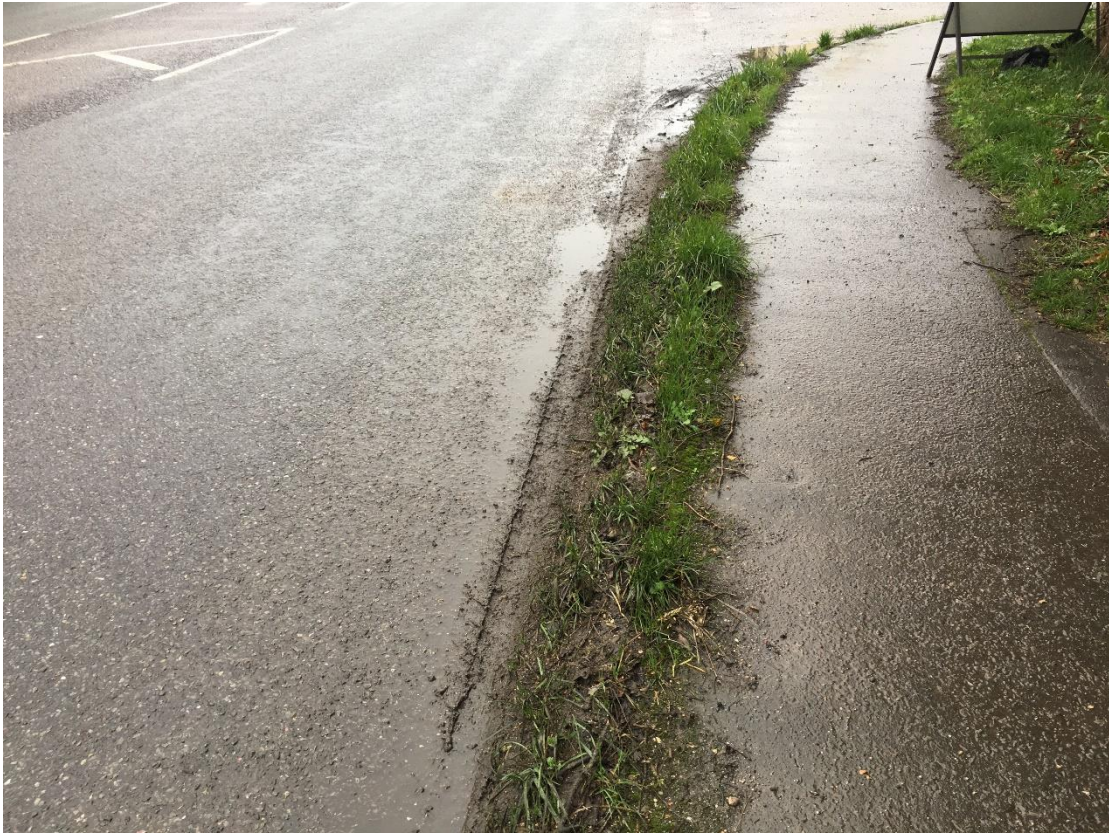
**Location** – A29 proposed pedestrian crossing point – west side

**Summary** – Risk of pedestrian/vehicle conflicts due to the existing road layout and inappropriate approaching speeds

The existing road layout at the A29/Shripney Lane junction and the provision of the new central refuge island means that those approaching from the south (often at speed and overtaking) will be squeezing past this point while pedestrians are waiting to cross increasing the likelihood of vehicle/pedestrian conflicts. Site observations also indicate vehicle wheel tracking very close to the existing kerblines (see photo 2.3).

*Photo 2.3 – Site observations indicate vehicles driving very close to the carriageway edge*

**Recommendation** – Install measures along the northbound approach of the dual carriageway in advance of the Shripney Lane junction to alter driver behaviour at this point. This may include reducing the northbound carriageway to a single lane of traffic (which will also improve visibility which has been raised as a problem in section 2.1), by the use of extra hatching on the approach, and possibly a local build out of the central reservation, appropriately signed; enhancing the existing signage; and reducing the existing speed limit. Also reinstate the existing edge of carriageway markings to guide vehicles away from the edge of the carriageway.

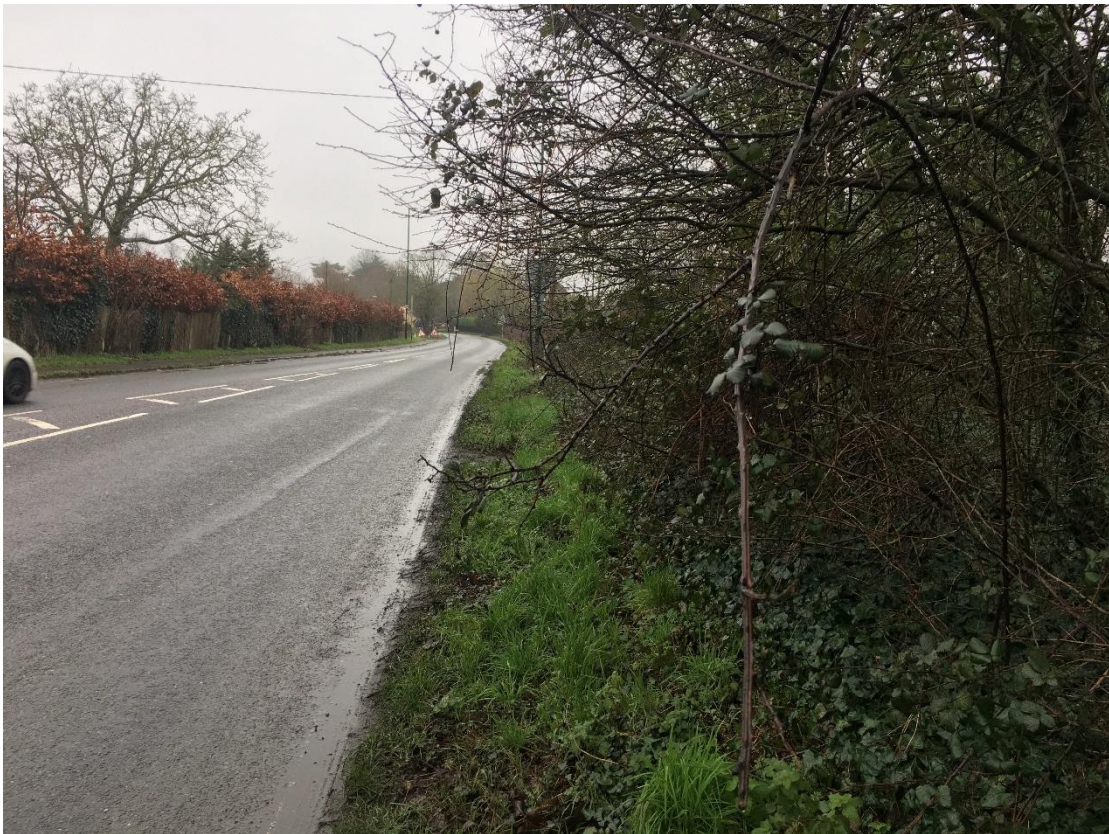
**Location** – A29 proposed pedestrian crossing point – west side

**Summary** – Pedestrian/vehicle conflicts due to a lack of visibility

The new crossing point is proposed to be installed within an area of existing foliage. If this is not removed to ensure sightlines to and from the new crossing are maintained there is a high risk of pedestrians stepping into the carriageway and being struck by approaching vehicles (see photo 2.5).

*Photo 2.5 –Sightlines at the proposed pedestrian crossing are impeded by existing foliage*

**Recommendation** – Remove the existing vegetation and establish methods to permanently maintain required sightlines.
