Our ref: GE18732/FG02/191219

**RE: New Barn Lane, North Bersted - Soakage**

Enc     Figure 1 – Site Location Plan  
         Figure 2 – Trial Pit Location Plan (proposed development)  
         Figure 3 – Trial Pit Location Plan (Aerial)  
         Appendix A – Exploratory Hole Logs  
         Appendix B – Soakage Test Results  
         Appendix C – Geochemical Laboratory Test Results

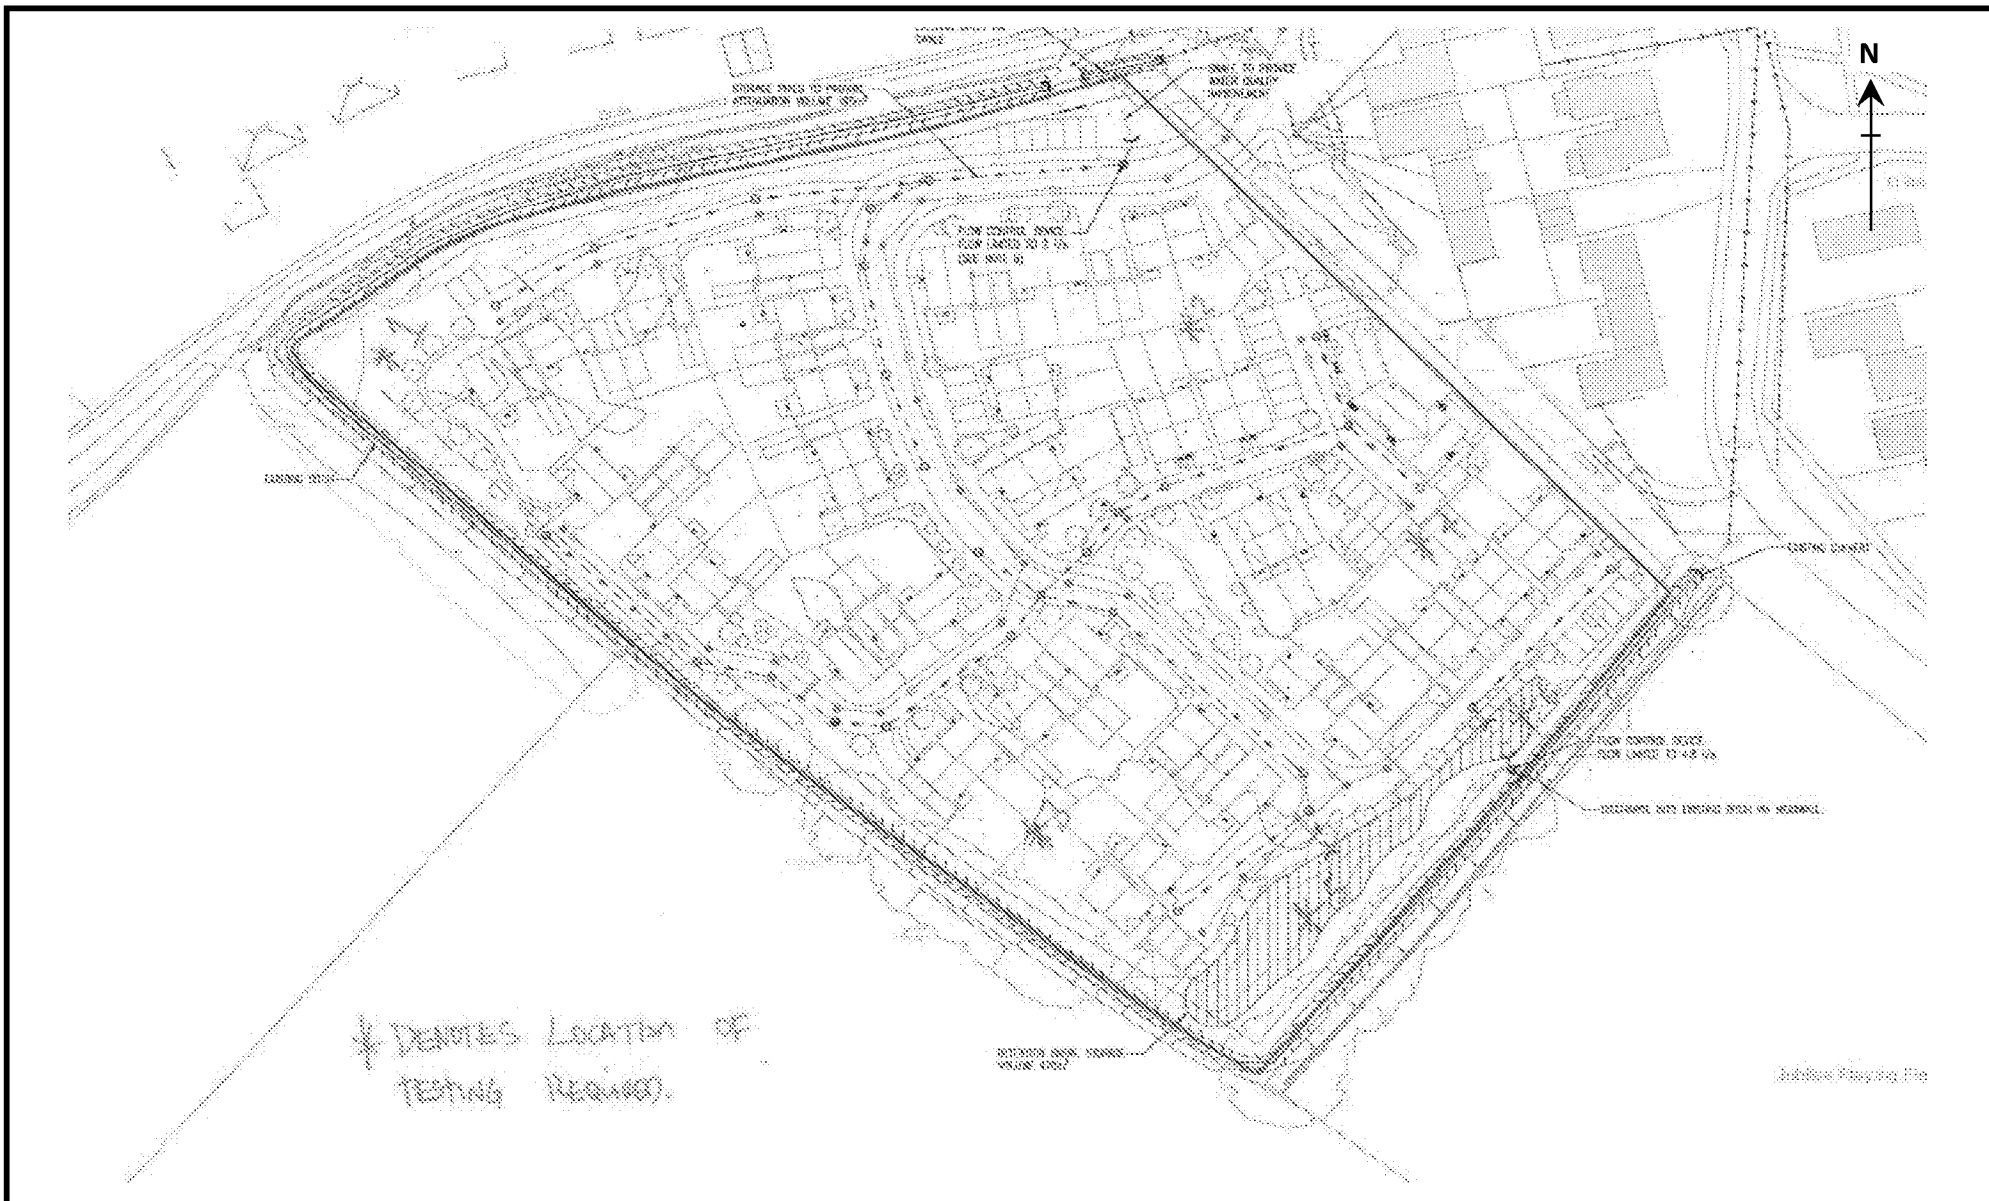
In total, the intrusive investigation comprised the excavation of 6No. trial pits to depths of between 1.40m and 2.0m bgl. Figure 2 presents the exploratory hole locations.

Figure 2 presents the investigation locations. For more a detailed descriptions of the ground conditions, reference should be made to the exploratory hole logs enclosed in Appendix A.

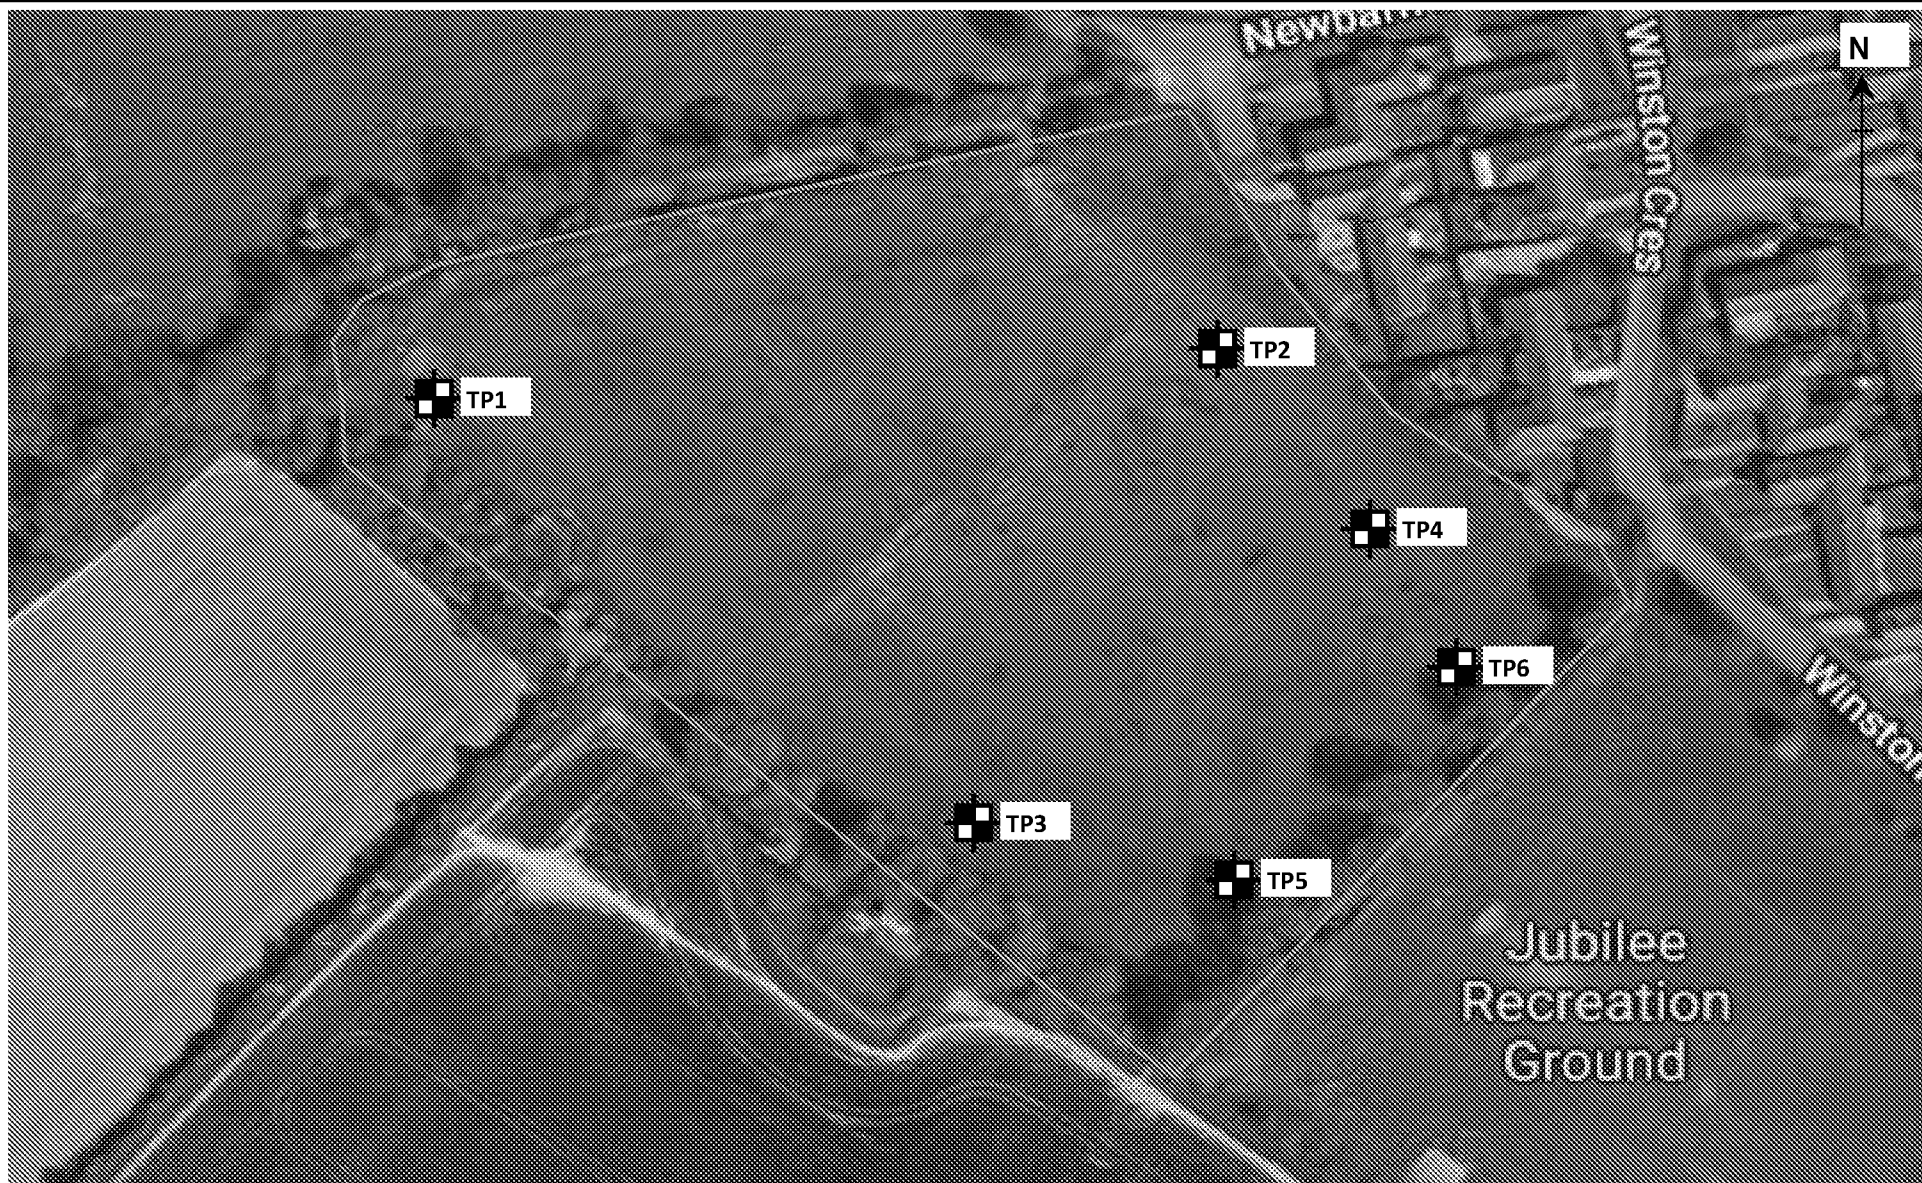
| <b>Project:</b> | Newbarn Lane, North Bersted, PO21 5DN | | | <b>Title</b> | Trial Pit Locations (Aerial) | | |
