## Bat Activity Surveys

The Cottage, Shripney Road  
Bognor Regis, West Sussex

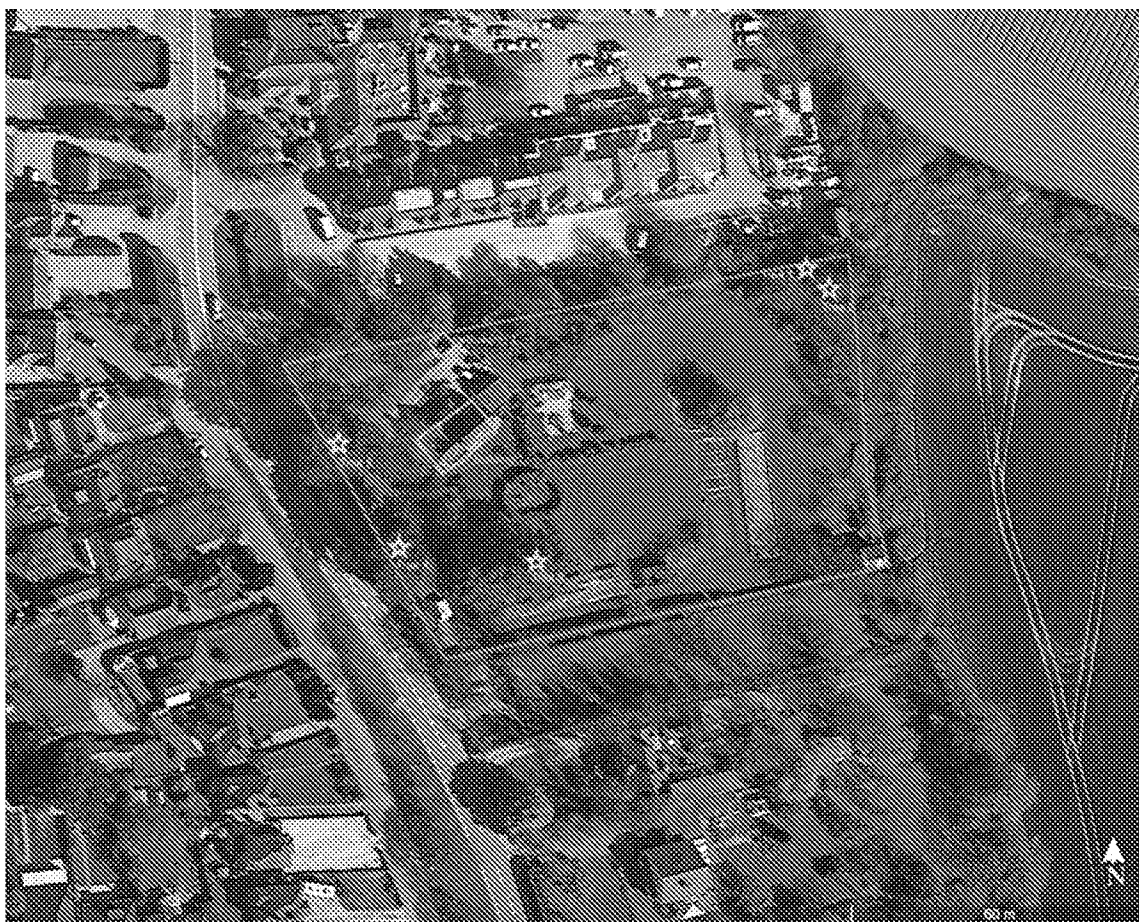
*Figure 4: Buildings subject to survey in orange, Trees with potential bat roosting features in green*

- 3.1 Due to the presence of suitable features within buildings 1 and 3 on site as well as suitable roosting features within mature trees on site emergence surveys were undertaken at site to assess the whether these features were in use by roosting bats. These features were identified during a PEA undertaken by The Ecology Partnership in 2016. No evidence was recorded within either building or at any of the trees. The buildings surveyed both had clay tiled pitched roofs with slipped and missing tiles, creating roosting opportunities for bats. The trees on site, contained features such as woodpecker holes and cracks within their stem.

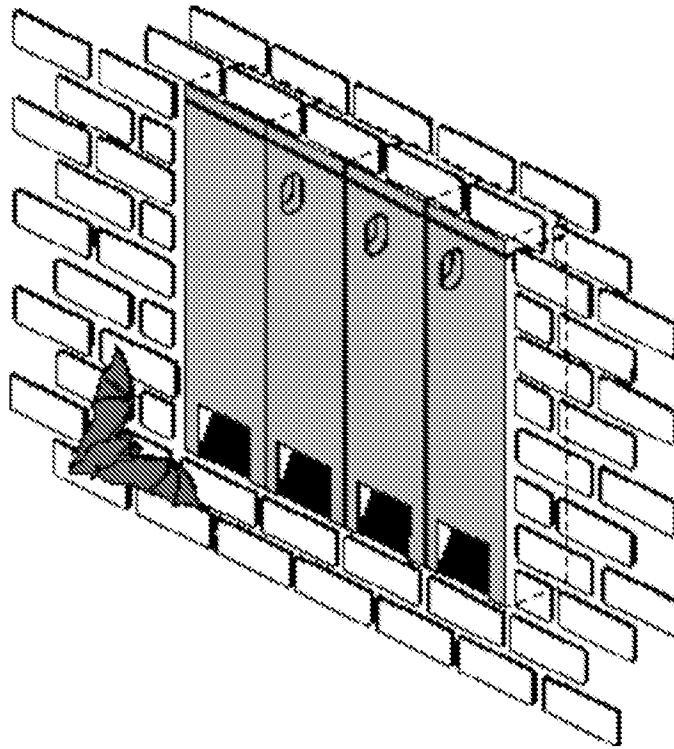
- 4.13 The development will include suitable mitigation measures in order to alleviate the loss of the bat roost within building 1. Common pipistrelle bats are a crevice dwelling species which require small access hole and features to roost within. The following will need to be undertaken within a mitigation strategy:
- Demolition works will only be undertaken when a licence has been issued.
  - Demolition works to the roof, external panels and any gable ends to be undertaken under Ecological Clerk of Works (by the Registered Consultant (RC) registered if under Natural England Low Impact Licence.
  - Four bat tubes will be incorporated into the south facing external wall of one of the new buildings on site, this will provide a similar roosting feature within the new development, to replicate the small roost that is being lost due to redevelopment. (Please see information below)

4.16 Long term compensation for the loss of this roost is through the use of the bat tubes on site. The use of the two Schwegler 2F and two 1FD bat boxes will be used as enhancement, whilst also providing bat roosting facilities whilst building works are to be undertaken. The bat boxes will be established prior to any site works on the mature trees on site. It is expected that these will be retained for a minimum of five years.

- The bat tubes will be included within the development build programme. The bat tubes will be checked to ensure they are fitted during the build process.

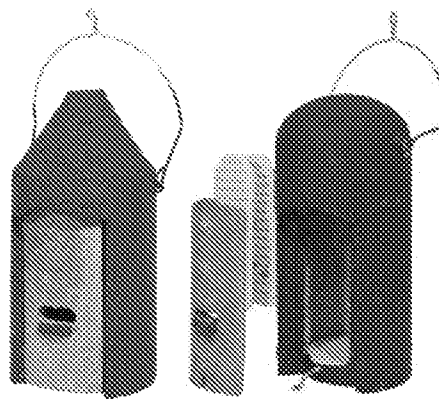
- Bat boxes will be erected as enhancement. Two Schwegler 2F Bat box (general purpose bat boxes and attract a wide variety of species) and two Schwegler 1FD Bat Box (developed specifically for smaller bats including pipistrelle species) will be erected within mature trees in the garden. (See boxes below)

- Establish two Schwegler 2F and two Schwegler 1FD bat boxes on mature trees within the red line boundary prior to works on site;
- Conduct a Tool Box Talk to all team members on site with regards to the presence of bats using the building, bats legal protection, measures that will be undertaken to ensure that bats are not harmed, good working practises, licensable activities and what to do if a bat is found;
