Preliminary Ecological Appraisal

The Cottage, Shripney Road  
Bognor Regis, West Sussex

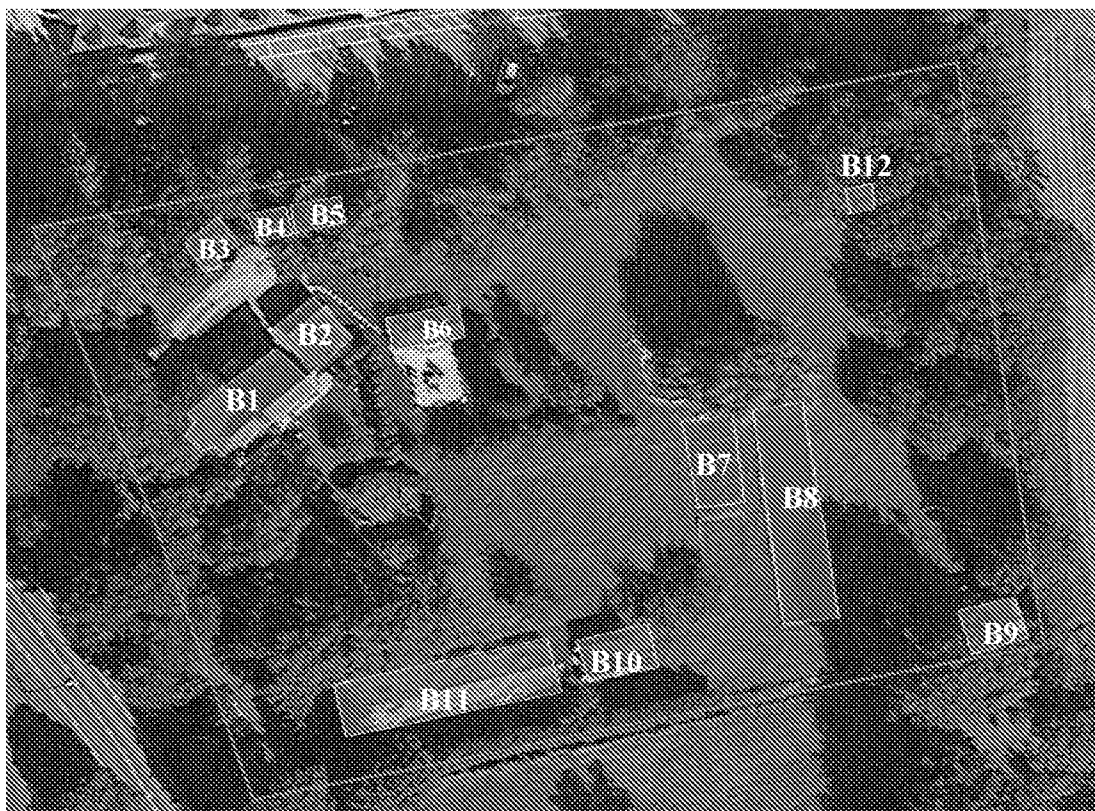
*Figure 3: Location and labels for buildings (B) present on site. Buildings highlighted in red have been removed/demolished since the last survey.*

3.23 There are a number of buildings on site:

- Building B1 – the residential dwelling;
- Building B2 – garage
- Building B3 – small outbuilding
- Building B4 – stable block
- Building B5 – wooden shed/workshop
- Building B6 – demolished
- Building B7 – removed
- Building B8 – demolished, but foundations still remain
- Building B9 – two storey dilapidated structure

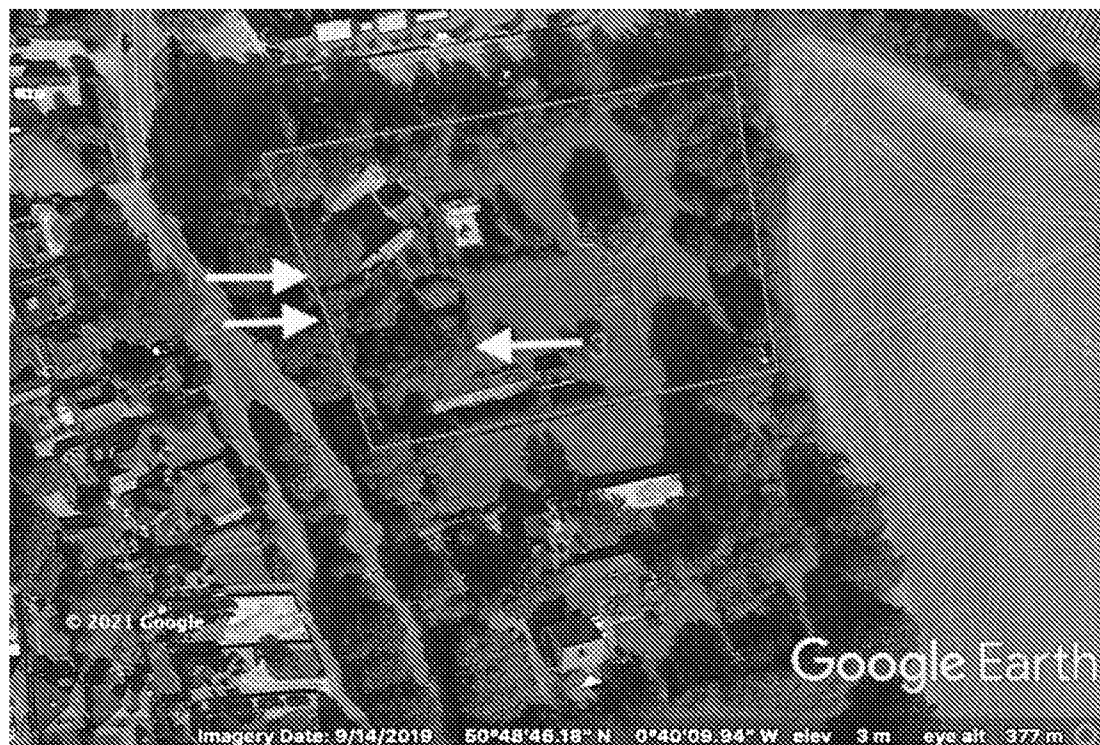
- 3.39 Several trees are present within the red-line boundary. The majority of trees within the red-line boundary were considered to have ‘negligible’ potential to support roosting bats owing to their small stature and/or lack of suitable roosting features, such as broken and split limbs, woodpecker holes, cavities and dense ivy cover. Those that had some potential are shown in figure 4.
- 3.40 Towards the south east of the site a mature Cedar of Lebanon with 4 woodpecker holes was identified. The lowest of the woodpecker holes appeared to be superficial. A climbing inspection is recommended to assess the suitability of the other holes in the tree for roosting bats.
- 3.41 Additionally, a mature Monterey cypress tree was present on the western boundary, to the south of the site entrance. There was a fair amount of lifted bark, which would provide low roosting potential for bats.

- 3.42 Also present on the western boundary was a dead tree, converted into a 10ft monolith. There were some areas of lifted bark, which would provide low roosting potential for bats.

*Figure 4: Location and labels for trees identified to have bat potential on site*

- 4.22 With regards to potential bat roost trees on site, the recommendations within the species-specific bat report are considered still valid. Trees 1 & 2 were both classed as low potential.

- 4.23 Trees 1 & 2 are classed as 'low' potential and need to be removed. Following guidance, no further surveys are necessary prior to removal but they should be felled in accordance with specific advice provided by the bat-worker ensuring that reasonable avoidance measures are followed. Recommended measures include:

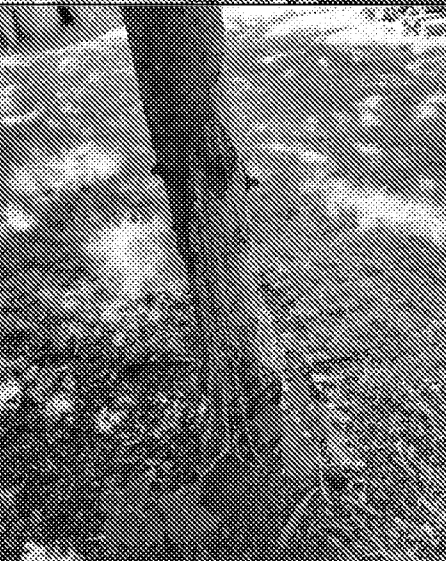
| <b>Photograph 3:</b> Damage caused by sheep gnawing at bark | | | |

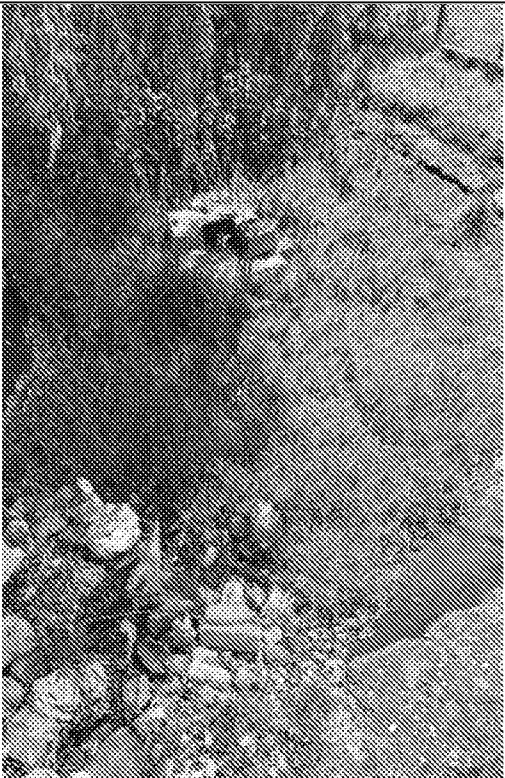
- 3.46 One ornamental garden pond was present on site at the time of the survey. The pond was dry and contained no water. The pond was partially shaded by sizeable adjacent trees. The pond is not historic or natural and was constructed by the current owner of the house, containing a pond liner. The pond was dry on both previous inspections in 2016 and 2018, was noted as such during subsequent bat surveys. The site is well maintained with very short grassland and a lack of thick vegetation to provide cover for amphibians from predators, whilst in their terrestrial phase.

| <p><b>Photograph 7: Dry pond</b></p> | |

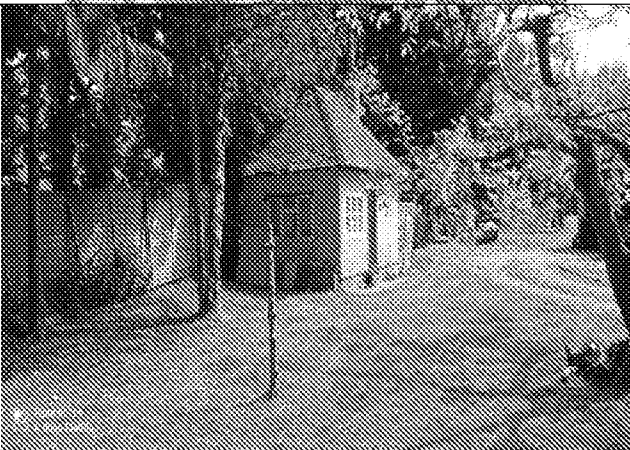
| <p><b>Photograph 8: Building 3</b></p> | |

- 3.29 Building 3 was a small outbuilding, to the north of the main house (building 1). The structure had a pitched clay tiled roof, with several gaps caused by slipped, missing, or lifted tiles. Between the southern wall and roof, there was a notable crevice that would also provide opportunities for crevice dwelling bats.
- 3.30 Internally, this building was used for storage. The tiles were lined with chipboard. There was no internal void, and the presence of windows meant the building was well lit. The building was unable to be accessed, but on a visual inspection through an open window, there was no evidence of bats using the space for roosting.

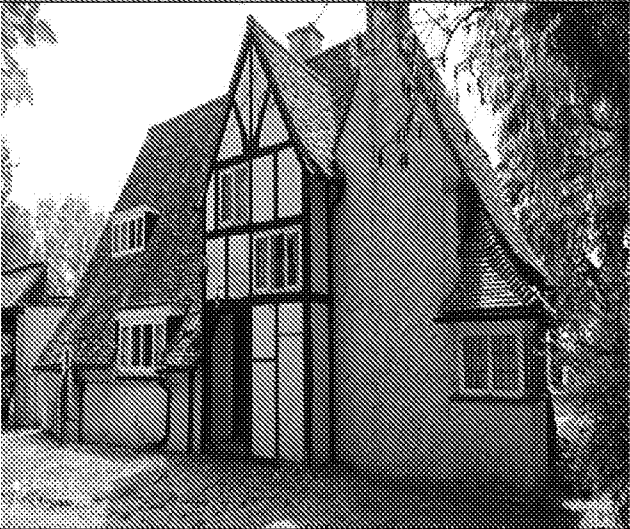
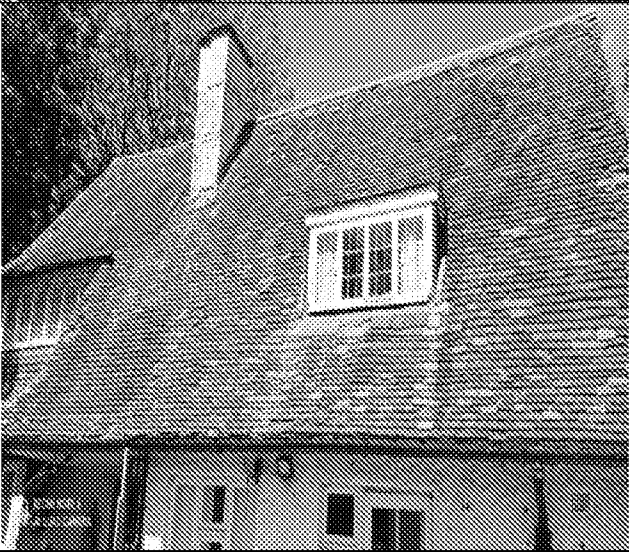
- 3.24 Building 1 was the single residential building on site. This detached house had a pitch tiled roof, with many cracked/missing tiles providing access to the two roof voids.

- 3.27 Externally the building had a large pitched roof which covered much of the first floor. The roof had numerous broken, missing, slipped and lifted clay tiles, presenting potential opportunities for crevice dwelling bats such as common pipistrelle.

| <p><b>Photograph 9: Building 1</b></p> | |

| <p><b>Photograph 12:</b> Building 1</p> | A black and white photograph of a two-story building with a steep, tiled roof. A chimney is visible on the left side of the roof. A small, white, rectangular window is visible on the upper floor. The building is surrounded by trees and foliage. The foreground shows a dark, possibly paved area. |

- 6.6 A confirmed common pipistrelle roost was previously identified within the residential dwelling (B1) and therefore it is recommended that three further bat surveys are undertaken by suitably qualified ecologists.

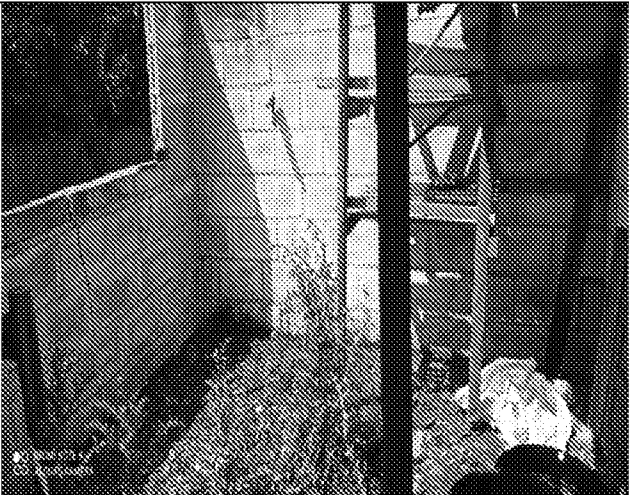
- 3.36 Building 10 was an old breezeblock shed. The flat, felt roof had previously collapsed, leaving a large hole and little shelter within the structure. This, alongside a lack of features, prevented the building being considered suitable for roosting bats. There were two old swallow nests present within the structure. However, these were both noted as ‘old’ and unused in both the 2016 and 2018 surveys, and are considered not to have been used since
