## Bat Report 2021

The Cottage, Shripney Road  
Bognor Regis, West Sussex

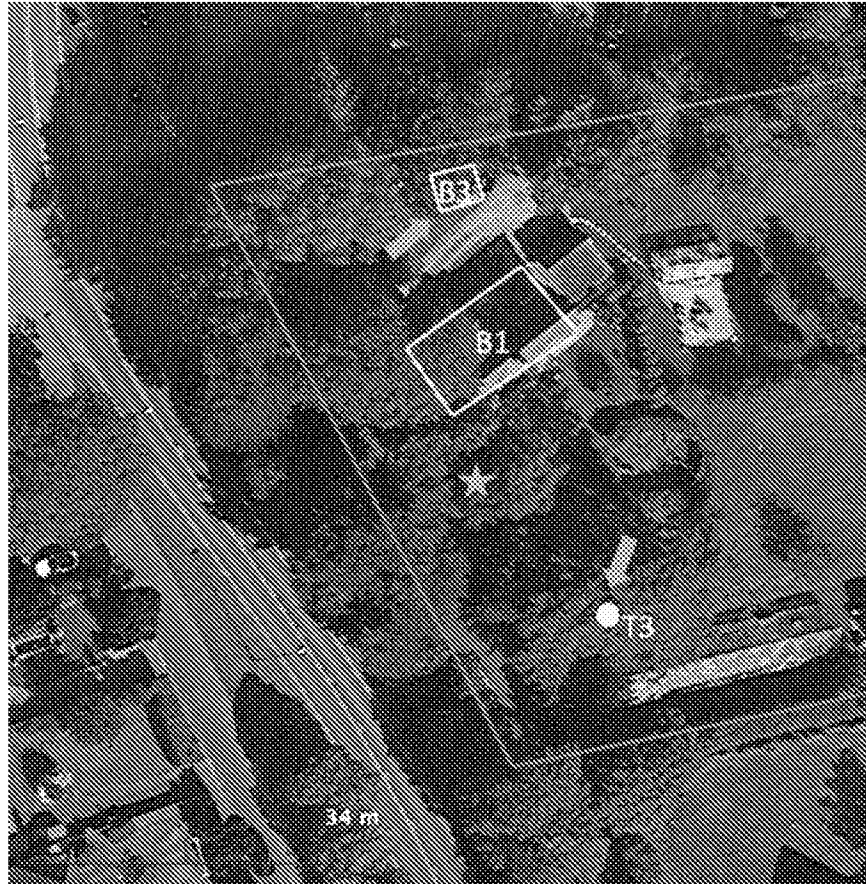
*Figure 2: Approximate location of the surveyors (blue stars) and infa-red cameras (blue arrows) across all three surveys (Taken from Google Earth on 21/09/21)*
