## ***CONTAMINATED LAND RISK ASSESSMENT***

### ***DESKTOP STUDY AND WALKOVER***

**Chalcroft Nurseries  
Bognor Regis**

**Contamination Consultants Ltd**  
March 2009

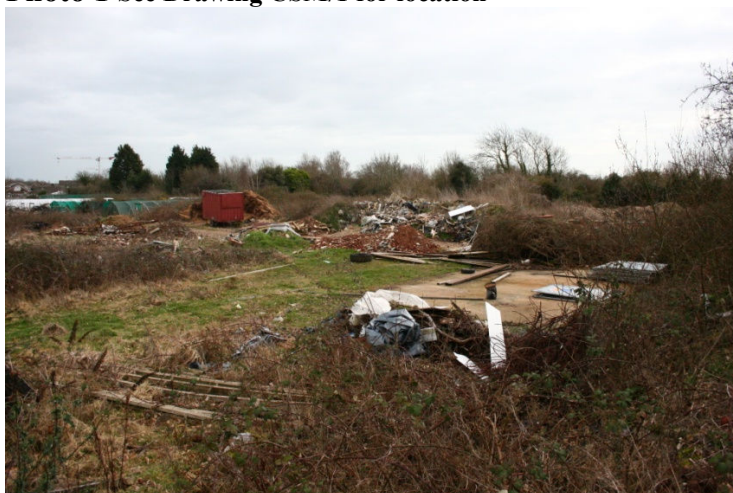
**Photo 1** See Drawing CSM/1 for location

The site assessed for this investigation currently comprises a garden centre and aquatics shop with disused land to the rear. The disused land comprises partially dismantled polytunnels, areas of bracken and piles of builder's waste rubble/bricks (Photo 1). The previous owner of the site was a thatcher and there was disused thatch and wire on the west of the site and burnt thatch on the south west of the site (Photo 2). There were three burnt-out cars on the west boundary of the site (Photo 3). There was a heating oil tank located on the site (Photo 4) which was empty and there was no evidence of leaks or spillages. There were ditches surrounding the site which were 1 m lower than the site and contained water in places (Photo 5).

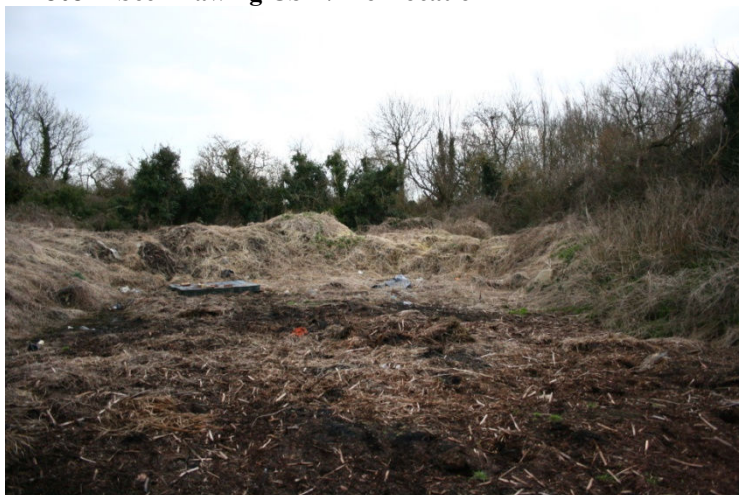
**Photo 3 See Drawing CSM/1 for location**

The burnt-out cars located on the site (Photo 3) may be potential sources of hydrocarbons, oil and metals.

The burnt-out cars located on the site are considered to pose a possible risk to human health due to the potential for dioxins from burnt plastics.

It is recommended that an intrusive investigation is undertaken for the site at Chalcroft Nurseries to further assess the extent of possible contamination on the site.

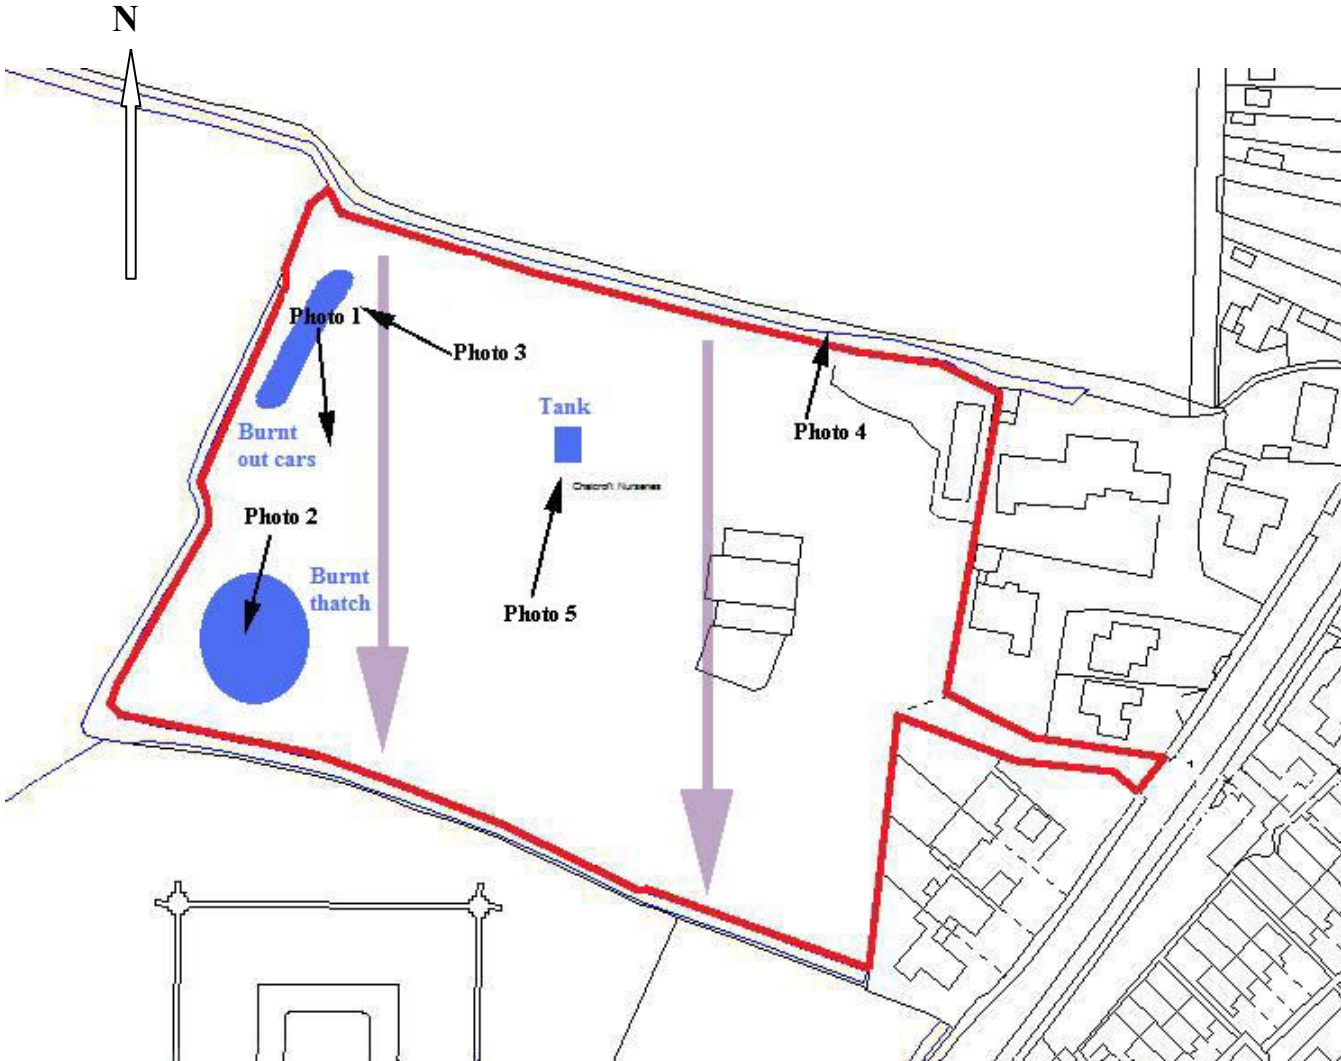
Drawing No.: CSM/1

The conceptual site model detailed here is by written and diagrammatical (drawing CSM/1) description of the sources, pathways and receptors.

Drawing Title: Conceptual site model

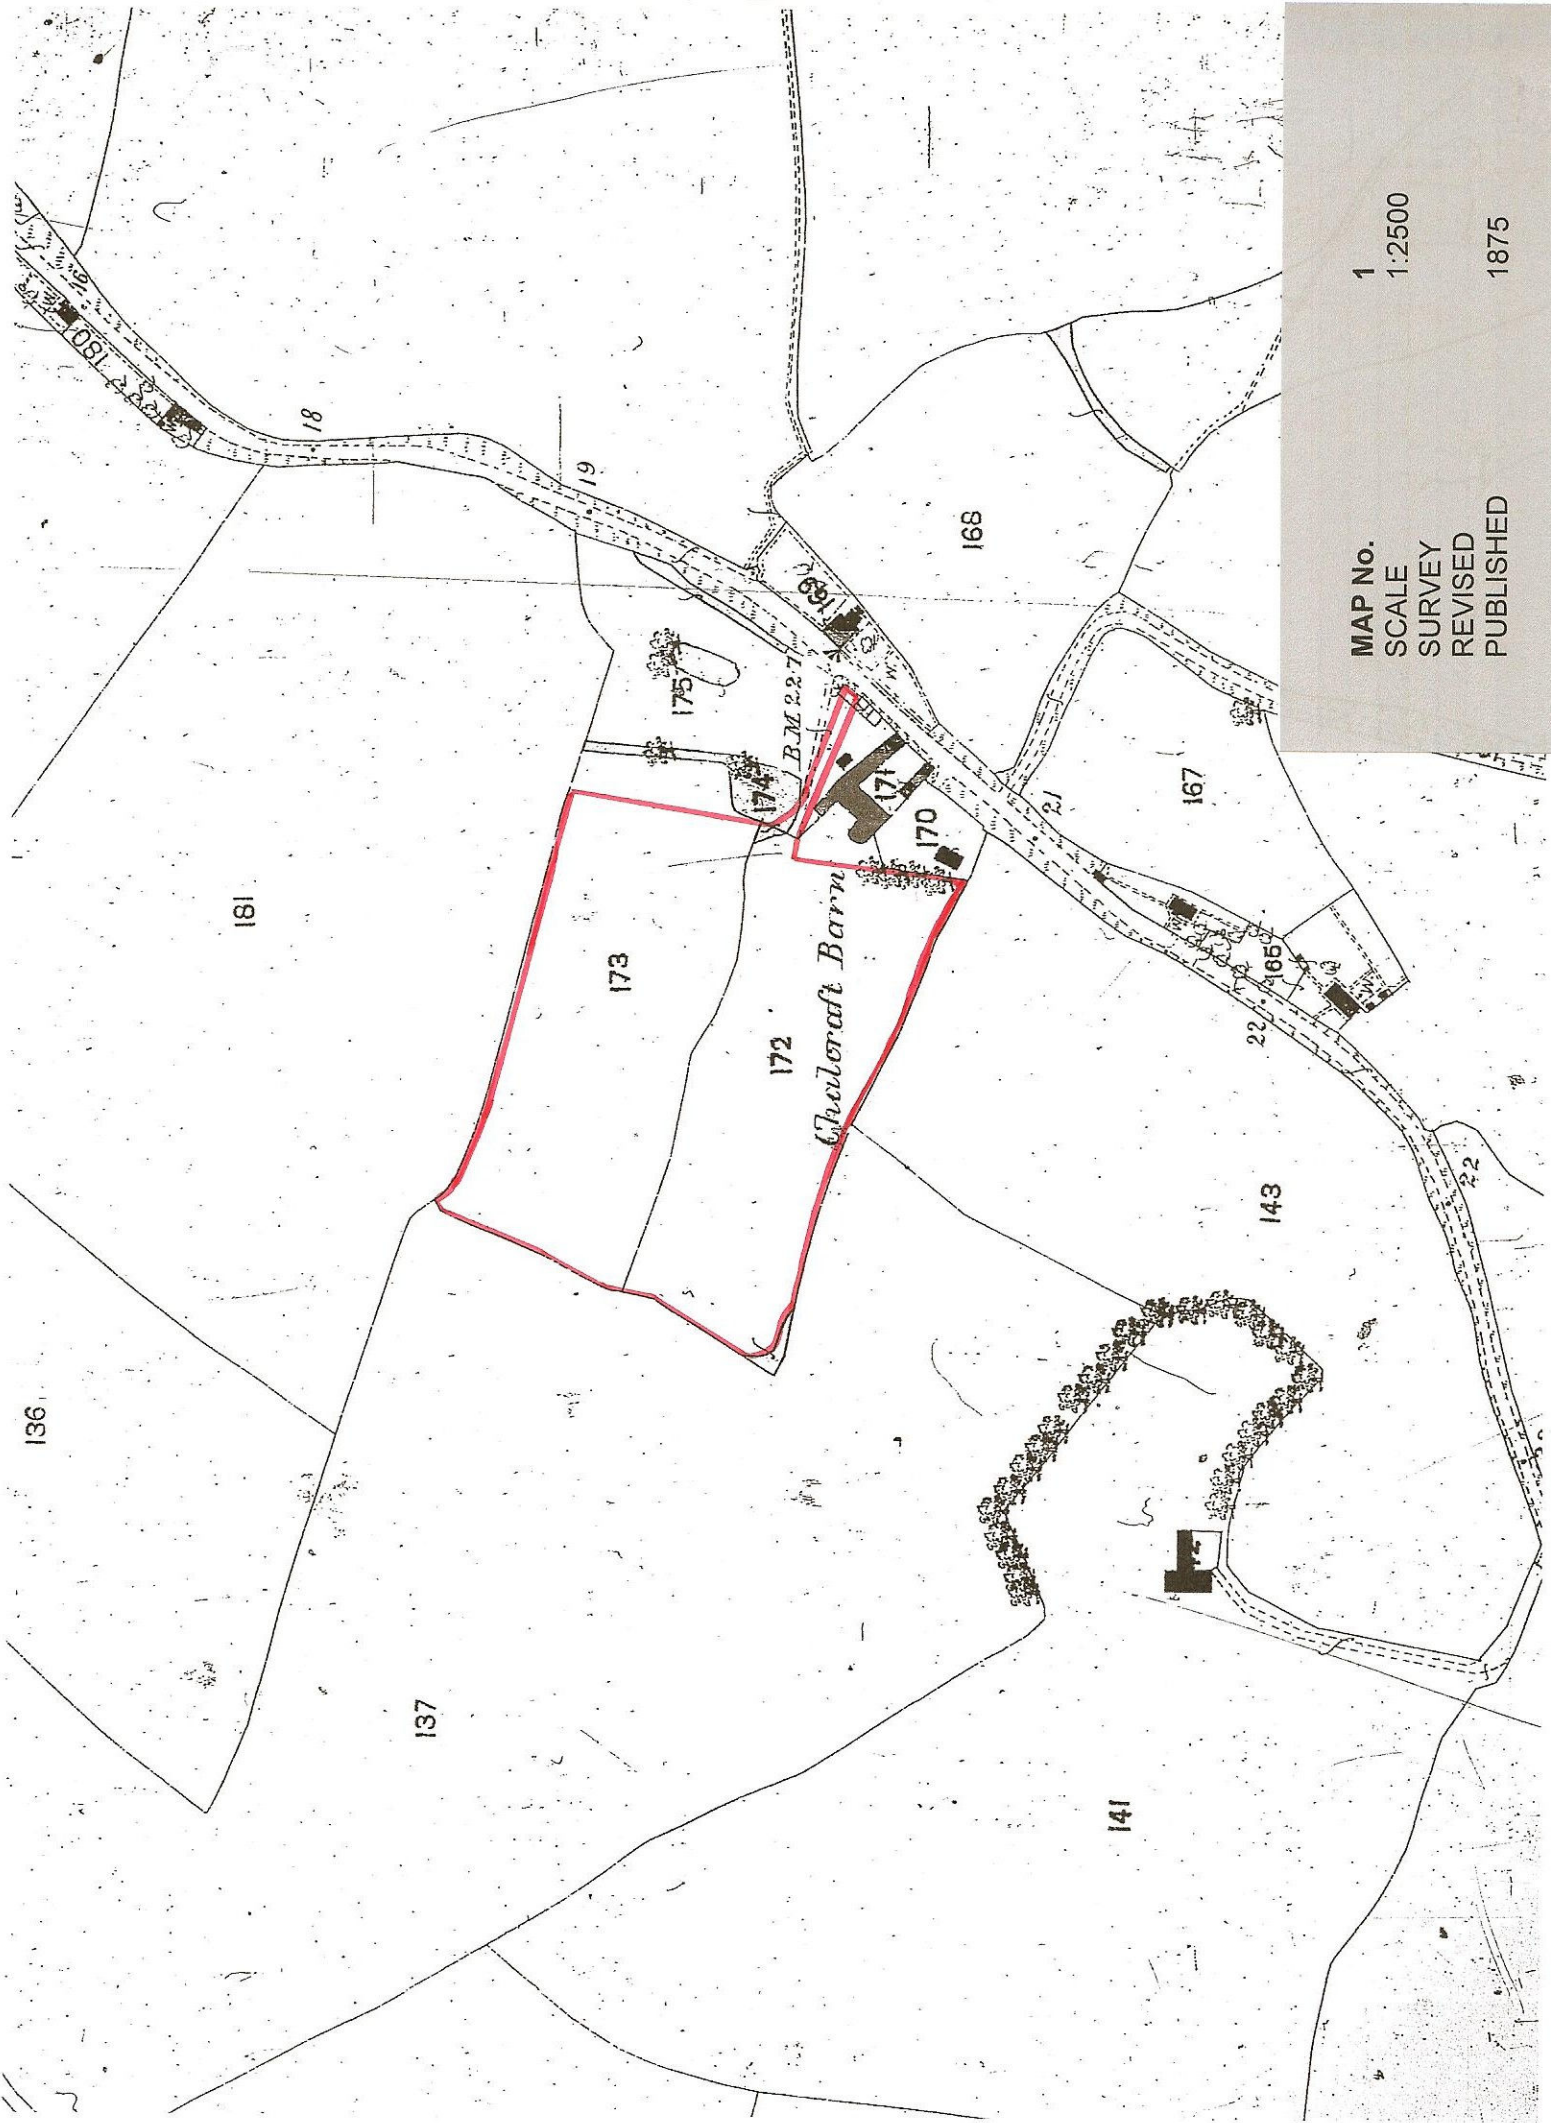
| MAP No. | 1 |

**Map 1: Prior to 1875**

The site was located within agricultural fields. A barn was located adjacent to the south east of the site and a road was located adjacent to the east boundary. Ponds were located adjacent to the north east of the site, 35 m east of the site and 65 m east.

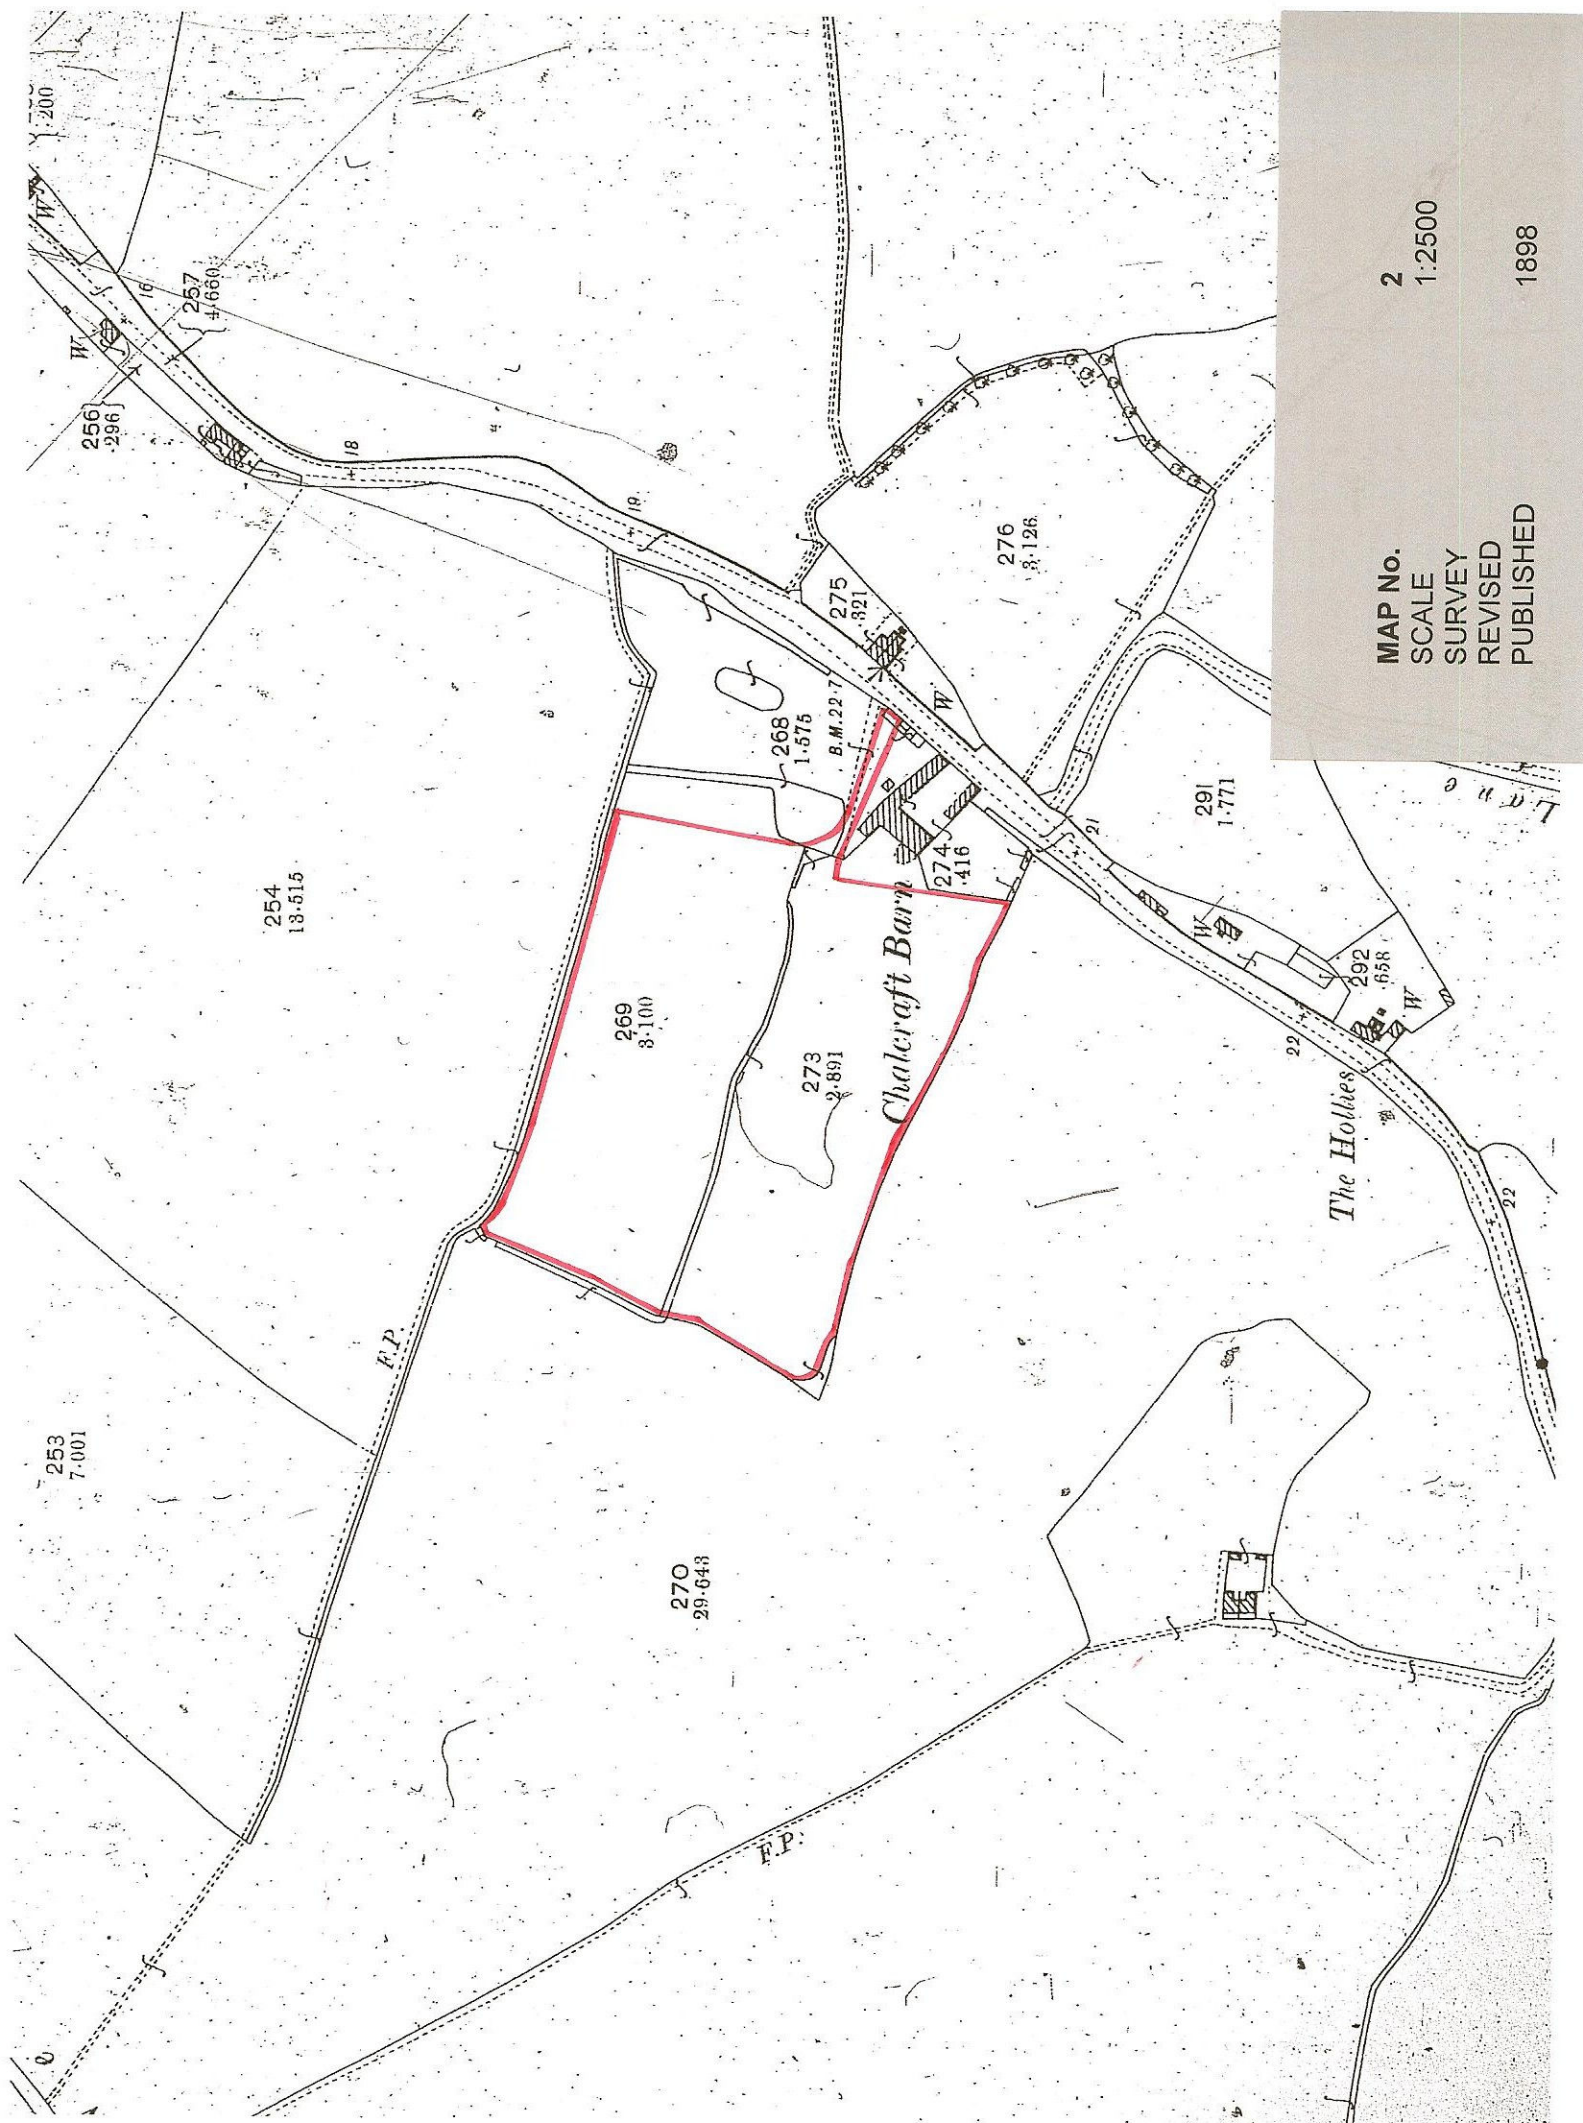
| MAP No. | 2 |

**Map 2: 1875 – 1898**

A drain had been established running north west to south east adjacent to the north of the site and a drain had also been established along the centre of the site in the same direction.

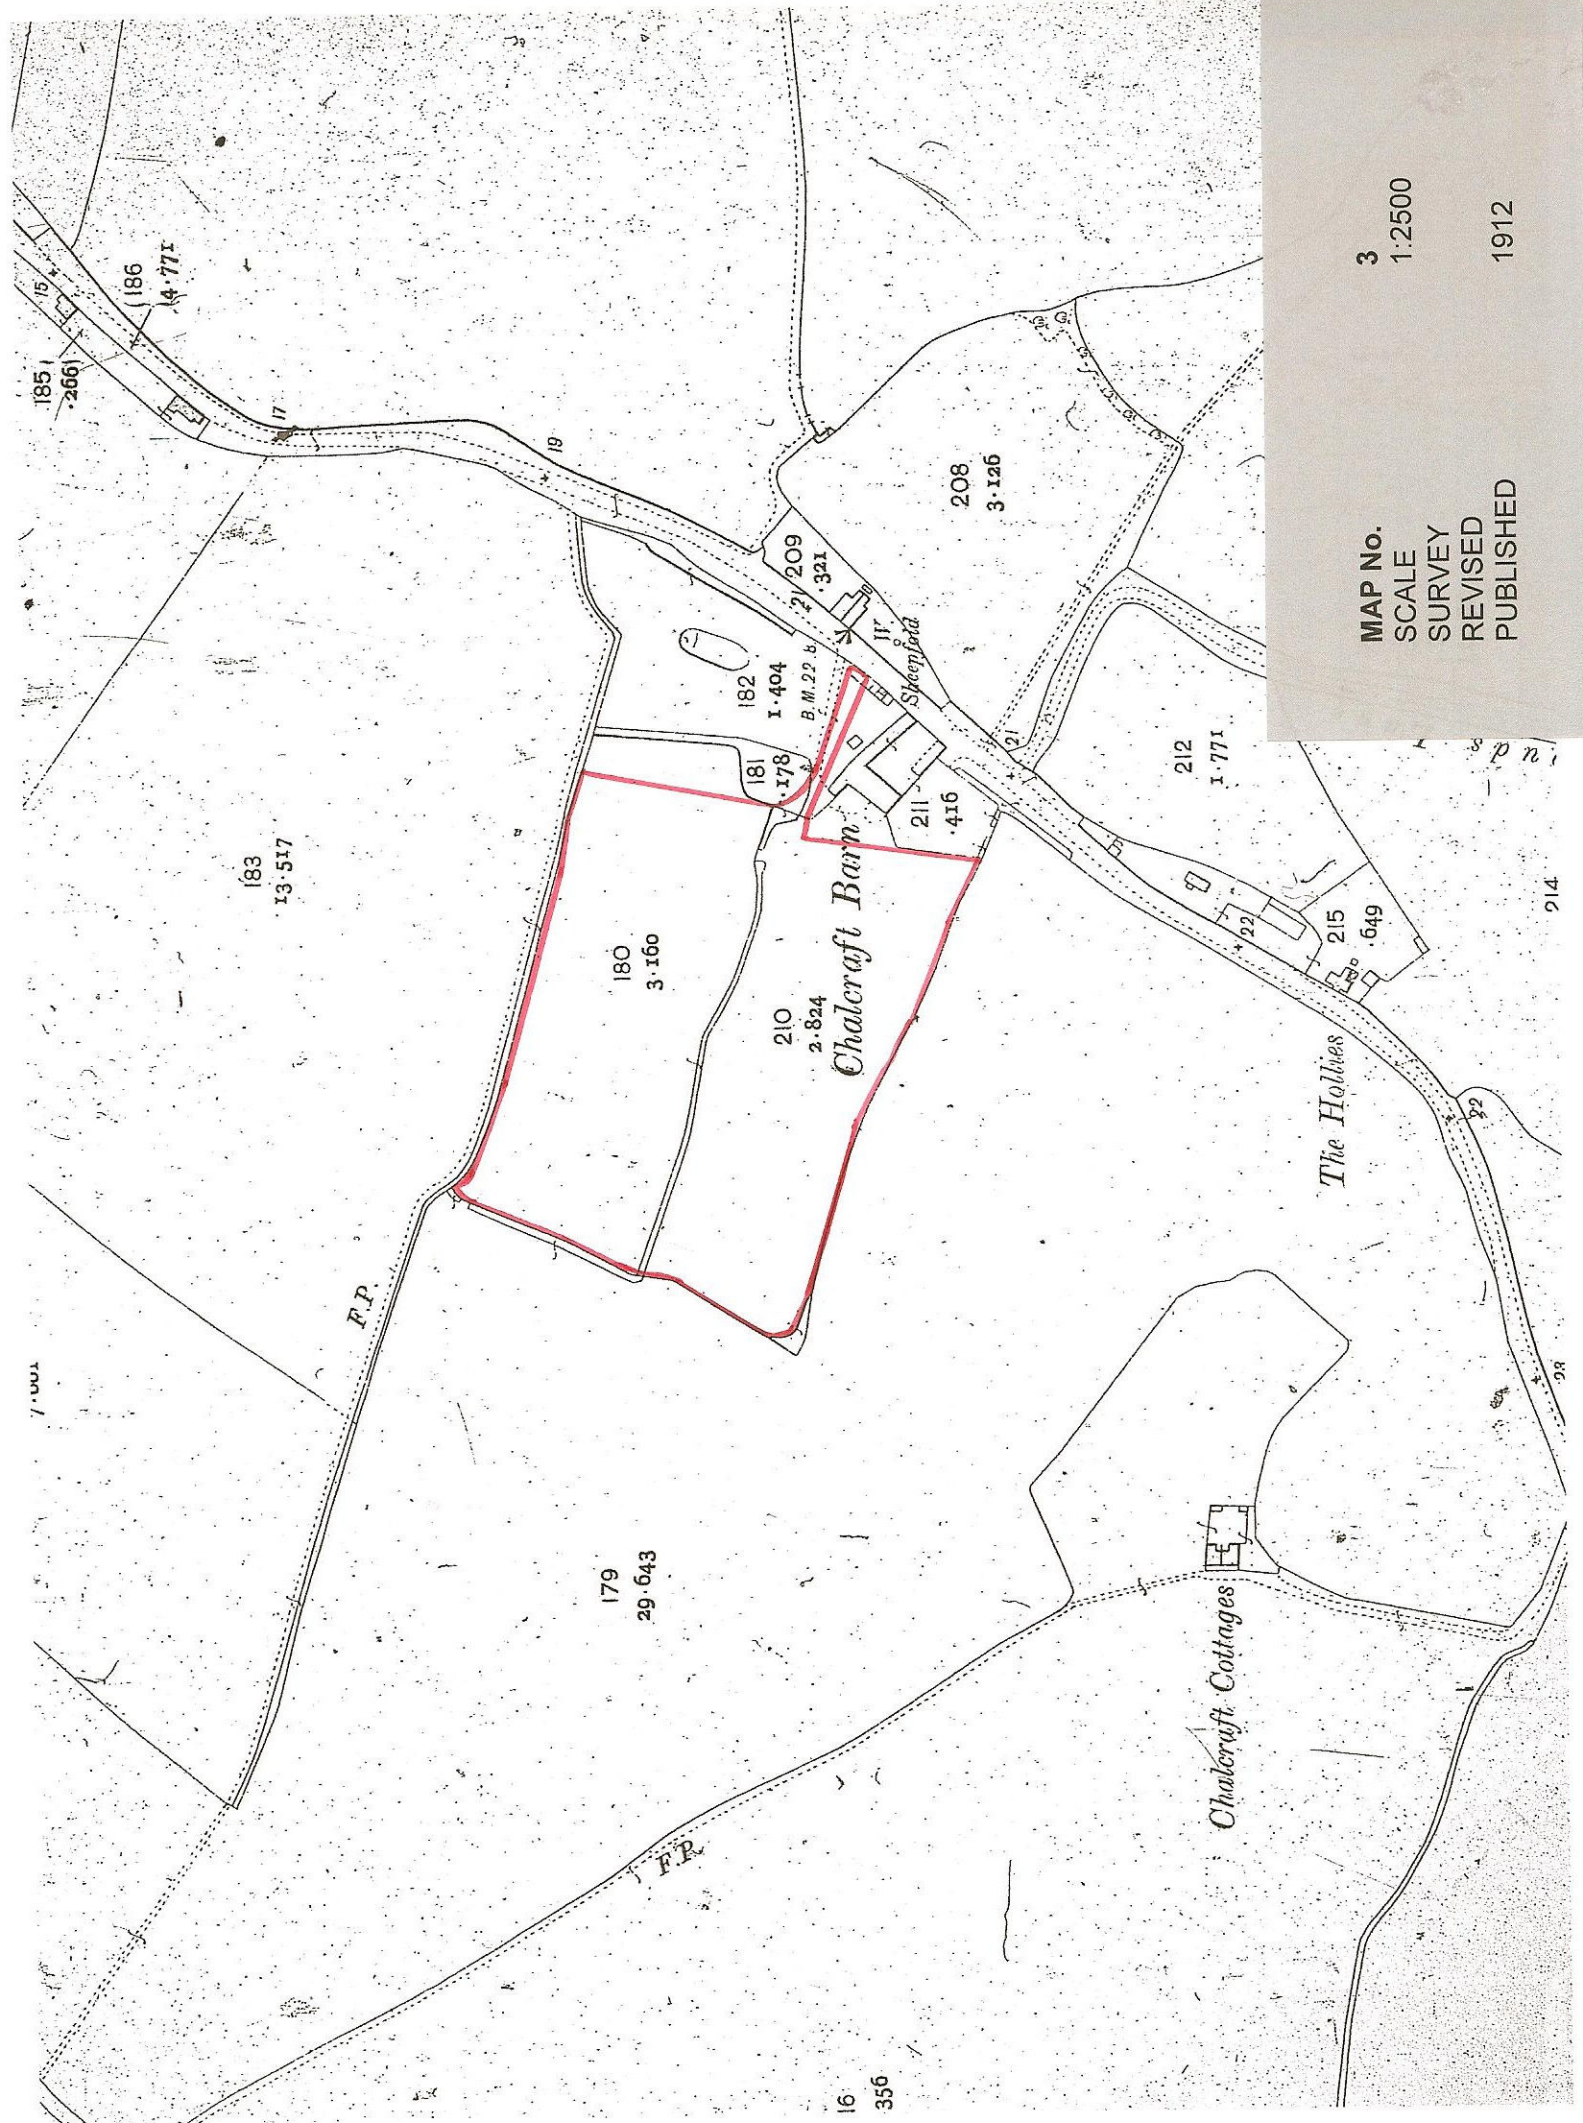
MAP No. 3  
SCALE 1:2500  
SURVEY  
REVISED  
PUBLISHED 1912

**Map 3: 1898 - 1912**

No significant changes on the site had occurred. A pond had been established adjacent to the south west of the site.

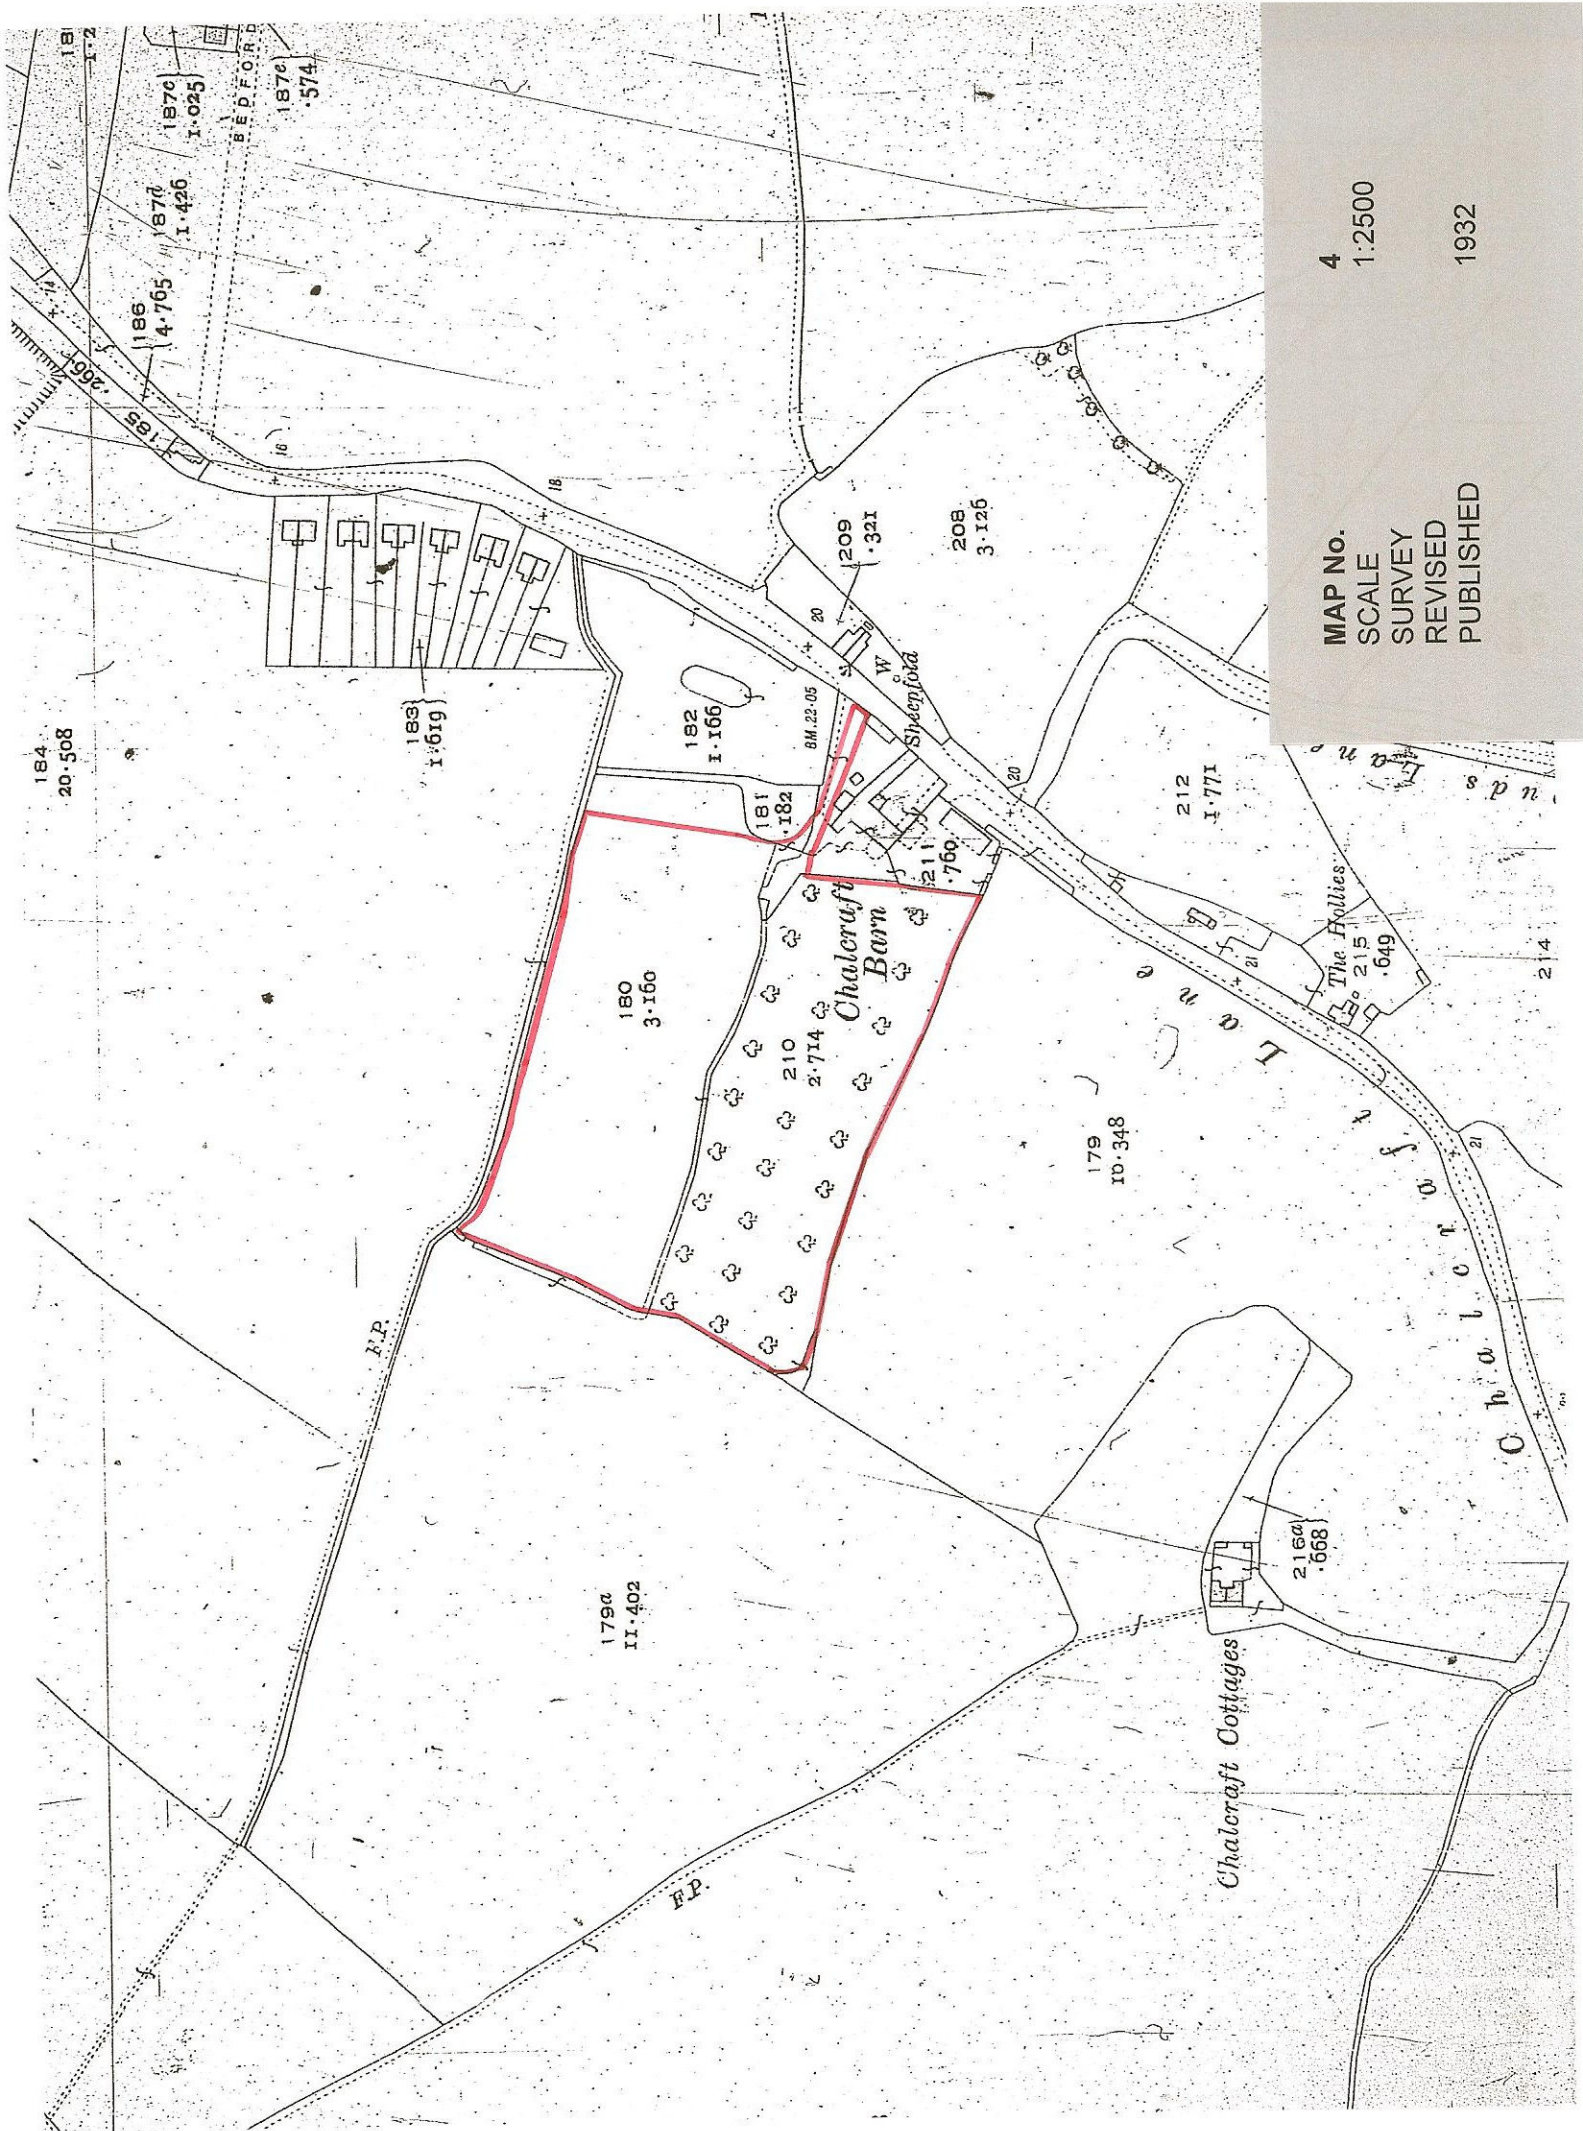
MAP No. 4  
SCALE 1:2500  
SURVEY  
REVISED  
PUBLISHED 1932

**Map 4: 1912 - 1932**

The southern half of the site had become woodland. A building had been constructed 20 m south east of the site and residential properties had been constructed 170 m north east.

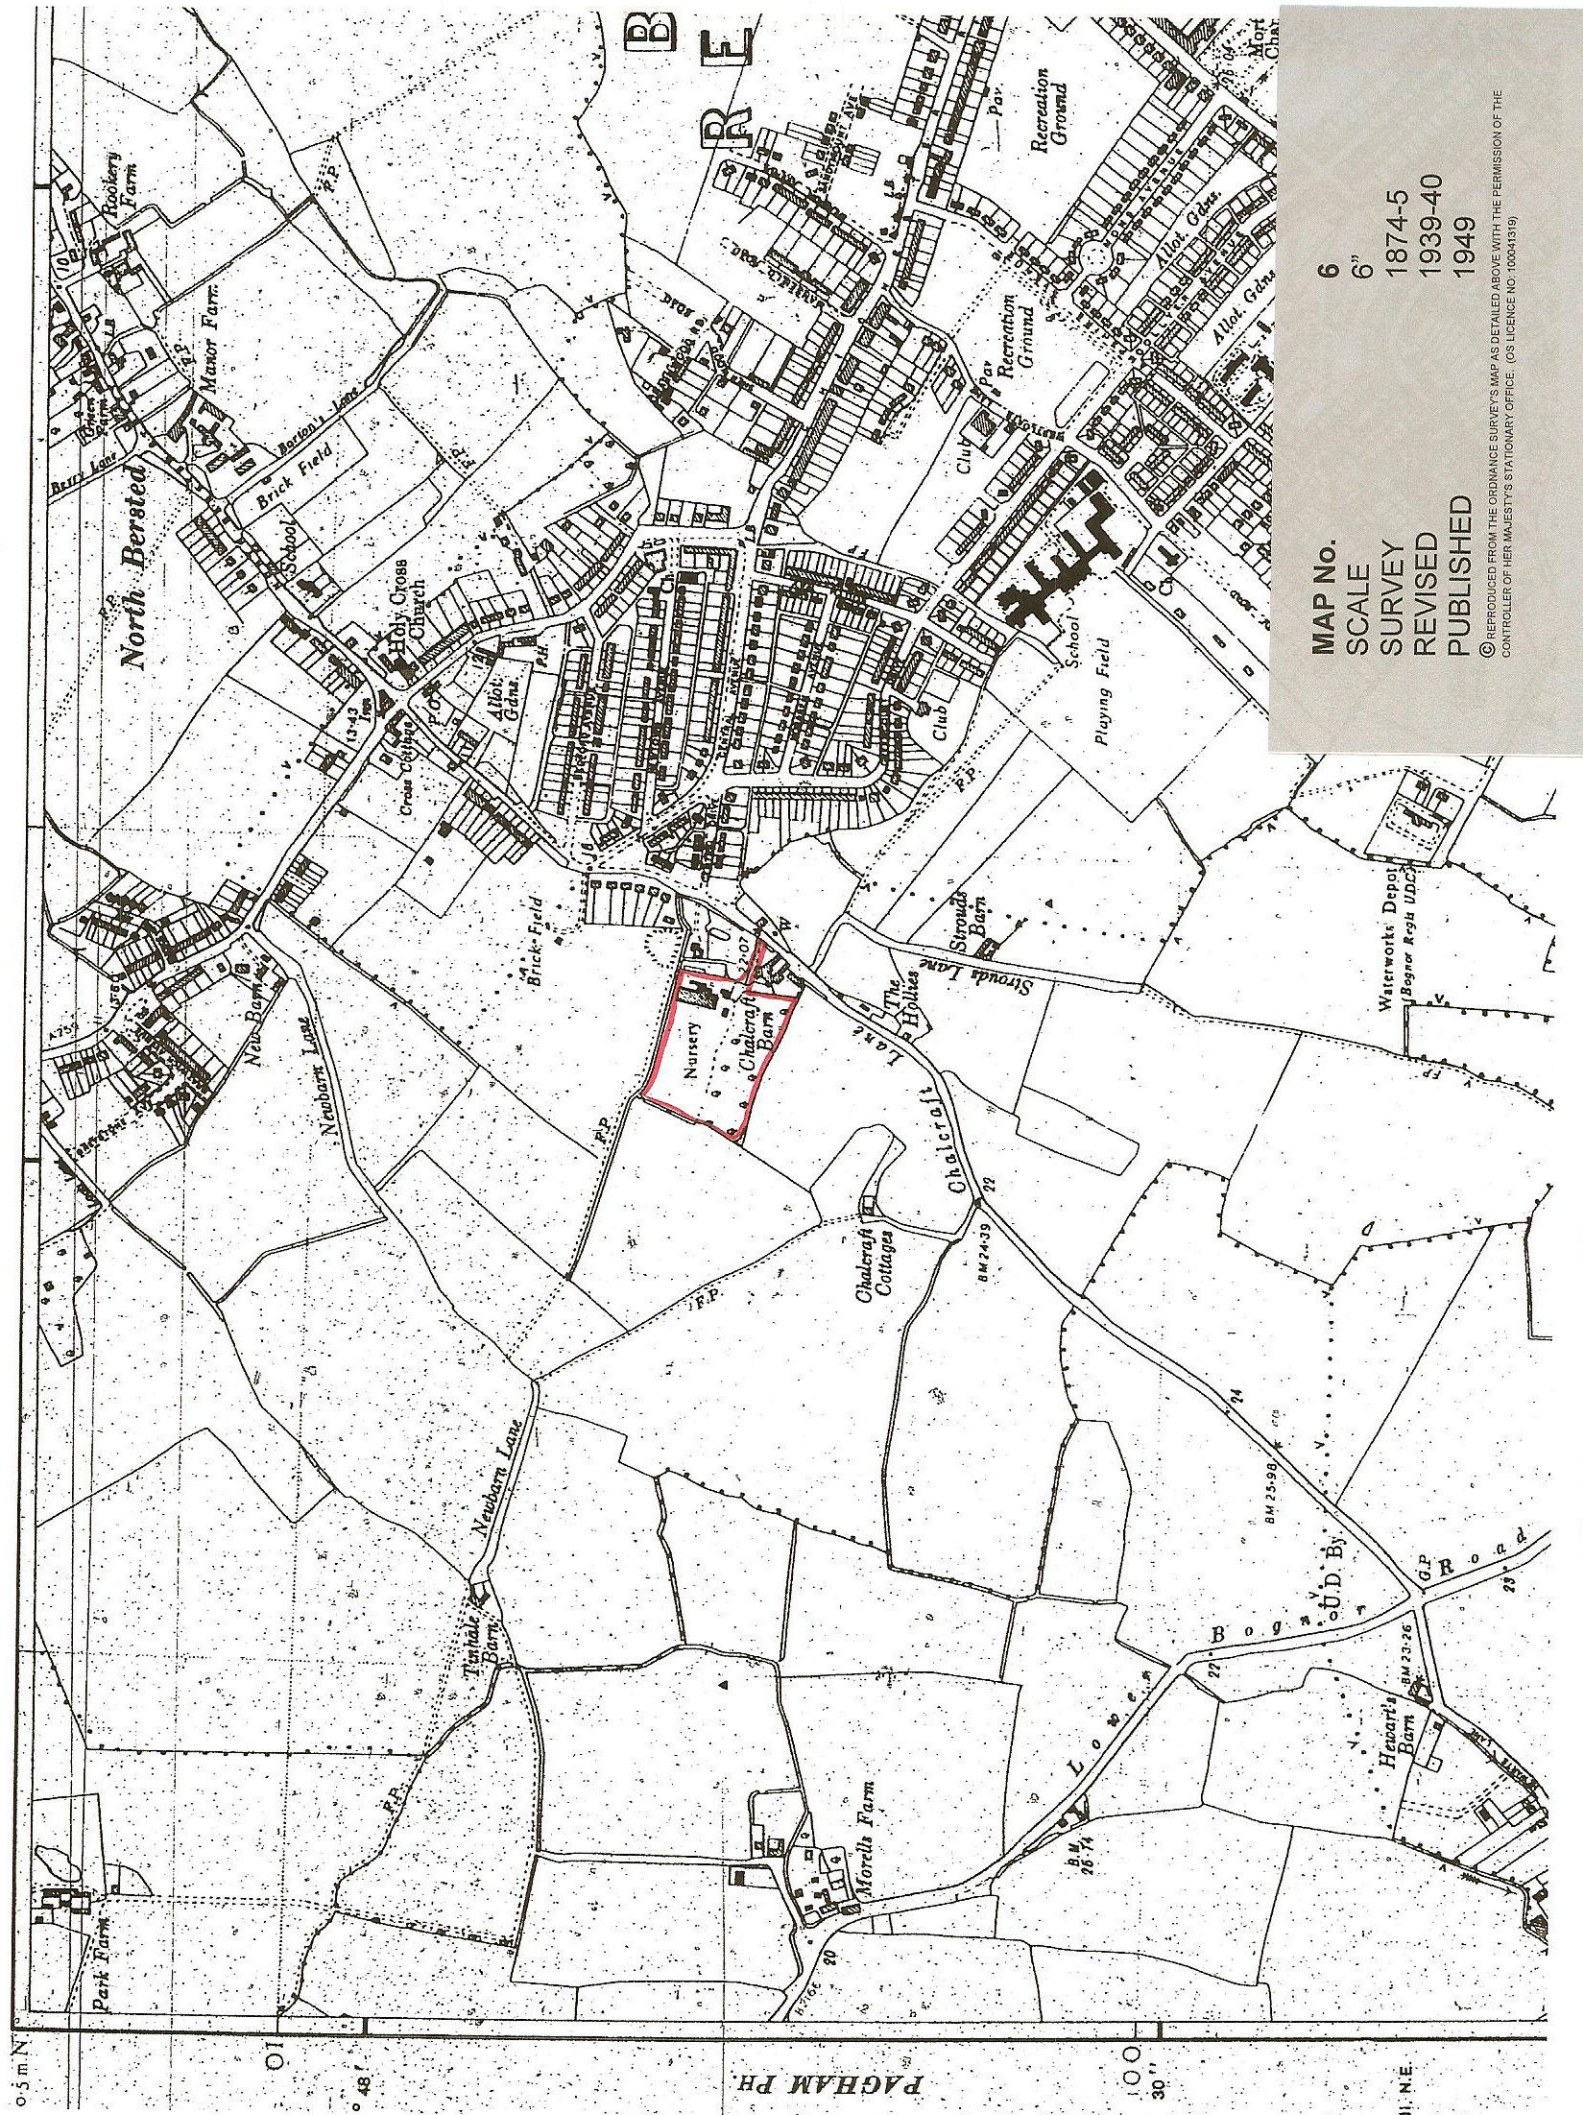
MAP No. 6  
SCALE 6"  
SURVEY 1874-5  
REVISED 1939-40  
PUBLISHED 1949

**Map 6: 1939 - 1949**

No significant changes on or surrounding the site had occurred.

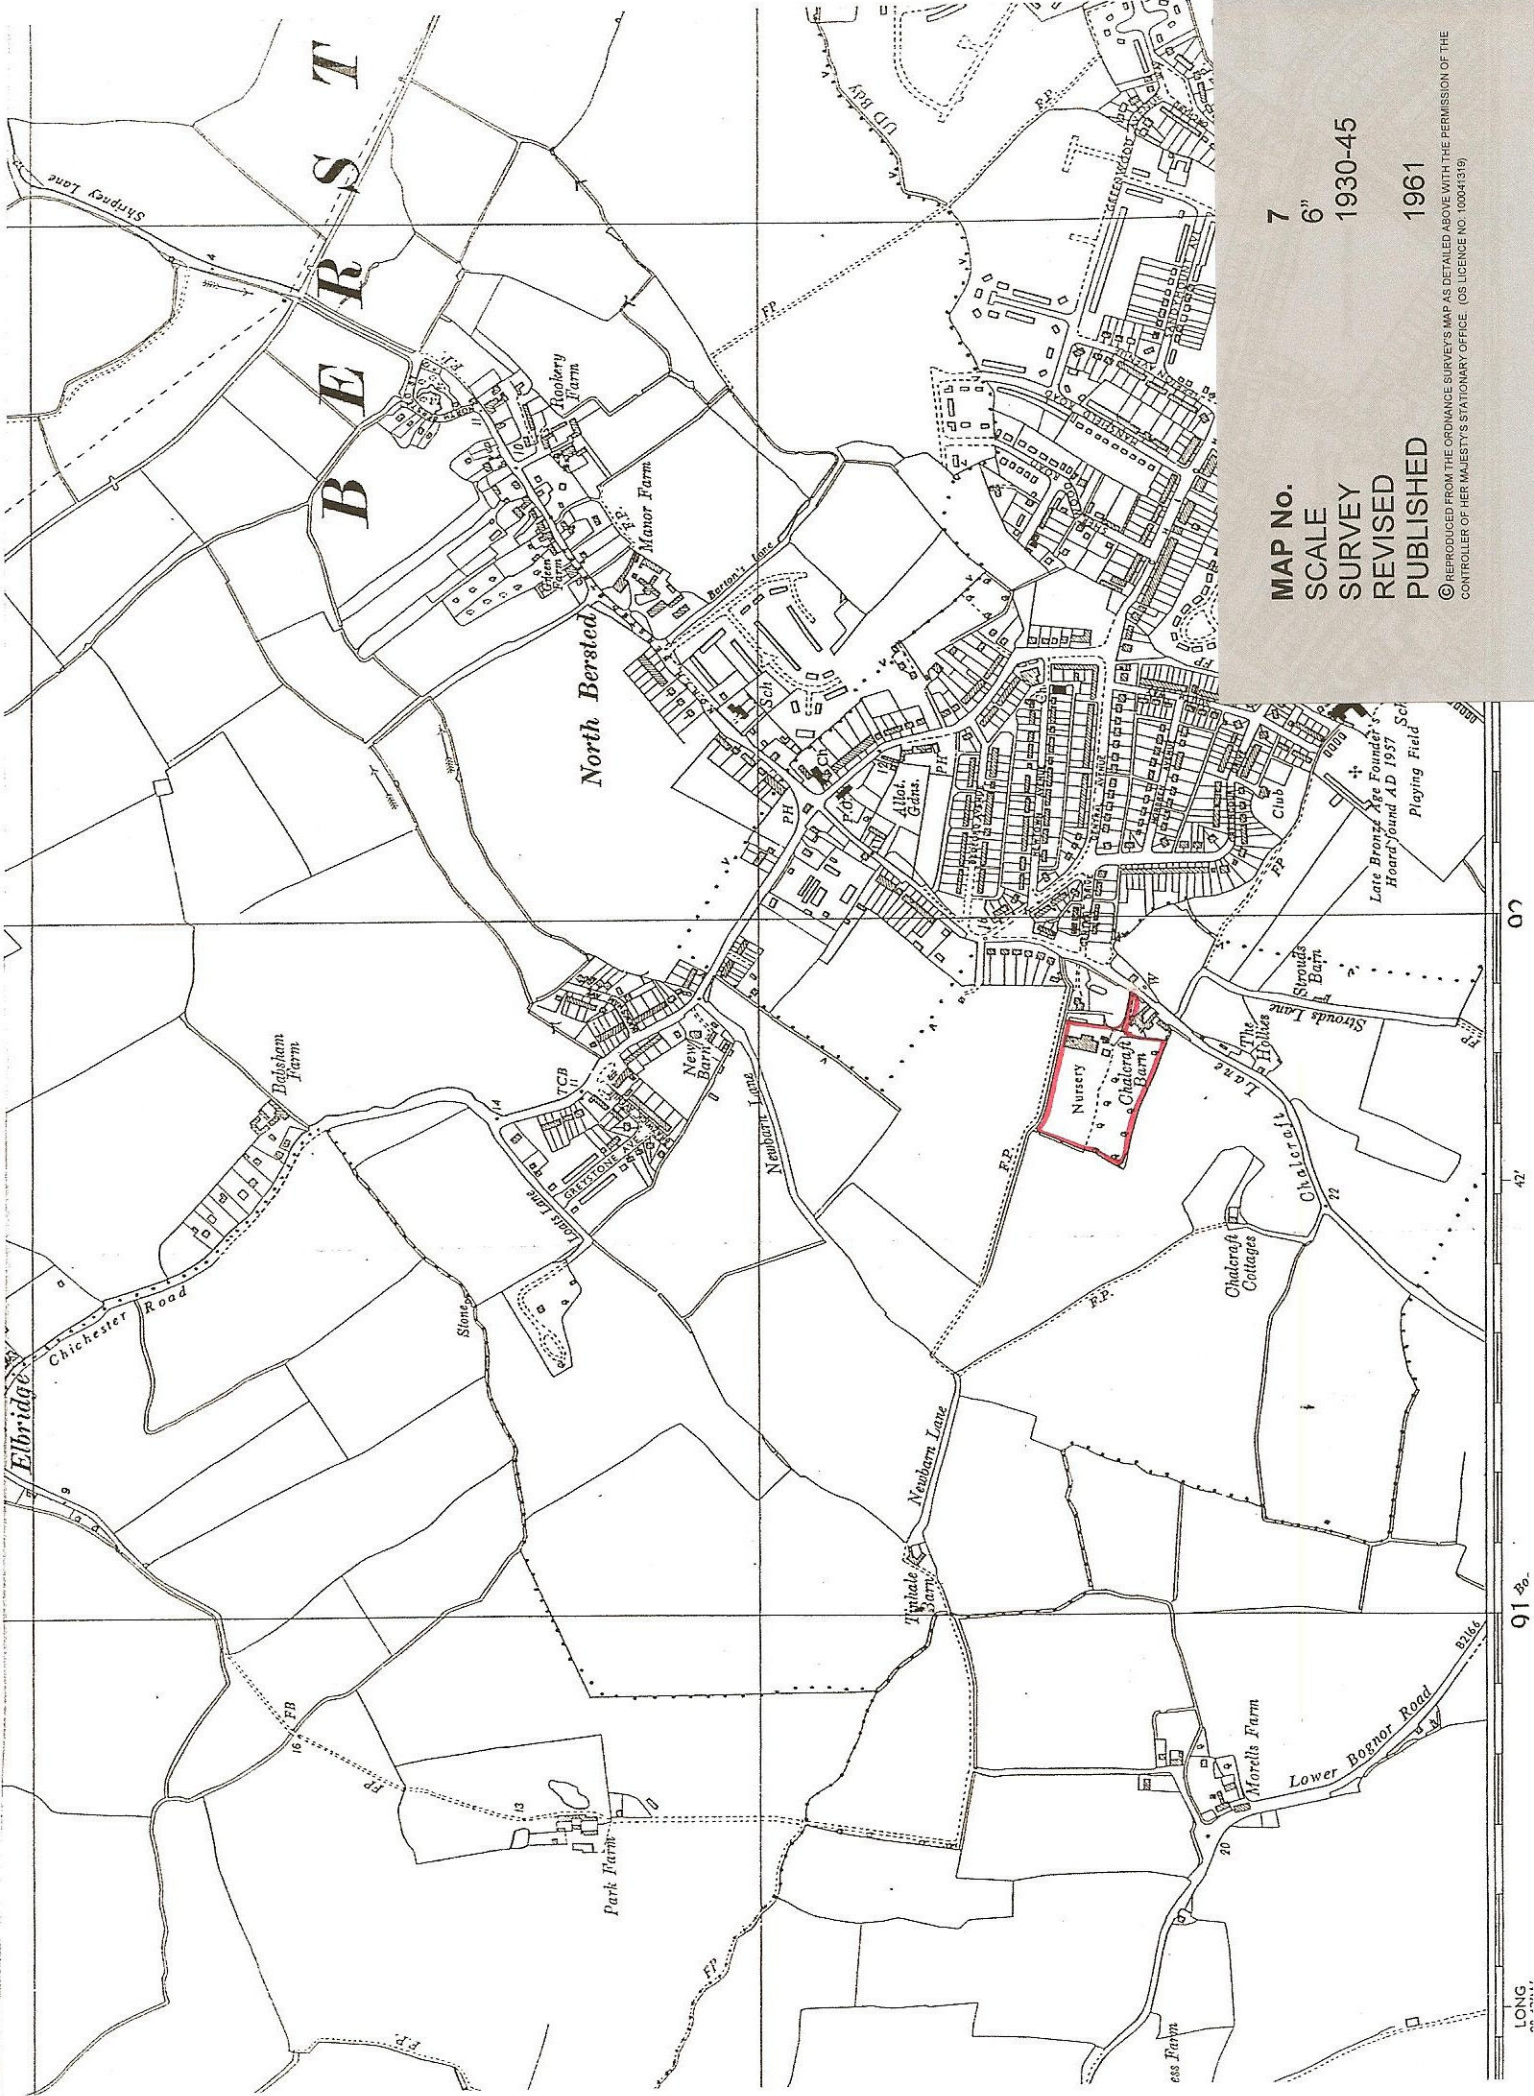
MAP No. 7  
SCALE 6" 1930-45  
SURVEY  
REVISED 1961  
PUBLISHED

**Map 7: 1949 – 1961**

No significant changes on the site had occurred. The pit 10 m north of the site had been in-filled.
