## ***CONTAMINATED LAND RISK ASSESSMENT***

### ***DESKTOP STUDY AND WALKOVER***

**Chalcroft Nurseries  
Bognor Regis**

**Contamination Consultants Ltd**  
March 2009

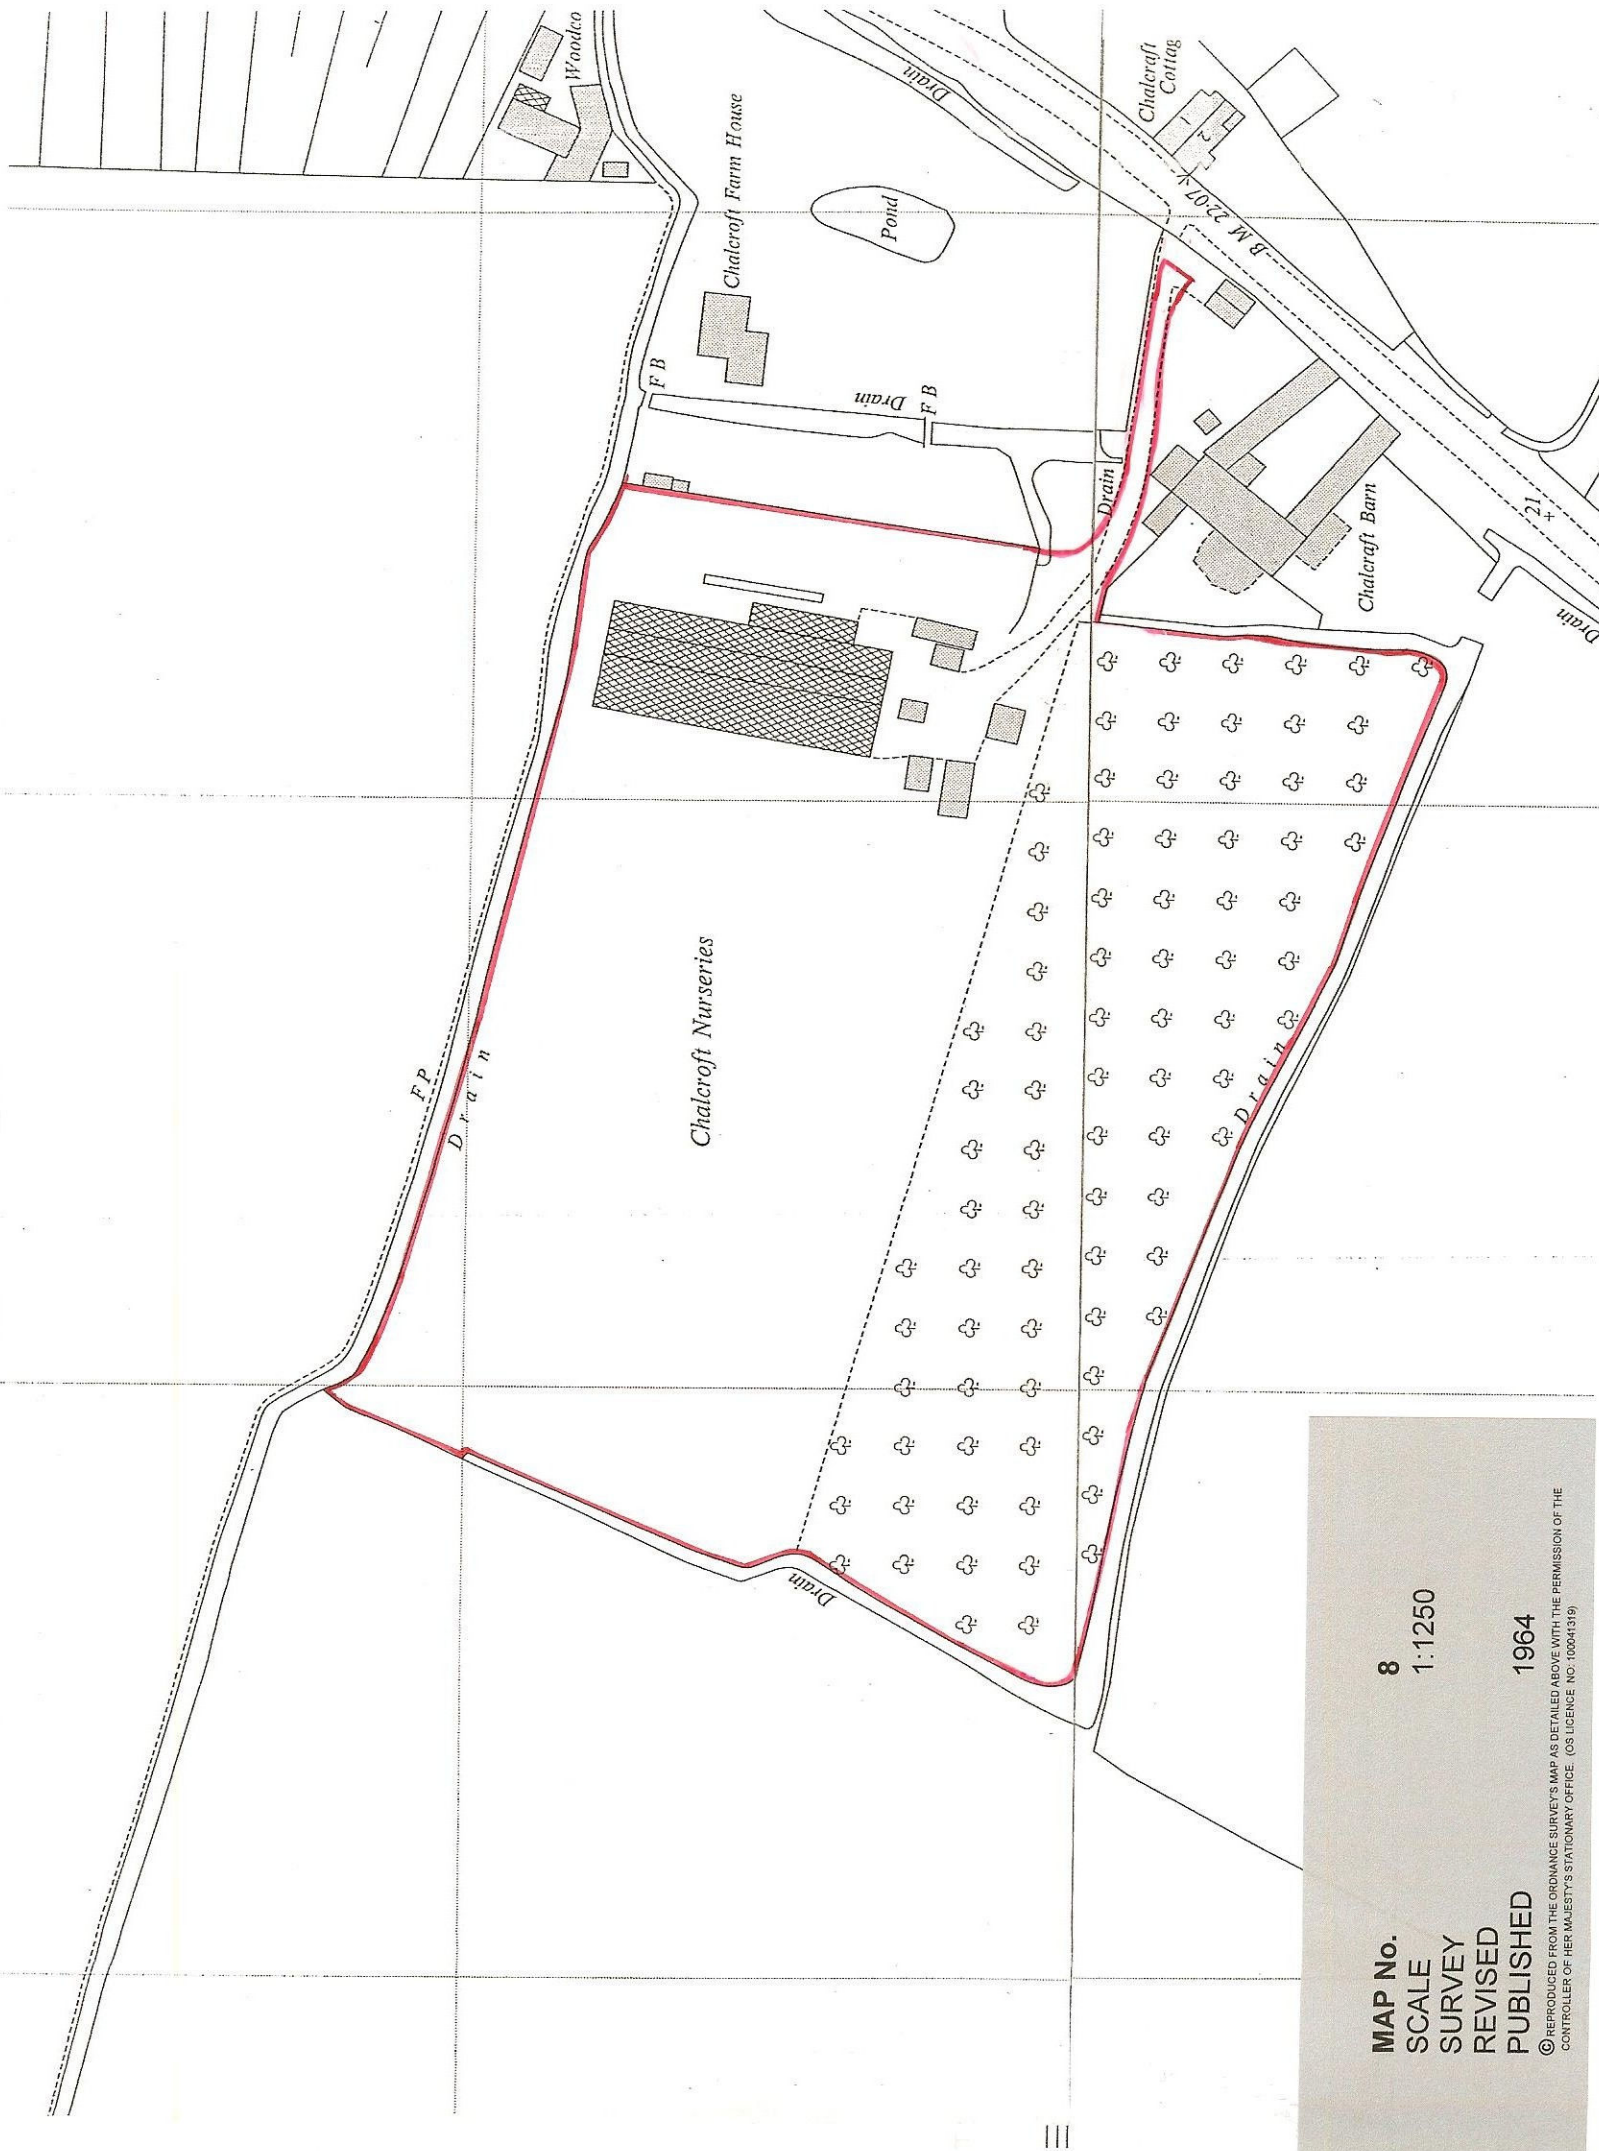
**Map 8: 1961 - 1964**

Three buildings had been constructed on the site. The pond adjacent to the south east had become adjoined to a drain which then ran along the west, south and east of the site.

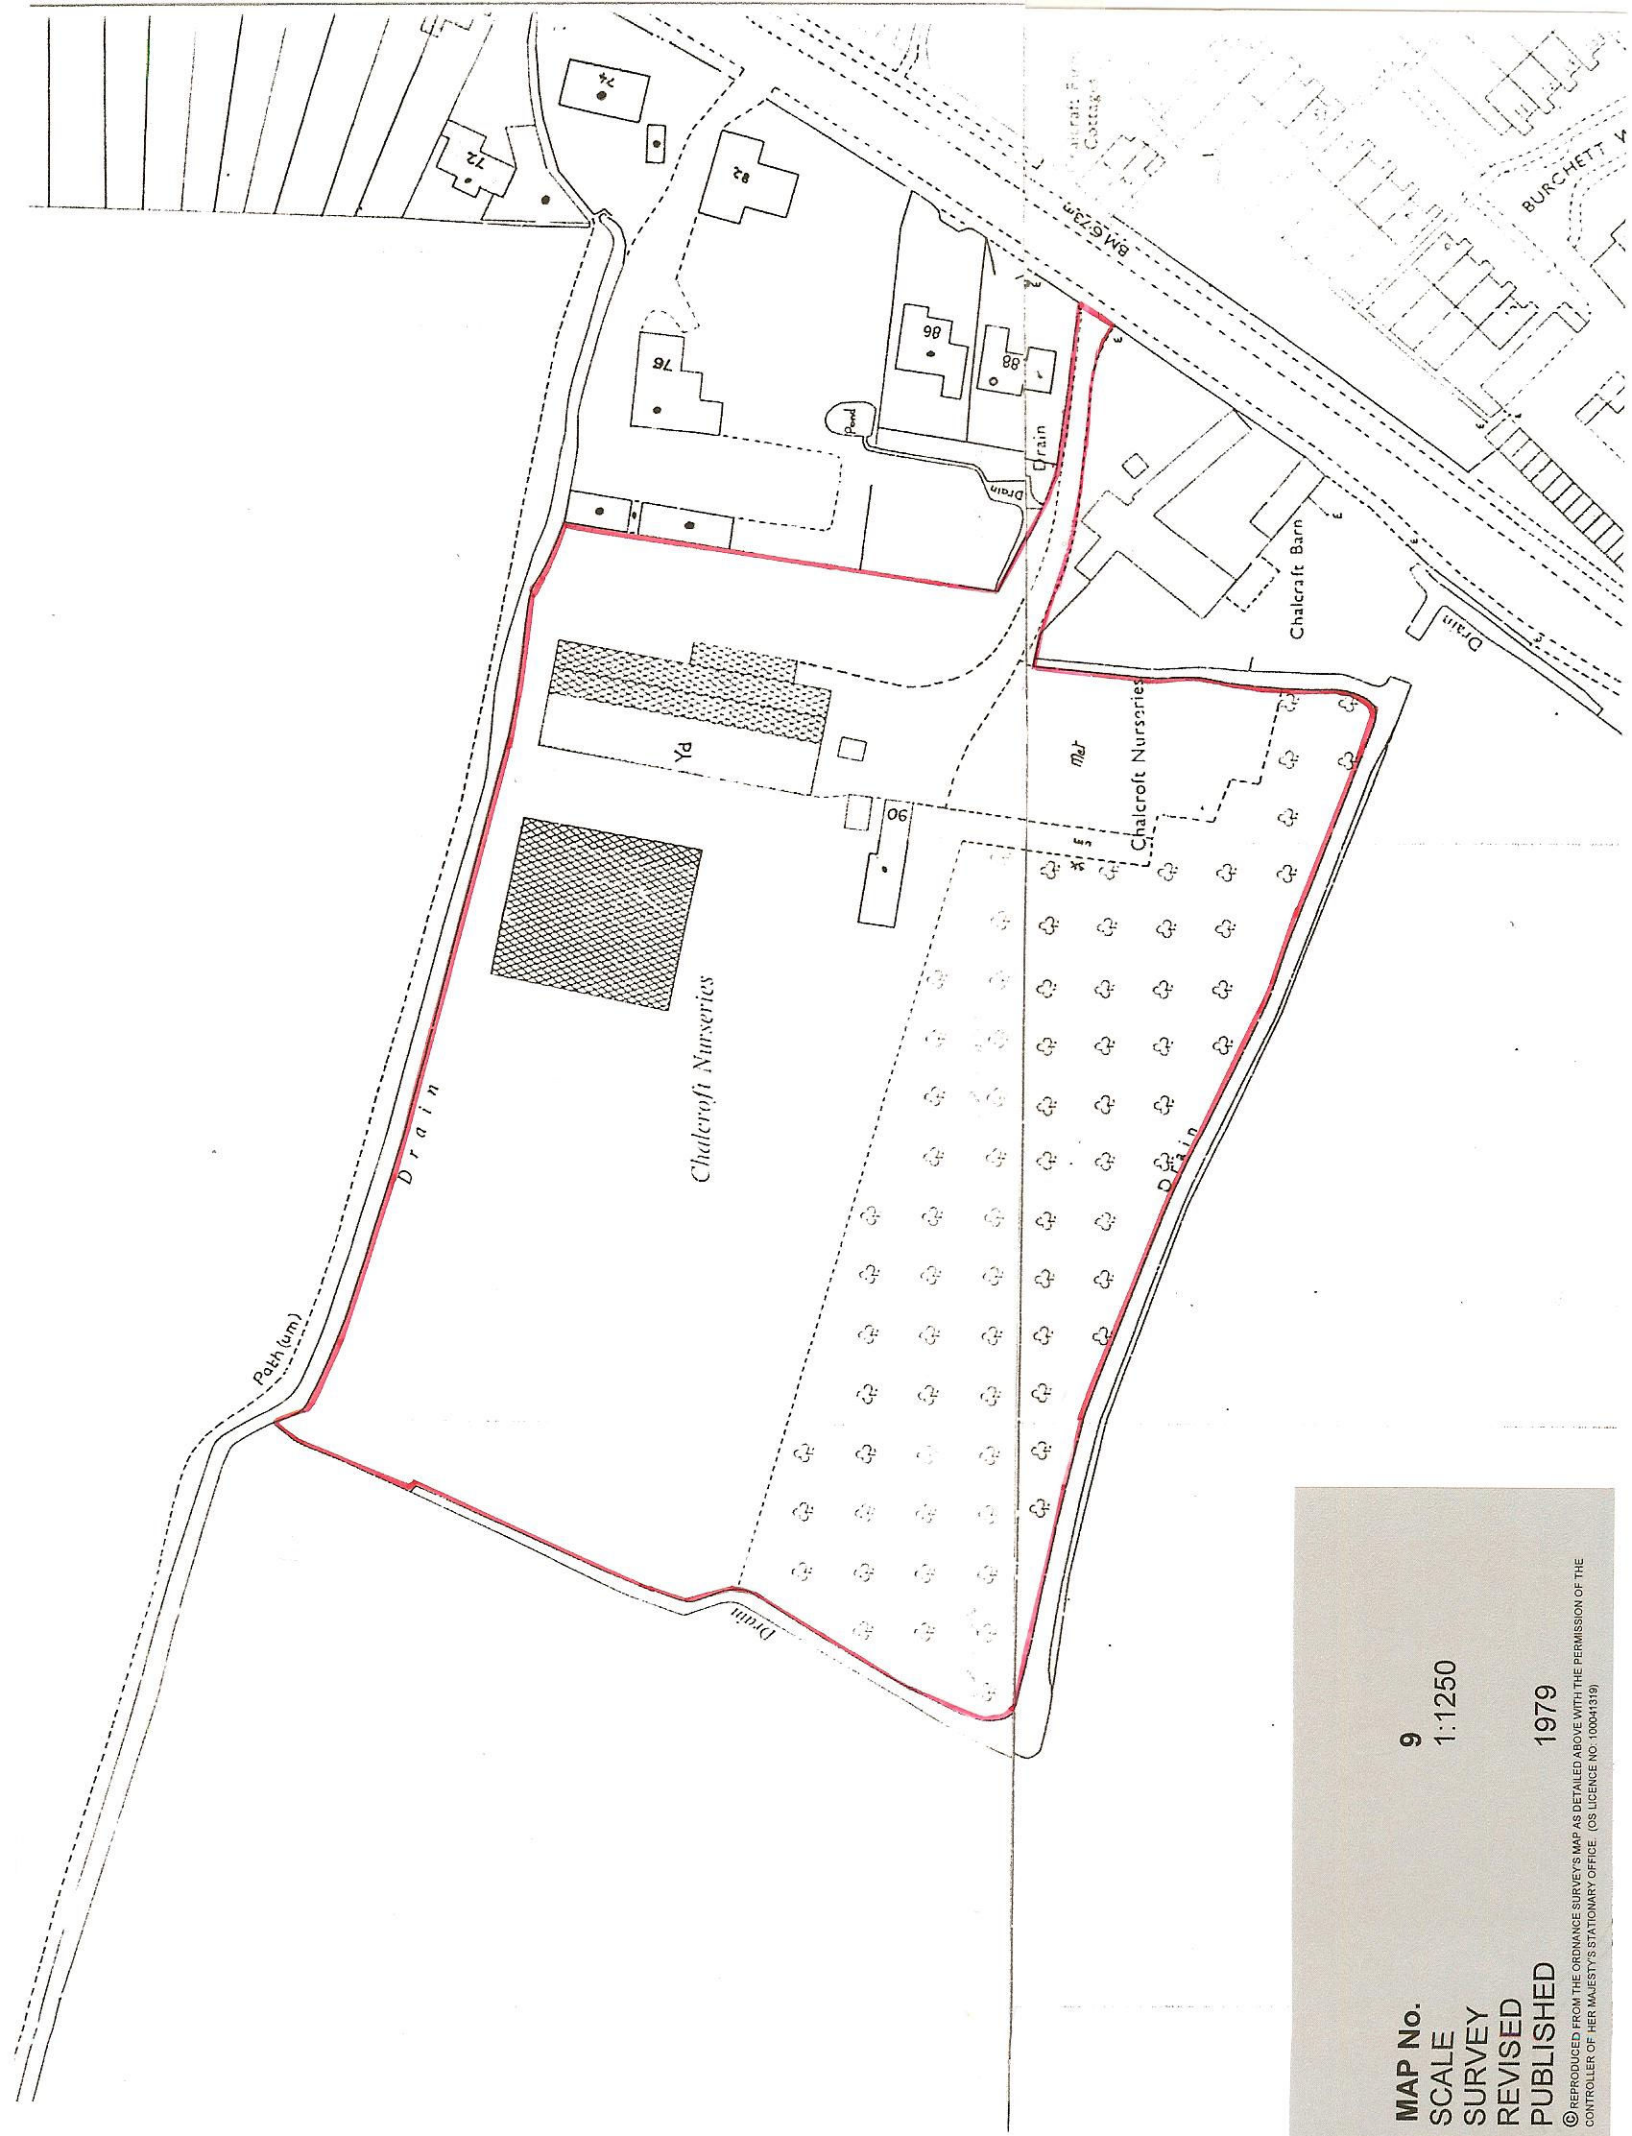
**MAP No. 9**  
**SCALE 1:1250**  
**SURVEY**  
**REVISED**  
**PUBLISHED 1979**

**Map 9: 1964 - 1979**

Four of the buildings had been removed from the site and one had been extended. A building had been constructed on the site. The pond 65 m east of the site had been in-filled and the pond adjacent to the north east had also been in-filled. Residential properties had been constructed 30 m east of the site.

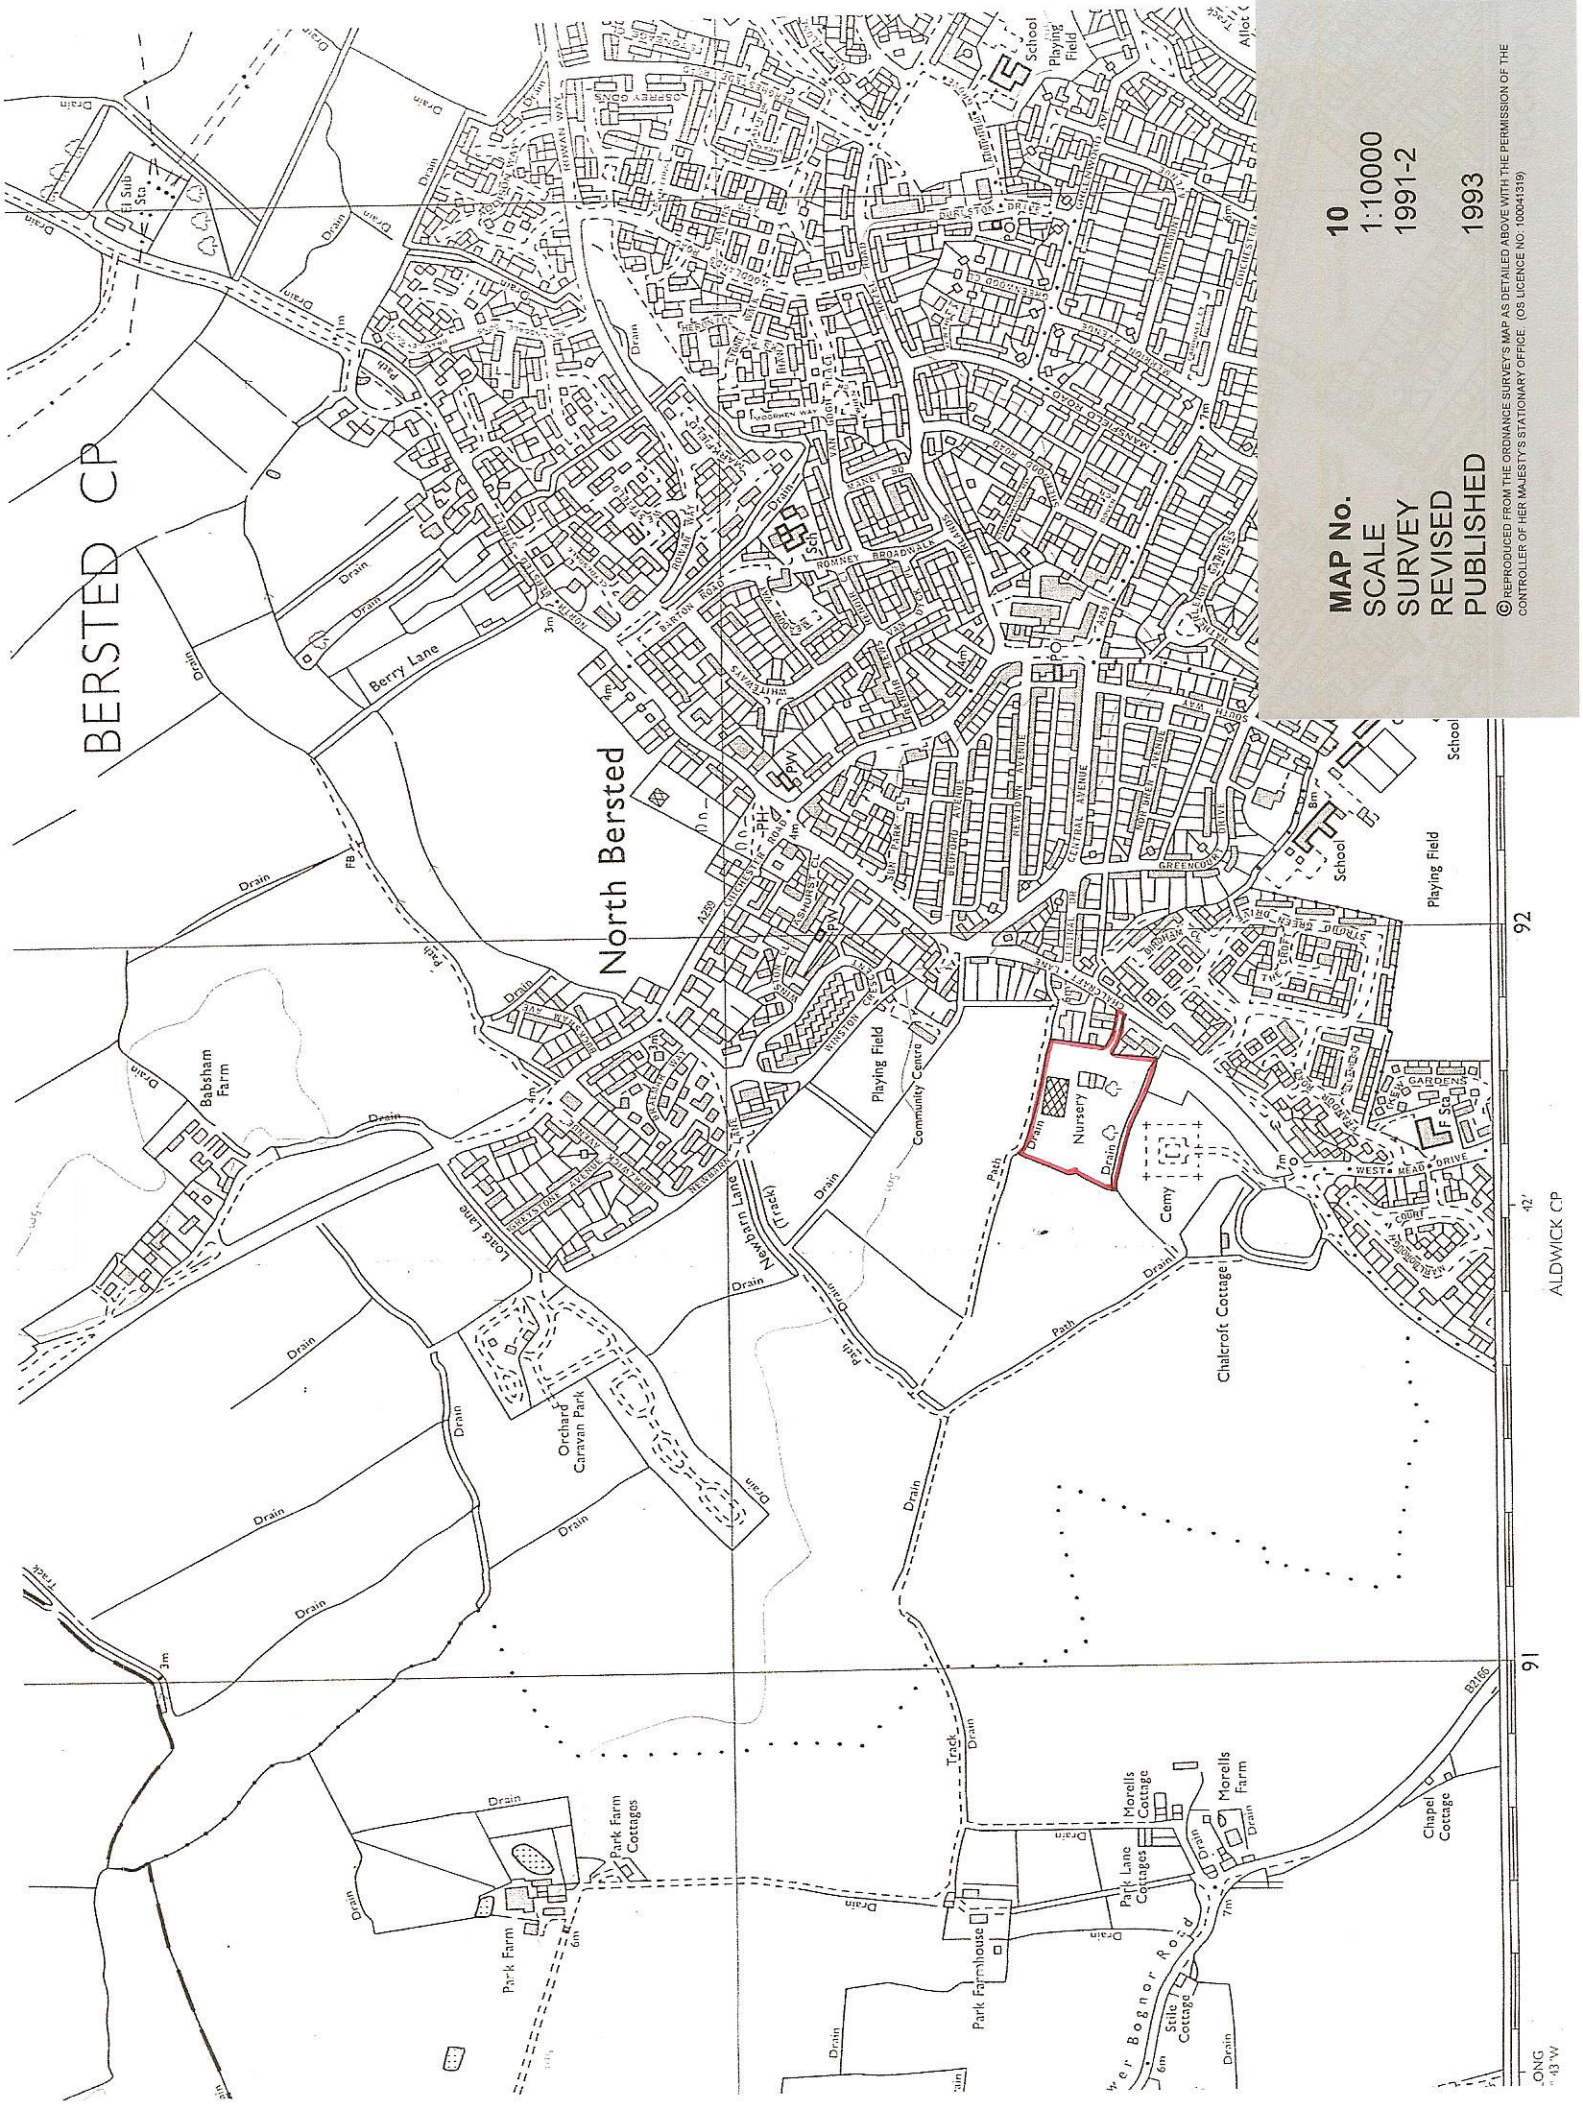
**MAP No. 10**  
**SCALE 1:10000**  
**SURVEY 1991-2**  
**REVISED 1993**  
**PUBLISHED**

**Map 10: 1979 – 1993**

Three of the buildings on the site had been removed and two had been constructed. The drain adjacent to the west of the site was no longer identified as a drain. The drain and

pond 35 m east were also no longer identified as drains on the map. A cemetery had been established 20 m south of the site.
