# **ECOLOGICAL ASSESSMENT OF 21 BUCKSHAM AVENUE, NORTH BERSTED, BOGNOR REGIS, WEST SUSSEX, PO21 5DT**

On behalf of VIVID design studio

June 2015

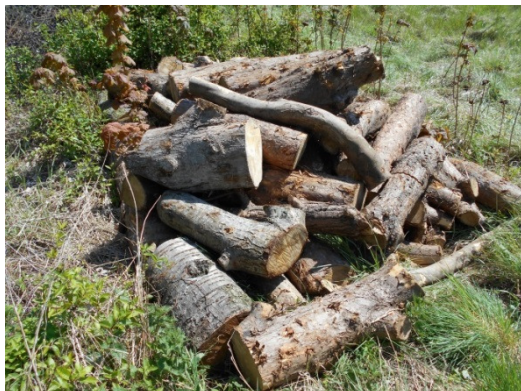
### Example of Log Pile Designs

Mixture of hard and soft woods heaped into a pile

- It is recommended that a further log pile is placed along the western boundary of the site in the retained wildlife corridor.
