## Bat Activity Surveys

The Cottage, Shripney Road  
Bognor Regis, West Sussex

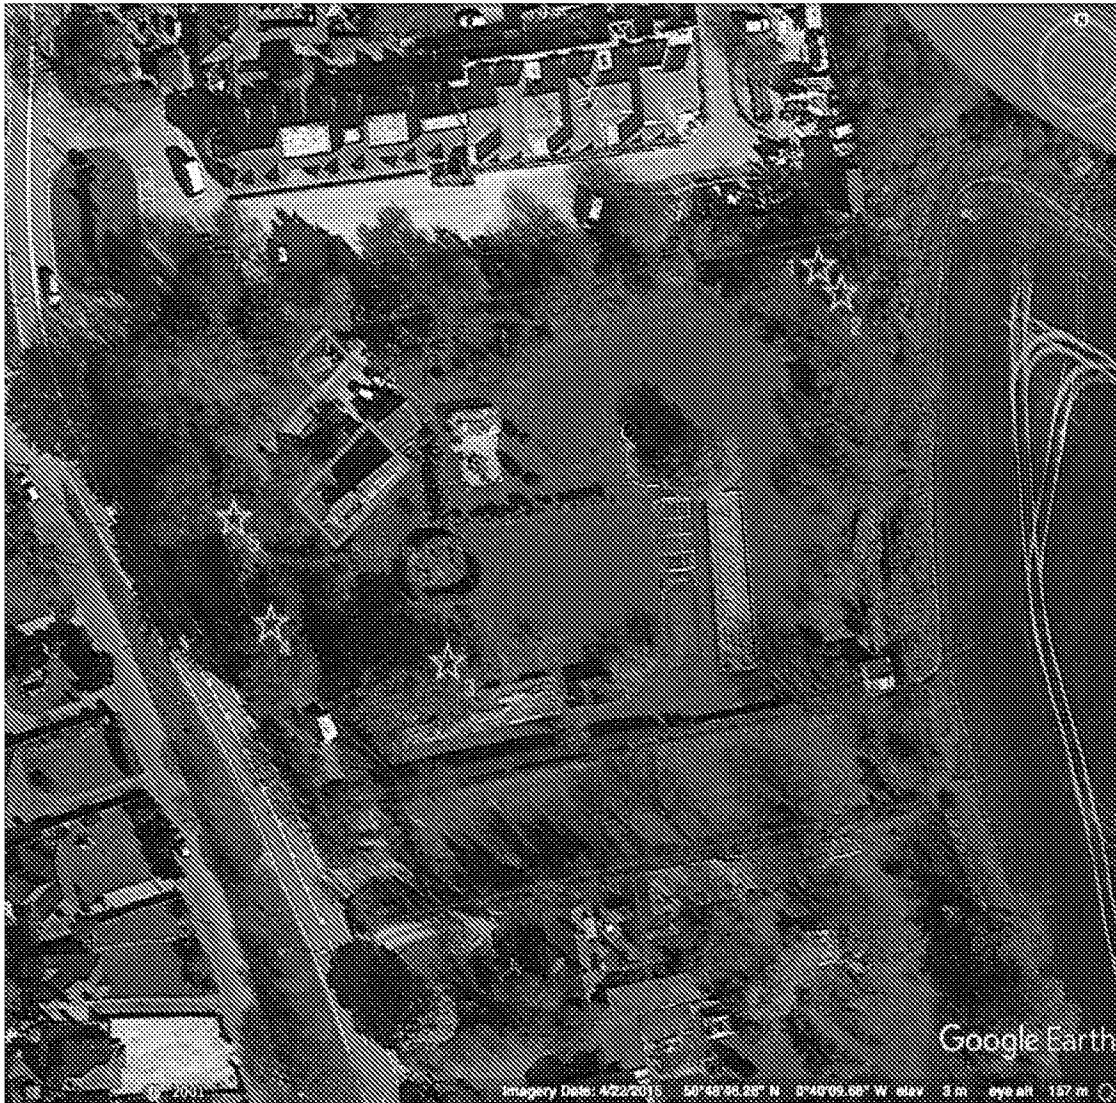
*Figure 4: Buildings subject to survey in red, Trees with potential bat roosting features in green*

- 3.1 Due to the presence of suitable features within buildings 1 and 3 on site as well as suitable roosting features within mature trees on site, emergence surveys were undertaken at site to assess the whether these features were in use by roosting bats.

- 4.1 There are a number of buildings on site, the vast majority are greenhouses and sheds which are not considered suitable for roosting bats. However, building 1, the main house and building 3 a small out building, were considered to have potential for roosting bats within their external features.

- 4.4 In addition, five trees were identified as having some potential to support roosting bats. It was recommended that further work is undertaken on these trees to establish whether they are used as roost sites by bat species.
