# Ecological Report

## Water Vole Presence/Absence Survey Report

Oldlands Farm,  
Shripney Road,  
Bognor Regis,  
West Sussex

140134-ED-05

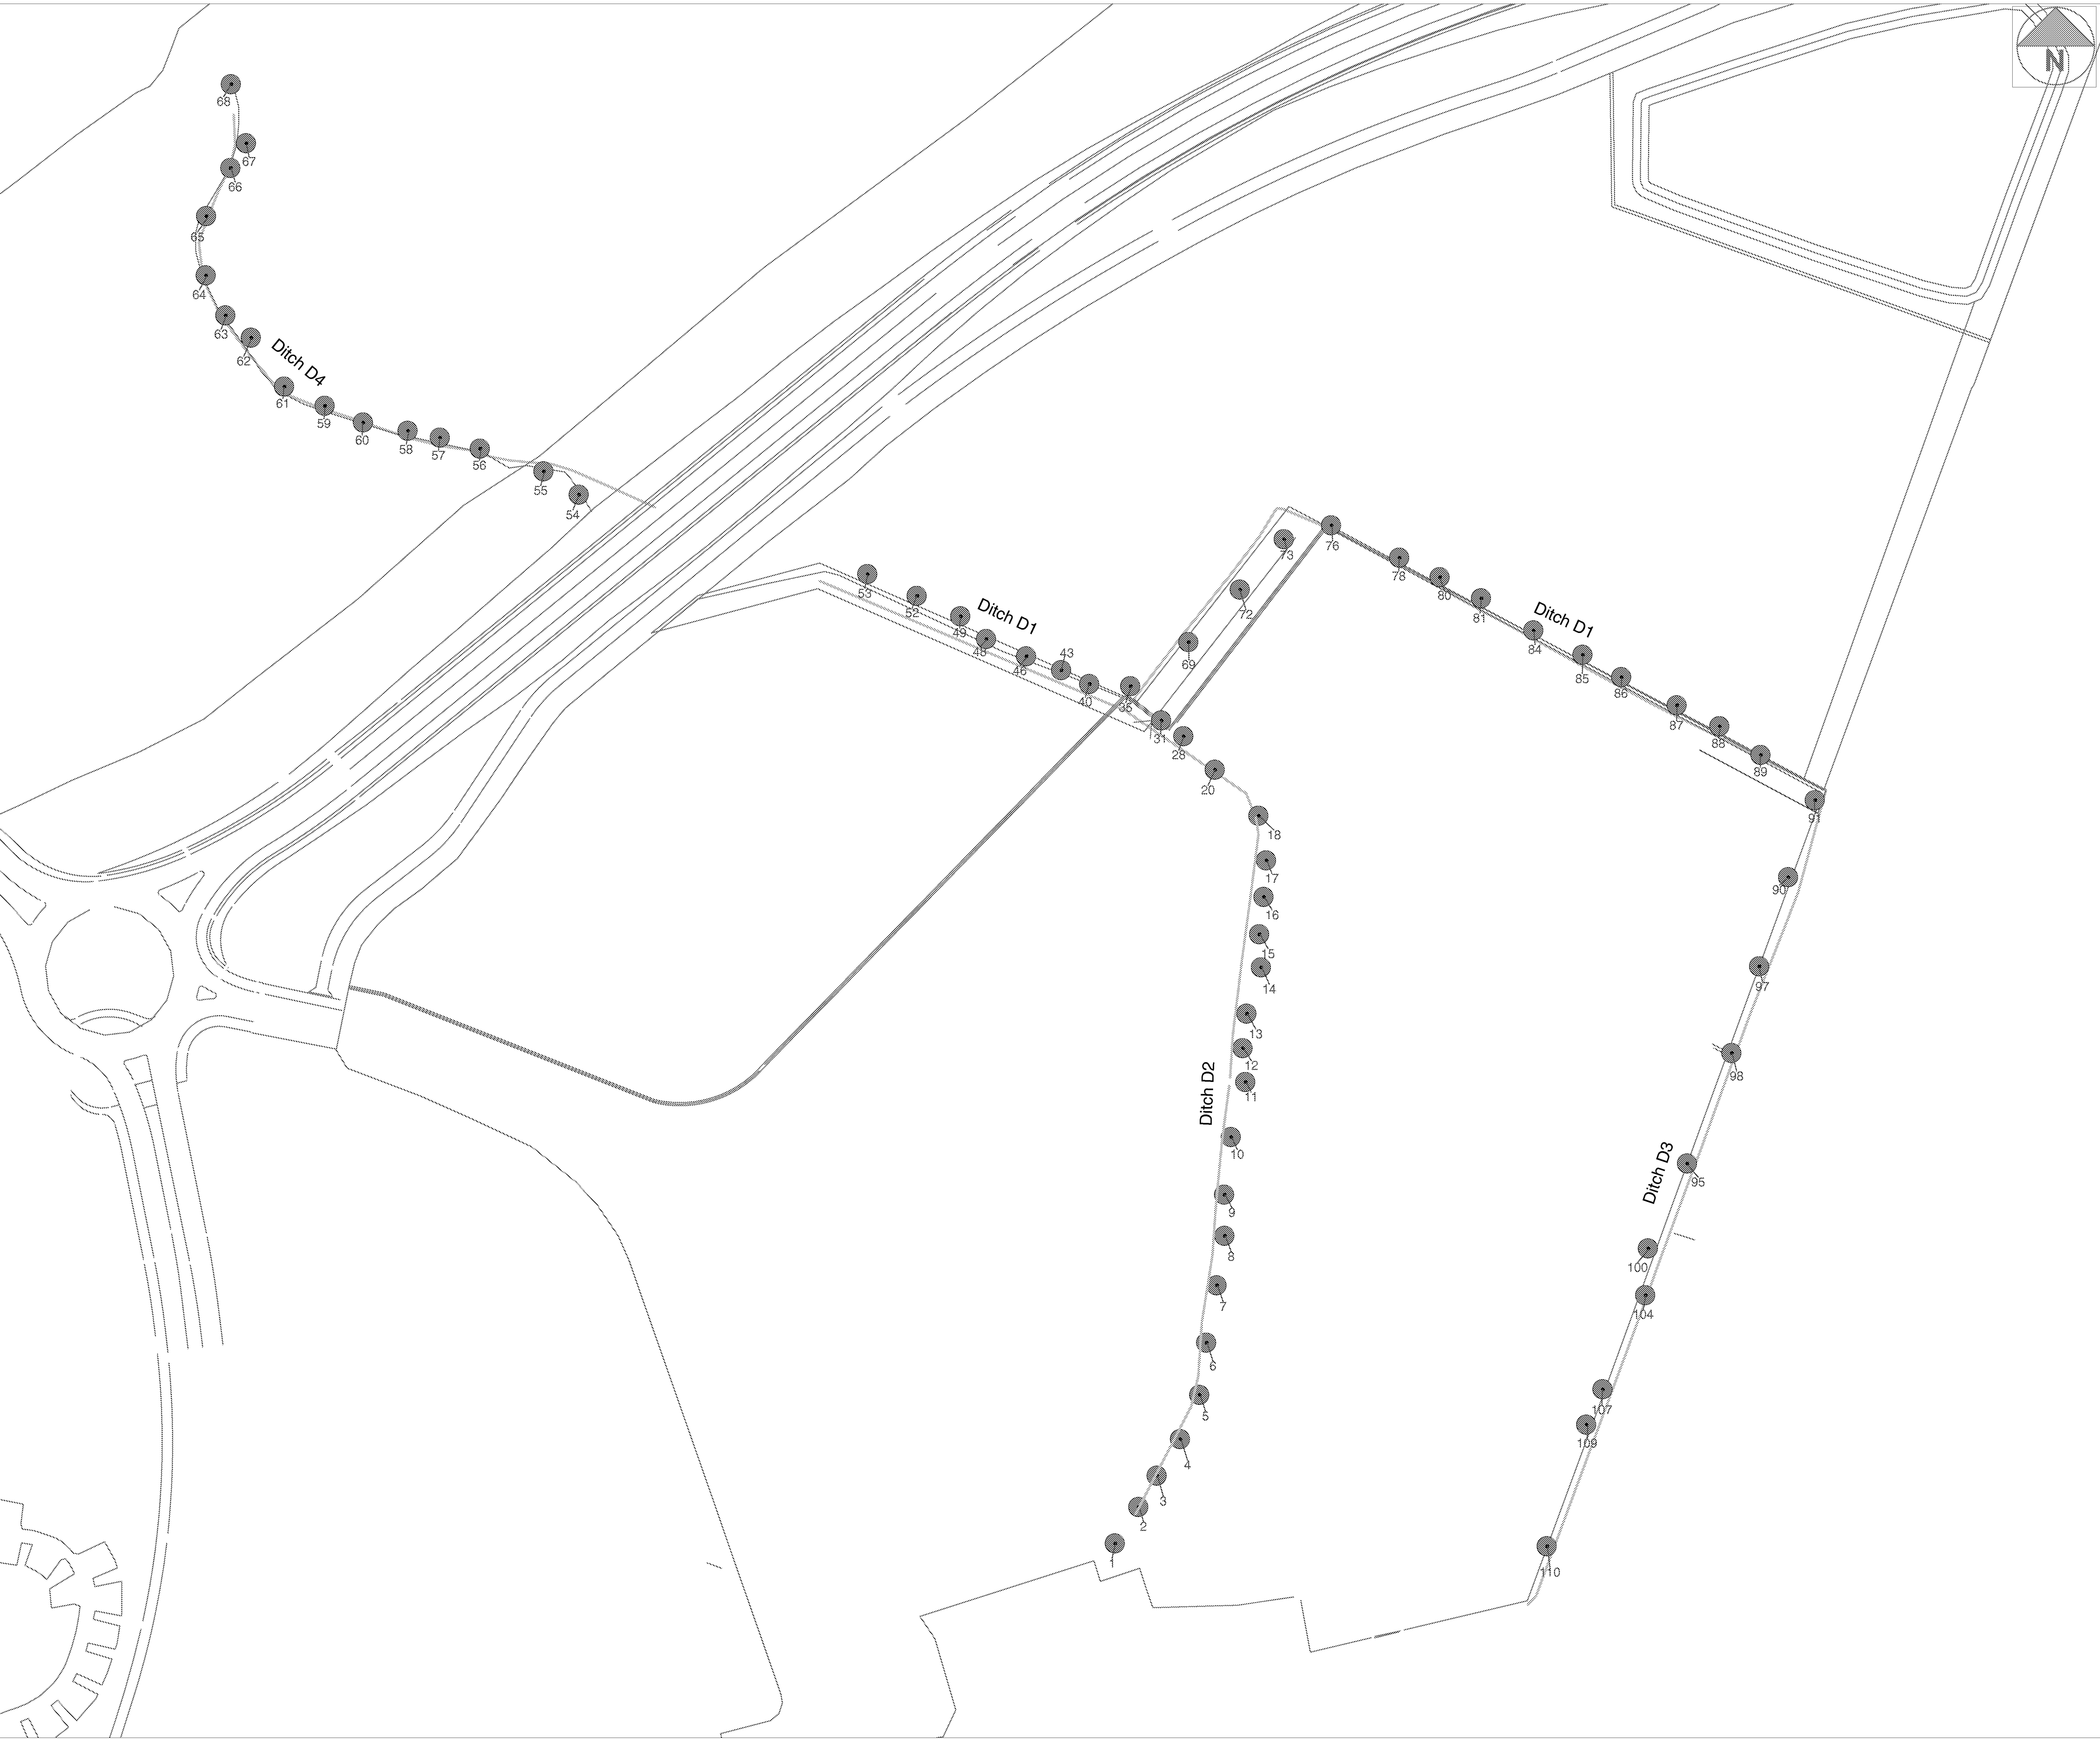
Water Vole Target Note Plan

- 3.3 A plan showing the signs of water voles recorded during the survey can be found in Appendix 1. Appendix 2 shows the points which were surveyed along with notes on the water depths and other features of the habitat at each point. No water vole tunnels were recorded within any of the ditches during the survey. However, the ditches were largely densely vegetated by common reed, amongst which water vole tunnels are likely to have been well-concealed. Water voles burrows are considered to be present in those ditches containing suitable water vole habitat and evidence of water voles.

| Object ID | Notes and findings |
|---|---|
| 1 | Completely dry. No evidence |

| Object ID | Notes and findings |
|---|---|
| 28 | Ditch holding up to 30cm of water. Water evidence found. Burrows considered likely in dense reed |
