# flood risk assessment

Chalcroft Nursery, Chalcroft  
Lane, Bersted, West Sussex

CCE/U101/FRA-02

For Landform Bersted Ltd

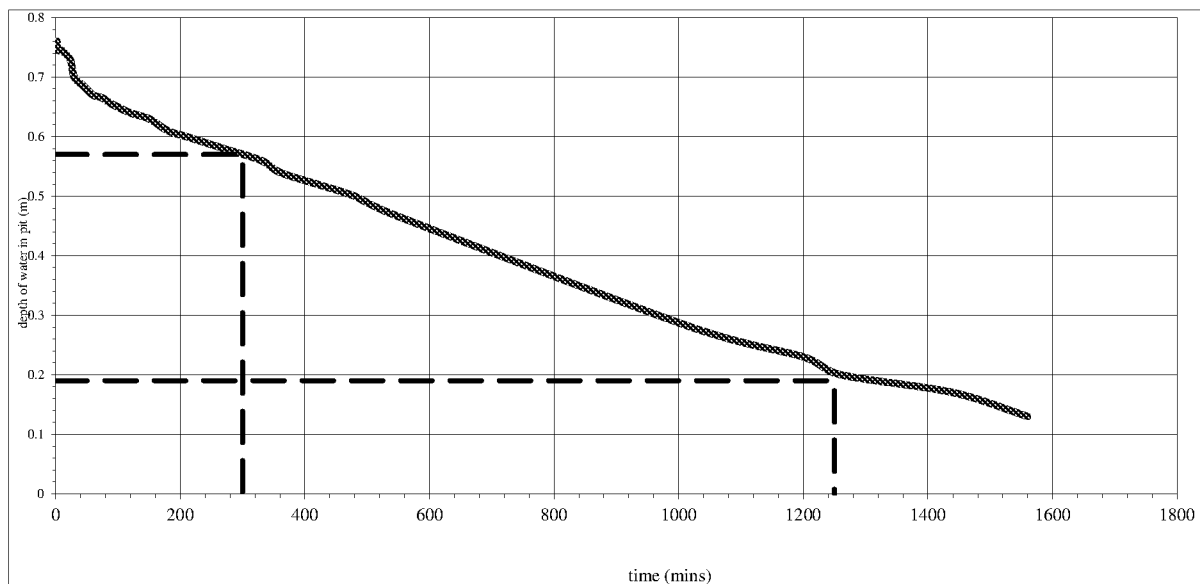
test infiltration rate (f) = 2.1E-06 m/s  
 groundwater depth before adding water (m) = 0

Based upon the above results and the ground conditions encountered (in accordance with BRE 365 2016) we recommend that soakaways are not suitable at this site. Further testing may be warranted to confirm this. Groundwater level monitoring is also recommended.

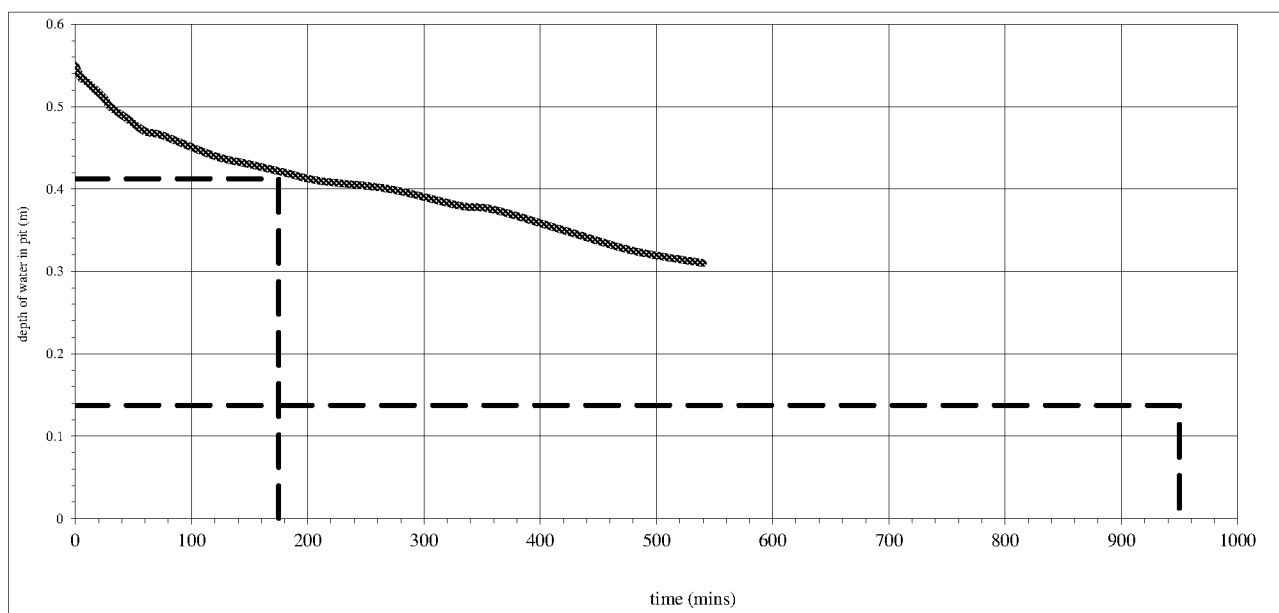
**Project No.:** 73002  
**Site:** West Bersted  
**Test Location:** TP1 - test 2  
**Date:** 6th and 7th May 2020

| test pit base dimensions | 0.4 | 1.95 | test infiltration rate (f) = 2.2E-06 m/s |

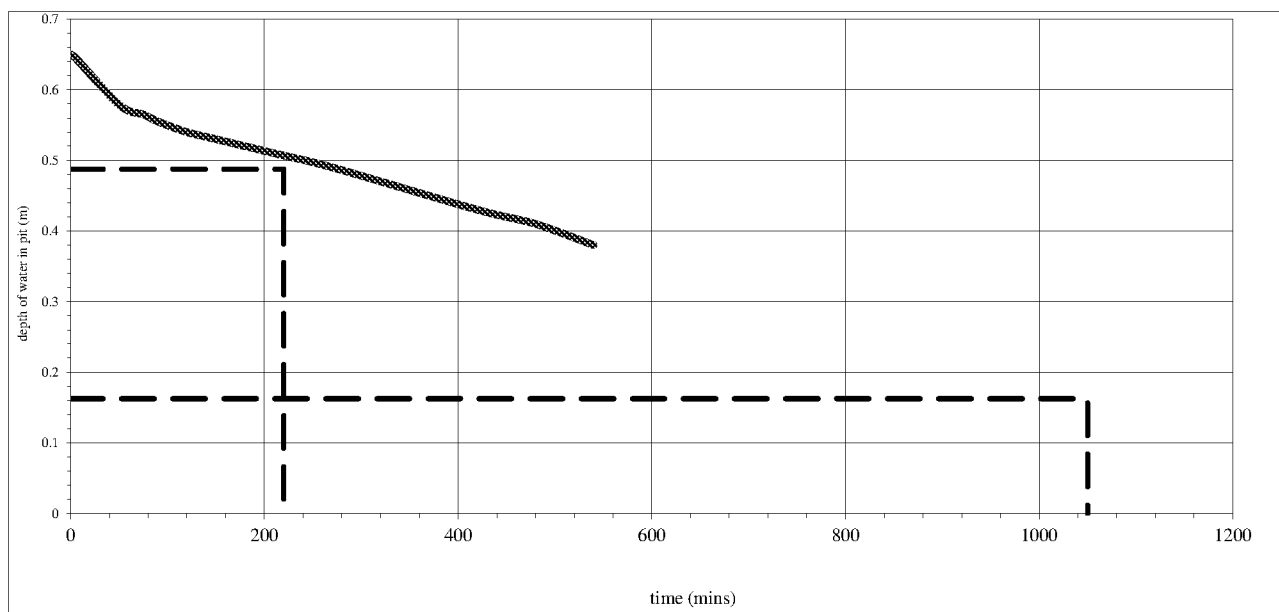
**Project No.:** 73002  
**Site:** West Bersted  
**Test Location:** TP1 - test 3  
**Date:** 6th and 7th May 2020

| test pit base dimensions | 0.4 | 1.95 | test infiltration rate (f) = 2.2E-06 m/s |

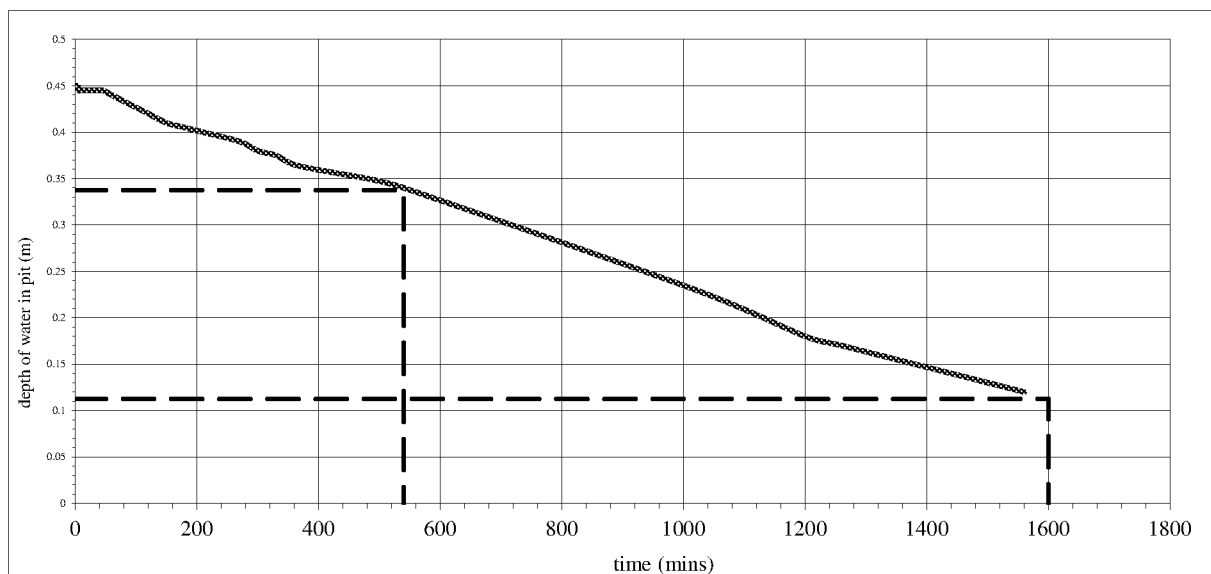
**Project No.:** 73002  
**Site:** West Bersted  
**Test Location:** TP2 - test 1  
**Date:** 6th and 7th May 2020

test infiltration rate (f) = 1.5E-06 m/s  
 groundwater depth before adding water (m) = 0

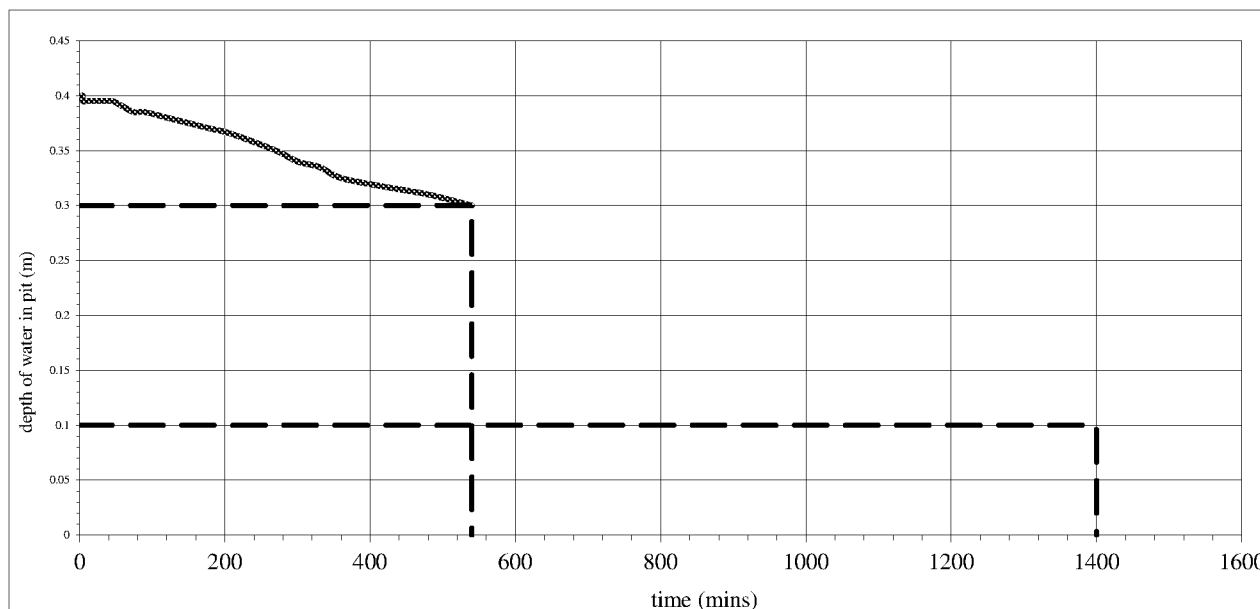
**Project No.:** 73002  
**Site:** West Bersted  
**Test Location:** TP2 - test 2  
**Date:** 6th and 7th May 2020

test infiltration rate (f) = 1.7E-06 m/s  
 groundwater depth before adding water (m) = 0

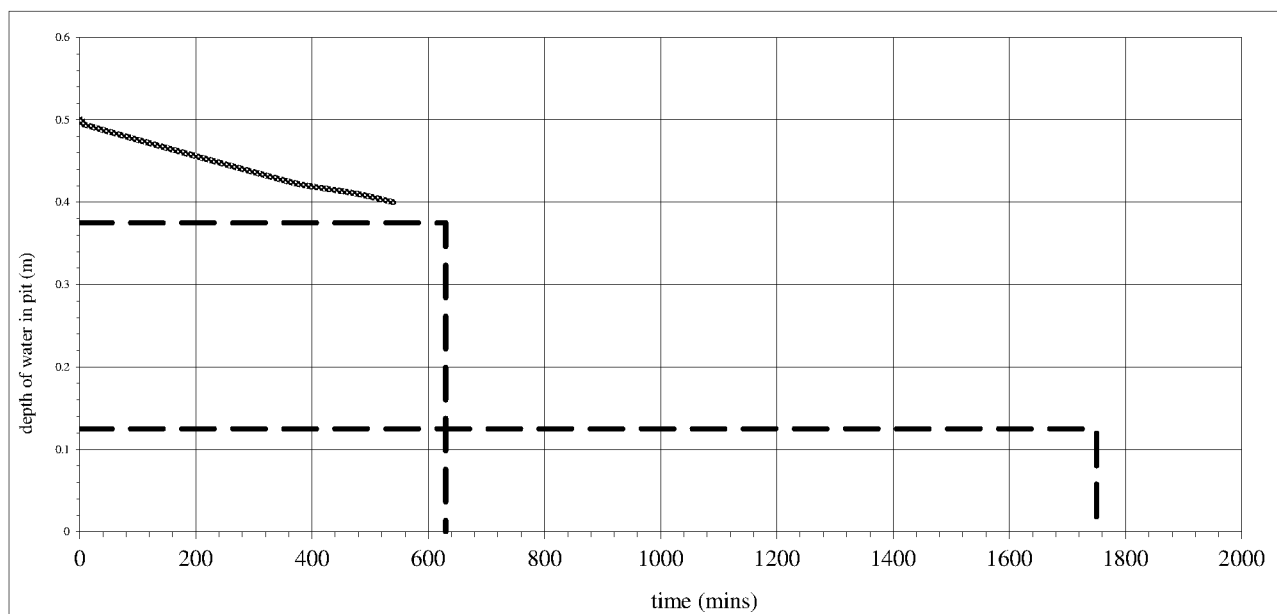
**Project No.:** 73002  
**Site:** West Bersted  
**Test Location:** TP2 - test 3  
**Date:** 6th and 7th May 2020

test infiltration rate (f) = 1.5E-06 m/s  
 groundwater depth before adding water (m) = 0

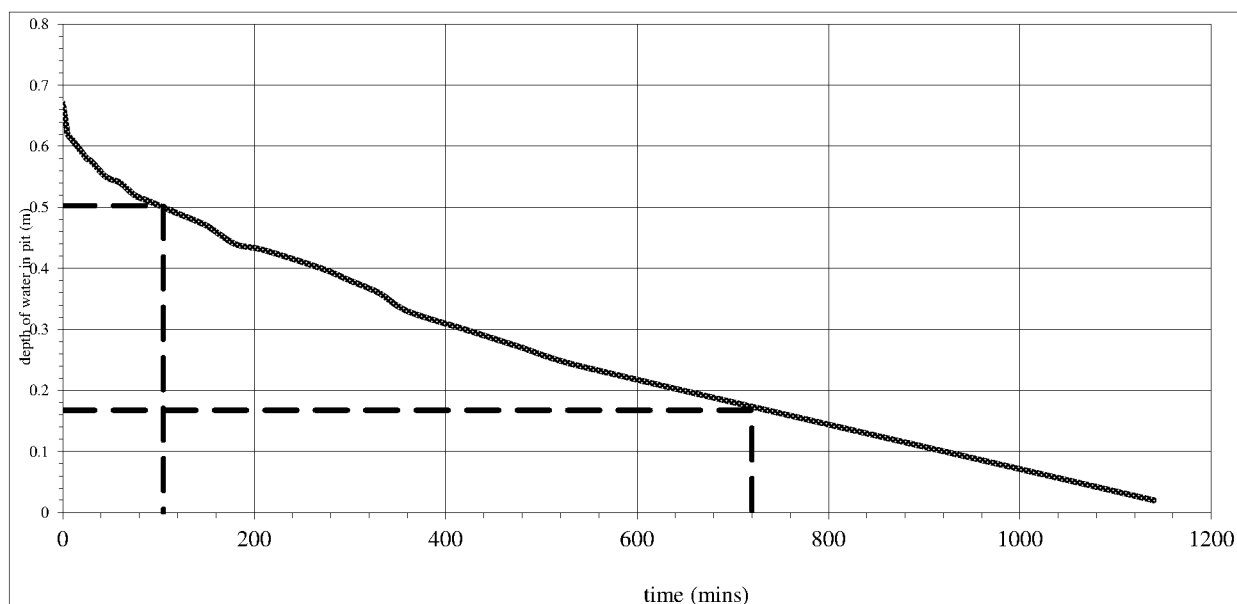
**Project No.:** 73002  
**Site:** West Bersted  
**Test Location:** TP3 - test 1  
**Date:** 6th and 7th May 2020

test infiltration rate (f) = 3.4E-06 m/s  
 groundwater depth before adding water (m) =

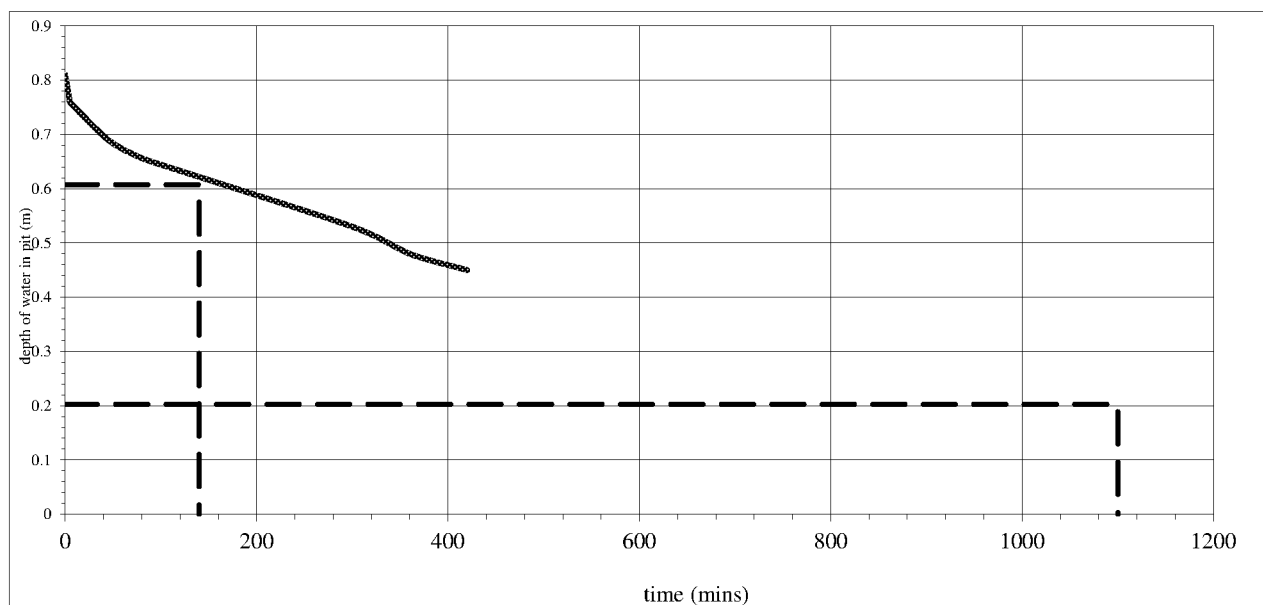
**Project No.:** 73002  
**Site:** West Bersted  
**Test Location:** TP3 - test 2  
**Date:** 6th and 7th May 2020

test infiltration rate (f) = 2.4E-06 m/s  
 groundwater depth before adding water (m) =

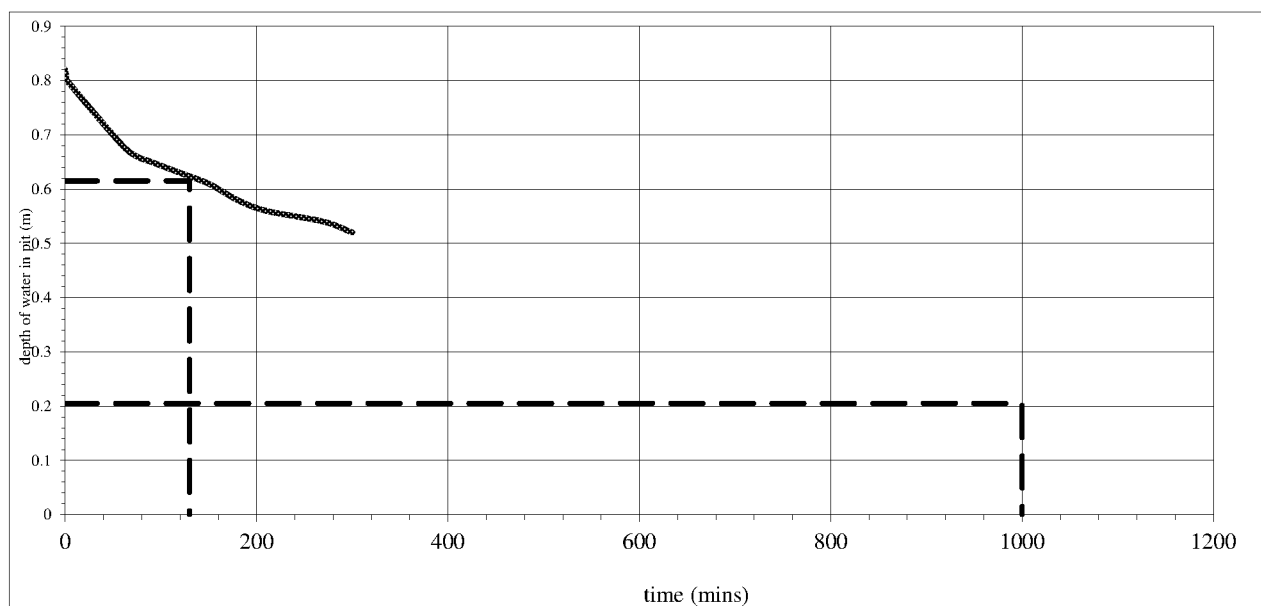
**Project No.:** 73002  
**Site:** West Bersted  
**Test Location:** TP3 - test 3  
**Date:** 6th and 7th May 2020

test infiltration rate (f) = 2.6E-06 m/s  
 groundwater depth before adding water (m) = 0

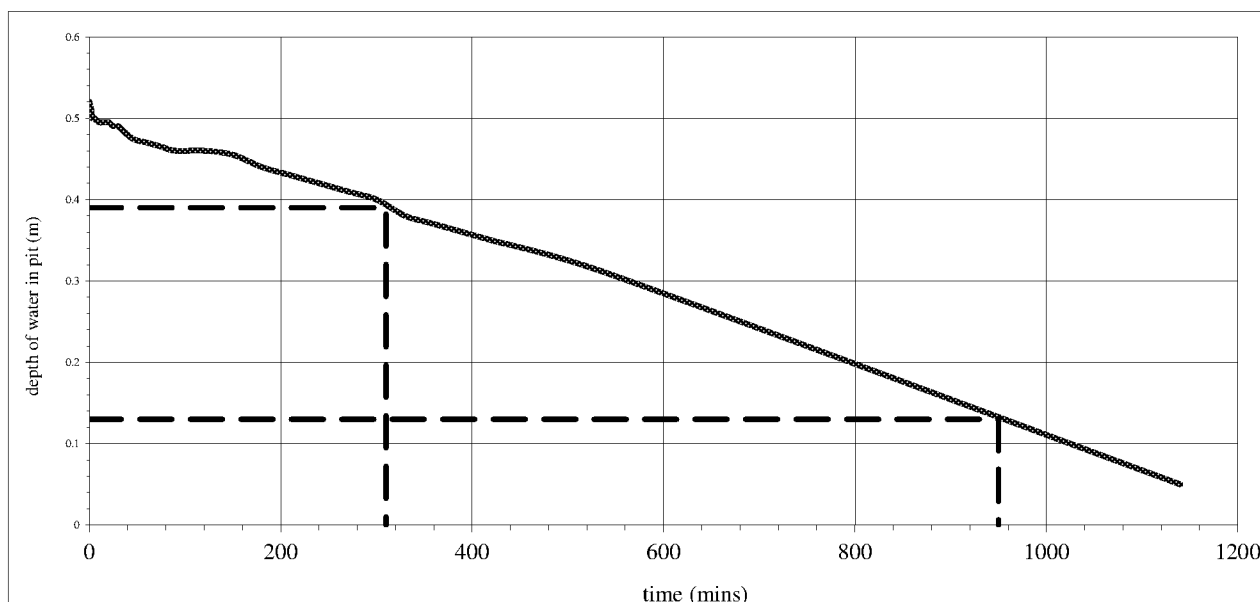
**Project No.:** 73002  
**Site:** West Bersted  
**Test Location:** TP4 - test 1  
**Date:** 6th and 7th May 2020

test infiltration rate (f) = 2.7E-06 m/s  
 groundwater depth before adding water (m) = 0

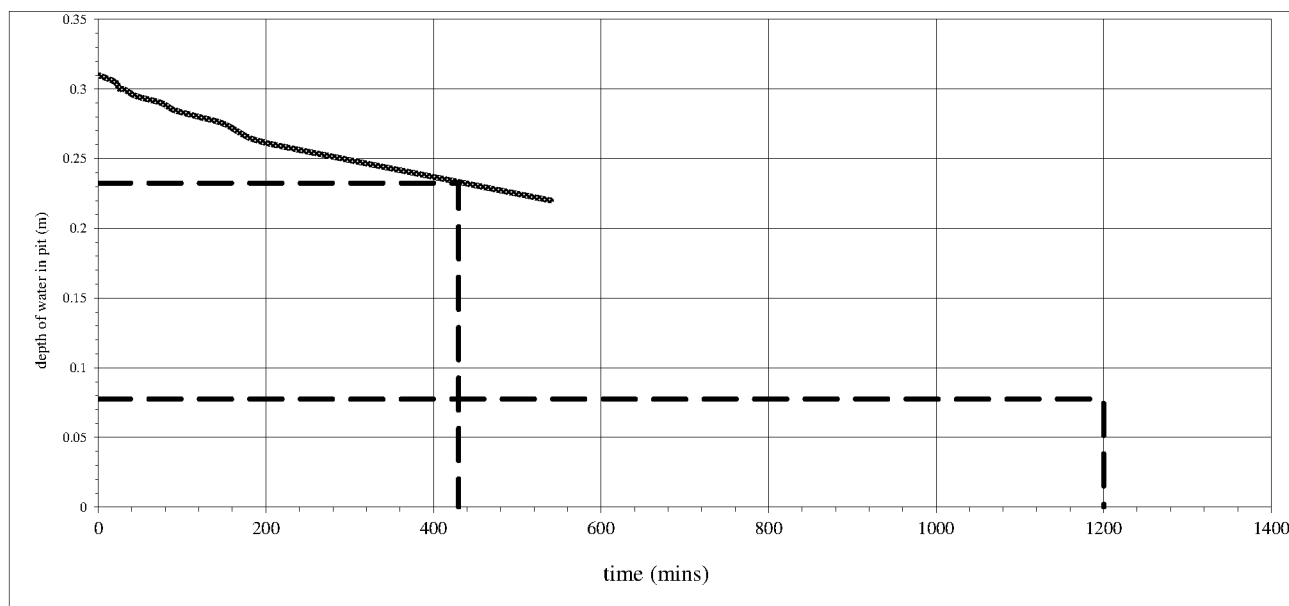
**Project No.:** 73002  
**Site:** West Bersted  
**Test Location:** TP4 - test 2  
**Date:** 6th and 7th May 2020

test infiltration rate (f) = 1.7E-06 m/s  
 groundwater depth before adding water (m) = 0

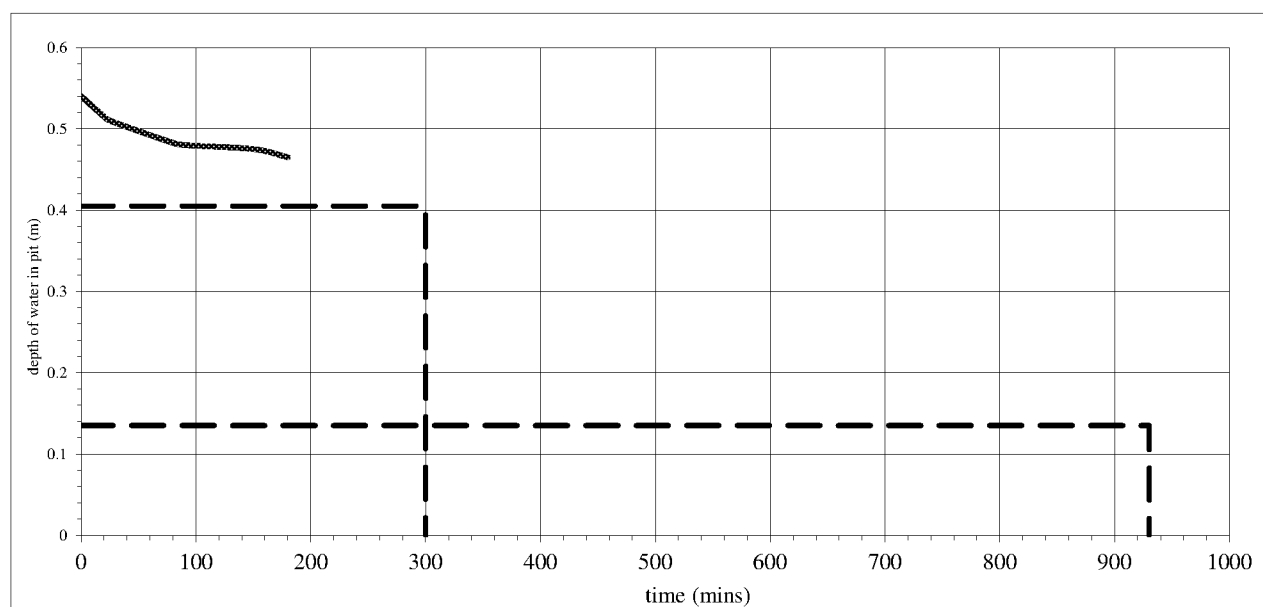
**Project No.:** 73002  
**Site:** West Bersted  
**Test Location:** TP4 - test 3  
**Date:** 6th and 7th May 2020

test infiltration rate (f) = 2.8E-06 m/s  
 groundwater depth before adding water (m) = 0
