# flood risk assessment

Chalcroft Nursery, Chalcroft  
Lane, Bersted, West Sussex

CCE/U101/FRA-02

July 2020

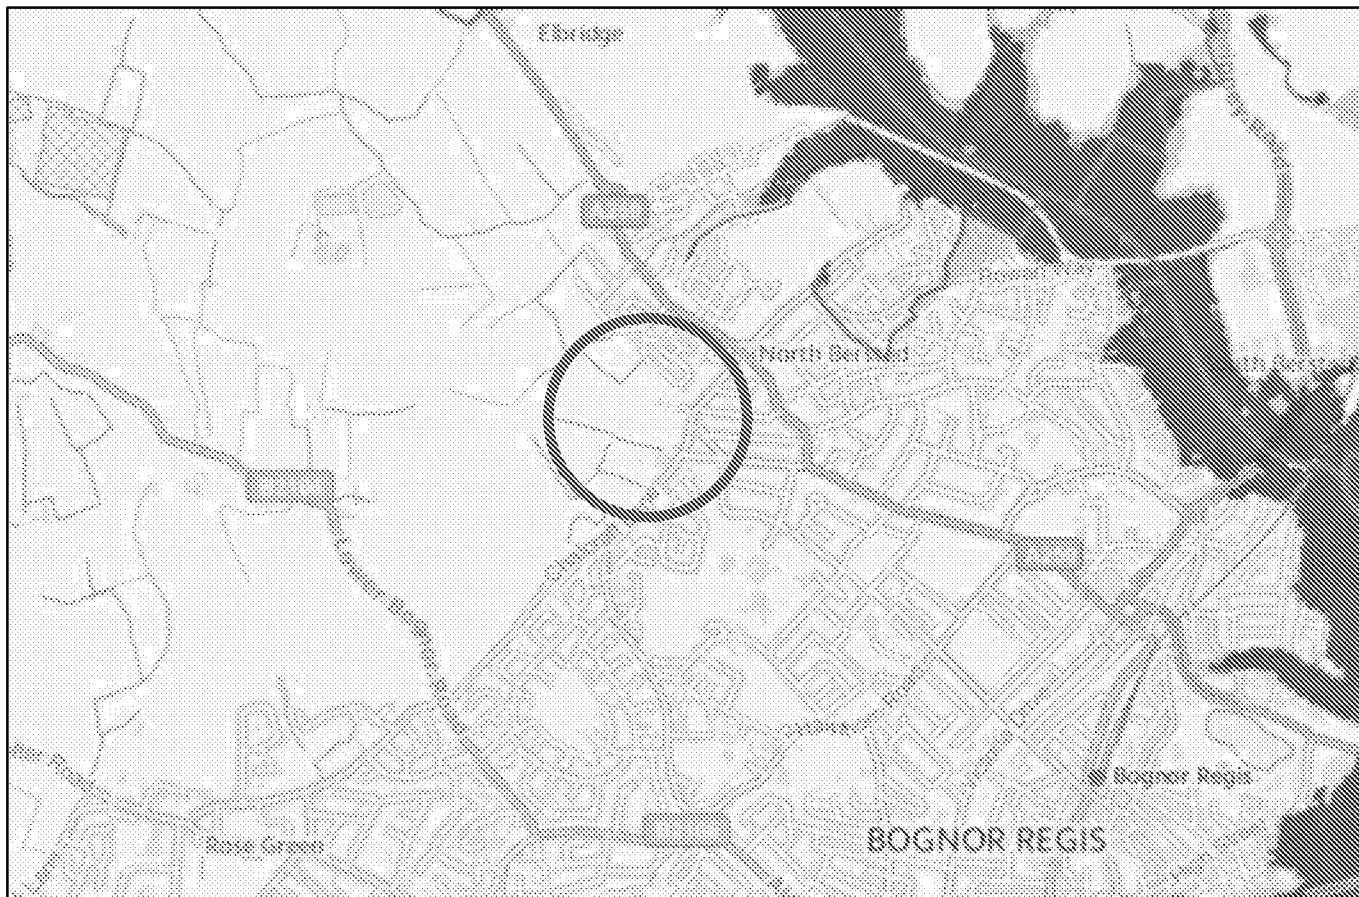
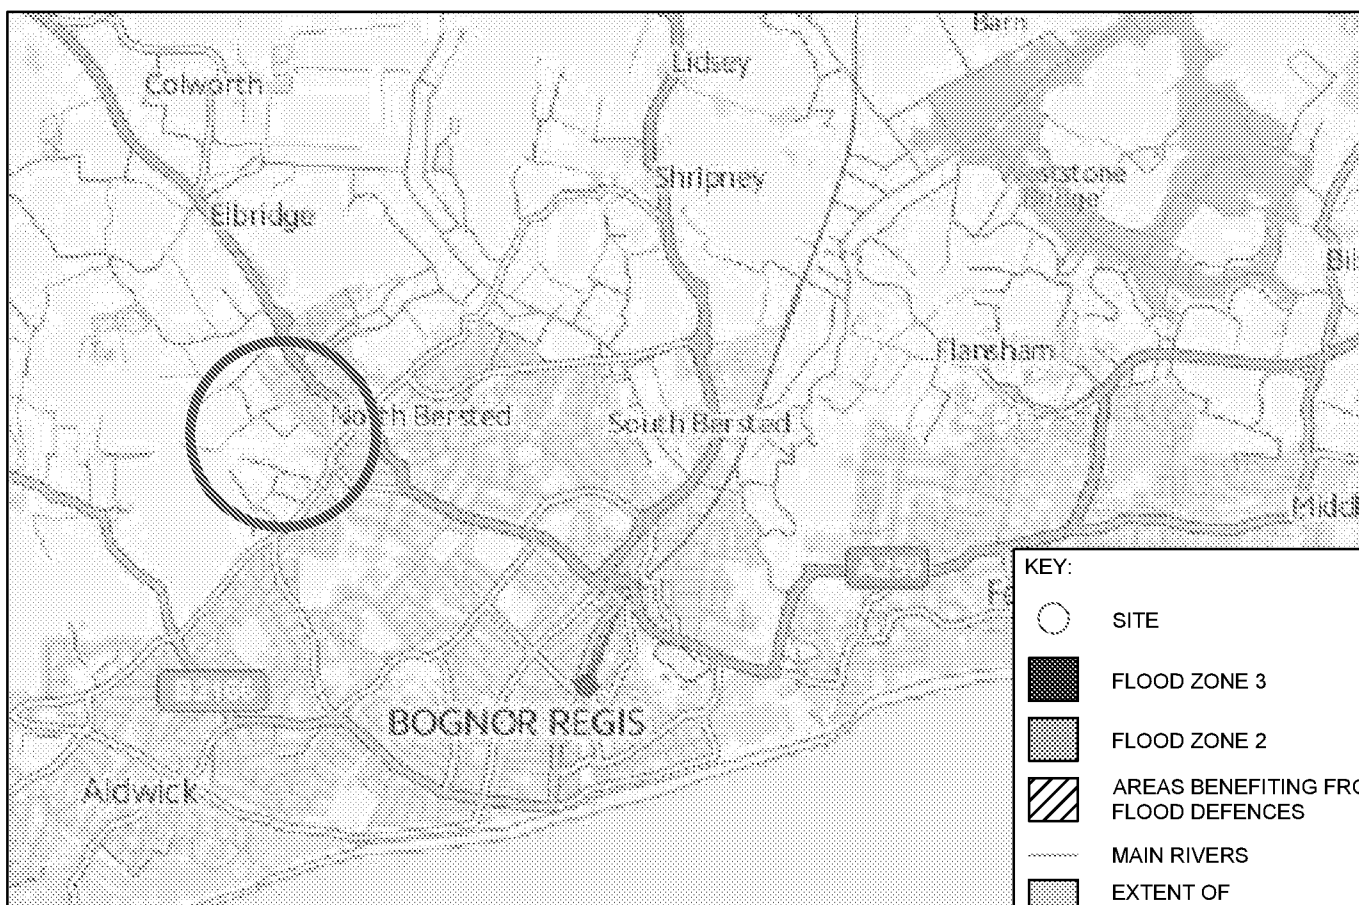
FIGURE TITLE  
FLOOD ZONES & RESERVOIR INUNDATION PLAN

- 2.1 As shown on Figure 2 the site sits in Flood Zone 1 (the low probability flood area) and is not considered likely to flood as the result of overtopping from a watercourse or from coastal flooding.

- 2.6 The site does not lie in a reservoir inundation area (see image Figure 2).

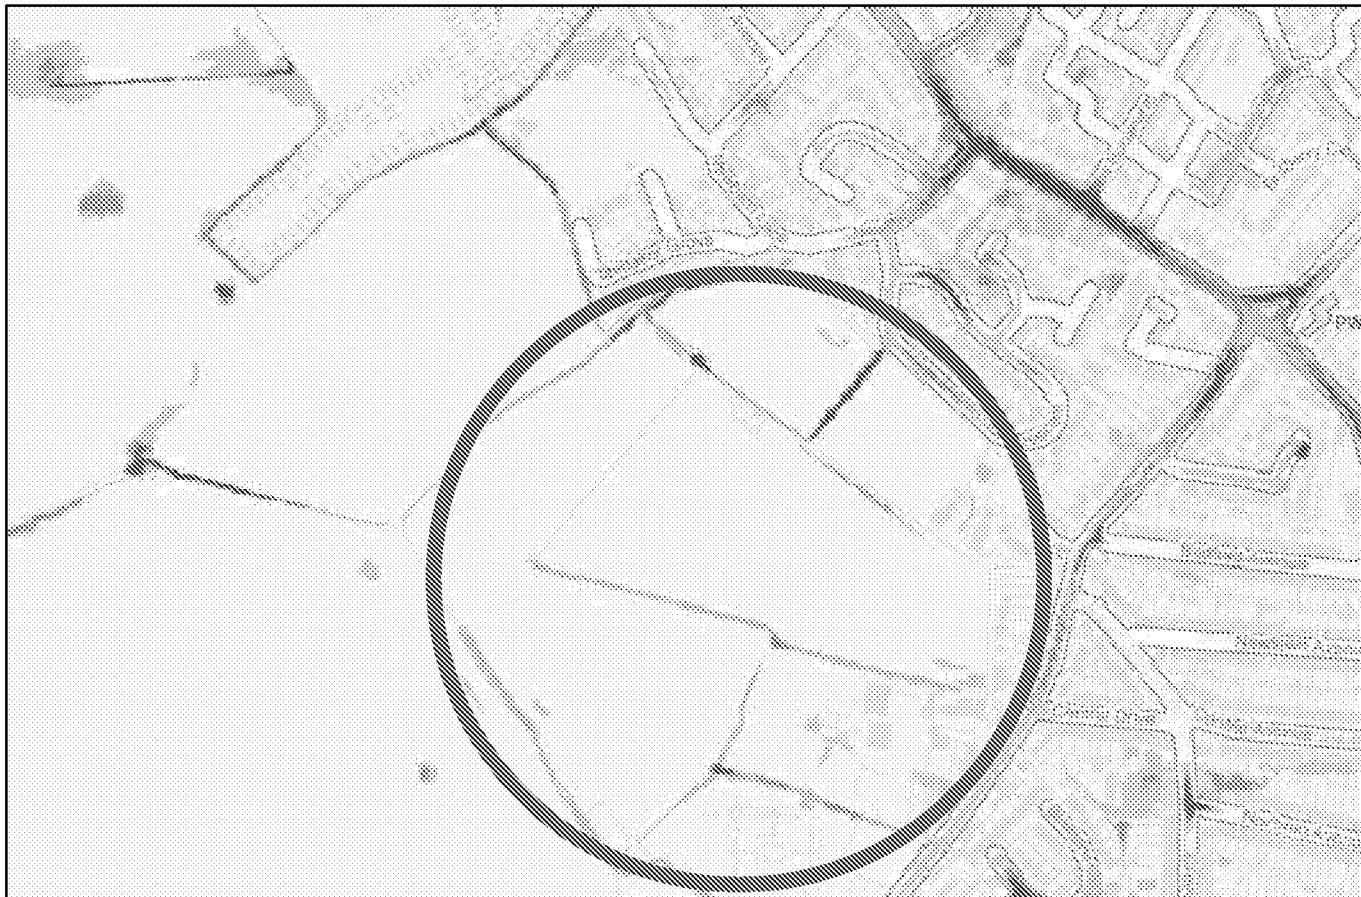
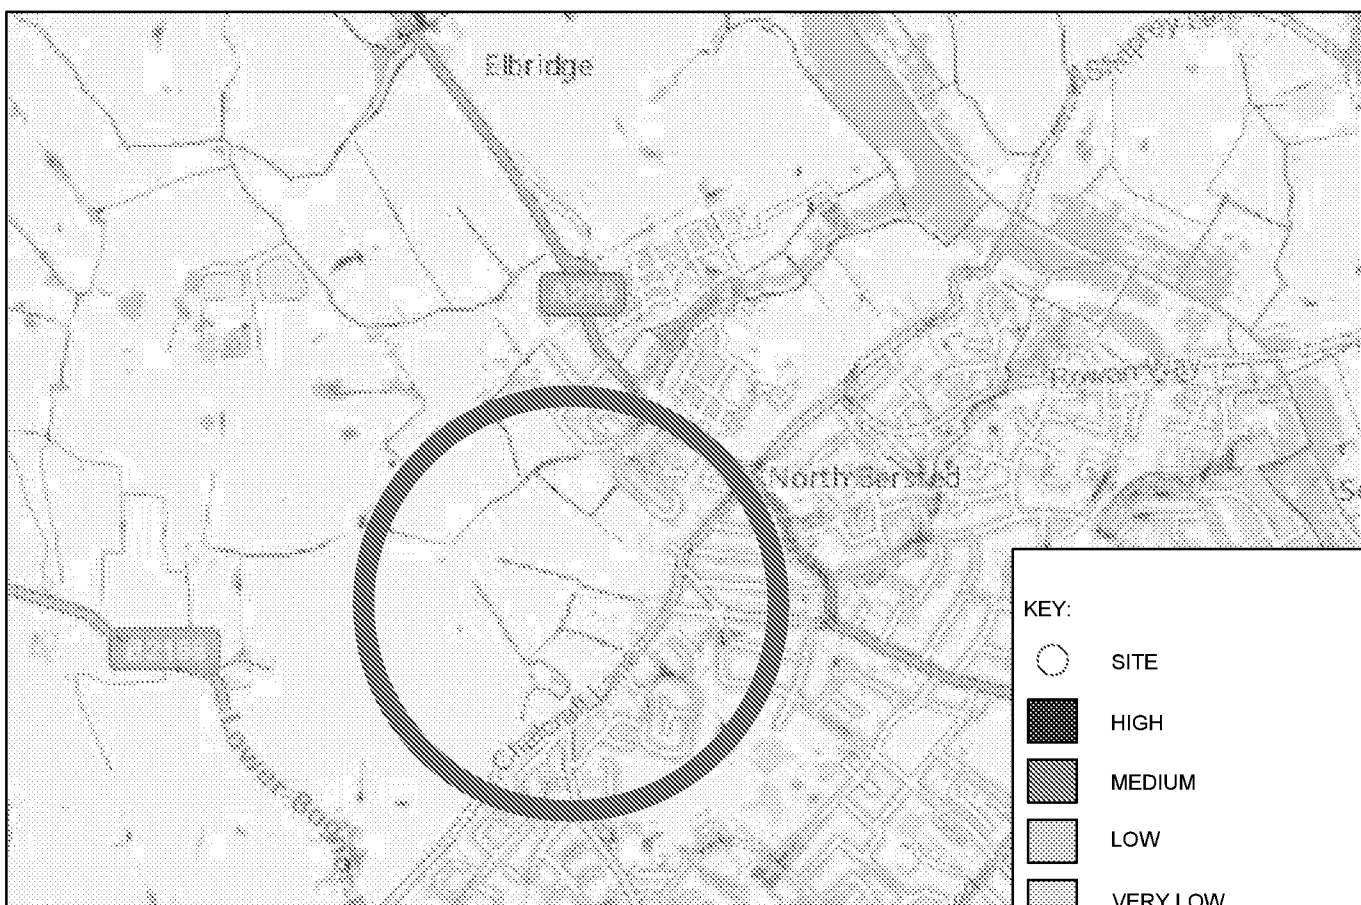
FIGURE TITLE  
SURFACE WATER FLOOD MAPS

- 2.2 Surface water flood mapping (see Figure 4) shows only minor spots of flooding on the site. The spots are likely to be the result of localised pooling of direct rainfall on the site. The scale of the flooding means that it is not considered a notable threat to the proposals.
- 2.3 Both the northern and southern boundary ditches are highlighted on the mapping. This is to be expected as the maps show where water will pool and/or flow. The mapping is effectively highlighting the presence of the ditches as functional land drains.

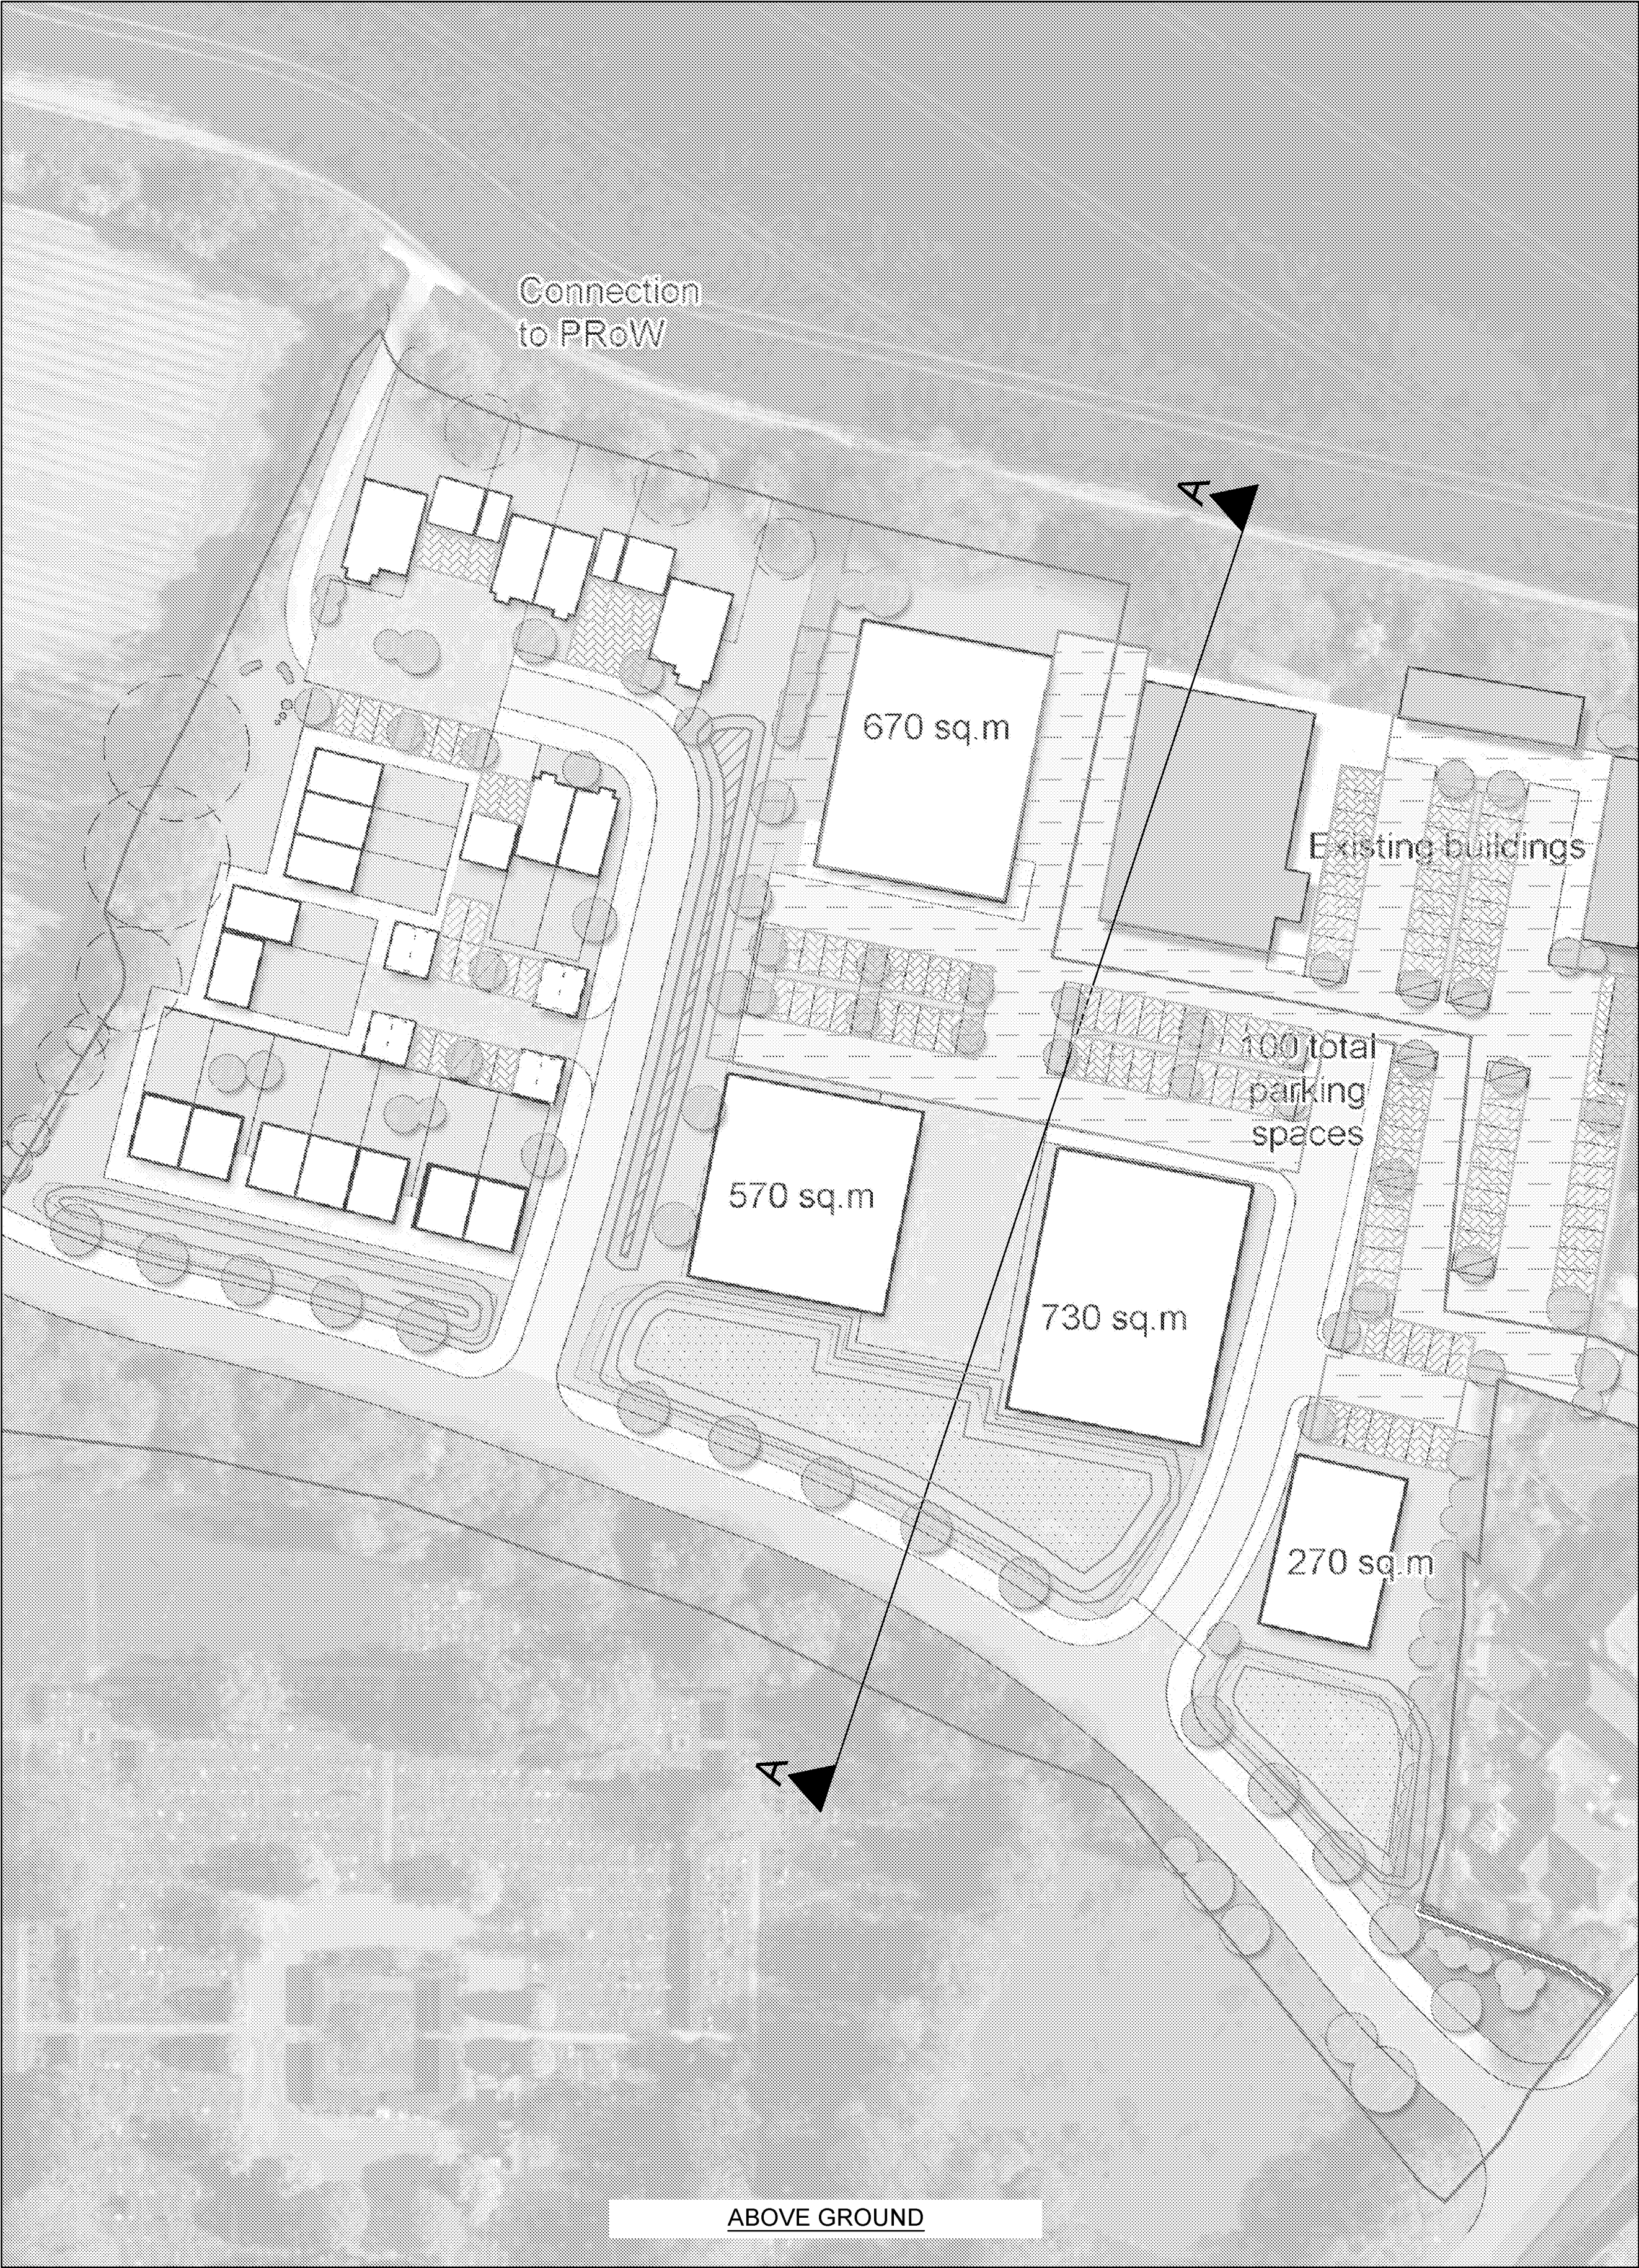
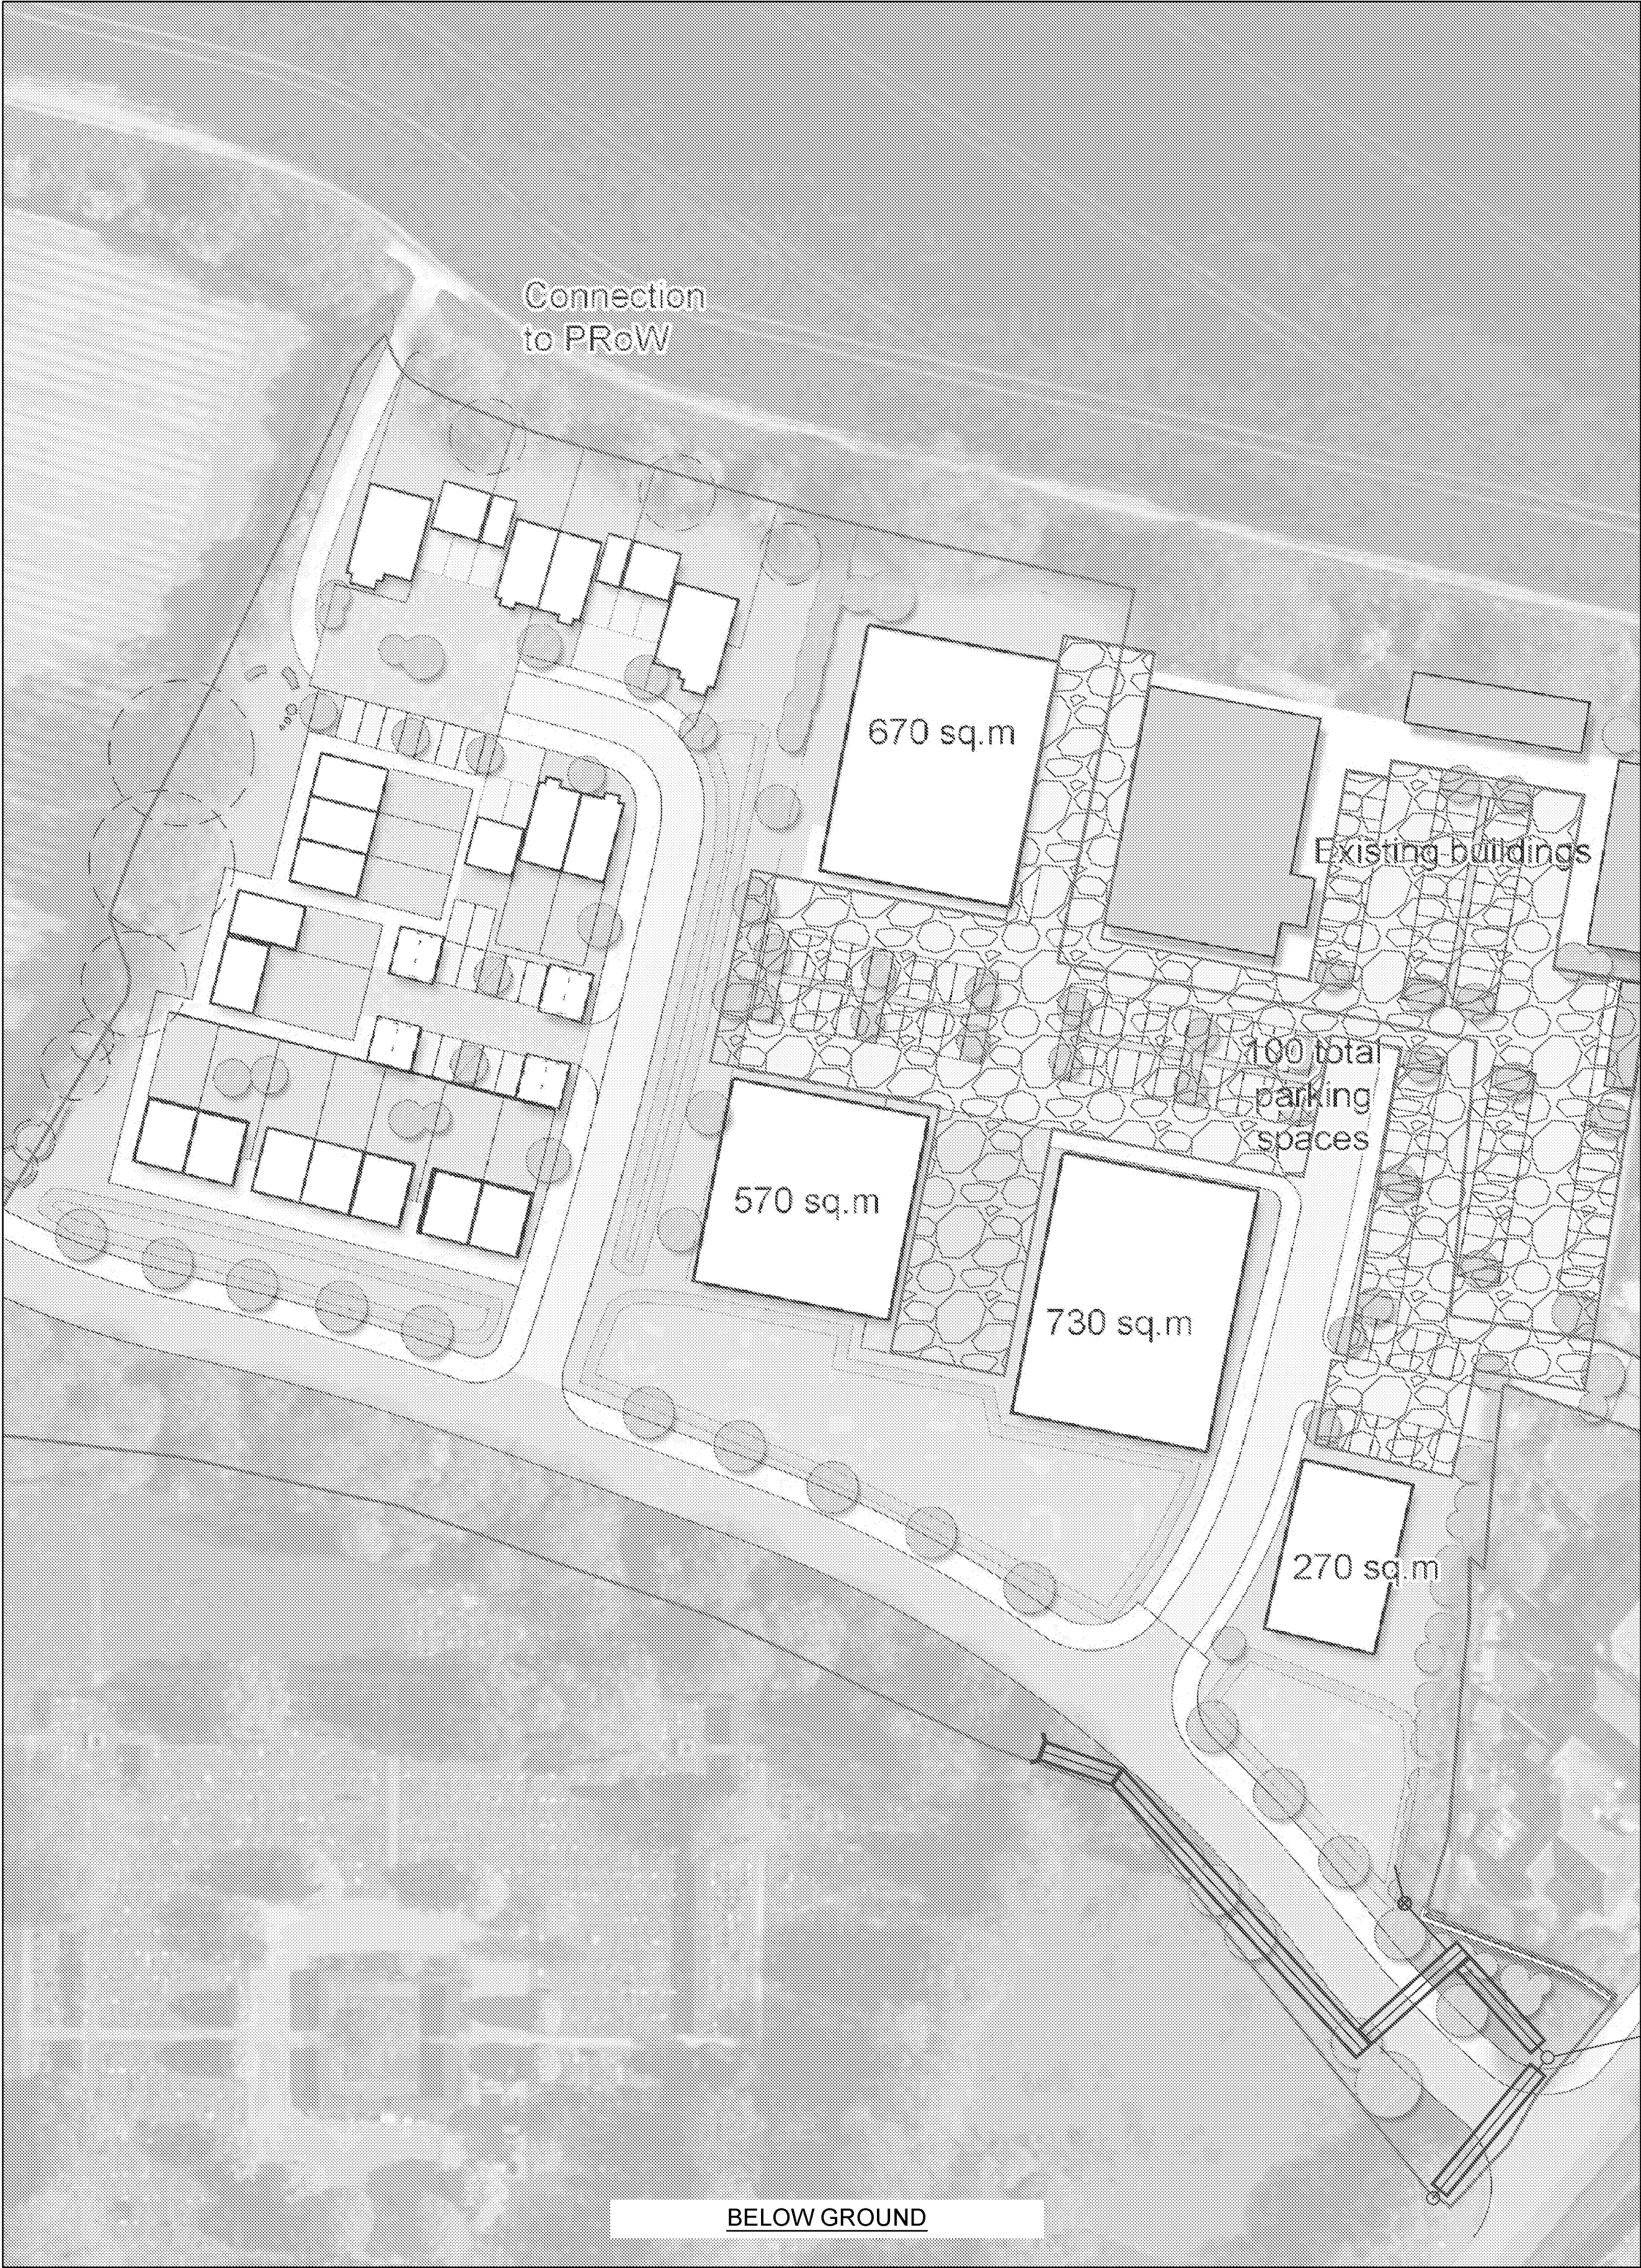
| U101 - PL - SK - 350 | | | | | | | - |

- 3.2 The primary surface water management scheme (refer to the plans and calculations in Appendix B) relies on two separate attenuation facilities each of which restricts the rates from the 1 in 100 annual probability storm plus 40 % climate change to the calculated annual greenfield rate (1.6 l/s/ha) for the area. The two residential units which will replace the current site access will manage their own runoff at source in private on-plot facilities which will be connected to the Southern Water surface water sewer network at rates to be agreed at a later stage.

- 3.3 The two facilities serving the main site comprise:
- A complex of three shallow basins, 500 to 700 mm deep with 1 in 3 side slopes which run along the northern boundary of the access road. The basins will be hydraulically linked by a \*drainage layer which will also serve to filter and treat runoff. The drainage layer will sit beneath engineered soils which will increase the treatment potential of the basins. The result will arguably be a hybrid facility, partway between a basin and a bioretention system. The facility will serve to drain the proposed access road, the western residential parcel, and an element of the commercial parcel. The facility will discharge via an orifice control chamber (protected by the drainage layer). The approximate impermeable catchment area for the facility is 0.65 ha (including a 5 % increase applied to the residential element for urban creep) and the allowable discharge rate is approximately 1.0 l/s.

- A 500 mm deep stone drainage blanket and floodable car park and hardstanding serving the remaining commercial parcel. Treatment will be provided by permeable car parking bays, SuDS planters, and the stone blanket itself. The outfall from the facility will be to the northern boundary ditch. The approximate impermeable catchment area served by the facility is 0.85 ha (with no creep applied given the proposed land used) and the allowable discharge rate is approximately 1.3 l/s.
