# Road Safety Audit Report

**Incorporating**  
**Stage 1 Completion of Preliminary Design;**  
Design Organisation Response to items raised.

## **Proposed Priority Access off Chalcraft Lane Bersted**

| Report Title: | Stage 1 Road Safety Audit |

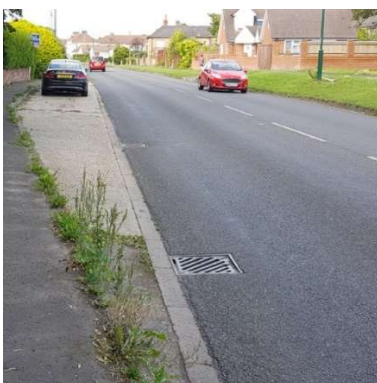
| <b>Summary:</b> | Existing road gully will be within the path of vehicles |
| <p>Chalcraft Lane benefits from a network of road gullies that provide for the drainage of surface water that accumulates on the carriageway. Following implementation of the proposed access, a pair of existing gullies will be situated within the path of a vehicle or cyclist approaching and entering the proposed access. A road gully within the path of a vehicle could give rise to loss of control type incidents especially for two wheeled vehicles and vehicles undertaking a braking manoeuvre.</p> | |

| It is recommended that the gullies are relocated and an adequate surface water drainage network is provided. | |
| Accepted – to be addressed as part of the S278 Detailed Design. | |

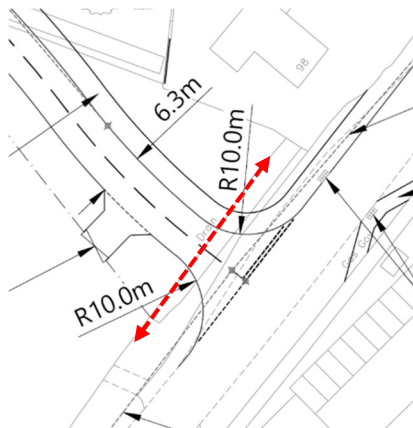
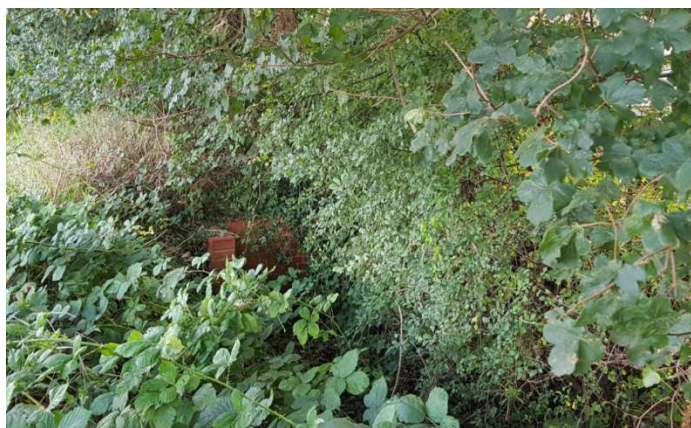
| <b>Summary:</b> | A ditch and number of outlets / headwalls are present within the area of the works |
| <p>A drainage ditch is present along the northern side of Chalcraft Lane that accommodates a number of headwalls and outlets from the network of road gullies that are situated along the channel line and allow surface water for the drainage of surface water. The proposals provide a priority junction</p> | |

that allows access to a 6.3-metre wide carriageway that accommodates a 3-metre wide shared footway / cycleway along the northern side, which will have an impact on the ditch and outlets that are present. Inadequate surface water drainage could result in ponding and loss of control incidents.

It is recommended that measures are provided to ensure that surface water drains adequately

Accepted – to be addressed as part of the S278 Detailed Design.

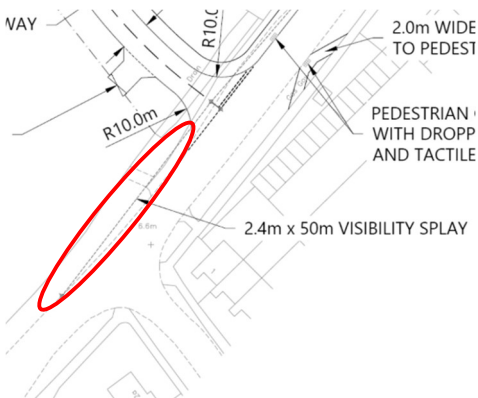
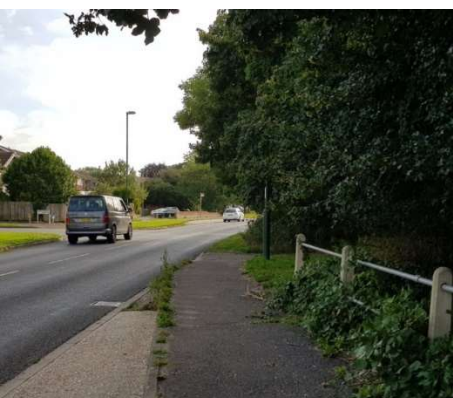
##### A.3.1 PROBLEM

**Summary:** Foliage within the verge to the south of the proposed access restricts visibility

Chalcraft Lane forms part of a primary route between North Bersted and Aldwick and is subject to a 30mph speed limit. The proposals include the provision of a simple priority access off the northern side of the carriageway from which the scheme drawing illustrates that 2.4 x 50 metre visibility splays are achievable in accordance with the 30mph speed limit of the road. However, the verge along the southern side of the proposed access is overgrown with foliage encroaching the carriageway in places. The tree canopies and vegetation will restrict visibility to and from a vehicle exiting the proposed simple priority access which could give rise to side impact or rear end collision when a vehicle proceeds when it is not safe to do so.

It is recommended that the appropriate visibility splays are maintained clear and free of obstructions.

| <p>Accepted – vegetation encroaching within the visibility splay to be cut back as part of the site access work. On-going maintenance of vegetation within the highway is a statutory responsibility of the local highway authority.</p> | |

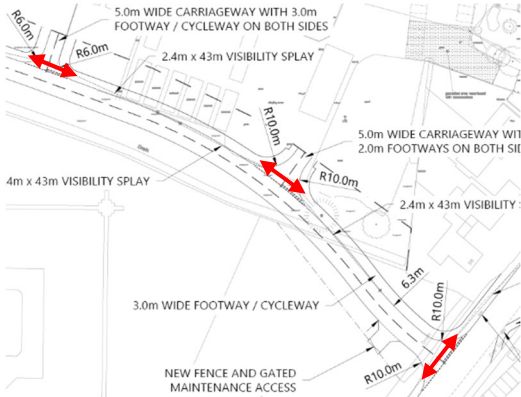
| <b>Summary:</b> | Full height kerbs will be an obstruction to pedestrians especially the mobility impaired |
| <p>Ffairfach Close provides access to the existing commercial development off Chalcraft Lane where pedestrians are required to walk in the carriageway. The proposals provide a spine road accessed off a simple priority junction with Chalcraft Lane and accommodates two priority accesses off the northern side that are to serve a commercial development and 20 dwellings. A shared footway / cycleway is provided along the northern side of the proposed carriageway that allows cyclists and pedestrians to join the existing footway along the northern side of Chalcraft Lane; however, the scheme drawings do not identify that dropped kerbs are to be provided where users are required to cross the proposed accesses. Whilst full height kerbs will become an obstruction to pedestrians particularly the mobility impaired or those walking with buggies and children on a scooter, the lack of a tactile warning could result in a visually impaired pedestrian entering the carriageway when it is not safe to do so which raises the risk of a vehicle-pedestrian collision.</p> | |

| <p>It is recommended that dropped kerbs with a maximum upstand of 6mm and tactile paving are provided where appropriate.</p> | |

| <p>Accepted – design amended to incorporate tactile paving and dropped kerbs (see drawing ITB14224-GA-001 Rev C).</p> | |

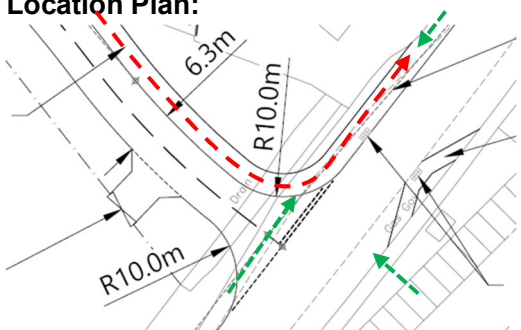
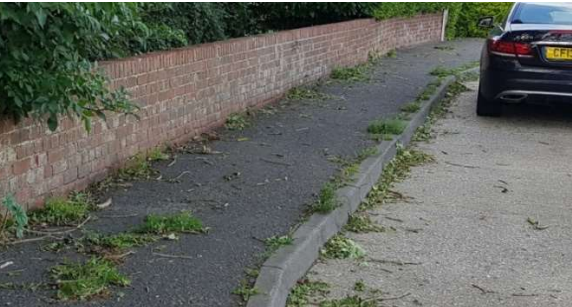
| <b>Summary:</b> | Visually impaired pedestrians could step into the path of a cyclist without warning |
| <p>Chalcraft Lane is subject to a 30mph speed limit and accommodates a footway along each side of the carriageway. The proposals provide a 3.0-metre shared footway cycleway along the northern side of the proposed access carriageway that wraps around the corner radius to meet the existing footway of Chalcraft Lane. The scheme drawings illustrate that the existing parking bay is to be stopped up and a dropped kerb crossing point with tactile paving provided to allow access to the footway on the eastern side of Chalcraft Lane; however, no measures are provided to highlight the transition between the existing footways and proposed shared facility where cyclists are likely to be observed. As such, pedestrians particularly the visually impaired, could step into the path of a cyclist or a cyclist could continue on the footway, raising the risk of a cyclist-pedestrian collision.</p> | |

| <p>It is recommended that sufficient warning is provided to highlight the change of use.</p> | |

Accepted – drawing has been amended to incorporate signing and corduroy paving to denote change of use.

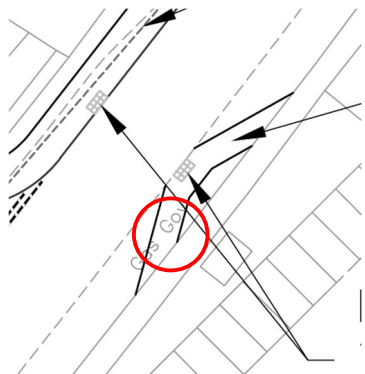
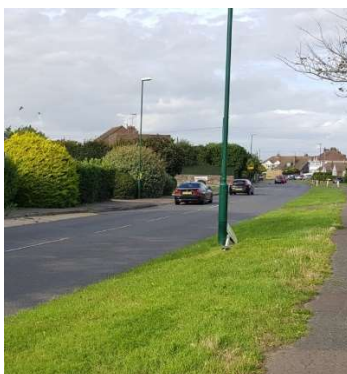
**A.4.3 PROBLEM**

**Summary:** Existing street lighting column will become an obstruction to pedestrians

Chalcraft Lane benefits from street lighting with a number of street lighting columns located within the existing verge to the east of the carriageway. The proposals provide a 2.0-metre footway link from the existing footway to a proposed uncontrolled crossing point on Chalcraft Lane. The Audit Team observed that an existing streetlight column may be situated at this location which will be located within the proposed footway and be an obstruction to pedestrians. Such an obstruction could be struck by a pedestrian or force one to enter the carriageway suddenly raising the risk of vehicle collisions with pedestrians as well as trips and falls.

It is recommended that the street lighting column is relocated out of the footway

Accepted – crossing point has been relocated as to avoid conflict with lighting column (see drawing ITB14224-001 Rev C).

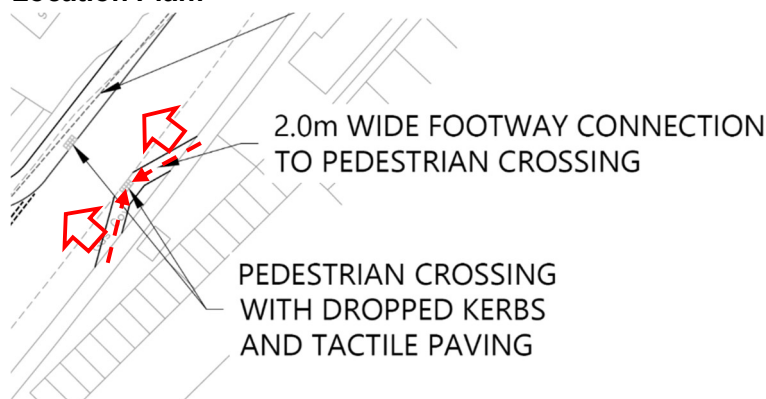
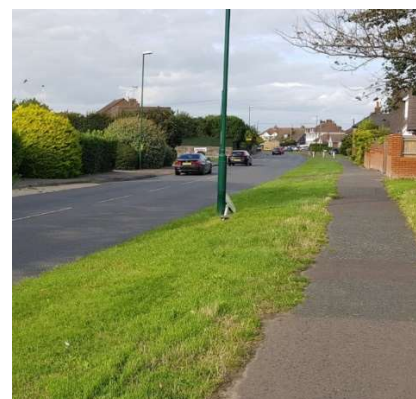
#### A.4.5 PROBLEM

**Summary:** The verge to the east of the carriageway forms an embankment

Chalcraft Lane is subject to a 30mph speed limit and accommodates a footway along each side of the carriageway with the footway to the east beyond a verge and set at a higher level. The scheme drawings identify that an uncontrolled crossing point is to be provided to the north of the access. Due to the gradient of the verge on the eastern side of Chalcraft Lane, the proposals

provide an angled 2.0-metre footway link from the existing footway to the crossing point; however, scheme drawings do not detail the effect of the likely crossfall towards the carriageway. As such, a user of a wheeled device such as a child on a scooter or wheelchair user, approaching the crossing point may not become aware of the crossfall combined with the steep incline towards the carriageway and could inadvertently lose control and continue into the path of an oncoming vehicle.

It is recommended that the crossing point is set at a maximum gradient of 1 in 12 down to the carriageway.

Accepted – to be addressed as part of the S278 Detailed Design.

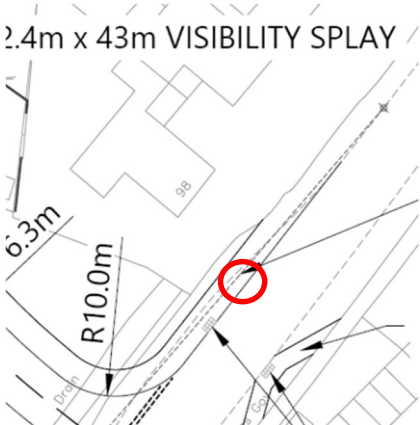
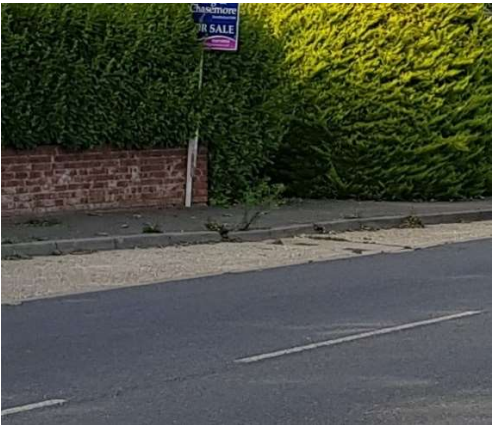
**Summary:** Services covers will be an obstruction

Chalcraft Lane accommodates a number of utility covers within the existing footway, verge, and carriageway. The proposals include the provision of a priority access off the western side of Chalcraft Lane that accommodates a 3.0-metre footway cycleway along the northern radius which ties into the local pedestrian network. The scheme stops up an existing parking bay situated along the western side of the Chalcraft Lane carriageway where a number of the utility covers are present and will be located within the footway following the works. Raised or sunken utility covers along a pedestrian desire line, will be an obstruction and trip hazard.

It is recommended that service covers are adjusted or relocated accordingly.

| <p>Accepted – to be addressed as part of the S278 Detailed Design.</p> | |
