# Barnham Eastergate & Westergate (BEW)

Parcel SC1  
Phase 1 Land Contamination  
Desk Study

### Phase 1 Land Contamination Desk Study Preliminary Risk Assessment

Report Ref: A13394-PF-C-ZZ-XX-RPT-0002

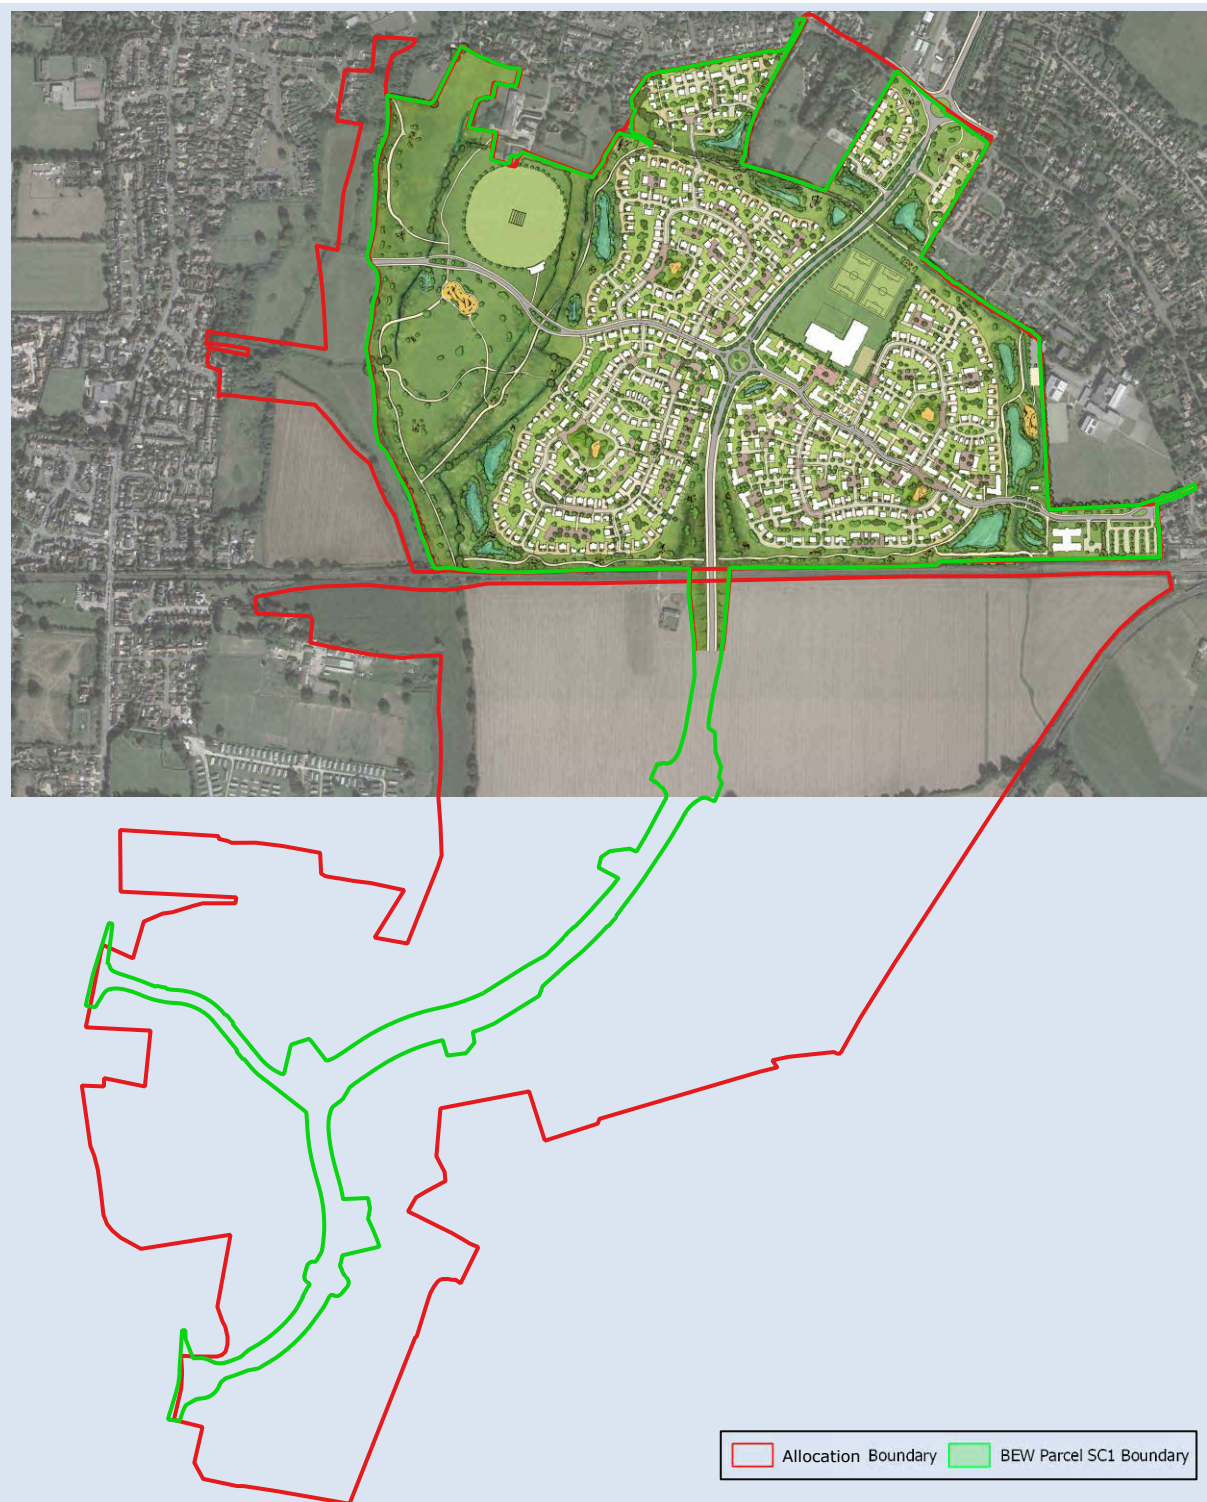
Figure 1: Proposed Development

Extracts of the proposed development plans are included as **Figure 1**.

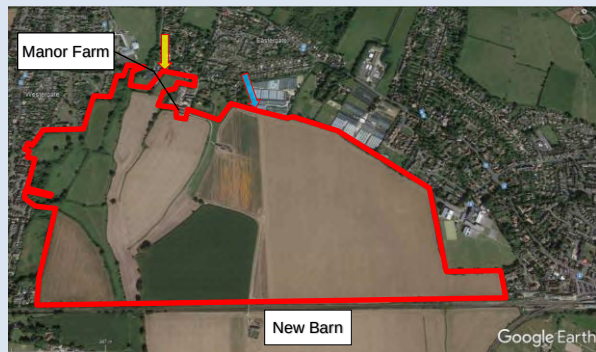
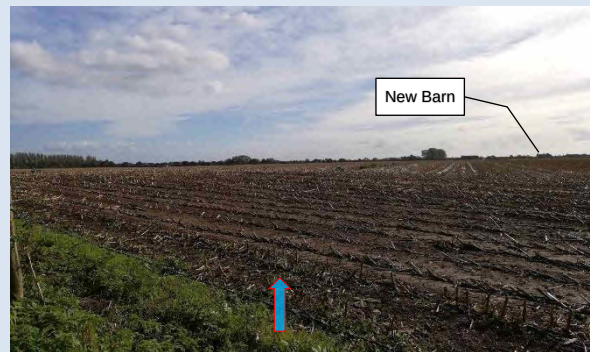
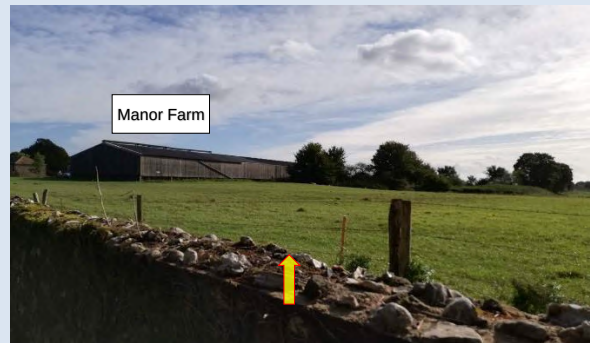
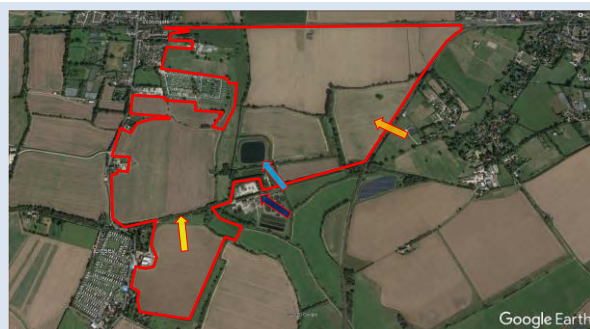
**Figure 3: Walkover Survey Photographs**

### North of railway – View to south.

Imagery indicates the site to mostly comprise agricultural land and which is surrounded by limited wooded areas and rough vegetation.

Although not captured due to restricted access in these pictures, the Lidsey rife is known to flow along a vegetated channel within a private housing area behind Eastergate Primary School.

No significant potential sources or signs of contamination were identified.

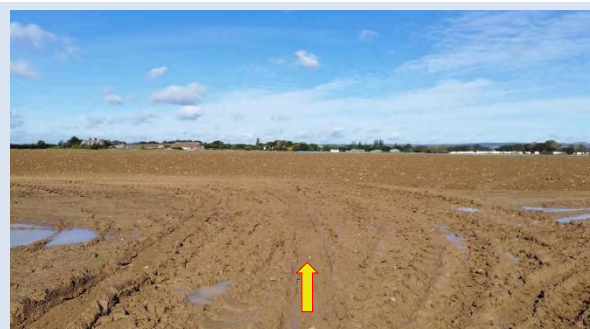
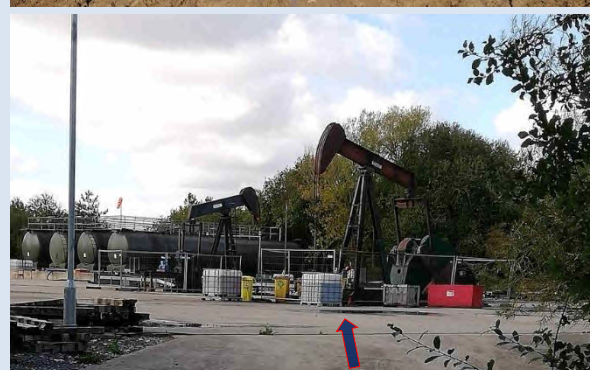
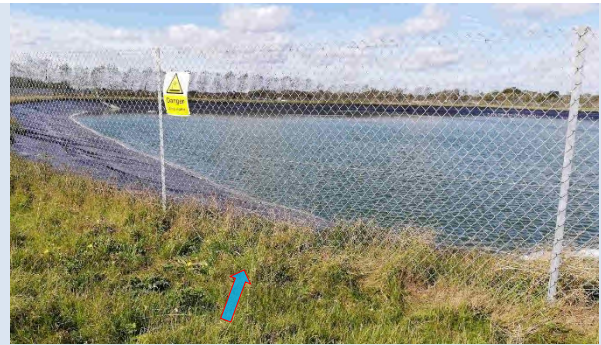
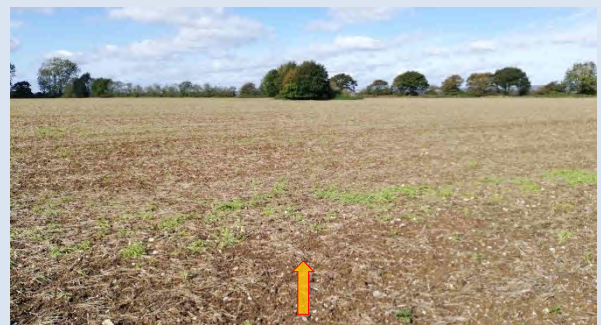
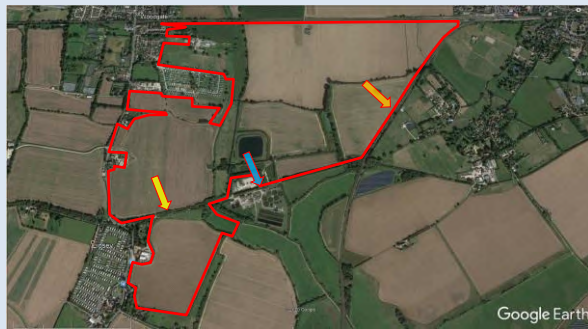
**Figure 3: Walkover Survey Photographs**

### South of the Railway – View to north and north west

The imagery relates to the area bound by Lidsey Road to the west, by the railway line to the north, the Bognor Regis Branch line to the east and by a footpath and Lidsey Oil Field to the south. The site area is clearly dominated by agricultural land with the exception of a surface water feature located approximately in the centre of the site.

The image shown by the yellow arrow shows bare agricultural land adjacent to the lower land area of the disused Arundel Canal. It is possible to identify Willows Caravan Park and adjacent housing to the north. No significant potential sources or signs of contamination were identified.

The dark blue arrow is image of the Lidsey Oil Field site. From external view the site was visually noted as clean and tidy with no obvious signs of oil spillages, however the site walkover did

not include access to the oil site. No significant signs of contamination were identified.

The light blue arrow points at the recent surface water reservoir feature constructed on-site to the north of the Lidsey Oil field. The purpose of the reservoir is not known however due to its elevation above the surrounding land it must receive recharge through pumping or solely from precipitation. No significant potential sources or signs of contamination have been identified.

The orange arrow direction points to another agricultural field adjacent to the east of the reservoir. More substantial vegetation including trees are present along the western and eastern peripheries. No significant potential sources or signs of contamination were identified.

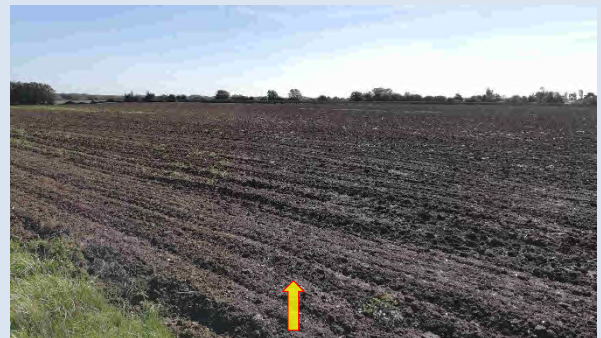
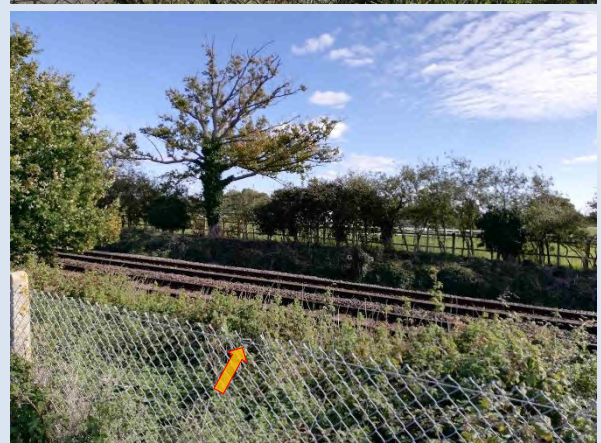
**South of the Railway – View to South and south west**

The imagery relates to the same area as described above with views to the south.

The Bognor Branch Railway line is identified by the arrow orange. No sidings or other evidences of potential contamination sources were identified.
