Land South of Barnham Station

## **Arboricultural Method Statement**

November 2020  
10716\_AMS.001

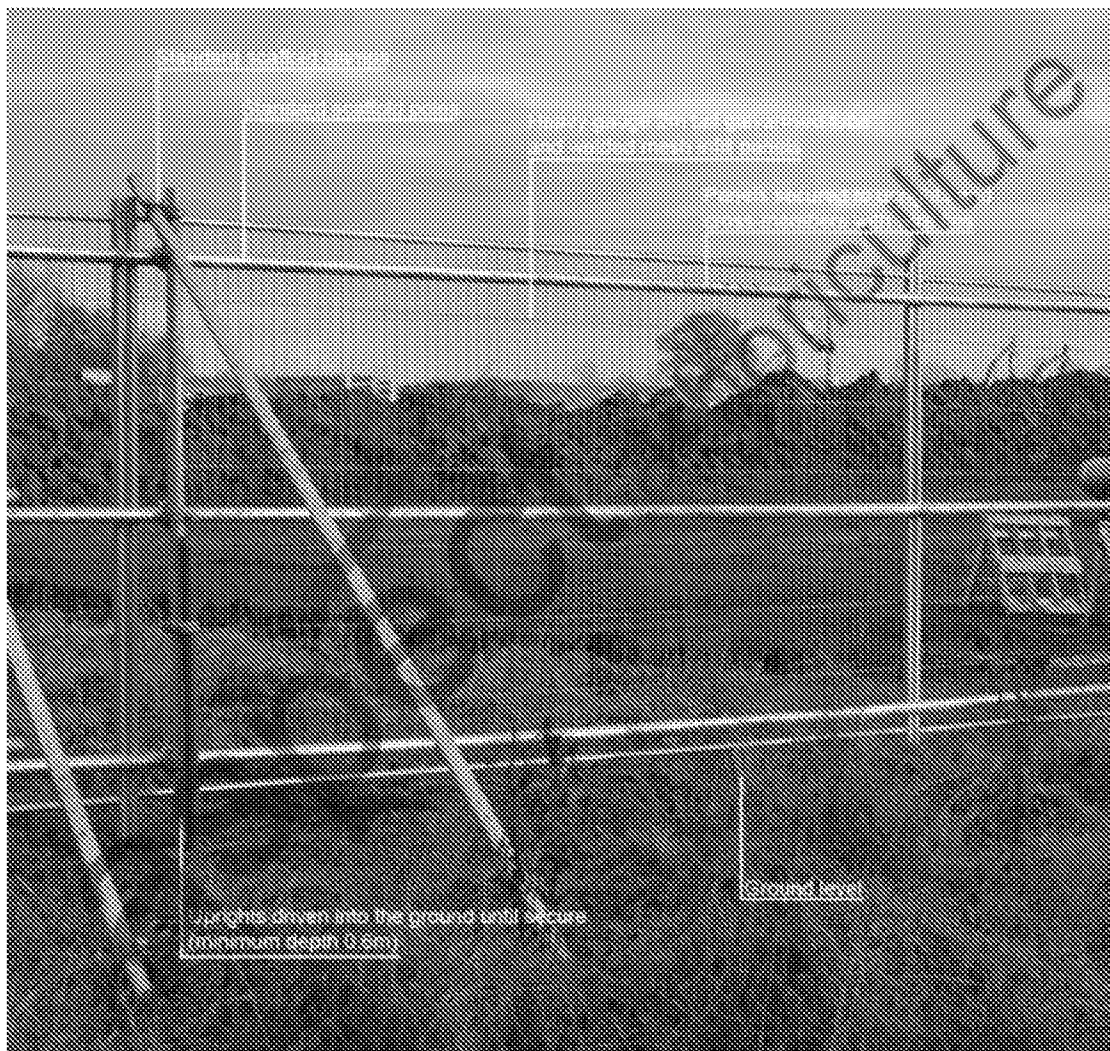
#### 2.4.2 Figure 1. Protective Barrier Specification

2.4.1 Tree protection barriers are required to safeguard retained trees from damage during construction works. Protective barriers should be installed before construction works commence and consist of the default BS5837:2012 barrier specification (refer to Figure 1

below). The location for protective barriers has been informed by retained trees' canopy extents and root protection areas (RPA). The location for protective barriers is illustrated with a solid dark blue line within the Tree Protection Plan (appendix A).

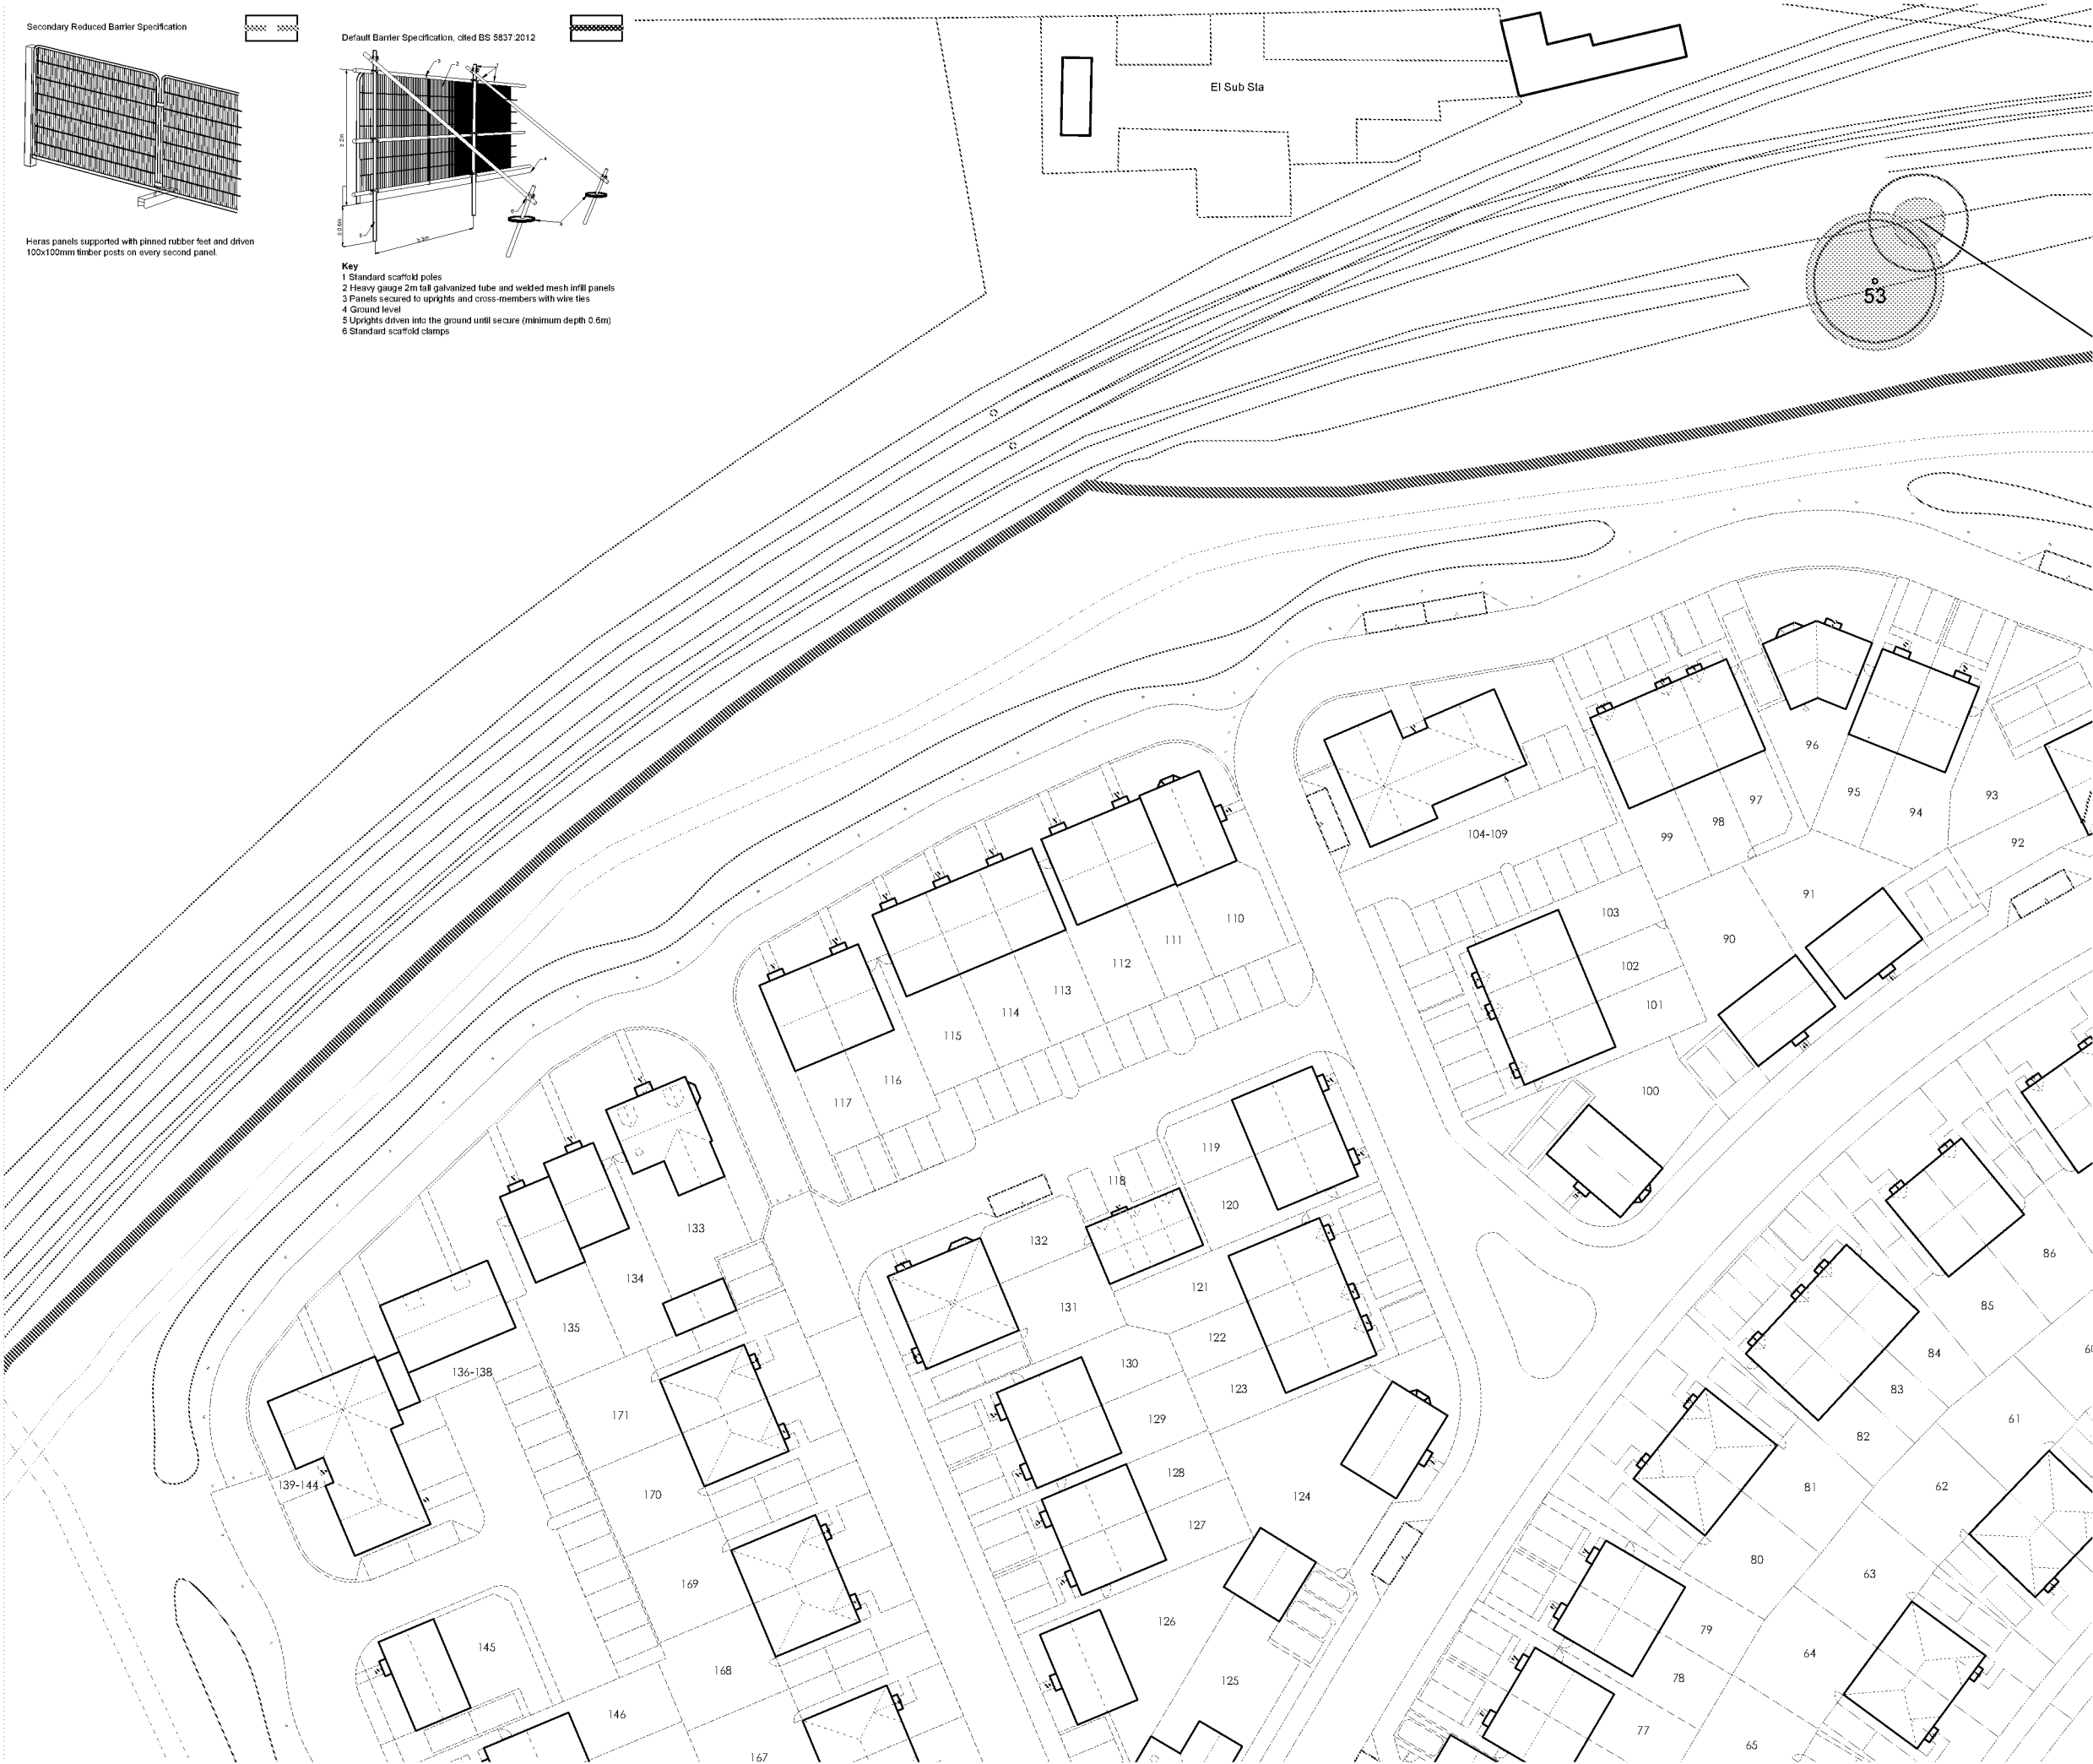
TREE PROTECTION PLAN - 10716 TPP 01 Rev A

Note: Trees 1-11, 15, 22, 23, 28-29 and 50-53. Groups 1-11, 13, 14, 16, and 21-22; and Hedgerows 1-4, 5 and 10 have been plotted using measurements onsite in conjunction with aerial imagery. Their locations were not recorded on the topographical survey of the site. Groups 18-20 and Hedgerows 7, 9 and 11 were partly recorded on the survey and have been plotted using this along with measurements onsite and aerial imagery (drawing ref: SOR017713-2d.dwg).

Note: The RPA footprint for Trees 5, 8-11, 13, 14, 16-18, 20, 21, 23, 25, 29-35, 39, 41-46 and 48-52 and Groups 9, 12, 17 and 21 have been displaced to allow for the effect of the adopted highway, existing building foundations and existing watercourse. The surface area of the RPA has not been reduced with the exception of Tree 49, due to its location.

2.1.1 The Tree Protection Plan (TPP) provided in appendix A will be relied upon during the construction of the development. It must be read in conjunction with the entirety of this document.

2.1.2 To prevent avoidable damage occurring to retained trees or erroneous tree loss, a scaled A1 copy of the TPP, accompanied by a copy of this document will be provided to the Site Manager. This will ensure they are able to:

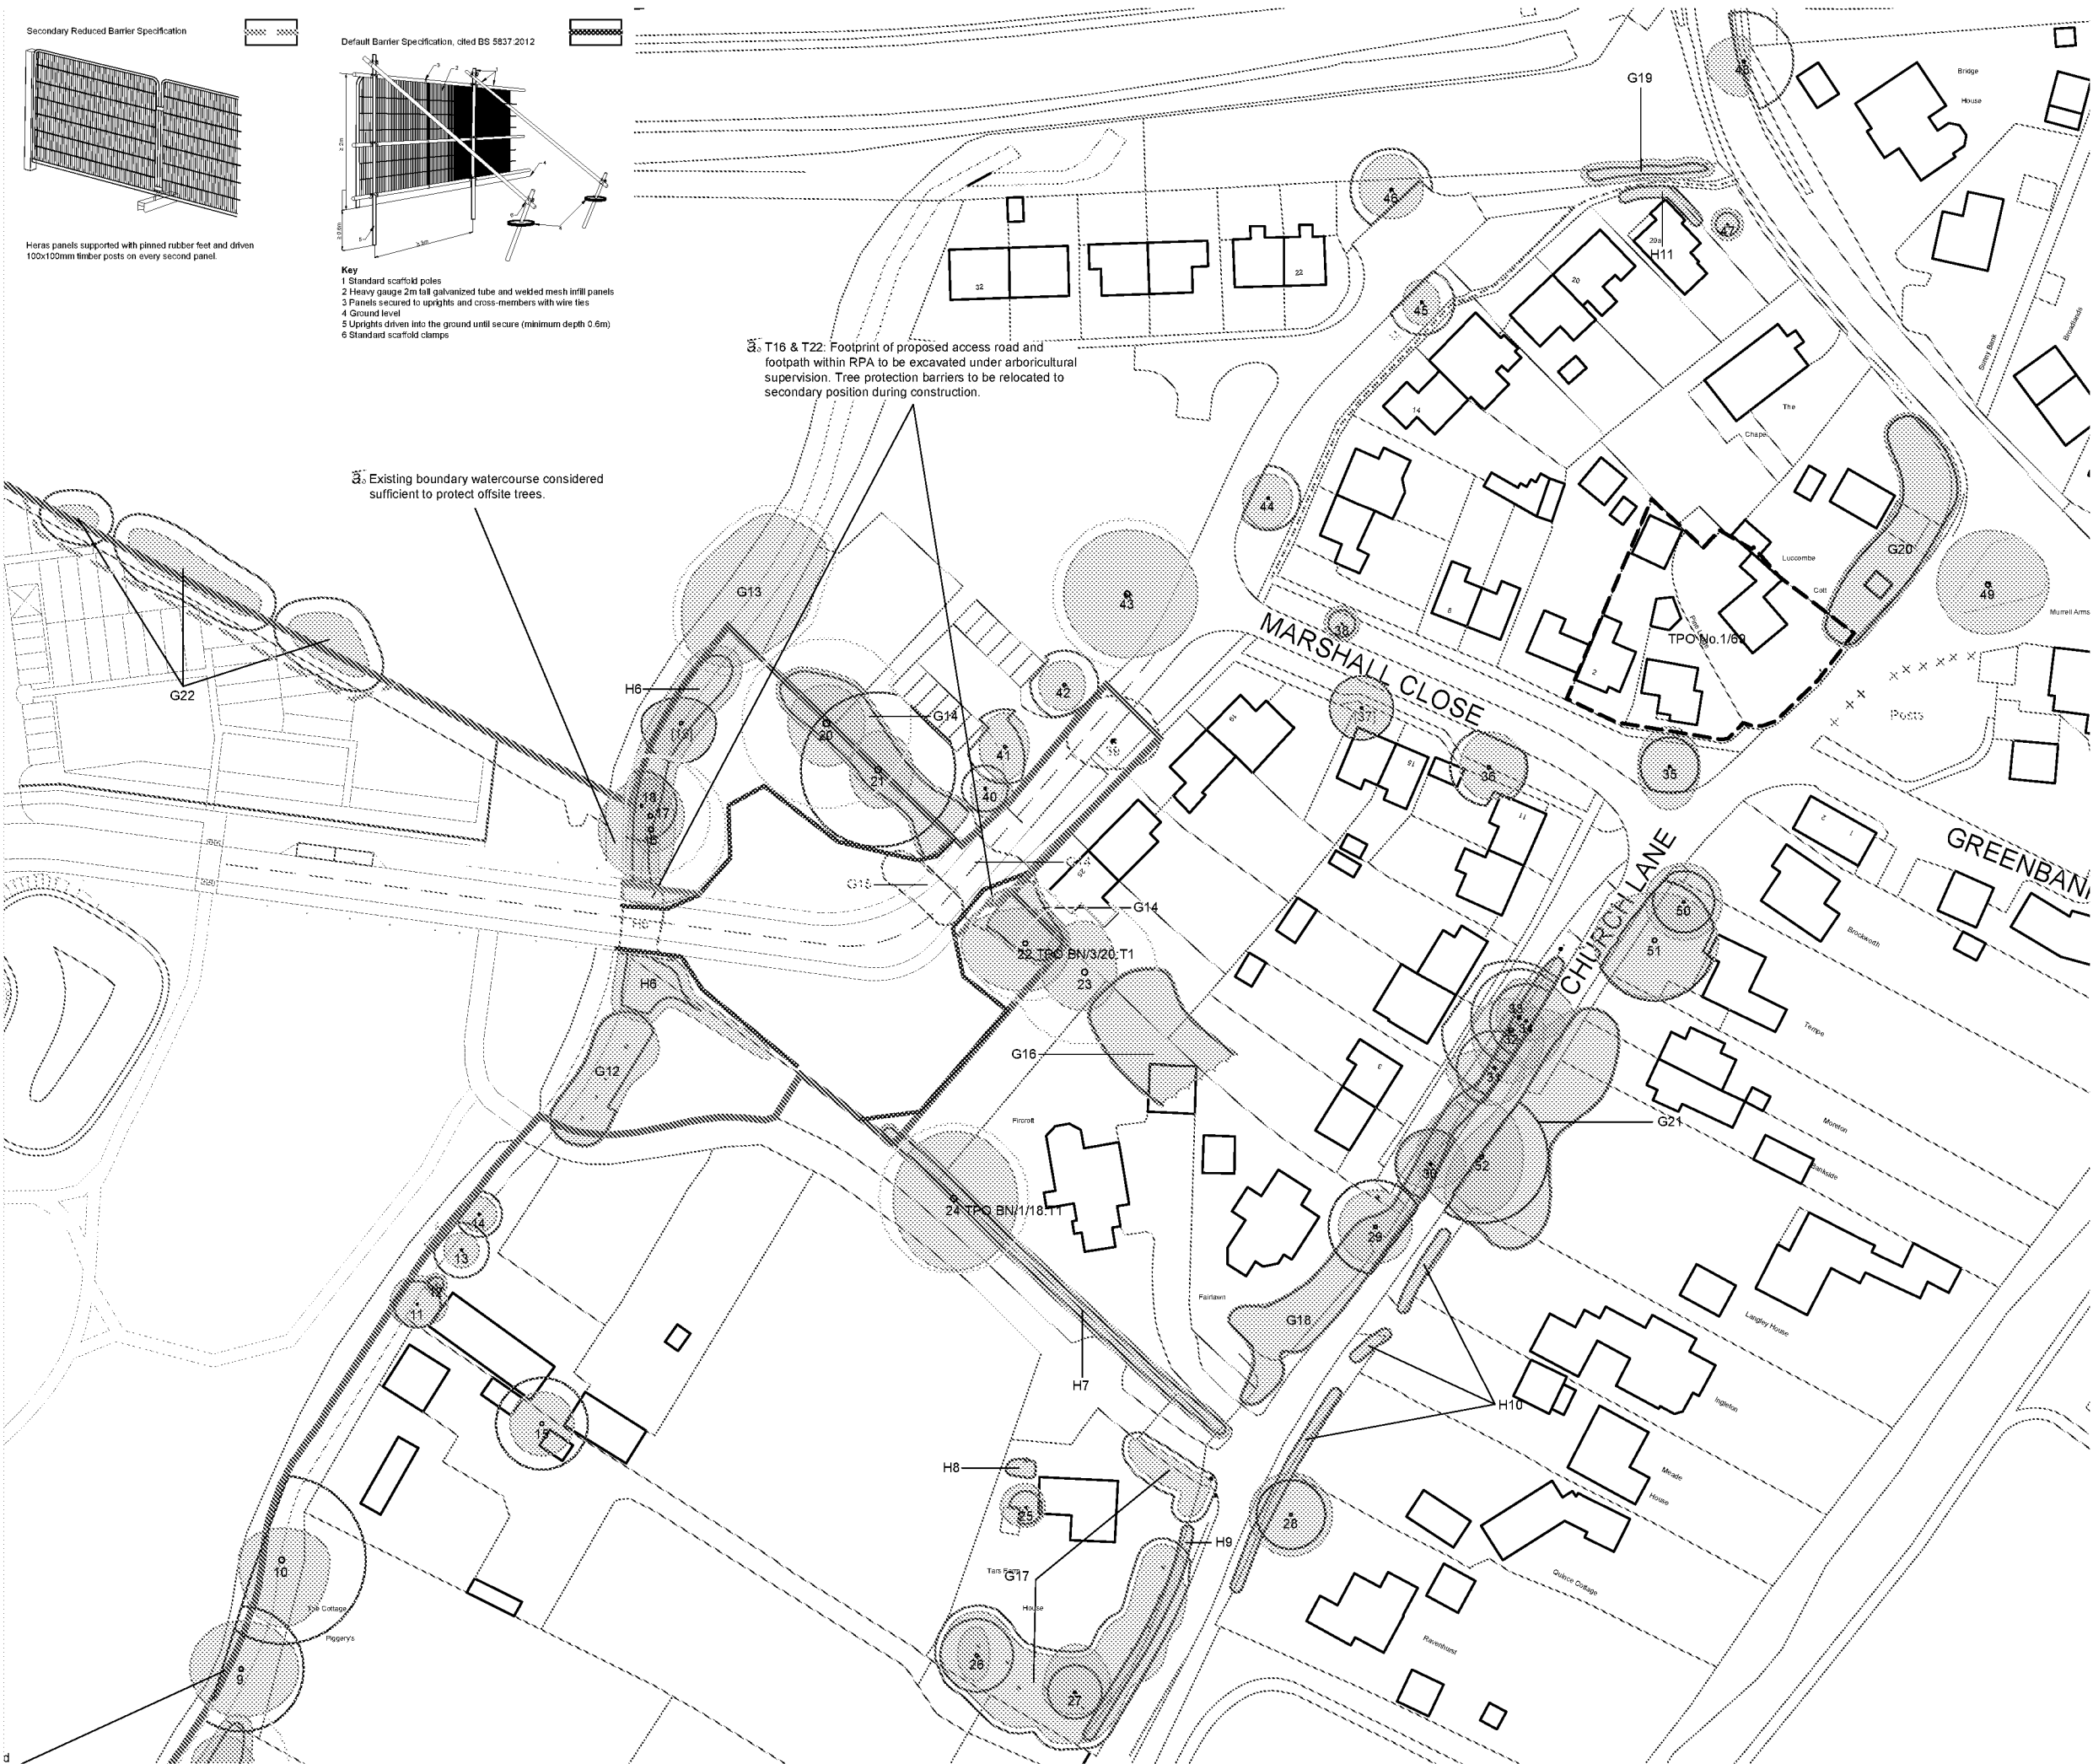
Note: Trees 1-11, 15, 22, 23, 28-29 and 50-53. Groups 1-11, 13, 14, 16, and 21-22: and Hedgerows 1-4, 5 and 10 have been plotted using measurements onsite in conjunction with aerial imagery. Their locations were not recorded on the topographical survey of the site. Groups 18-20 and Hedgerows 7, 9 and 11 were partly recorded on the survey and have been plotted using this along with measurements onsite and aerial imagery (drawing ref: SOR017713-2d.dwg).

Note: The RPA footprint for Trees 5, 8-11, 13, 14, 16-18, 20, 21, 23, 25, 29-35, 39, 41-46 and 48-52 and Groups 9, 12, 17 and 21 have been displaced to allow for the effect of the adopted highway, existing building foundations and existing watercourse. The surface area of the RPA has not been reduced with the exception of Tree 49, due to its location.

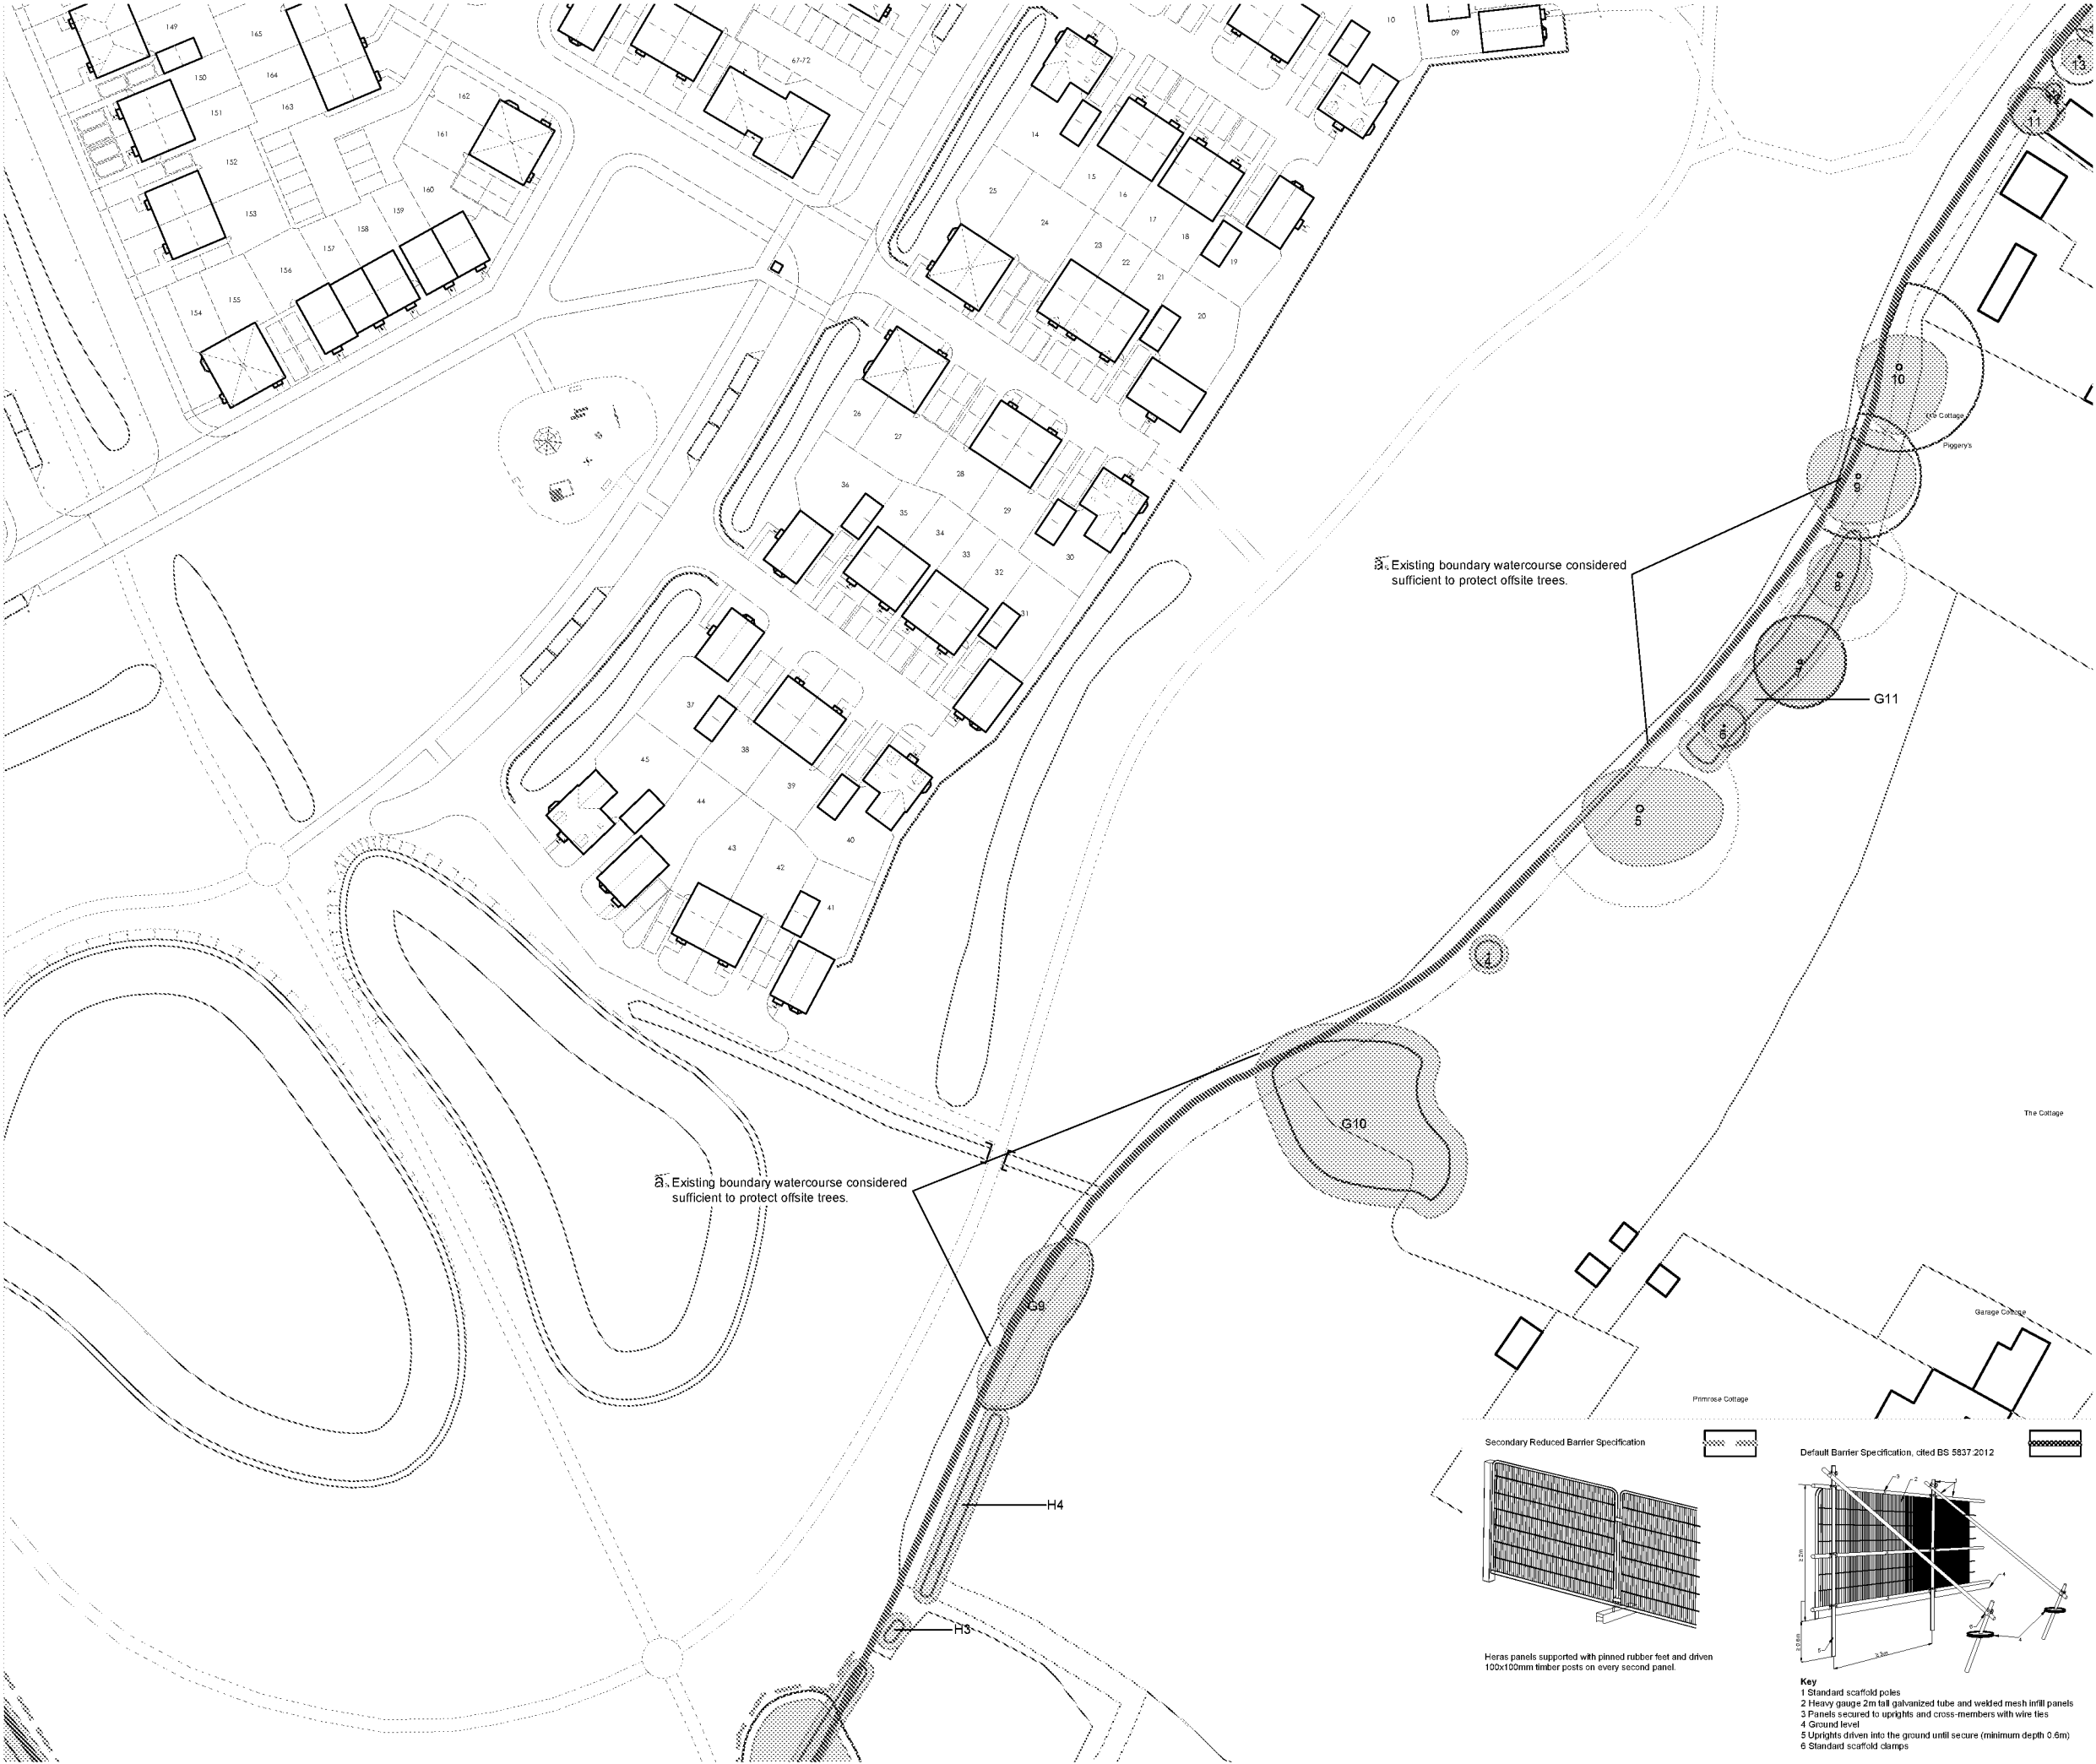
Existing boundary watercourse considered sufficient to protect offsite trees.

Note: Trees 1-11, 15, 22, 23, 28-29 and 50-53. Groups 1-11, 13, 14, 16, and 21-22; and Hedgerows 1-4, 5 and 10 have been plotted using measurements onsite in conjunction with aerial imagery. Their locations were not recorded on the topographical survey of the site. Groups 18-20 and Hedgerows 7, 9 and 11 were partly recorded on the survey and have been plotted using this along with measurements onsite and aerial imagery (drawing ref: SOR017713-2d.dwg).

Note: The RPA footprint for Trees 5, 8-11, 13, 14, 16-18, 20, 21, 23, 25, 29-35, 39, 41-46 and 48-52 and Groups 9, 12, 17 and 21 have been displaced to allow for the effect of the adopted highway, existing building foundations and existing watercourse. The surface area of the RPA has not been reduced with the exception of Tree 49, due to its location.
