**Extended Phase 1 Ecological & Bat Roost Assessment**

**84 Barnham Road, Barnham, Bognor Regis, PO22 0ES**

**Omnia ref: C10687/PEA/1.2**

**July 2022**

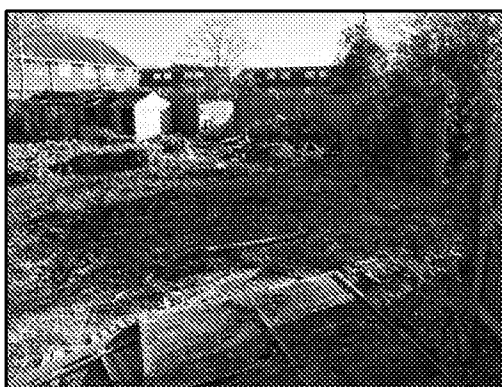
**Figure 2** – recently created bare ground at the southern end of the site

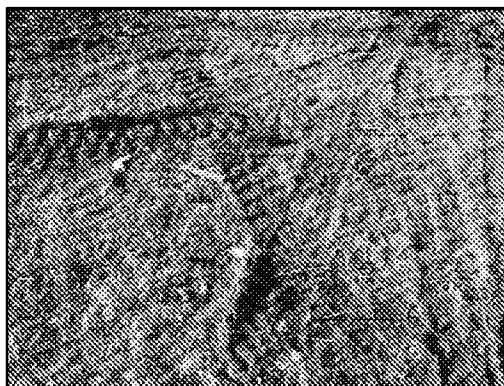
Figure 4 – recently disturbed grassland in the front garden

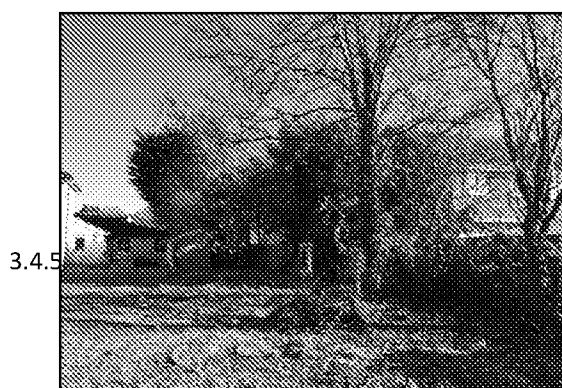
Figure 5 – tree line and fence along the eastern boundary

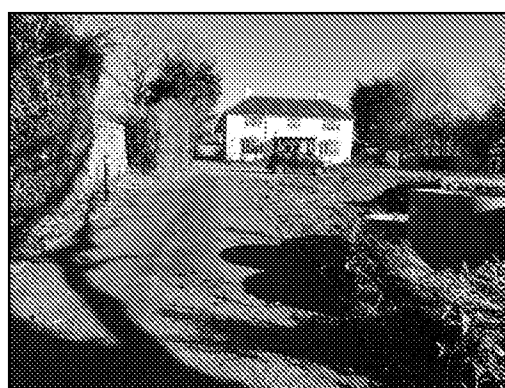
A defunct hedgerow runs along the more southerly section of the north-western fence line (Figure 6). The species present include bay, holly, cherry laurel, Japanese photinia *Photinia glabra*, garden privet *Ligustrum ovafolium*, elder, hazel *Corylus avellana* box honeysuckle *Lonicera nitida* and ivy. The understorey includes ivy, lords-and-ladies, stinking iris *Iris foetidissima* and *Heliohorus*.

Figure 6 – defunct hedgerow and fence along the western boundary

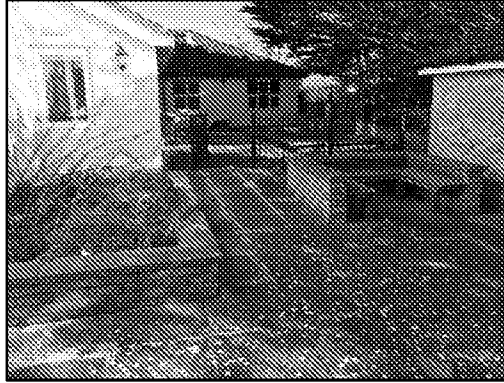
Access to the site is via a long tarmac driveway which widens into a paved parking area towards the house (see Figure 6, above). Paved patio also surrounds the house (Figure 7). A small area of wooden decking is present on the patio to the east of the house.

**Figure 7** – paved patio between the house and garage

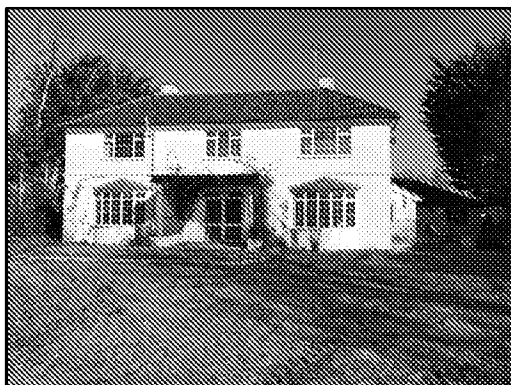
**Figure 8** – south-western elevation of the main section of the house

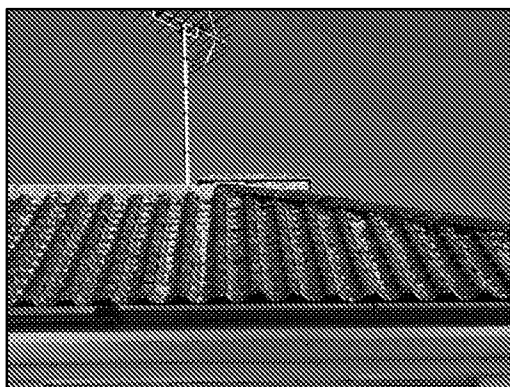
| | <b>Suitability</b> | <b>Evidence</b> |
|---|---|---|
| <b>Exterior</b> | <p>The following suitable access/egress and roosting features were recorded externally during the survey:</p> <ul style="list-style-type: none"> <li>- Lifted roof tiles, on both sections of the house.</li> <li>- Gaps under hip tiles (Figure 11).</li> <li>- Gaps under the last course of roof tiles on the main section of the house.</li> <li>- Lifted tiles and lead flashing around the westernmost metal chimney.</li> <li>- Gap under the base of the slatted tower (Figure 12).</li> </ul> | <p>No evidence of roosting activity was recorded on the external elevations of the building during the survey.</p> <p>On closer inspection, the gaps under the lifted roof tiles on the single-storey section of the house were found to be filled with moss, cobwebbing and/or debris.</p> <p>The proximity of the guttering prohibits a suitable access/egress flight path to/from the gaps under the last course of roof tiles.</p> |

**Figure 11** – gaps under hip tiles

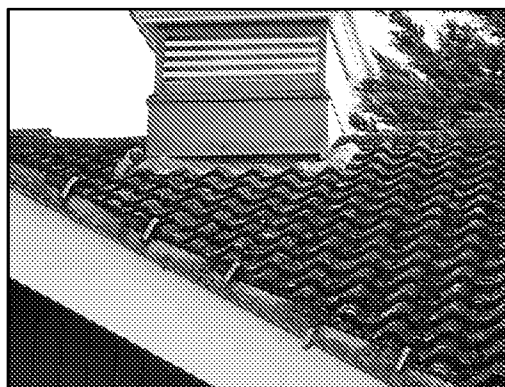
**Figure 12** – gap under the base of the stalled tower

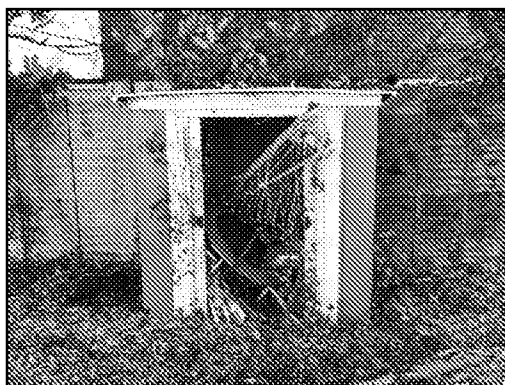
The metal store comprises a simple single-skinned metal structure which is open on one elevation (Figure 16). Due to the design of the structure, the store is considered wholly unsuitable for supporting roosting bats.

**Figure 16** – metal store against the south-eastern elevation

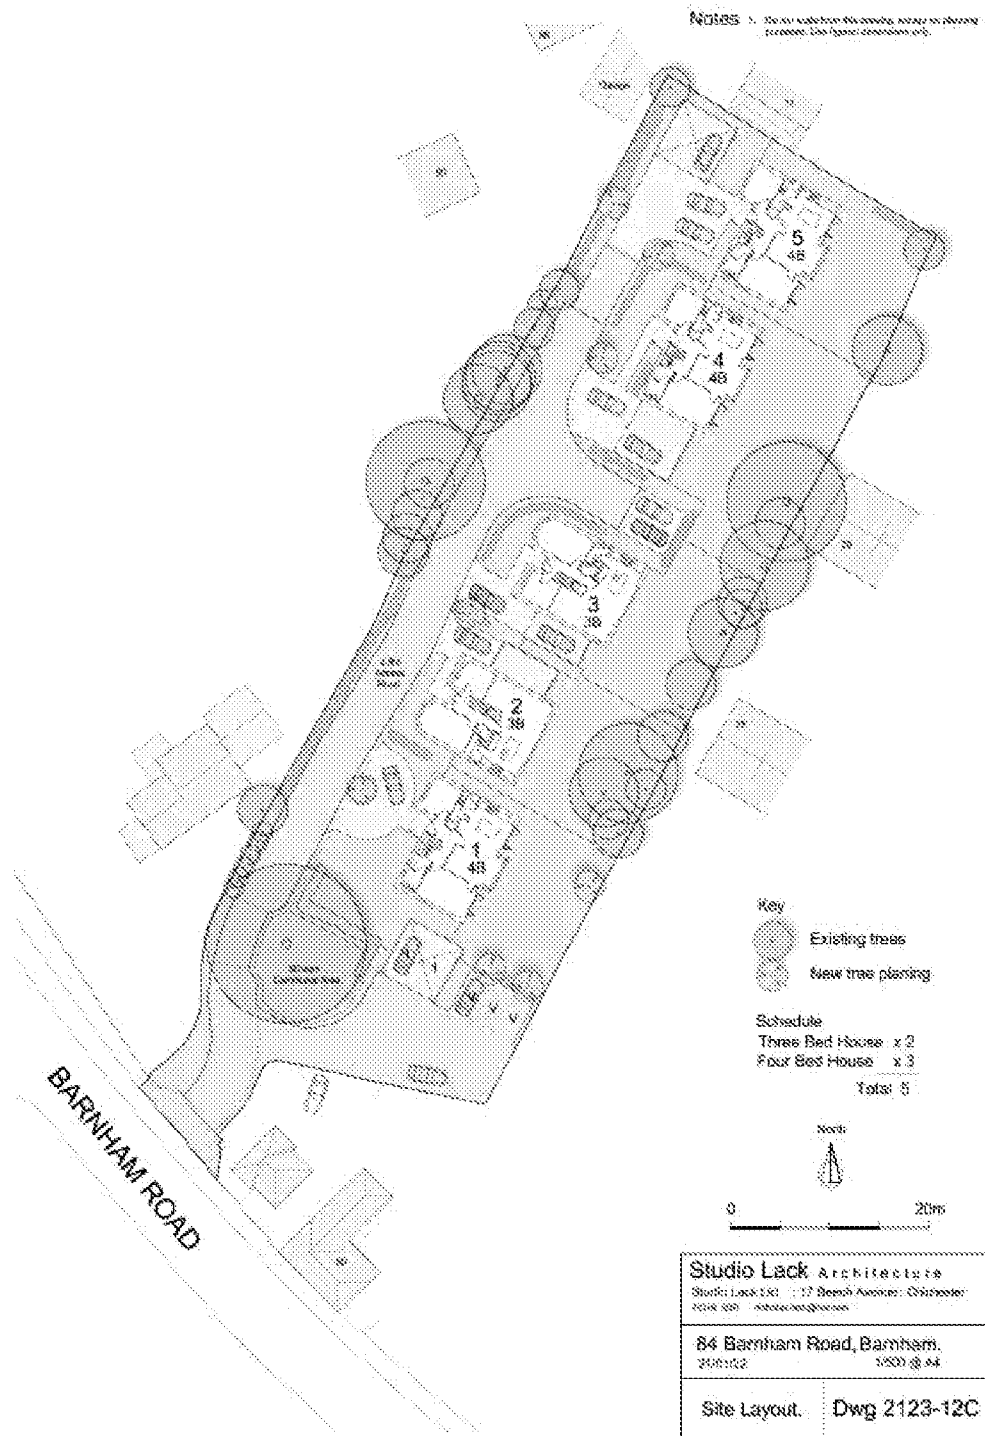
## Appendix 1 – Proposed Site Plan

The current proposals comprise the demolition of the existing structures and the construction of ten replacement dwellings with associated landscaping. The existing access to the site will remain.
