# **Drainage Impact Assessment**

## **Proposed Residential Housing Development**

**37 Hill Lane  
Barnham, Bognor Regis  
West Sussex  
PO22 0BL**

Project: FC2781  
Date: Oct 2018  
Author: MH  
Status: Planning Issue  
Revision: A

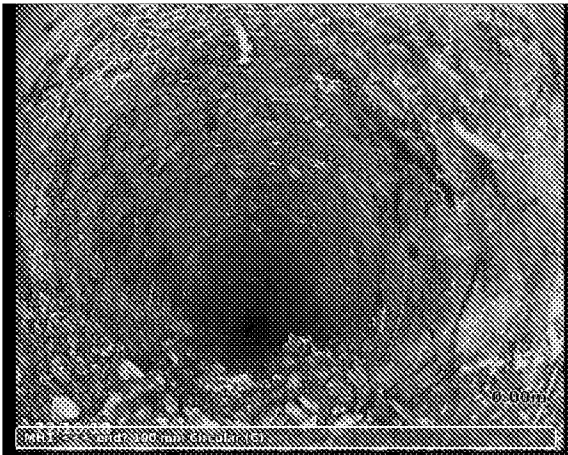
20181022-084759-snap0000.jpg, 00:00:01, 0.00 m  
Start node type, manhole, reference number: MH1 12oc

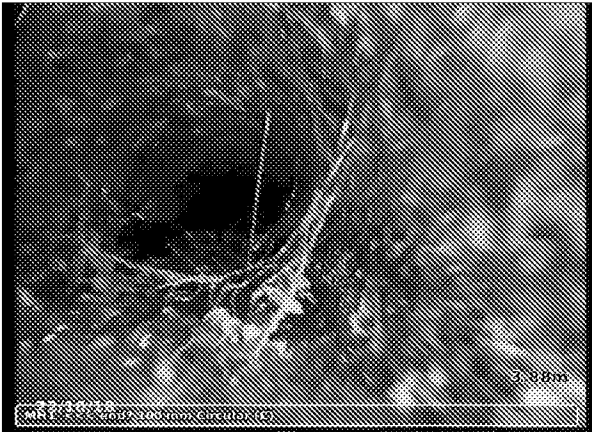
X\_186b6554-4b67-40cc-a5d0-0c324681b8c7\_20181025\_200526\_755.jpg, 00:00:30, 3.88 m  
Settled deposits, fine, 10% cross-sectional area loss

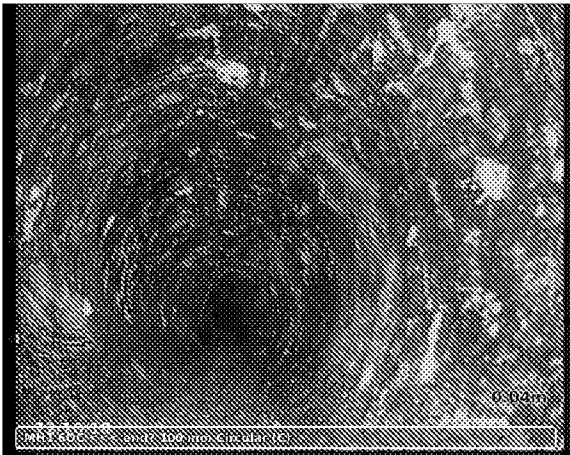
20181022-085911-snap0000.jpg, 00:00:04, 0.04 m  
Start node type, manhole, reference number: MH1 6OC

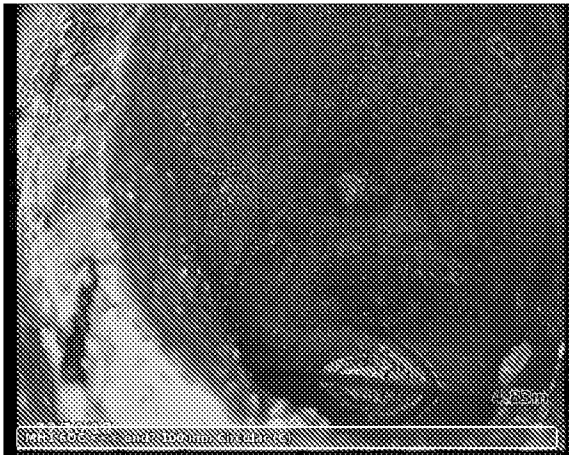
20181022-085911-snap0001.jpg, 00:00:40, 4.83 m  
Finish node type, gully, reference number: Gully

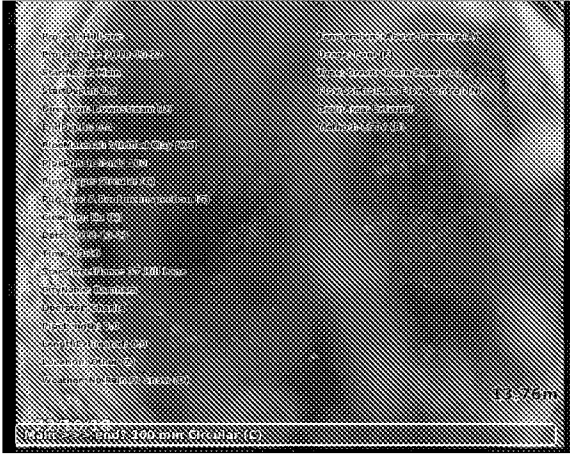
20181022-091042-snap0000.jpg, 00:00:01, 13.76 m  
Start node type, manhole, reference number: Main

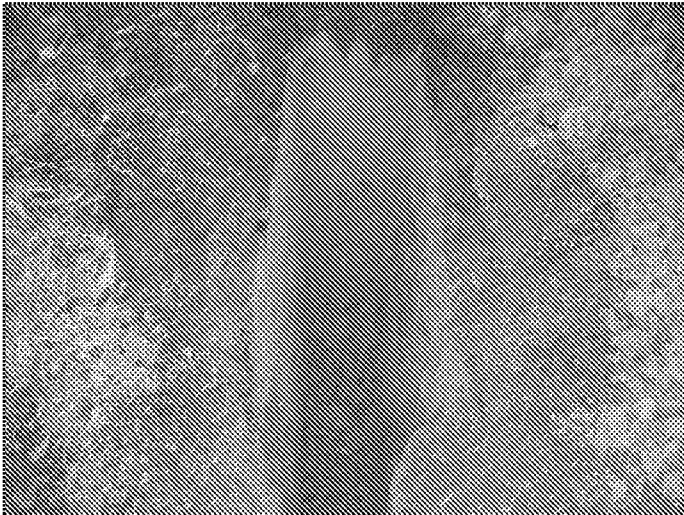
- 1) TP1
- 2) TP1
- 3) TP2

Testing was conducted in both pits (TP1 and TP2) in locations as per the site plan attached and was carried out in general accordance with BRE 365 methods; following the mechanical excavation, squaring of the pit sides, the trial pit was filled rapidly with potable water and the subsequent fall in water level monitored over time. The aim of the test is to reach the 25% fill depth marker to determine an infiltration rate for the soil.
