**Re: Tars Farm, Barnham – Attenuation Pond Investigations**

RSK Environment Limited (RSK) was commissioned by BDW Homes to provide an outline specification for the construction of the 2 attenuation ponds and a swale at the above site, based upon additional site investigation information and laboratory testing.

The following aspects are covered in this document relating to the construction of the two attenuations ponds/swale upon the site:

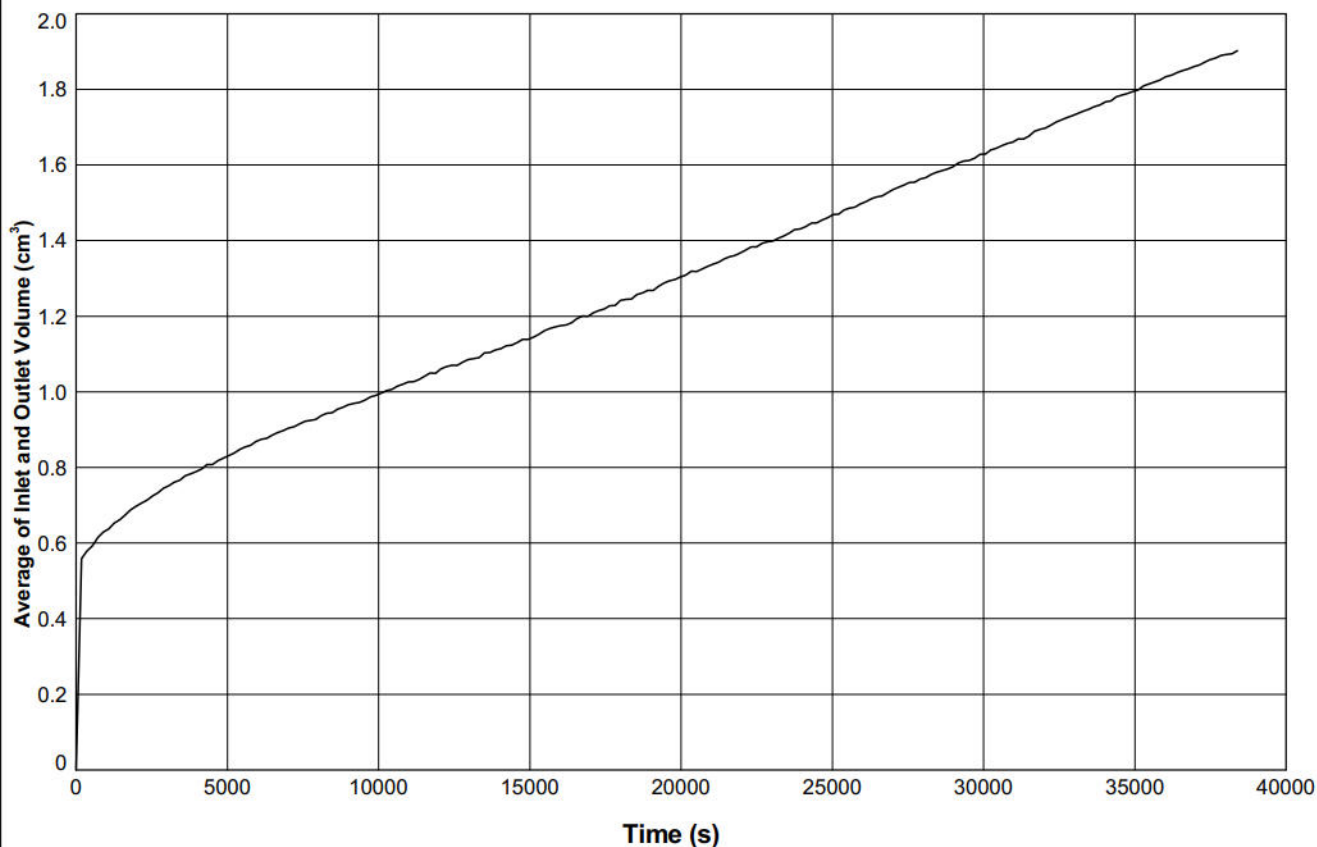
| PERMEABILITY | | |
|---|---|---|
| Coefficient of Permeability at 20°C | m/s | $8.03 \times 10^{-11}$ |

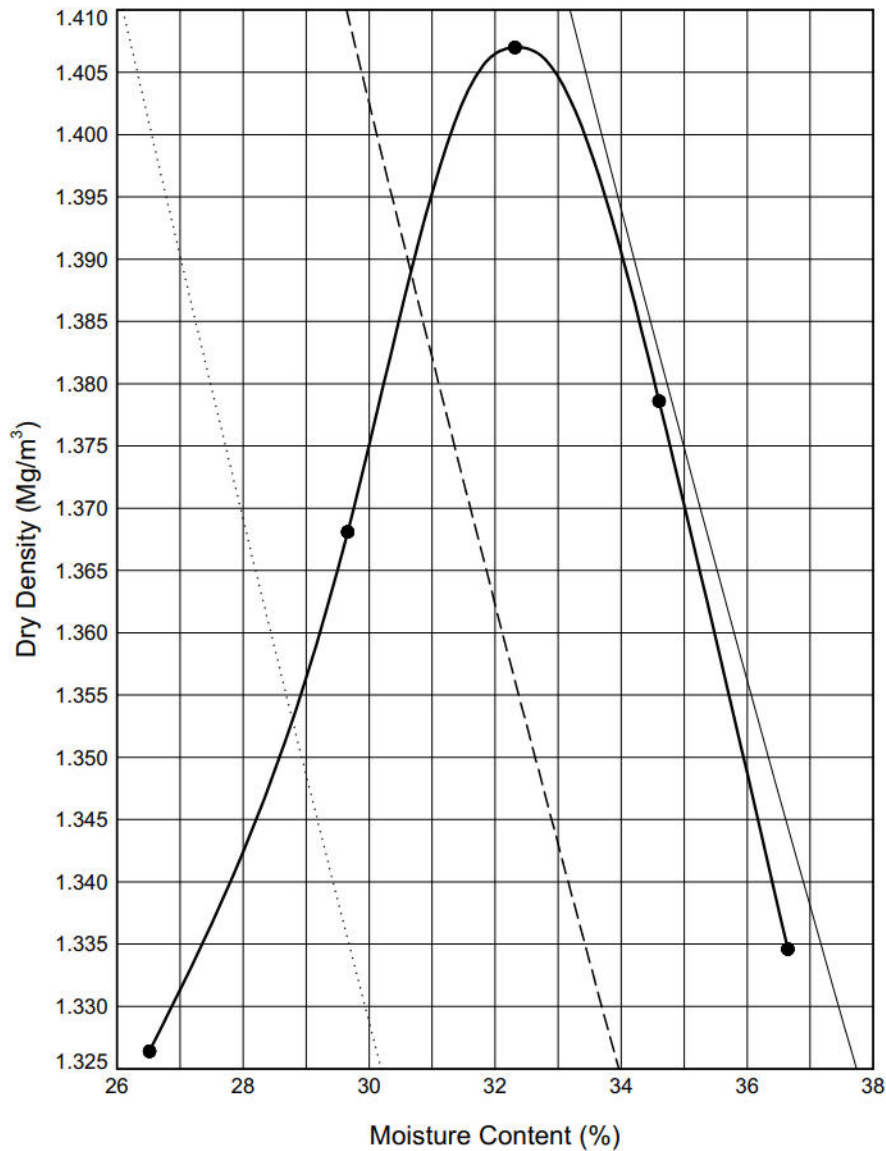
# DRY DENSITY / MOISTURE CONTENT RELATIONSHIP TEST

| Initial Sample Conditions | | Test Details | | Test Results | |
|---|---|---|---|---|---|
| Initial Moisture Content (%) | : 32 | Compaction Type | : Light | Maximum Dry Density (Mg/m³) | : 1.41 |
| % Retained on 37.5mm BS Sieve | : 0 | Mass of Rammer (kg): | 2.5 | Optimum Moisture Content (%) | : 32 |

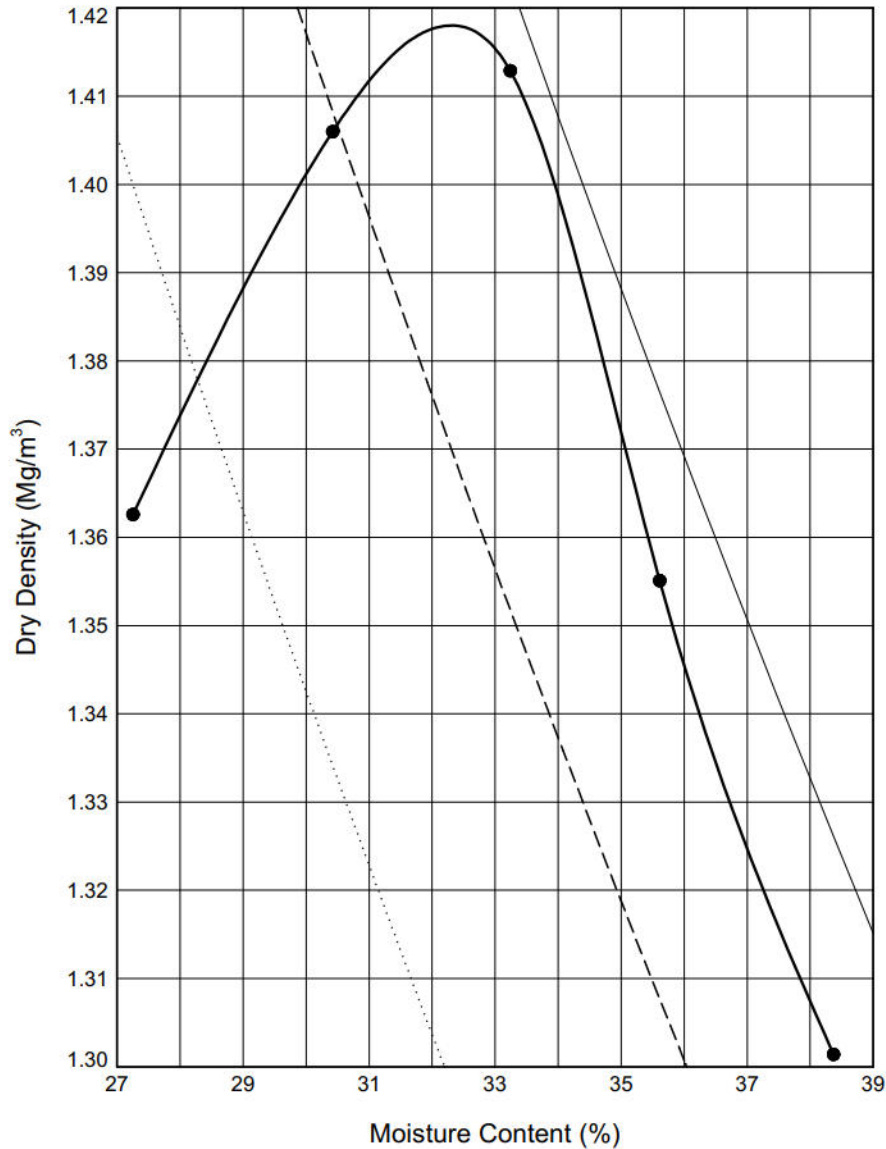
# DRY DENSITY / MOISTURE CONTENT RELATIONSHIP TEST

| Initial Sample Conditions | | Test Details | | Test Results | |
|---|---|---|---|---|---|
| Initial Moisture Content (%) | : 33 | Compaction Type | : Light | Maximum Dry Density (Mg/m³) | : 1.42 |
| % Retained on 37.5mm BS Sieve | : 0 | Mass of Rammer (kg): | 2.5 | Optimum Moisture Content (%) | : 32 |

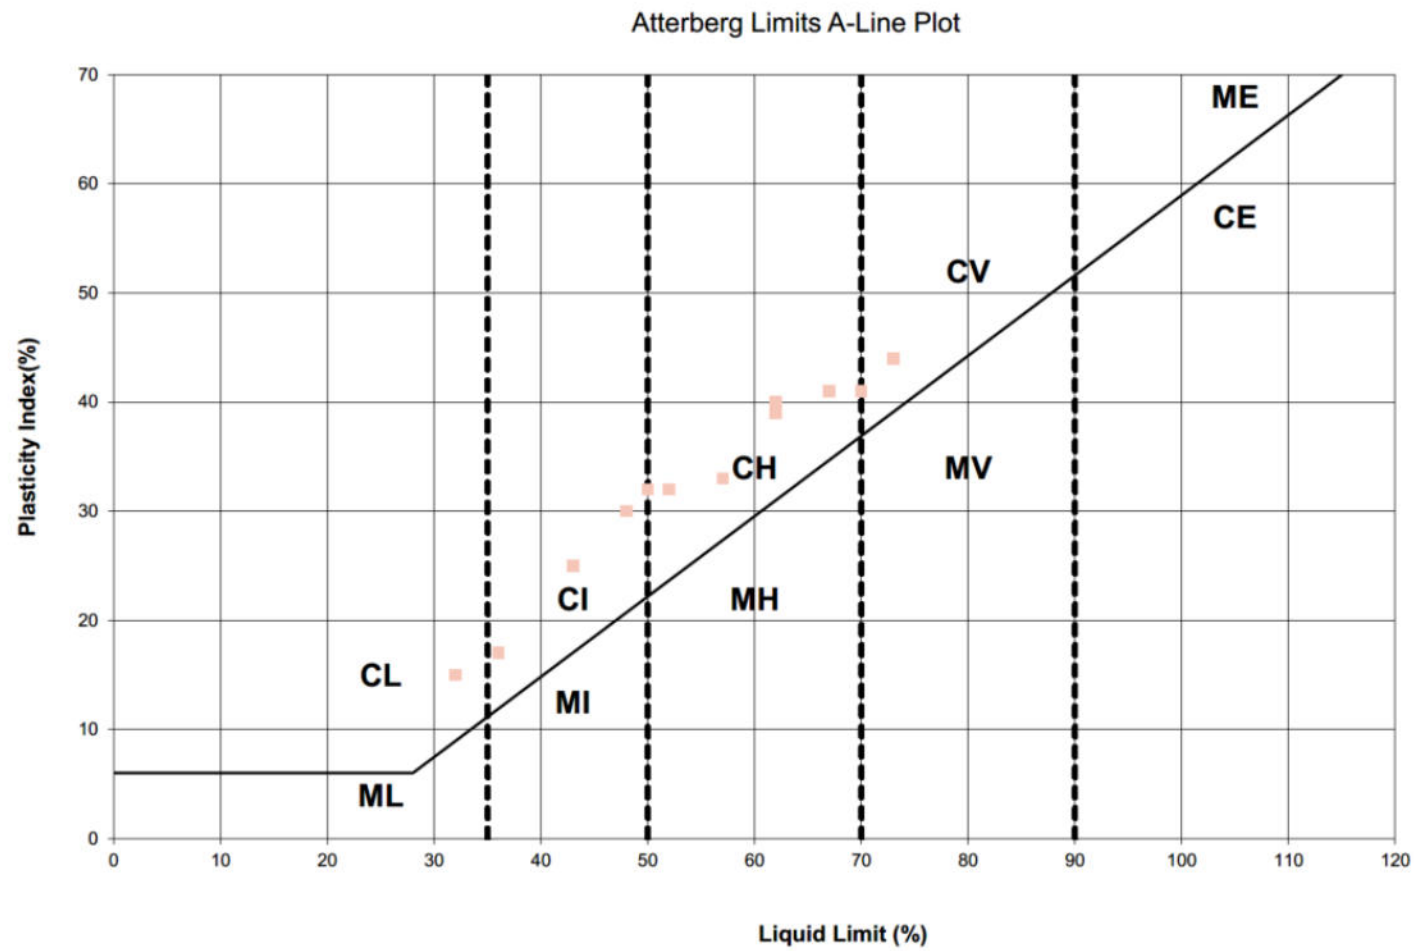
| | Project: | Tars Farm, Barnham | Title: | A Line Plot (superficial deposits) | Fig. No. | 3 |

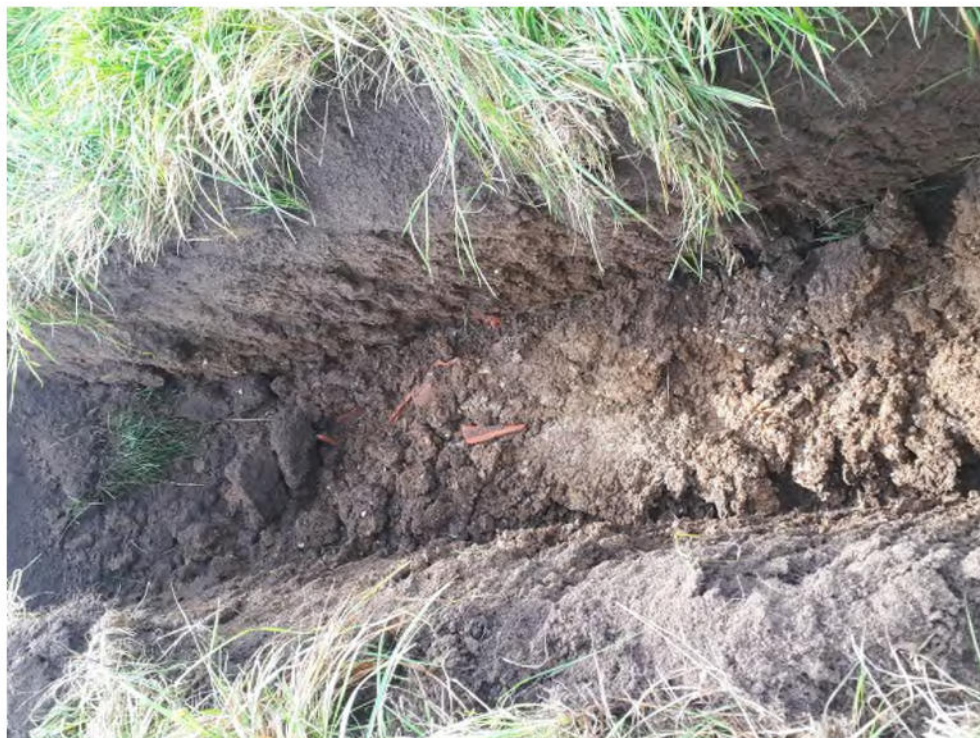
Plate 8: TP47 land drain strike

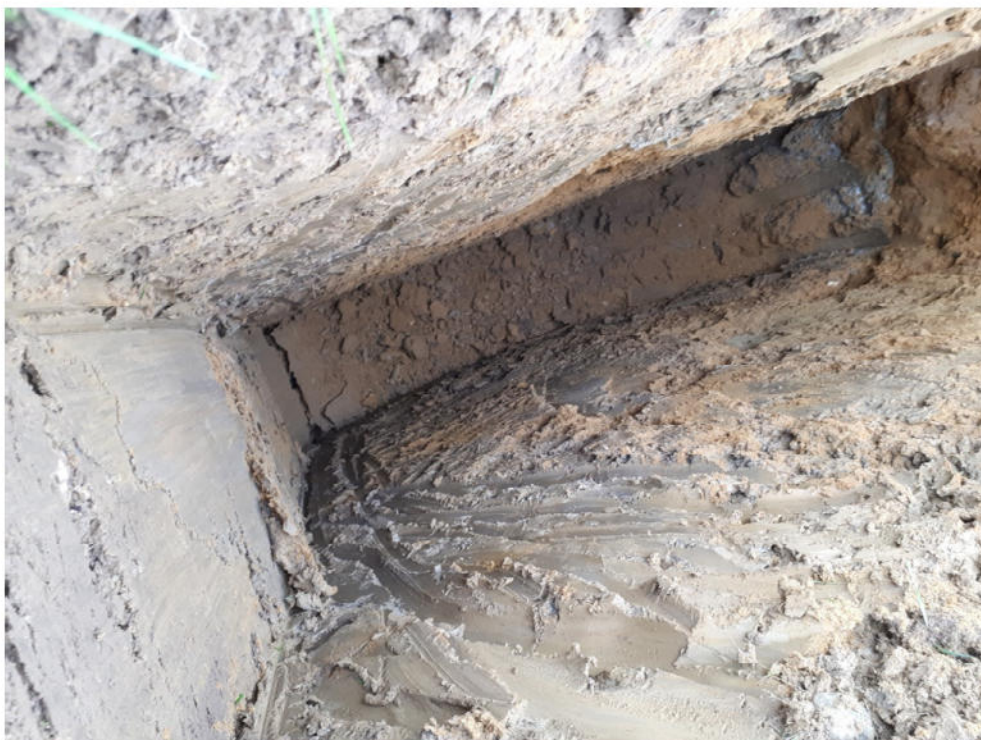
Plate 10: TP06 possible shear surface

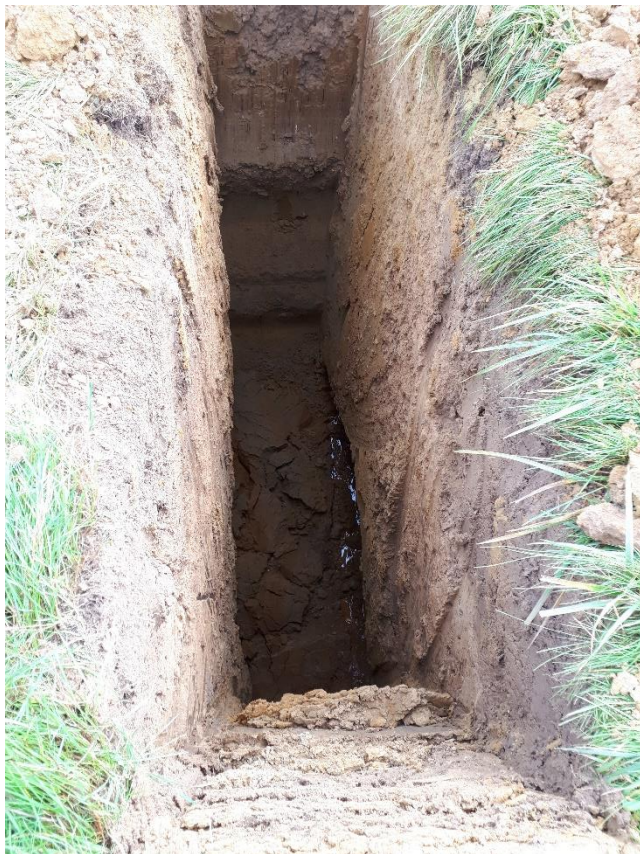
Plate 15: TP50 collapse and seepages

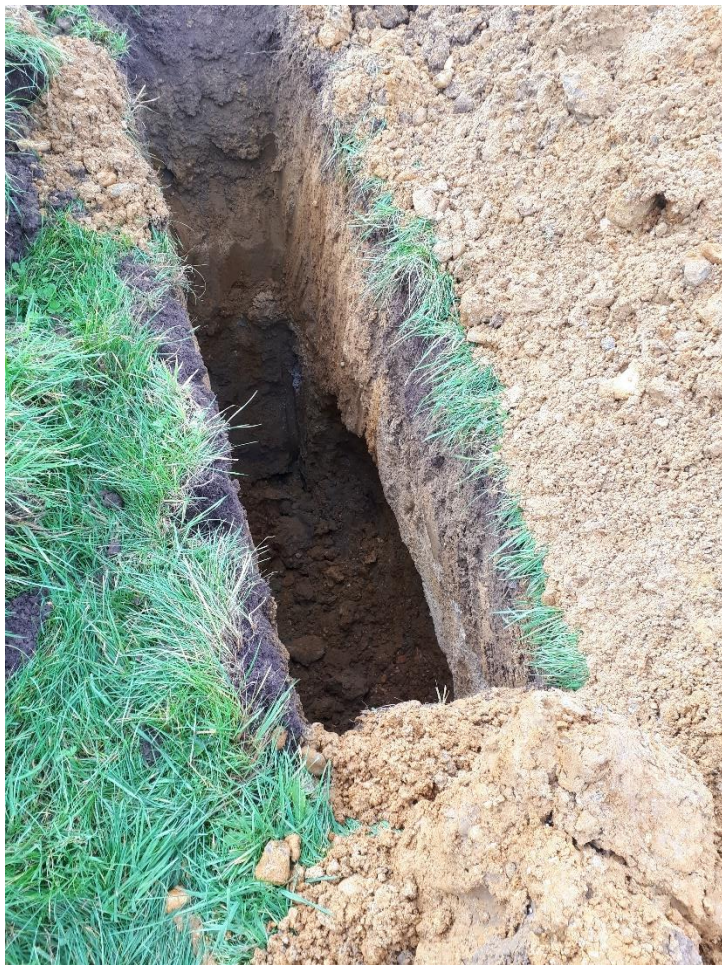
Plate 19: TP44 collapse

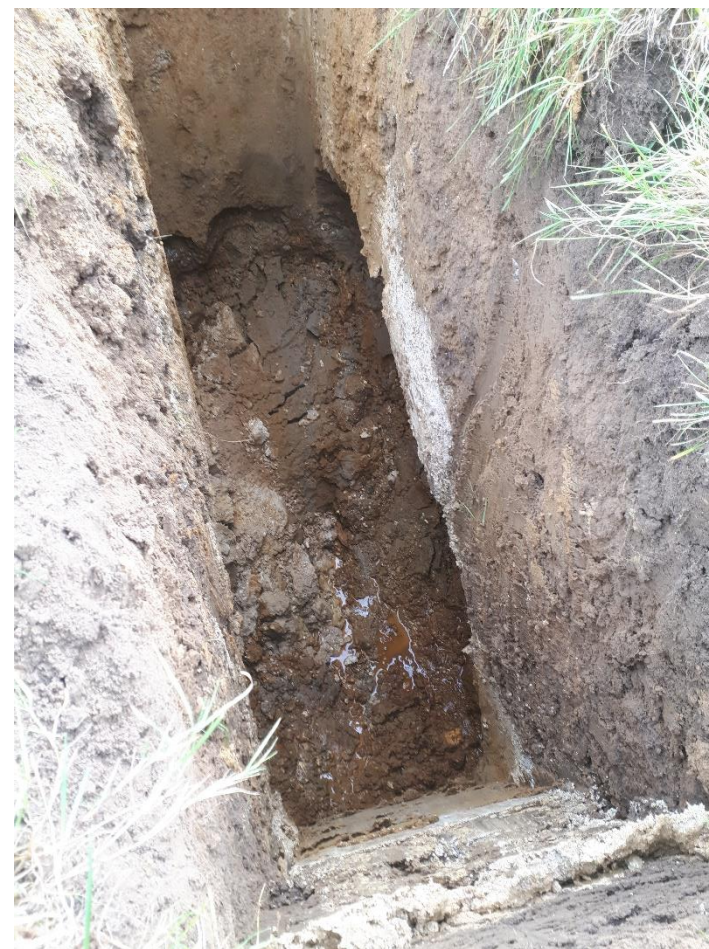
Plate 20: TP47a collapse and seepage

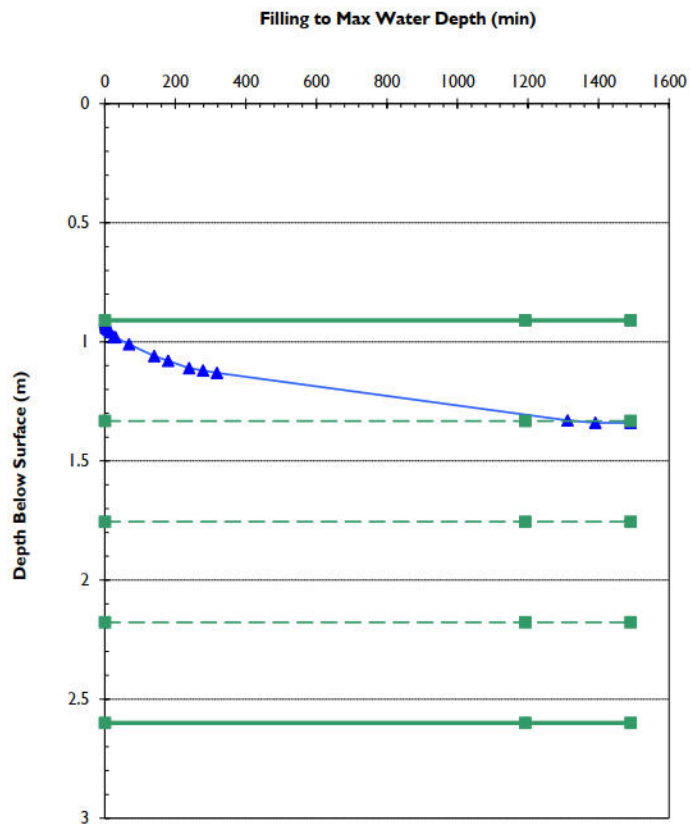
## BRE Digest 365 - Soakage Test

Test Hole No: TP03  
Test No: Test No 1

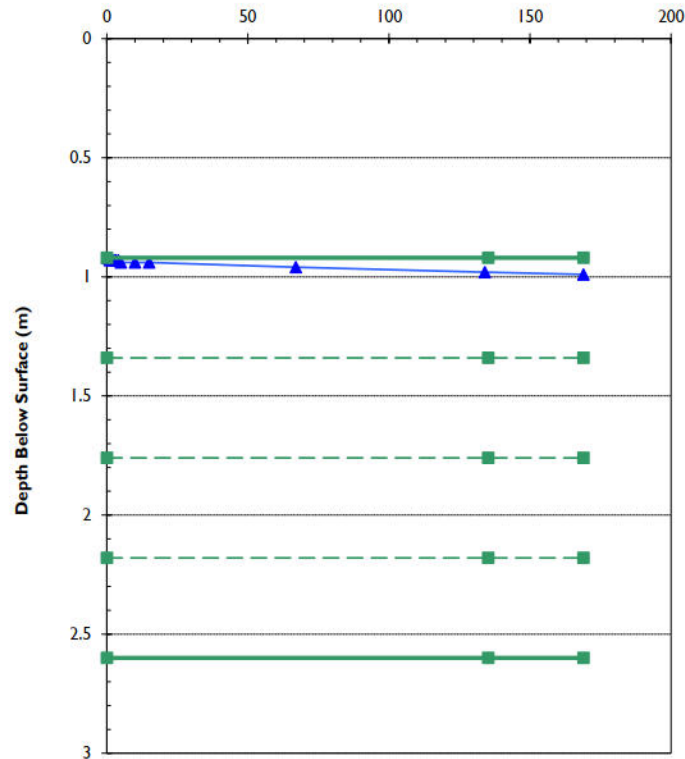
## BRE Digest 365 - Soakage Test

Test Hole No: TP03  
Test No: Test No 2

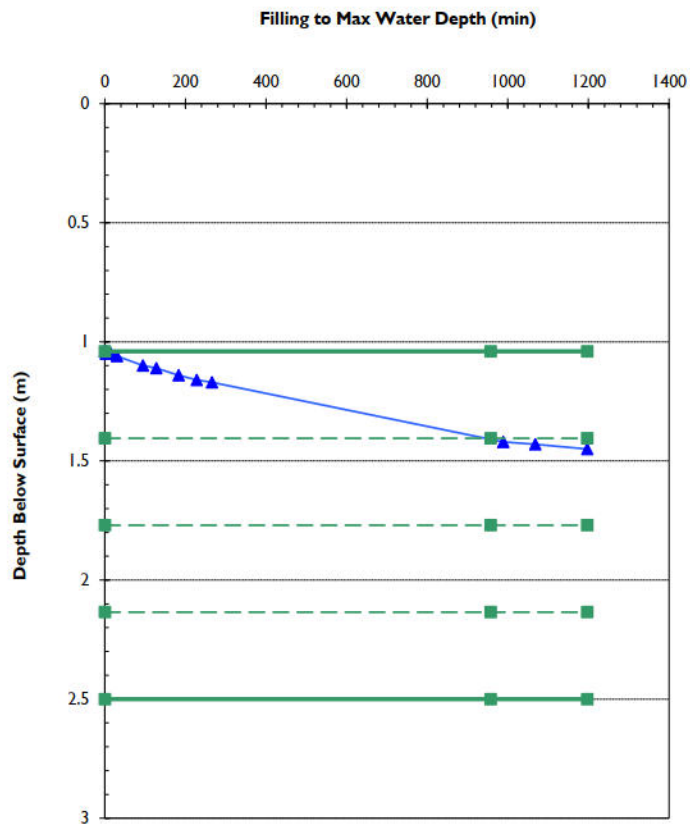
## BRE Digest 365 - Soakage Test

Test Hole No: TP28  
Test No: Test No 1

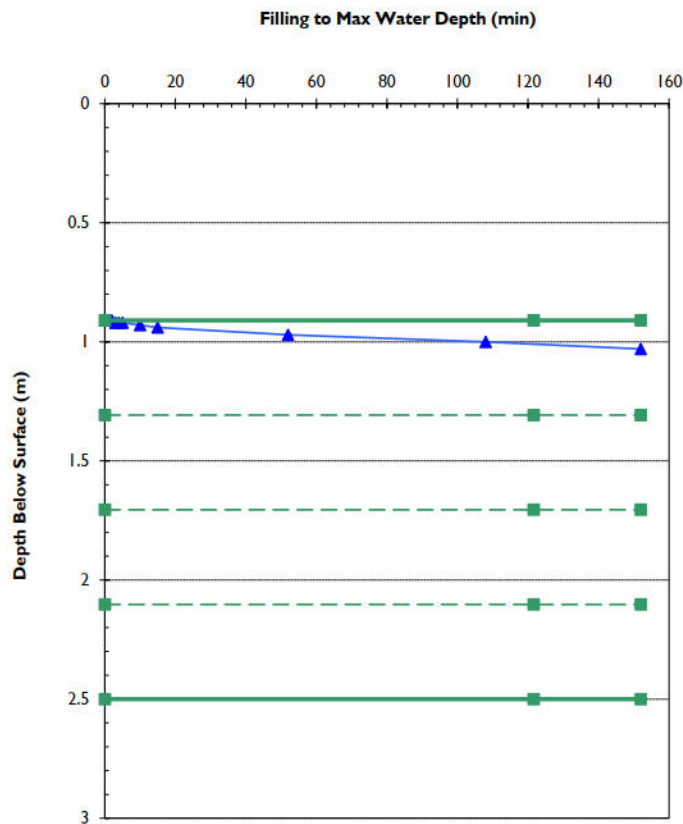
## BRE Digest 365 - Soakage Test

Test Hole No: TP28  
Test No: Test No 2

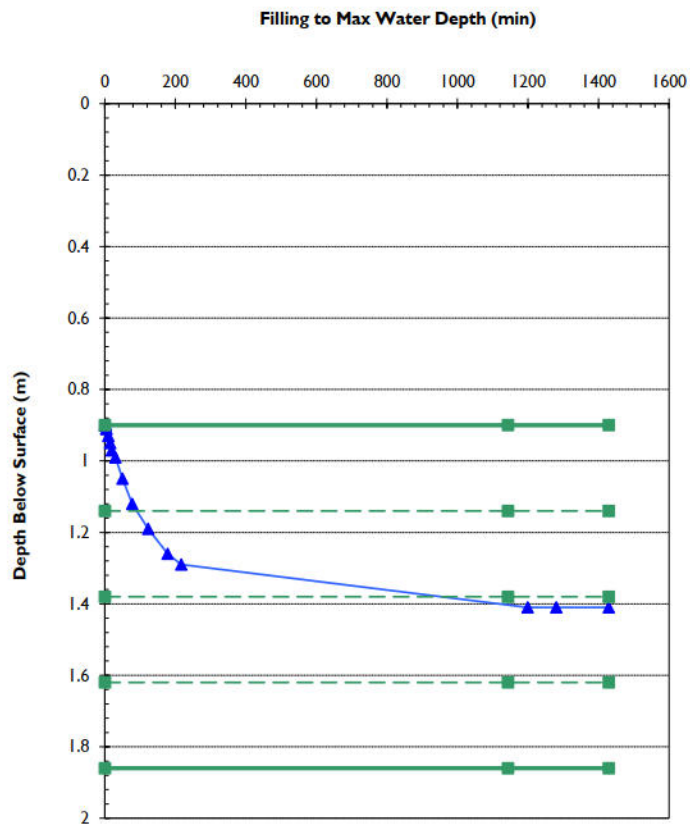
## BRE Digest 365 - Soakage Test

Test Hole No: TP49  
Test No: Test No 1

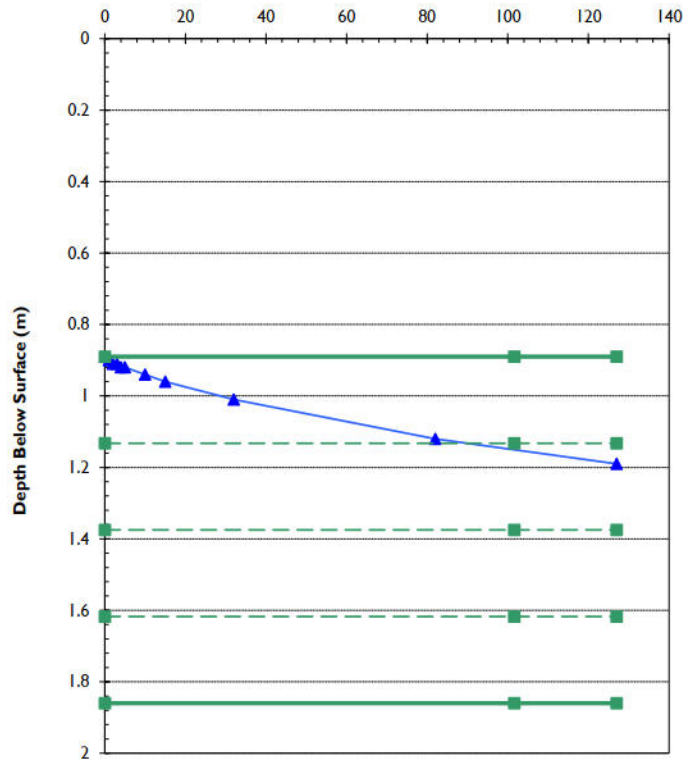
## BRE Digest 365 - Soakage Test

Test Hole No: TP49  
Test No: Test No 2
