**Yapton Road, Barnham**

Preliminary Geoenvironmental and  
Geotechnical Assessment

# **Yapton Road, Barnham**

## **Preliminary Geoenvironmental and Geotechnical Assessment**

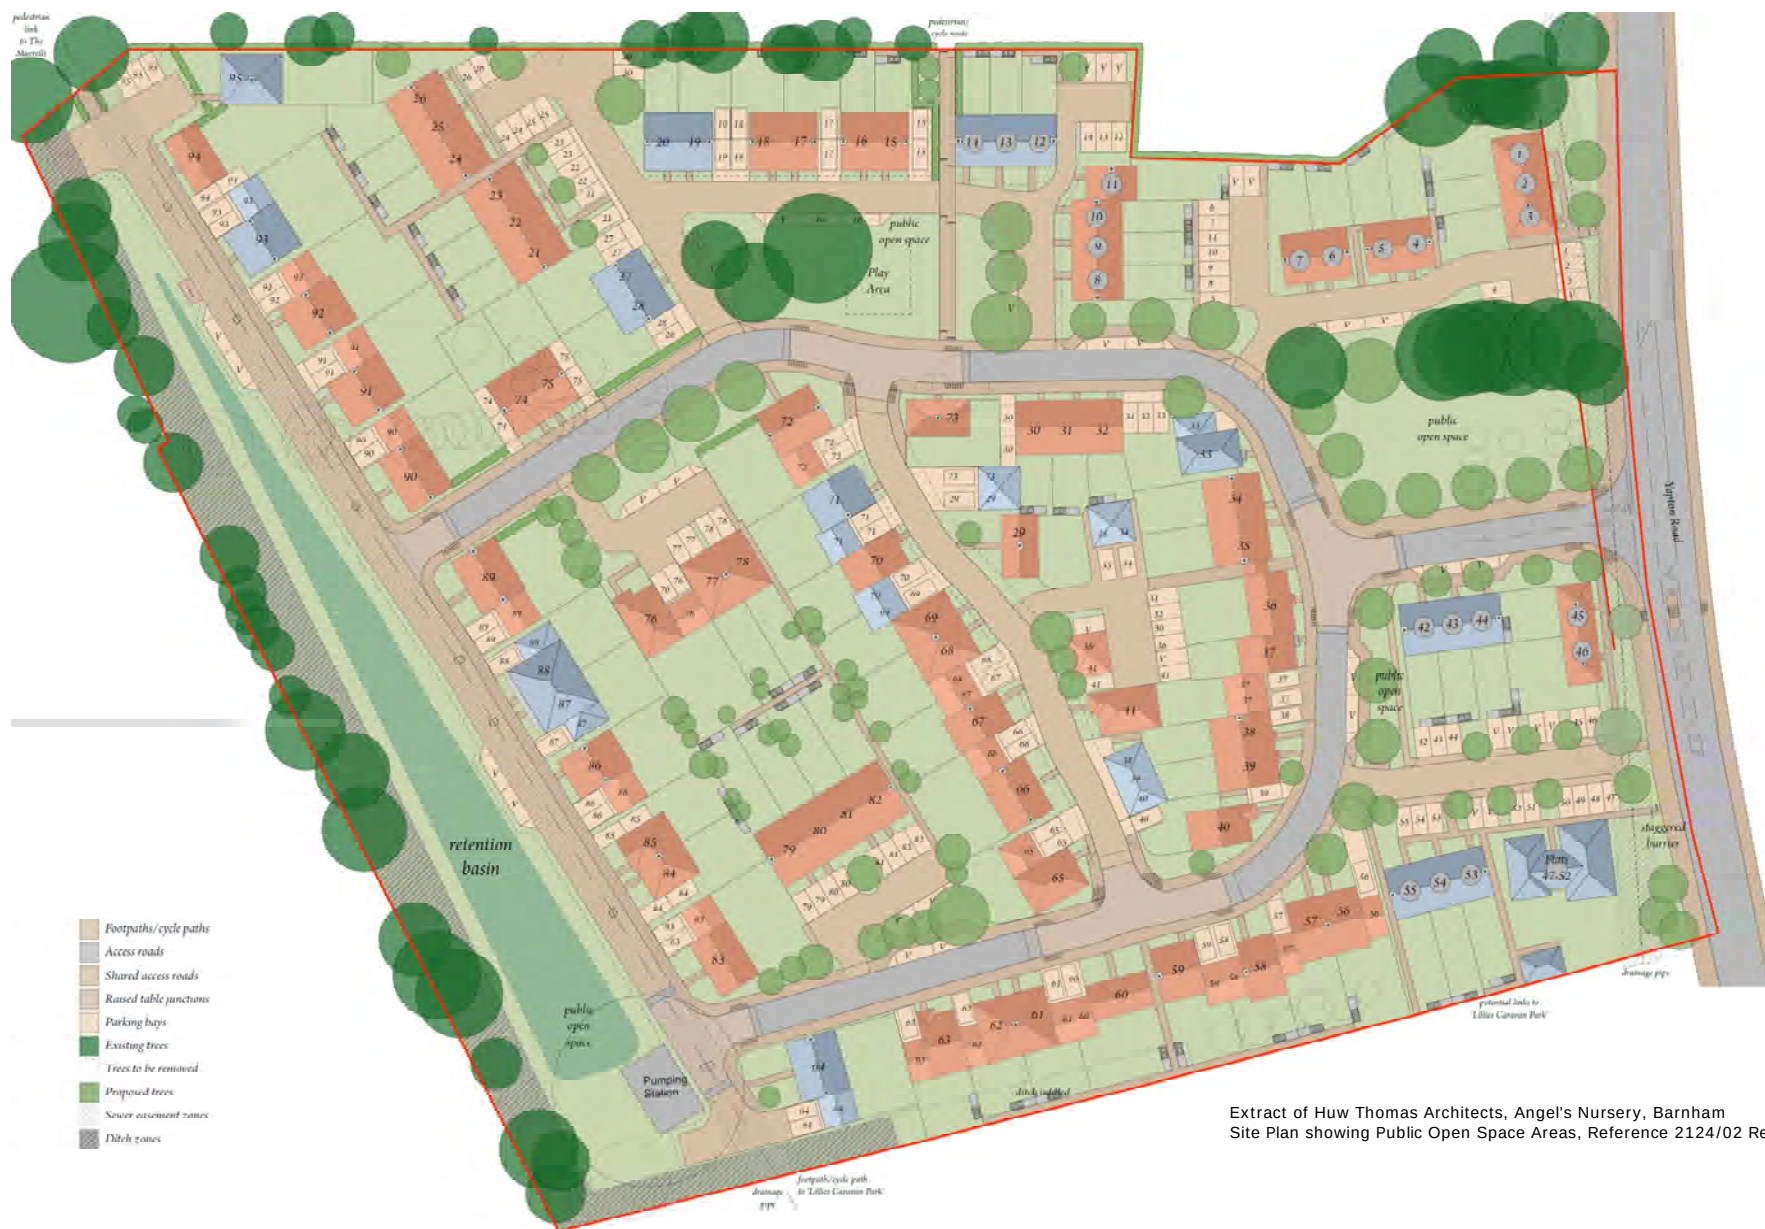
Extract of Huw Thomas Architects, Angel's Nursery, Barnham  
Site Plan showing Public Open Space Areas, Reference 2124/02 Rev A, September 2016

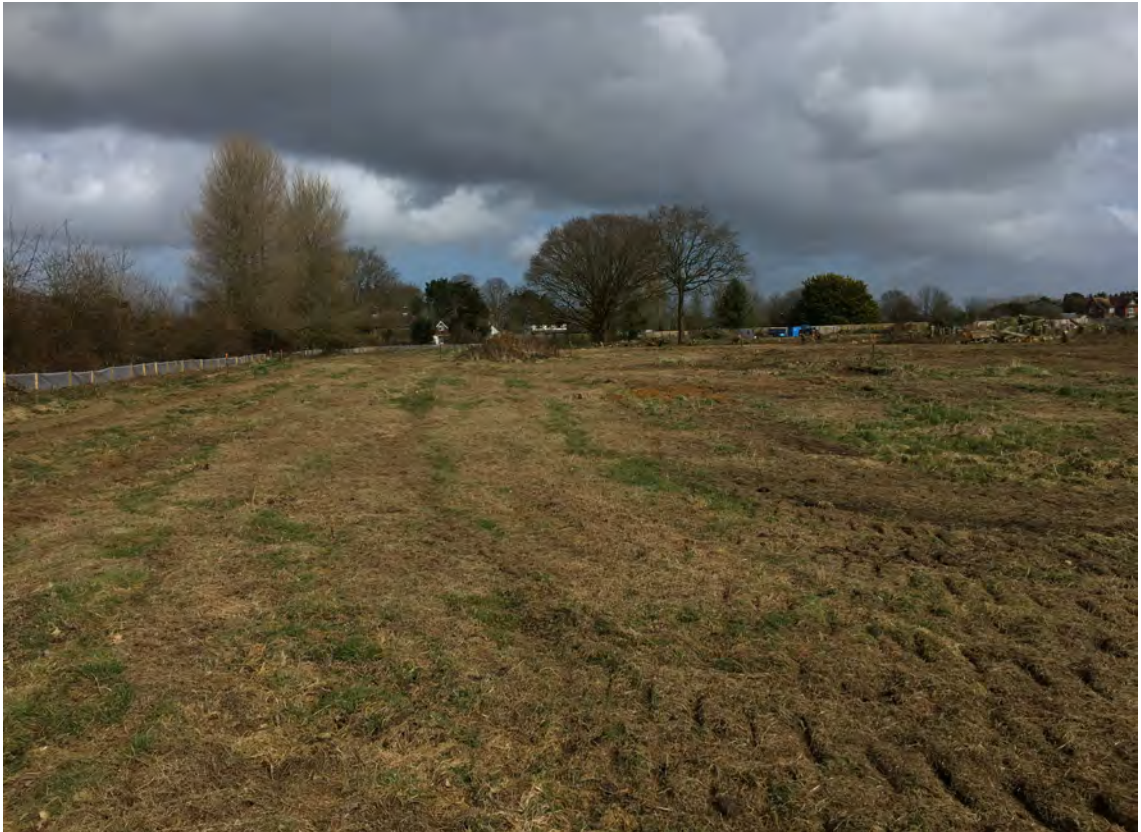
Photograph 1: View from the southern corner of the site facing north-west.

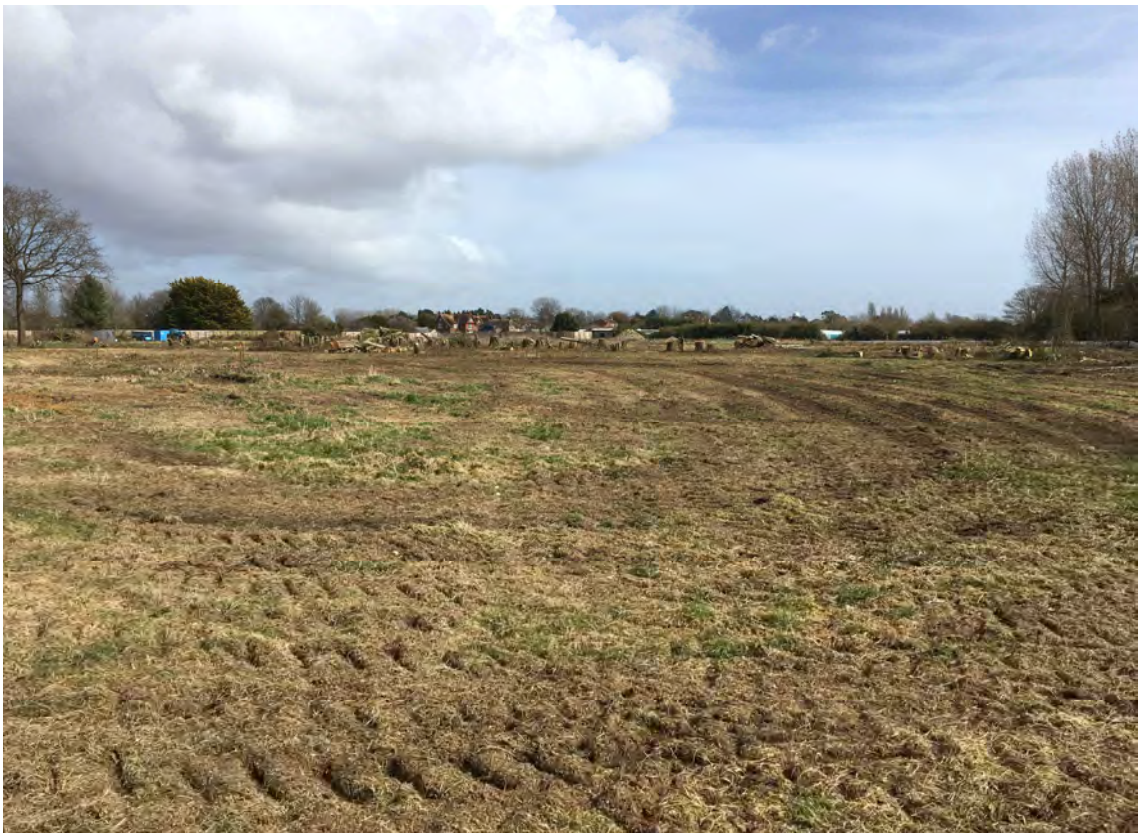
Photograph 2: View from the southern corner of the site facing north.

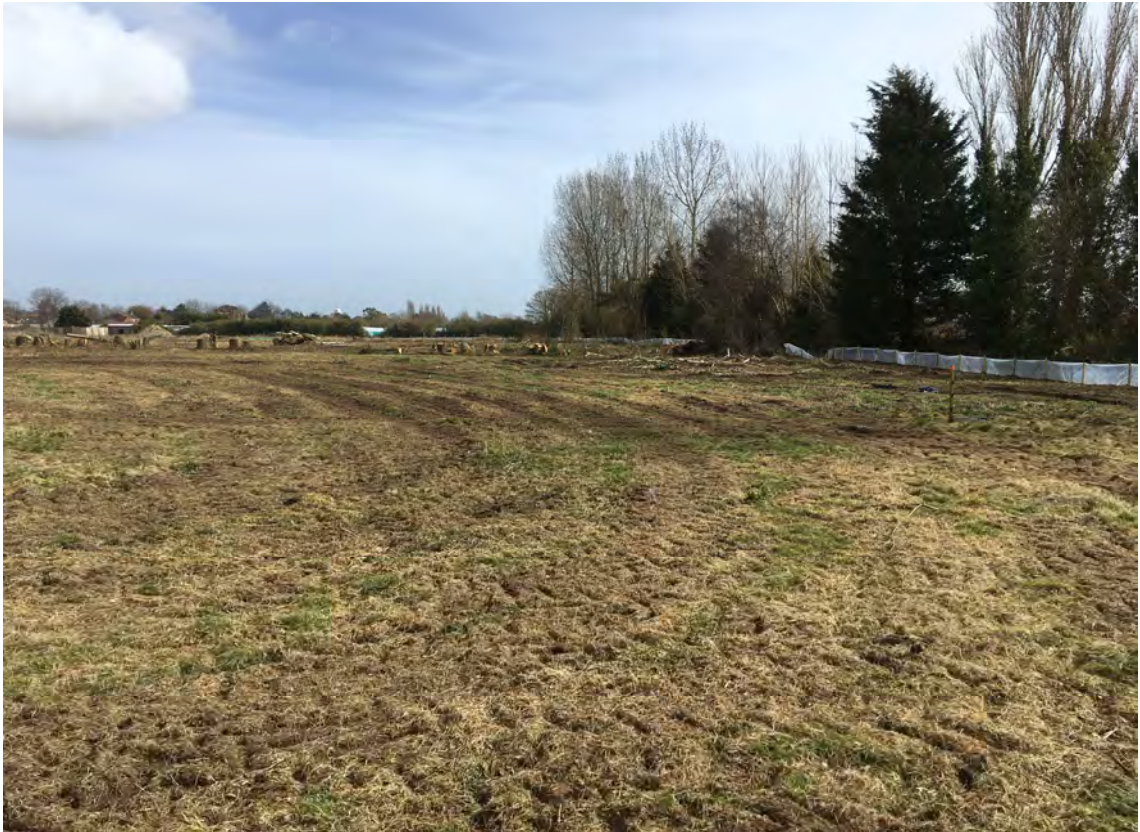
Photograph 3: View from the southern corner of the site facing north-east.

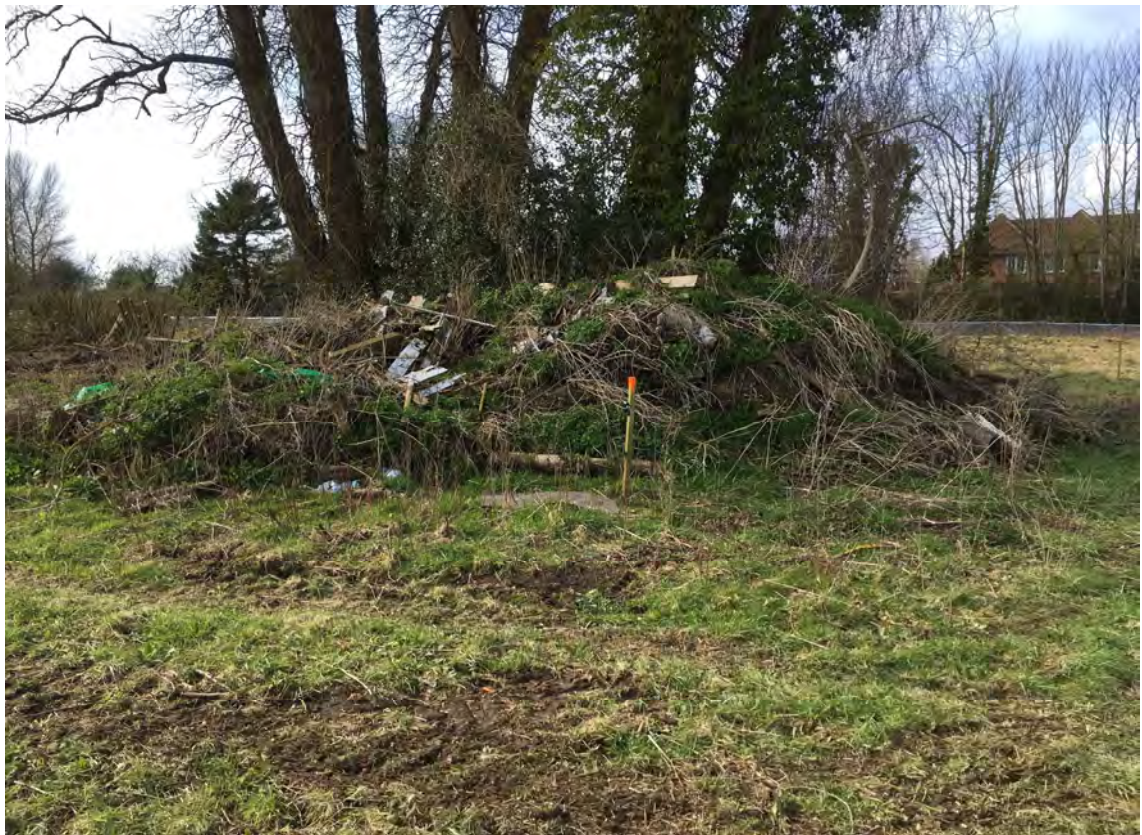
- 2.2.3 The site was observed to be generally flat, with the exception of a spoil mound in the north-western part of the site (Photograph 4).

Photograph 4: Spoil heap in the northern portion of the site.

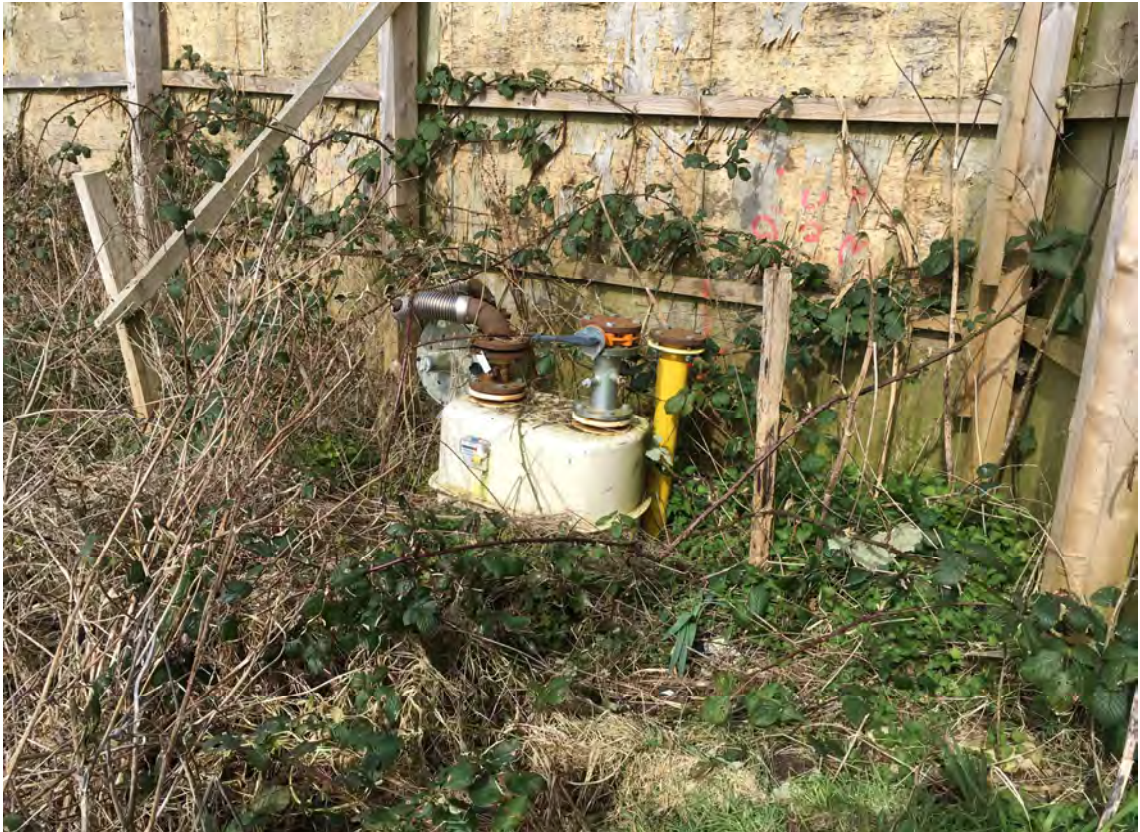
Photograph 5: Evidence of potential gas mains along the north-eastern boundary of the site. Now understood to be disconnected from the road.

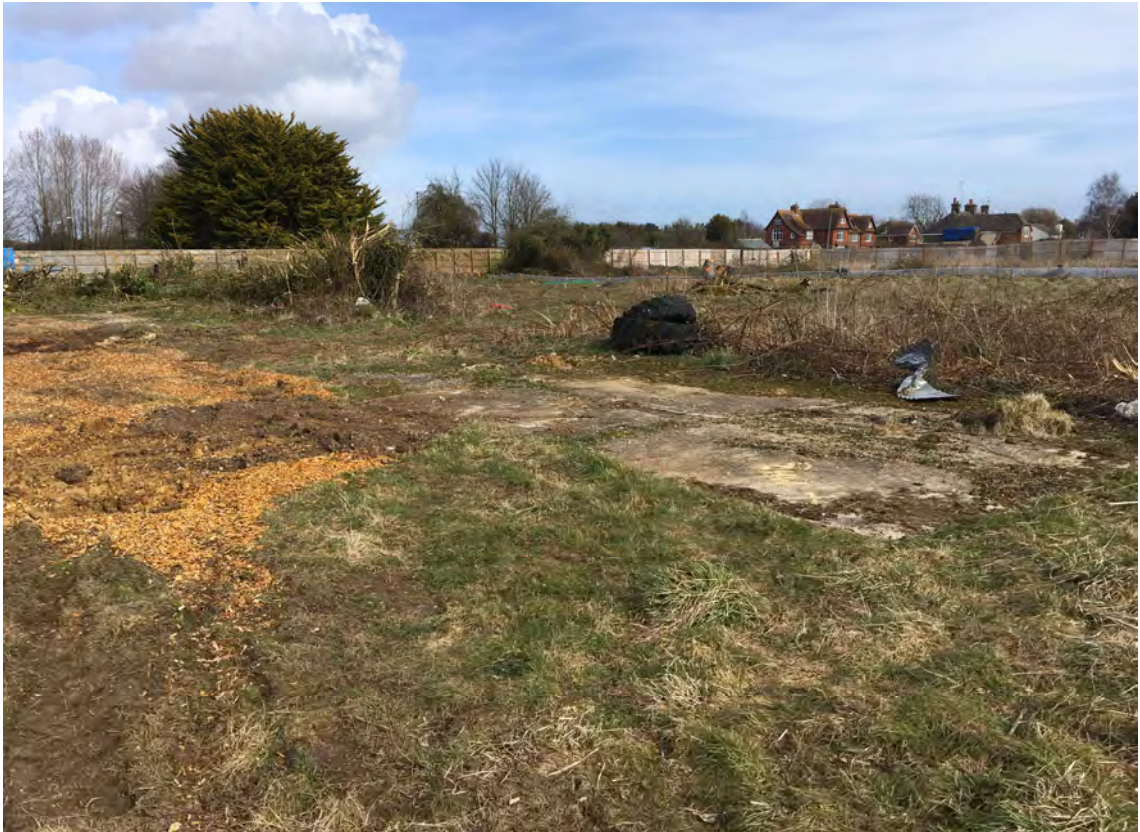
- 2.2.2 At the time of the site walkover, the site was not in use and was fenced off from the public. Evidence of previous structures was observed during the walkover, eg foundations (Photograph 7) and 2No. shallow ditches running approximately north-east to south-west across the site (Photograph 8).

Photograph 7: Example of hardstanding associated former site development.

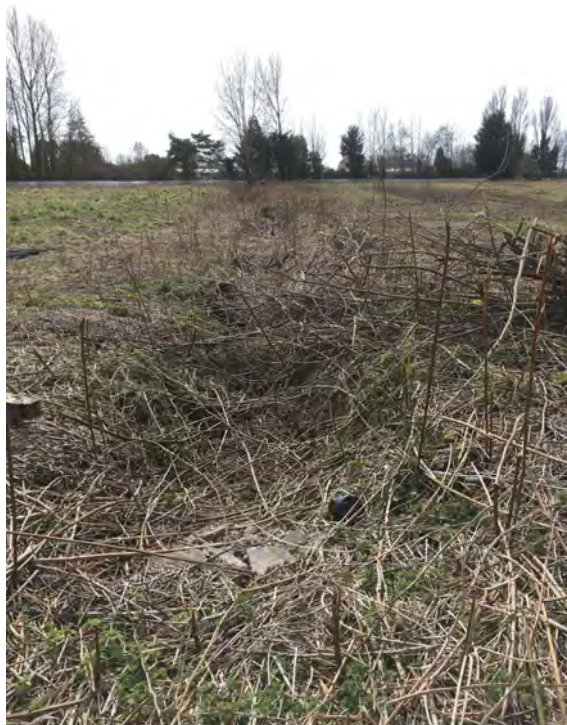
- 2.2.8 Two shallow ditches were observed at the site, running through the site in an approximate north-east to south-west orientation (Photograph 8). Manholes were also observed on site, possibly associated with relict site drainage.

Photograph 8: View of one of the two drainage ditches that run approximately north-east to south-west across the site.
