Land South of
Wandleys Lane
Eastergate
West Sussex
PO20 3SE

Mineral Assessment
Update Note

Application Ref:
BN/46/25/PL

July 2025

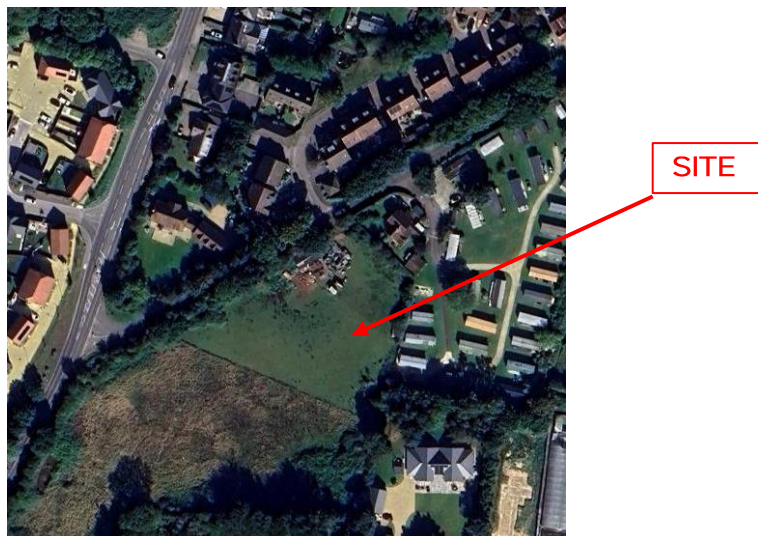
Figure 2 – Aerial Photograph of Site

The site covers an area of approximately 0.43ha and is occupied by some dilapidated stables and associated farm type structures, with the rest of the site laid to grass and currently being used as grazing land for sheep and a pony. An aerial photograph of the site is shown in the Figure 2 below.

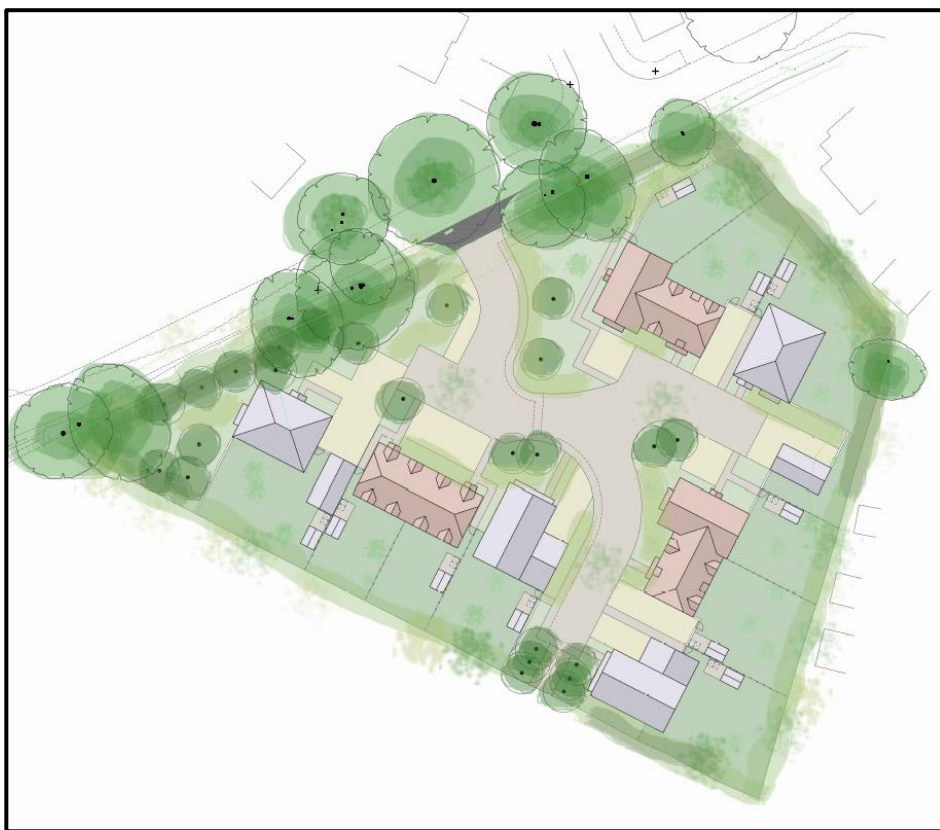
Figure 3 – Proposed Development Plan

The development proposals for this site consist of 10 residential dwellings, 3 car-ports and 1 single garage. The proposed development layout can be shown in Fig 3 below.
