Land west of Fontwell Avenue, Eastergate

Preliminary Investigation Report

**Job Reference: 18158/PIR\_R26 Rev 1.02  
February 2020**

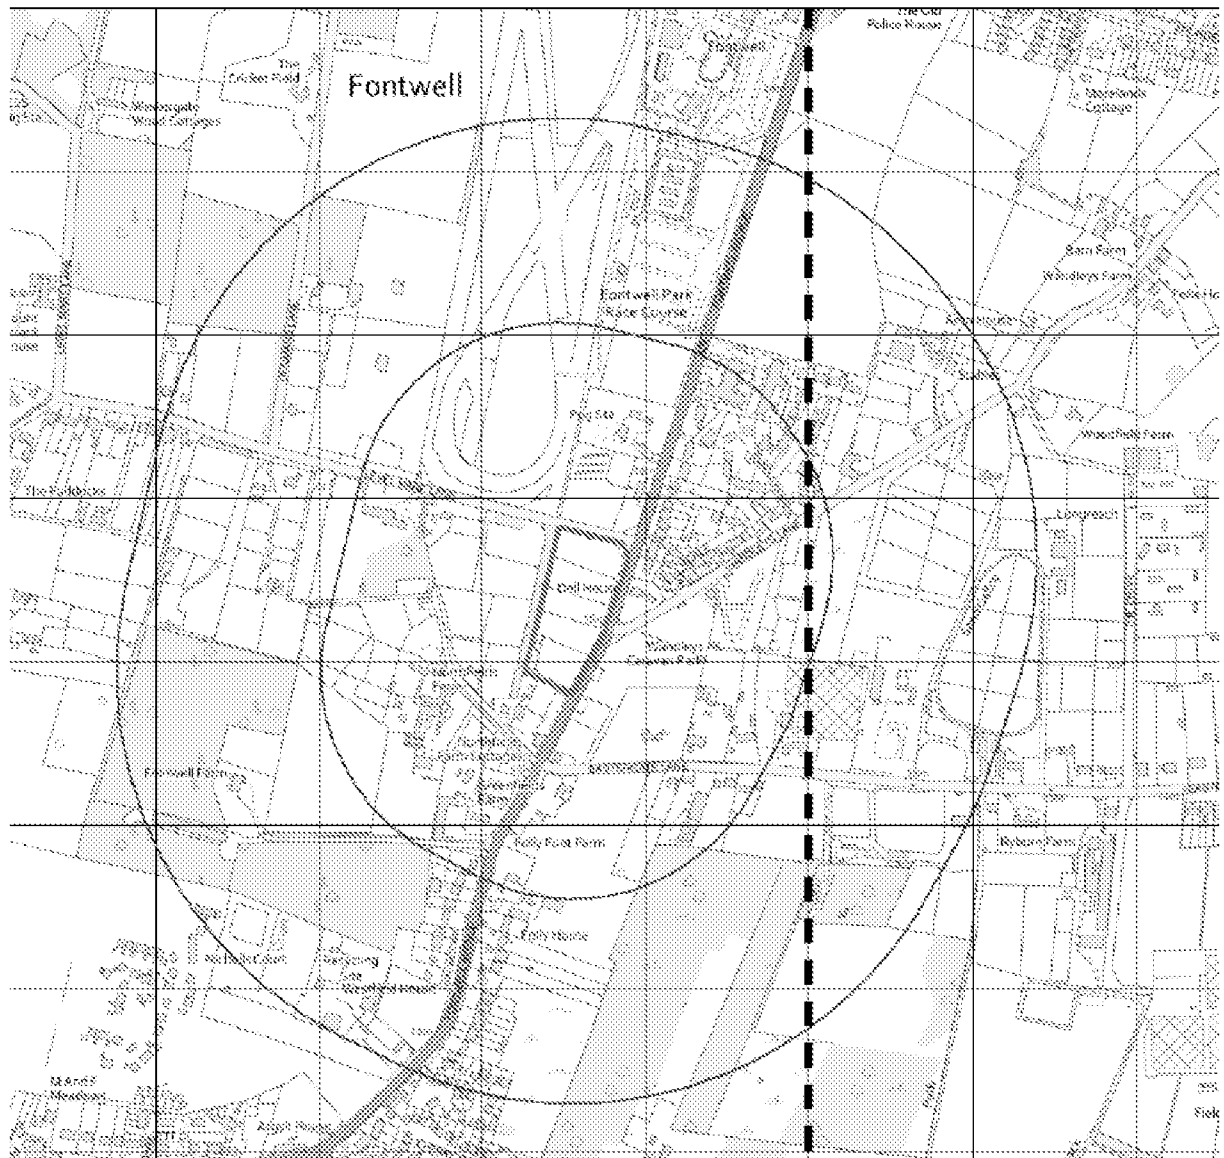
**Figure 1 – Site Location Map**

The site was located at Land west of Fontwell Avenue, Eastergate, Chichester, West Sussex PO20 3RX and had an O.S Land Ranger Grid Reference of SU 947 063.

The site location map is presented in Figure 1 and the full Site Walkover is discussed in Section 2.1 of this report.

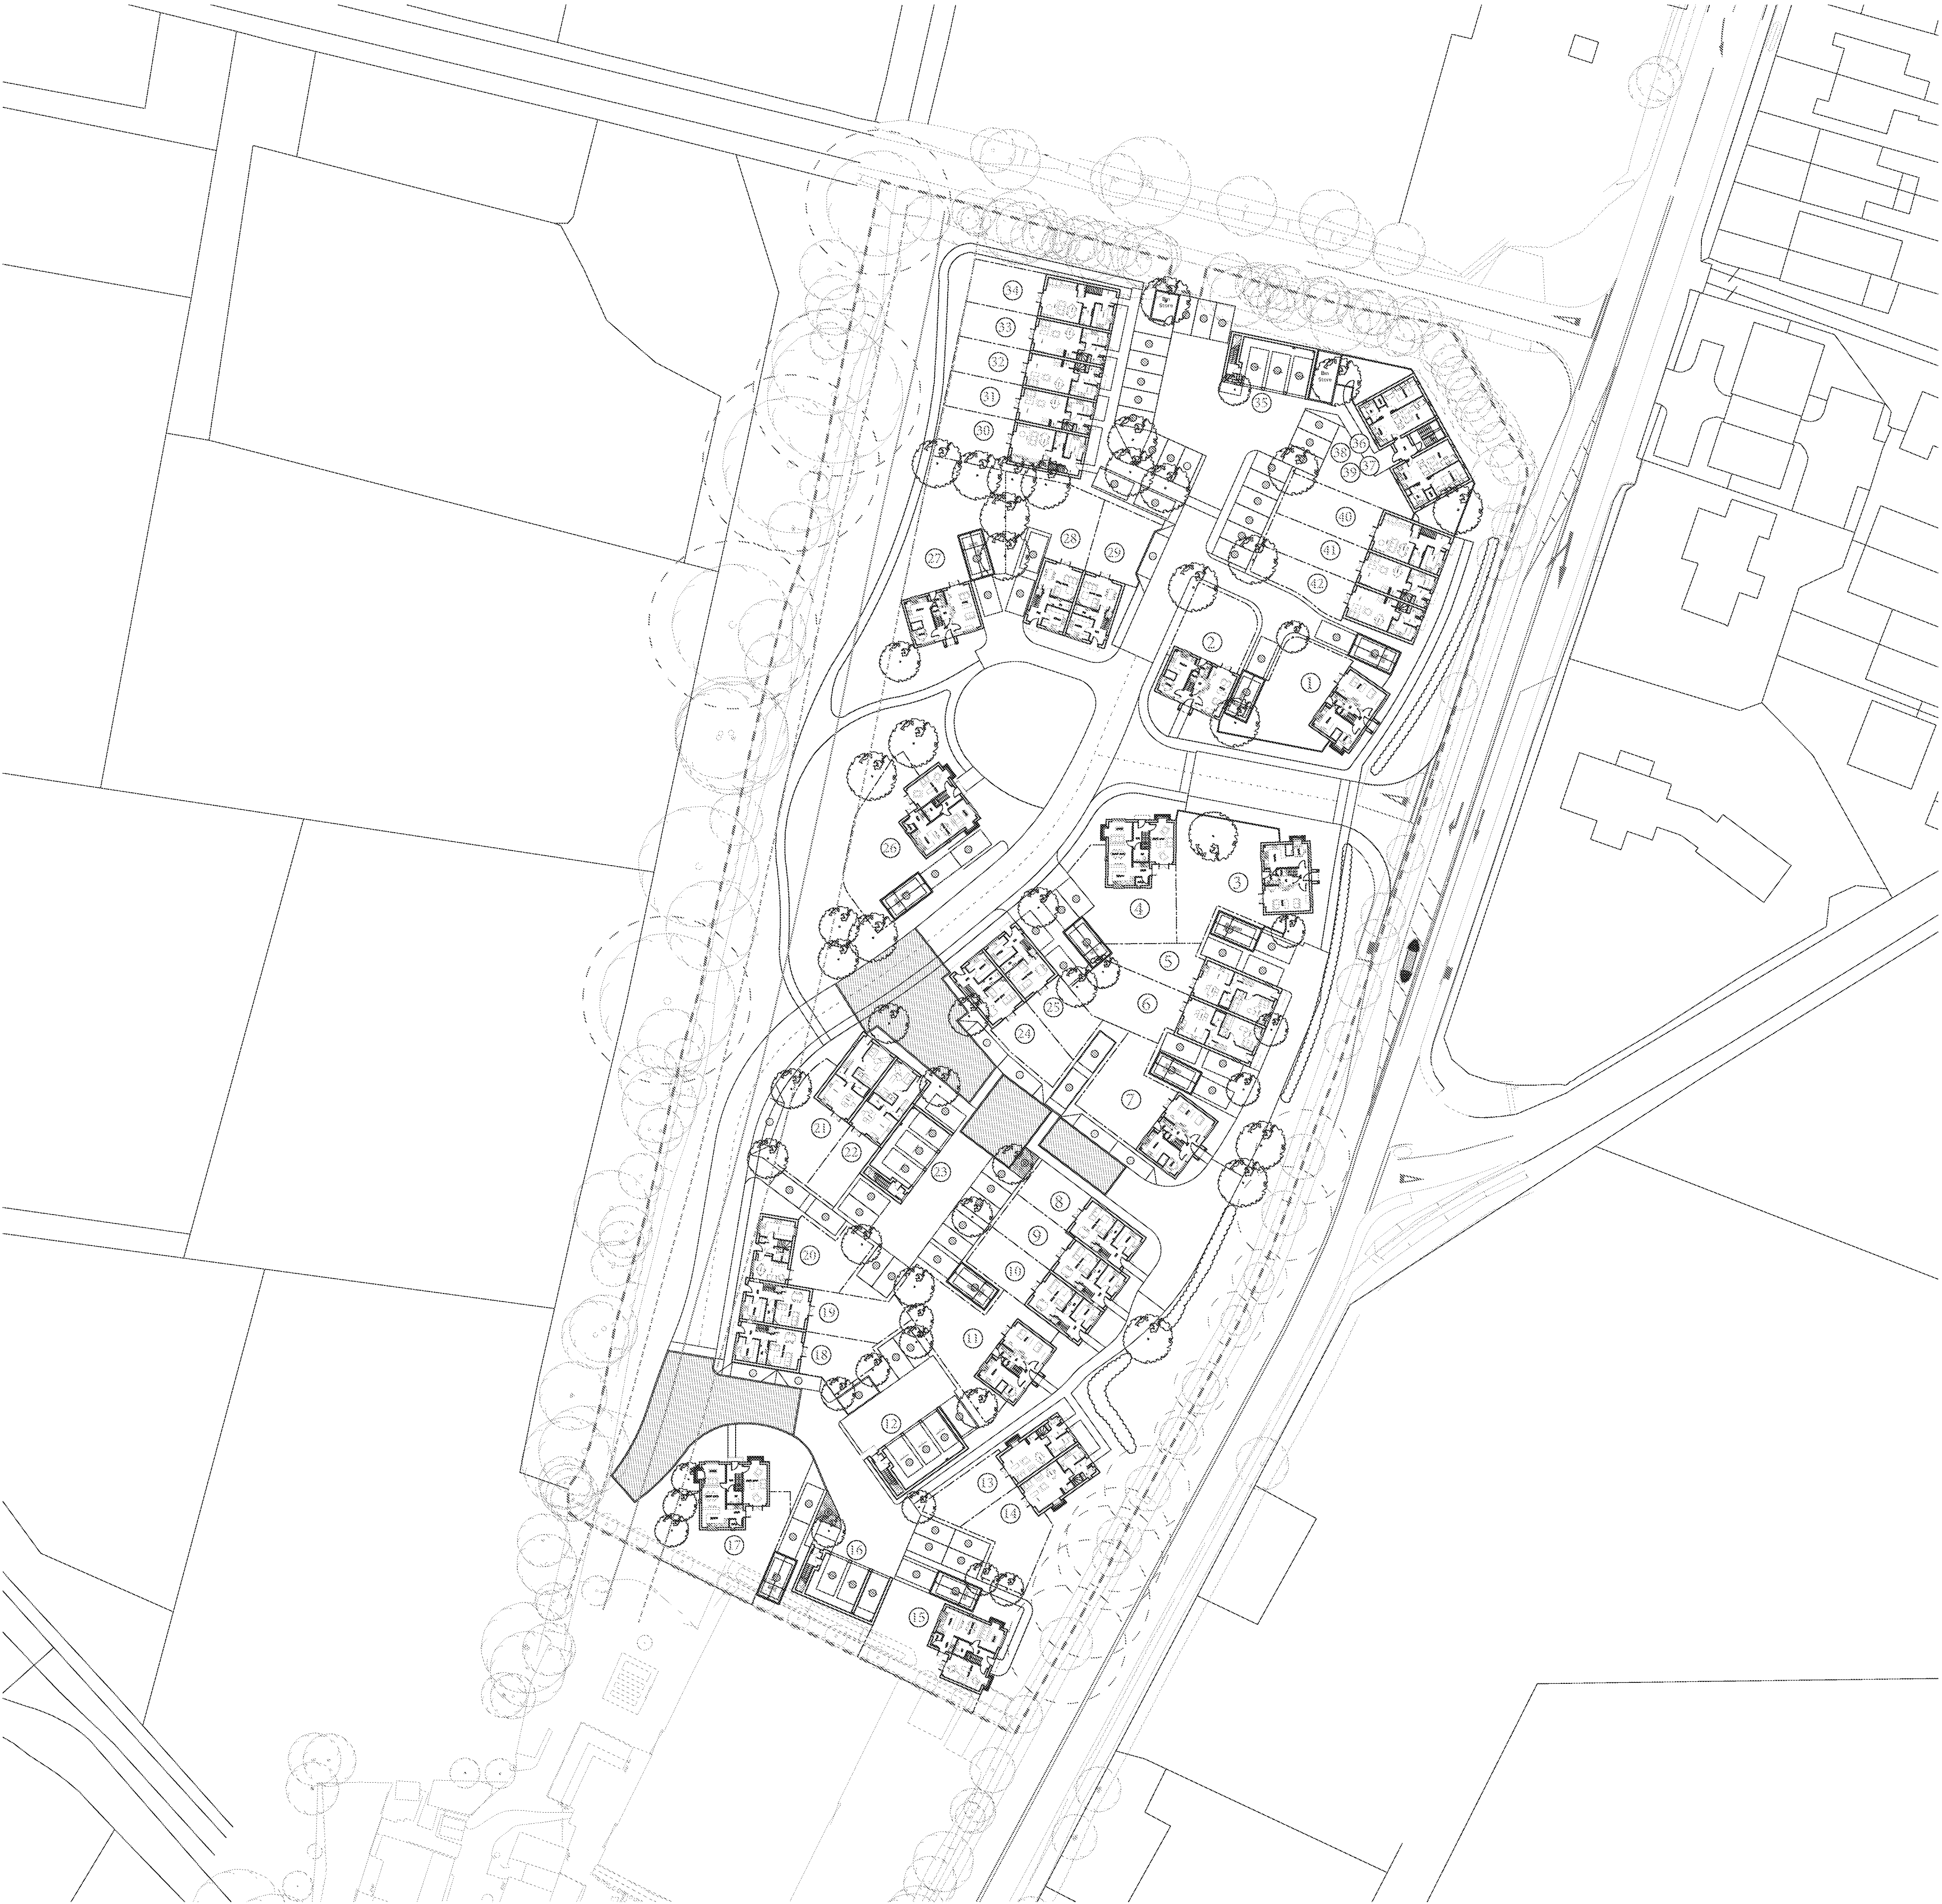
## **Appendix A Proposed Development Plans**

The proposal comprised construction of a low-rise residential development to include 42No. dwellings with areas of hard landscaping including access roads, driveways and pavements and areas of soft landscaping to include private gardens and public open space.

In compiling this report reliance was placed on drawing 29662A\_100-P, dated March 2020, prepared by Clague Architects. Any change or deviation from the scheme outlined in the drawing could invalidate the recommendations presented within this report. Soils Limited must be notified about any such changes.

The proposed development plans have been provided in Appendix A.

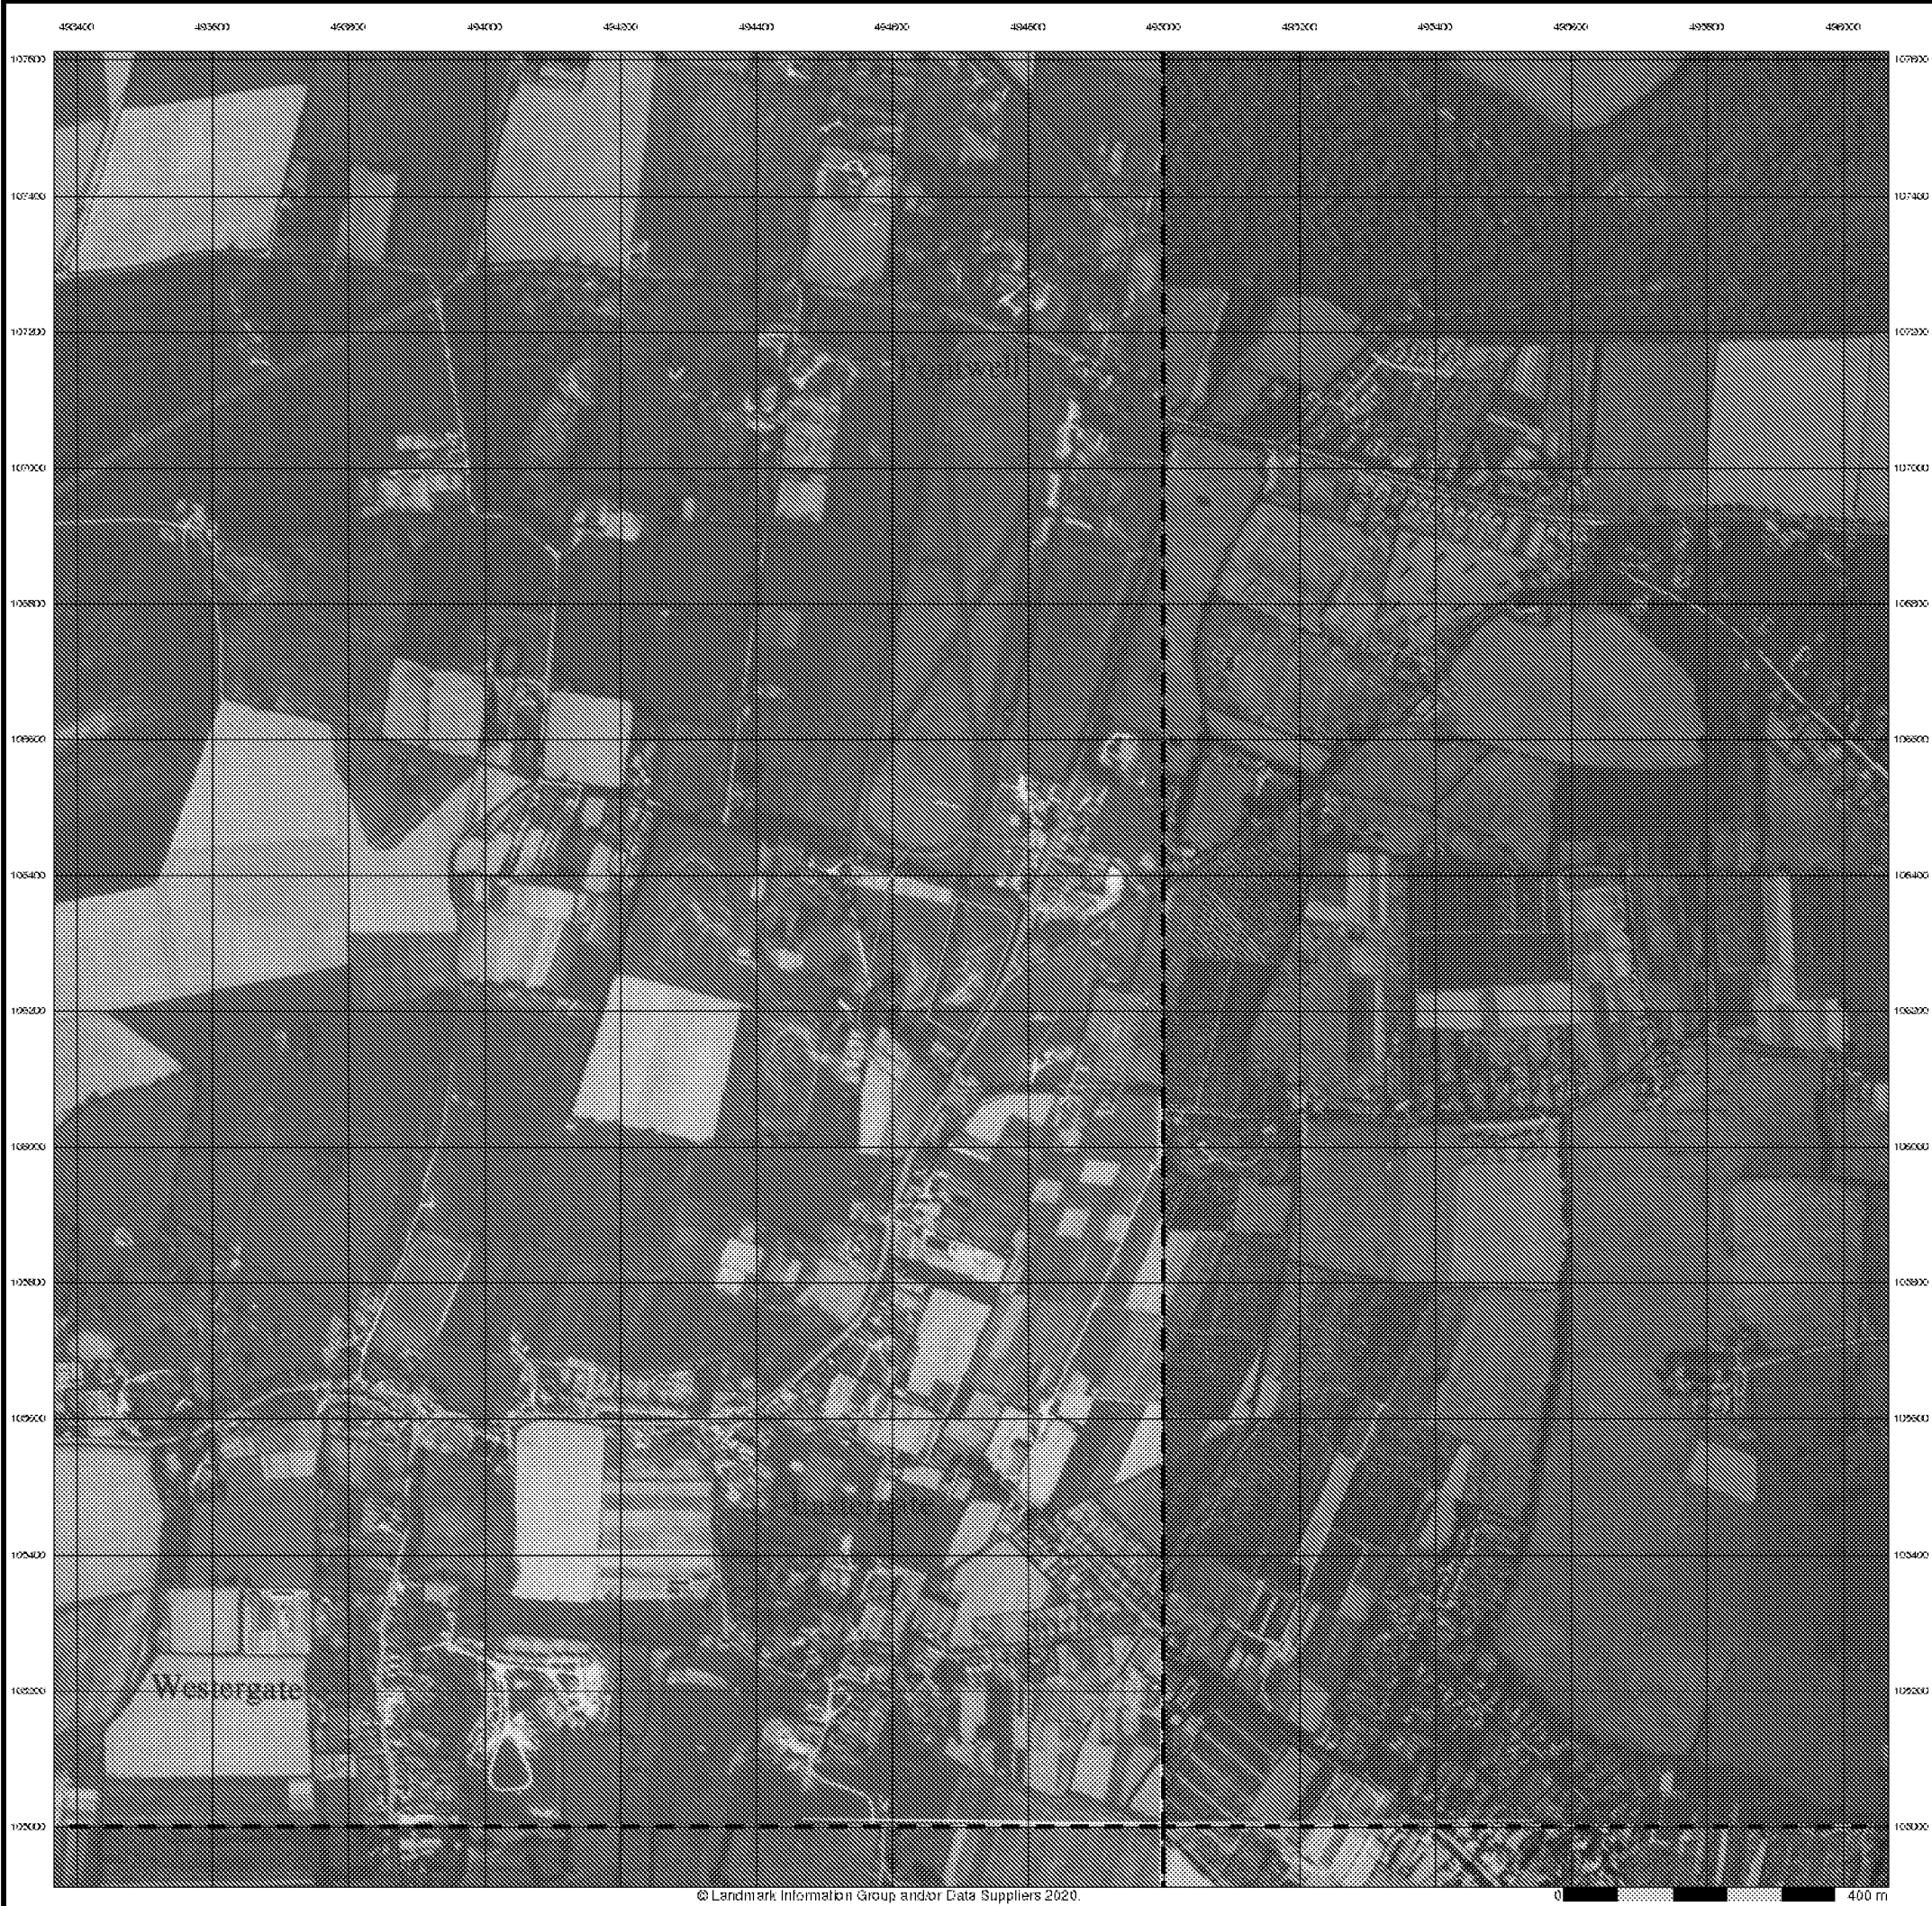
**Historical Aerial Photography**  
**Published 1947 - 1949**  
**Source map scale - 1:10,560**

The Historical Aerial Photos were produced by the Ordnance Survey at a scale of 1:1,250 and 1:10,560 from Air Force photography. They were produced between 1944 and 1951 as an interim measure, pending preparation of conventional mapping, due to post war resource shortages. New security measures in the 1950's meant that every photograph was re-checked for potentially unsafe information with security sites replaced by fake fields or clouds. The original editions were withdrawn and only later made available after a period of fifty years although due to the accuracy of the editing, without viewing both revisions it is not easy to spot the edits. Where available Landmark have included both revisions.
