**Project Name:** REDROW HOMES, BARNHAM S104 SW OUTFALLS  
**Project Description:** S104 SW OUTFALL SURVEY  
**Project Number:** 646  
**Project Status:** Complete  
**Project Date:** 30/08/2024  
**Inspection Standard:** MSCC5 Sewers & Drainage GB (SRM5 Scoring)

## Section Inspection - 30/08/2024 - SMH2X

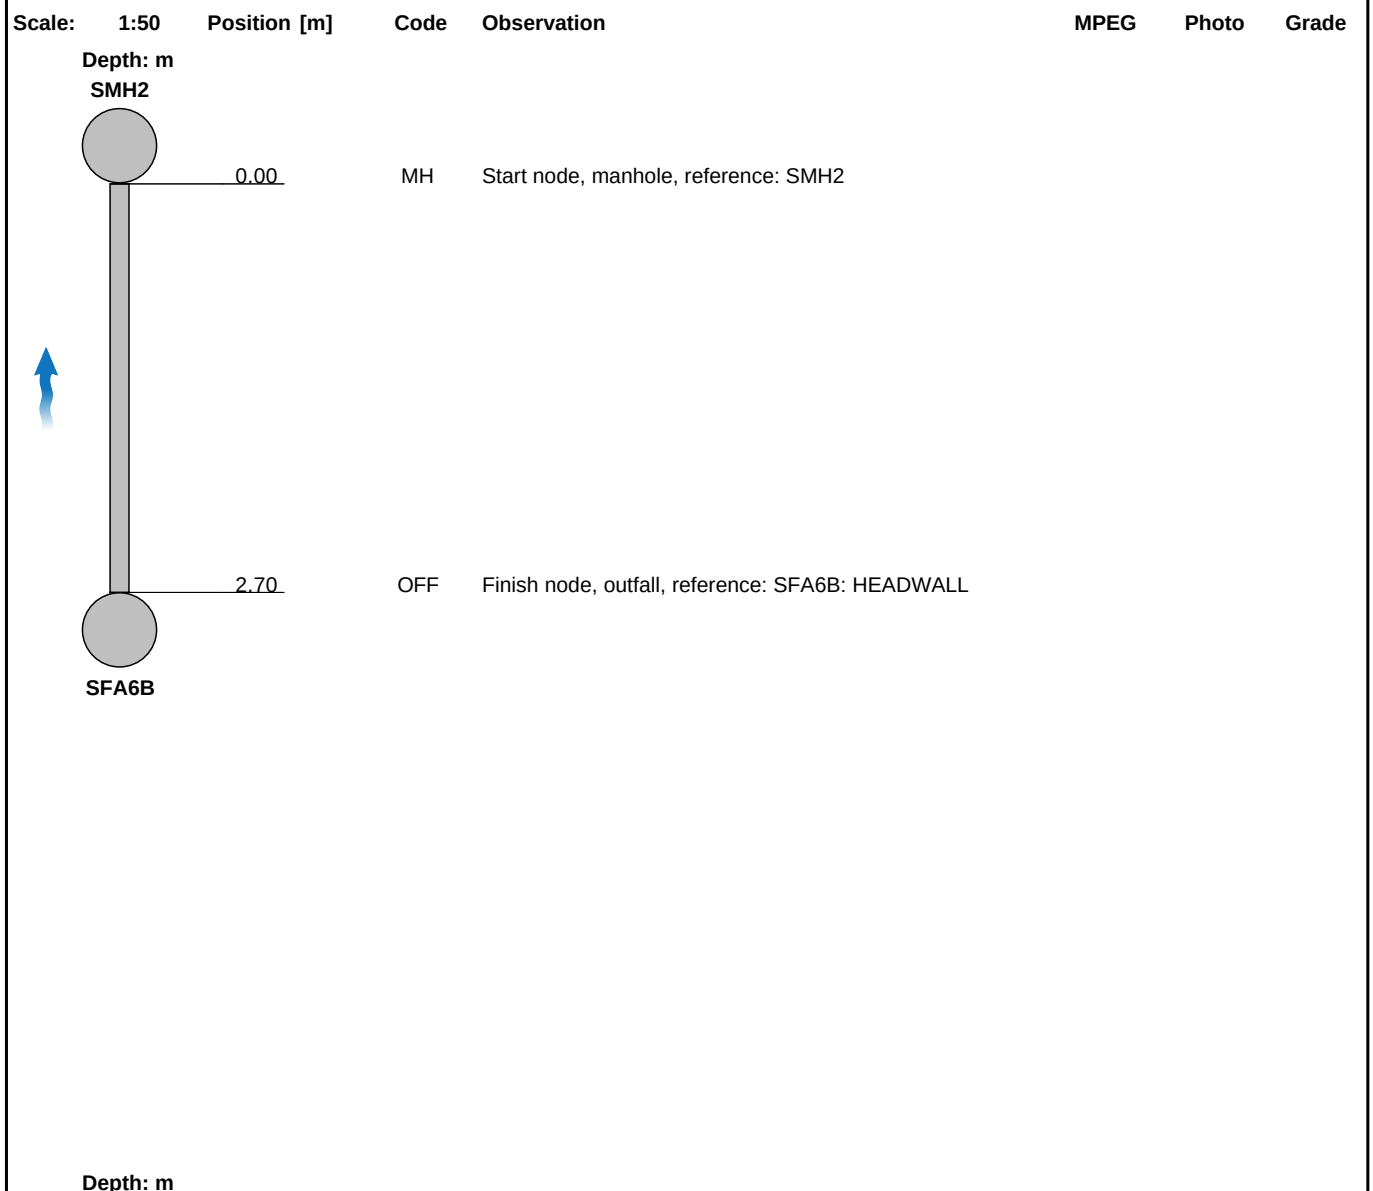
## Section Inspection - 30/08/2024 - SFA6BX

| Town or Village: | Barnham | Inspection Direction: | Upstream | Upstream Node: | SFA6B |
| Use: | Surface water | Pipe Shape: | Circular | | |
| Type of Pipe: | Gravity drain/sewer | Dia/Height: | 225 mm | | |
| Flow Control: | | Material: | Vitrified clay | | |

| Construction Features | | | | | Miscellaneous Features | | | | |
|---|---|---|---|---|---|---|---|---|---|
| 0 | 0.0 | 0.0 | 0.0 | 1.0 | 0 | 0.0 | 0.0 | 0.0 | 1.0 |
