**Application for approval of details reserved by condition imposed under planning permission BN/7/18/PL relating to condition**

- 3 (proposed surface water drainage),**
- 4 (Discharge of watercourse)**
- 5 (Surface water drainage system)**

**Land to the north of The Flint Barn Yapton Road, Barnham**

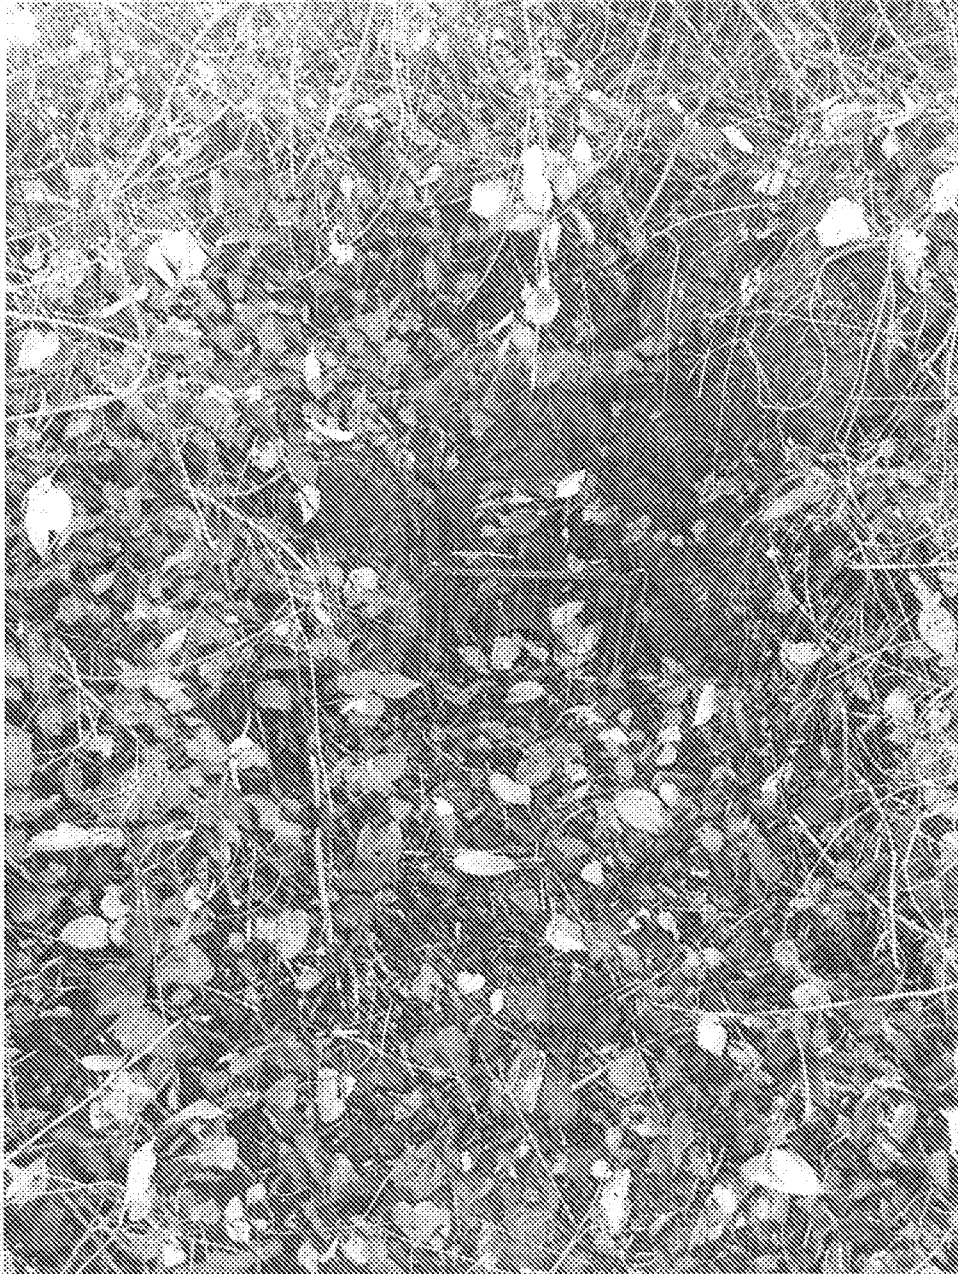
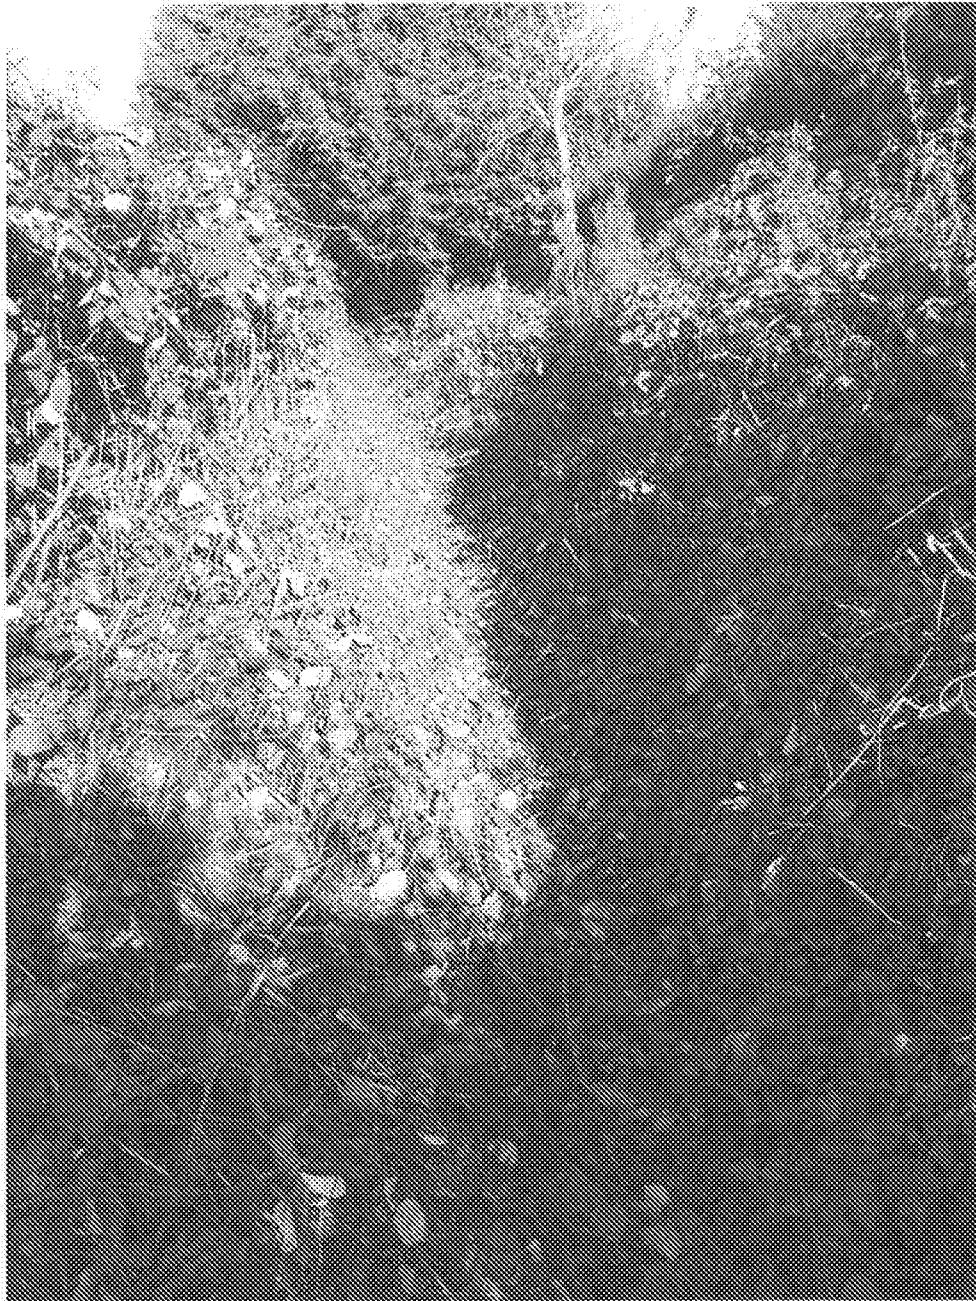
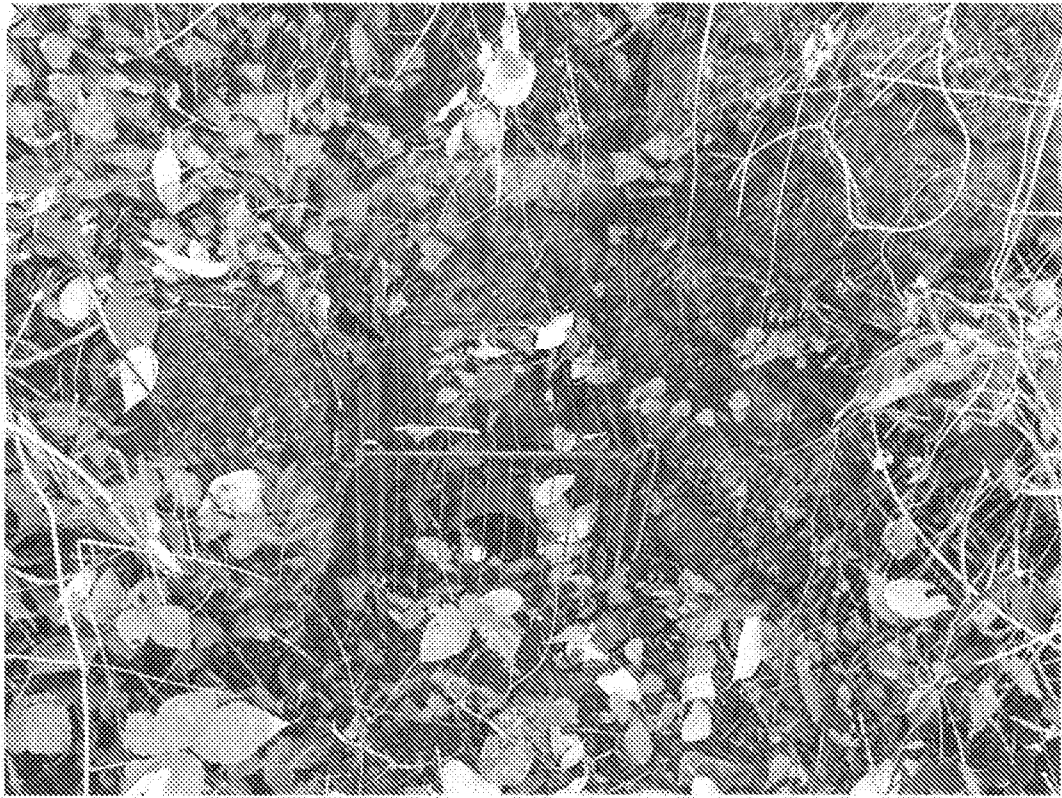
The watercourse has been cleared and photographs are attached below.

As can be seen there is a head wall at the southern end of the ditch with a pipe running under the driveways which continues under the road and in to Hill Lane

The ditch is 2.1m wide at the top and circa 1m wide at the base. The height from the bottom of the pipe (shown in the photo with a debris cage around it) to the top of the head wall is 1m and then a further 250-300mm from the top of the head wall to ground level.

The previous owner of the site who has lived there all his life advised that the ditch has been maintained and cleared every year and that it has always operated well. He replaced the section of pipe that is on his land a few years back and it has to his knowledge always operated well. Currently the greenhouses to the west of the ditch all discharge rainwater via downpipes in to the ditch and it disperses well without issue.
