Land west of Fontwell Avenue, Eastergate

Factual Letter Report 18158/FLR Rev 1.02 February 2020

**Re: Land west of Fontwell Avenue, Eastergate, Chichester, West Sussex PO20 3RX**

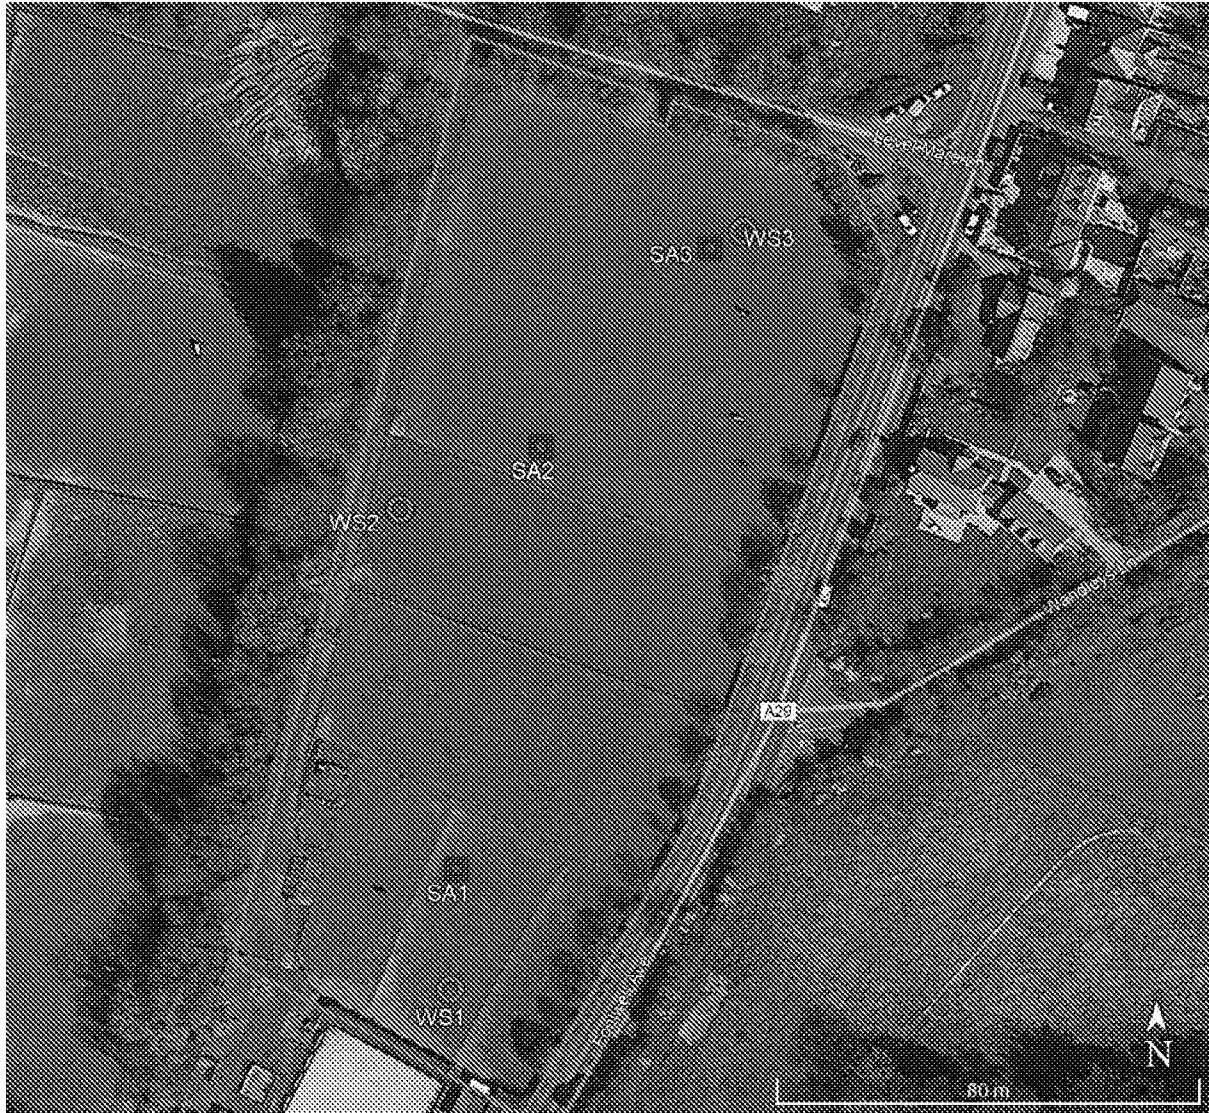
Trial Hole Location Plan

A trial hole location plan is included as Figure 2.

The locations of the standpipes are included within trial hole location plan in Figure 2.

Site Works were undertaken on 3<sup>rd</sup> February 2020 and comprised the machine excavation of three trial pits (SA1 – SA3), using 5 tonne tracked 360 excavator, to depths ranging between 2.10m and 3.00m below ground level (bgl) at locations selected by the client.

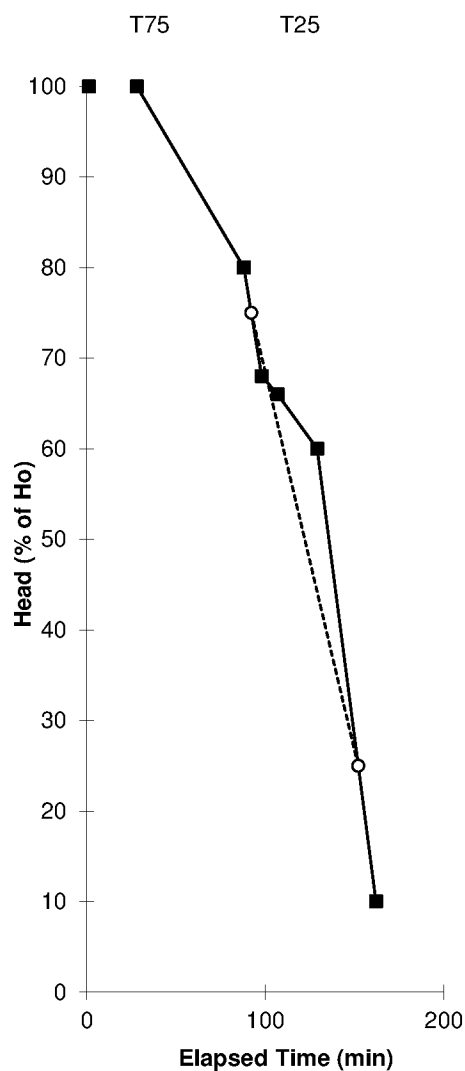
| Soakaway Test No. | SA2 Test 1 |

Pit walls collapsing resulting in raise in head

| Trial Hole<br>(Test No.) | Test<br>Stratum | Trial Pit<br>Depth<br>(m bgl) | Water Level<br>Start of Test<br>(m bgl) | Infiltration<br>Rate<br>(m/sec) | Comments |
|---|---|---|---|---|---|
| SA2(1) | HEAD | 2.40 | 1.90 | $3.29 \times 10^{-5}$ | Pit walls collapsing during test. |

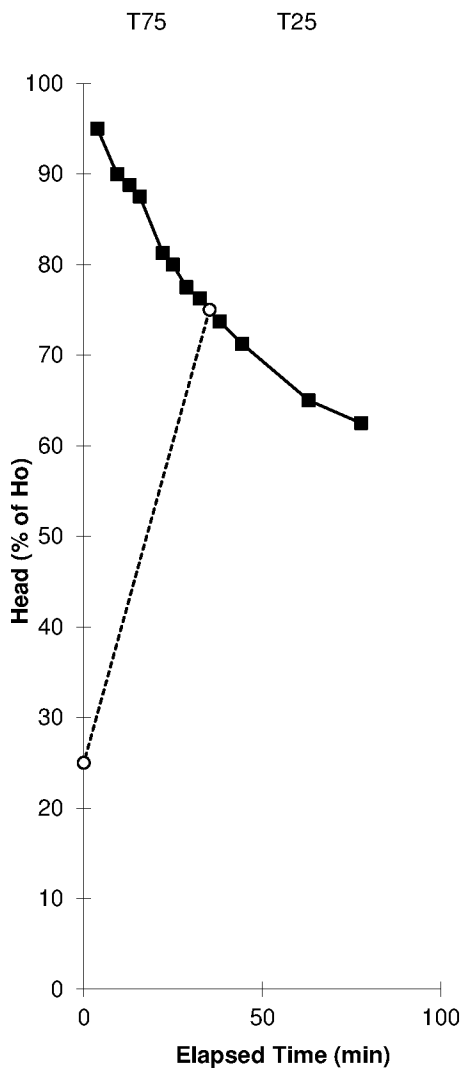
| Soakaway Test No. | SA2 Test 2 |

Pit walls collapsing. Test not complete within observation period.

| Trial Hole<br>(Test No.) | Test<br>Stratum | Trial Pit<br>Depth<br>(m bgl) | Water Level<br>Start of Test<br>(m bgl) | Infiltration<br>Rate<br>(m/sec) | Comments |
|---|---|---|---|---|---|
| SA1(2) | HEAD | 2.40 | 1.60 | n/a | Pit walls collapsing during test. Test did not complete within observation period. 300mm fall in head observed over 78 minutes. |

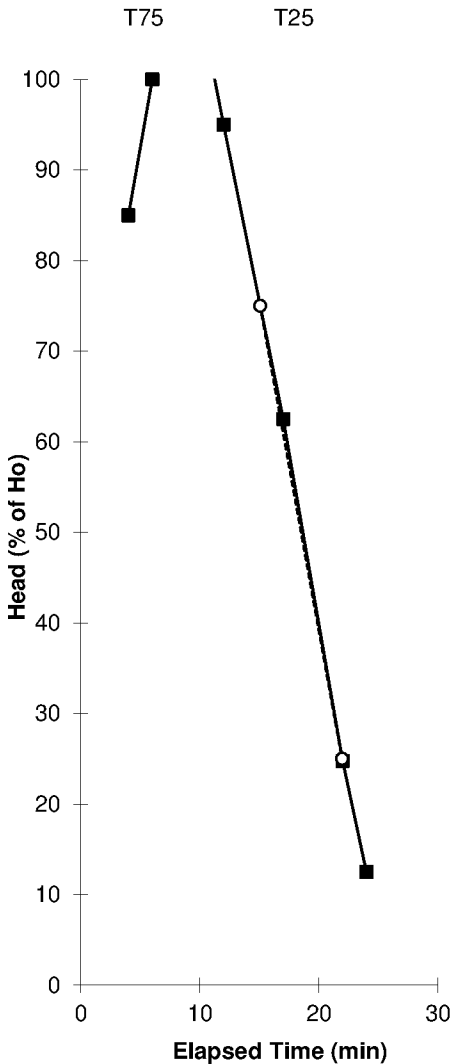
| Soakaway Test No. | SA3 Test 1 |

Pit walls collapsing resulting in raise in head

| Trial Hole<br>(Test No.) | Test<br>Stratum | Trial Pit<br>Depth<br>(m bgl) | Water Level<br>Start of Test<br>(m bgl) | Infiltration<br>Rate<br>(m/sec) | Comments |
|---|---|---|---|---|---|
| SA3(1) | HEAD | 2.50 | 2.10 | $2.65 \times 10^{-4}$ | Pit walls collapsing during test. |
