## **Main Investigation Report**

**The Croft Medical Centre, Barnham Road, Eastergate,  
West Sussex PO20 3RP**

**PHP Primary Care Developments**

**Reference: I9023/MIR\_R27  
March 2021**

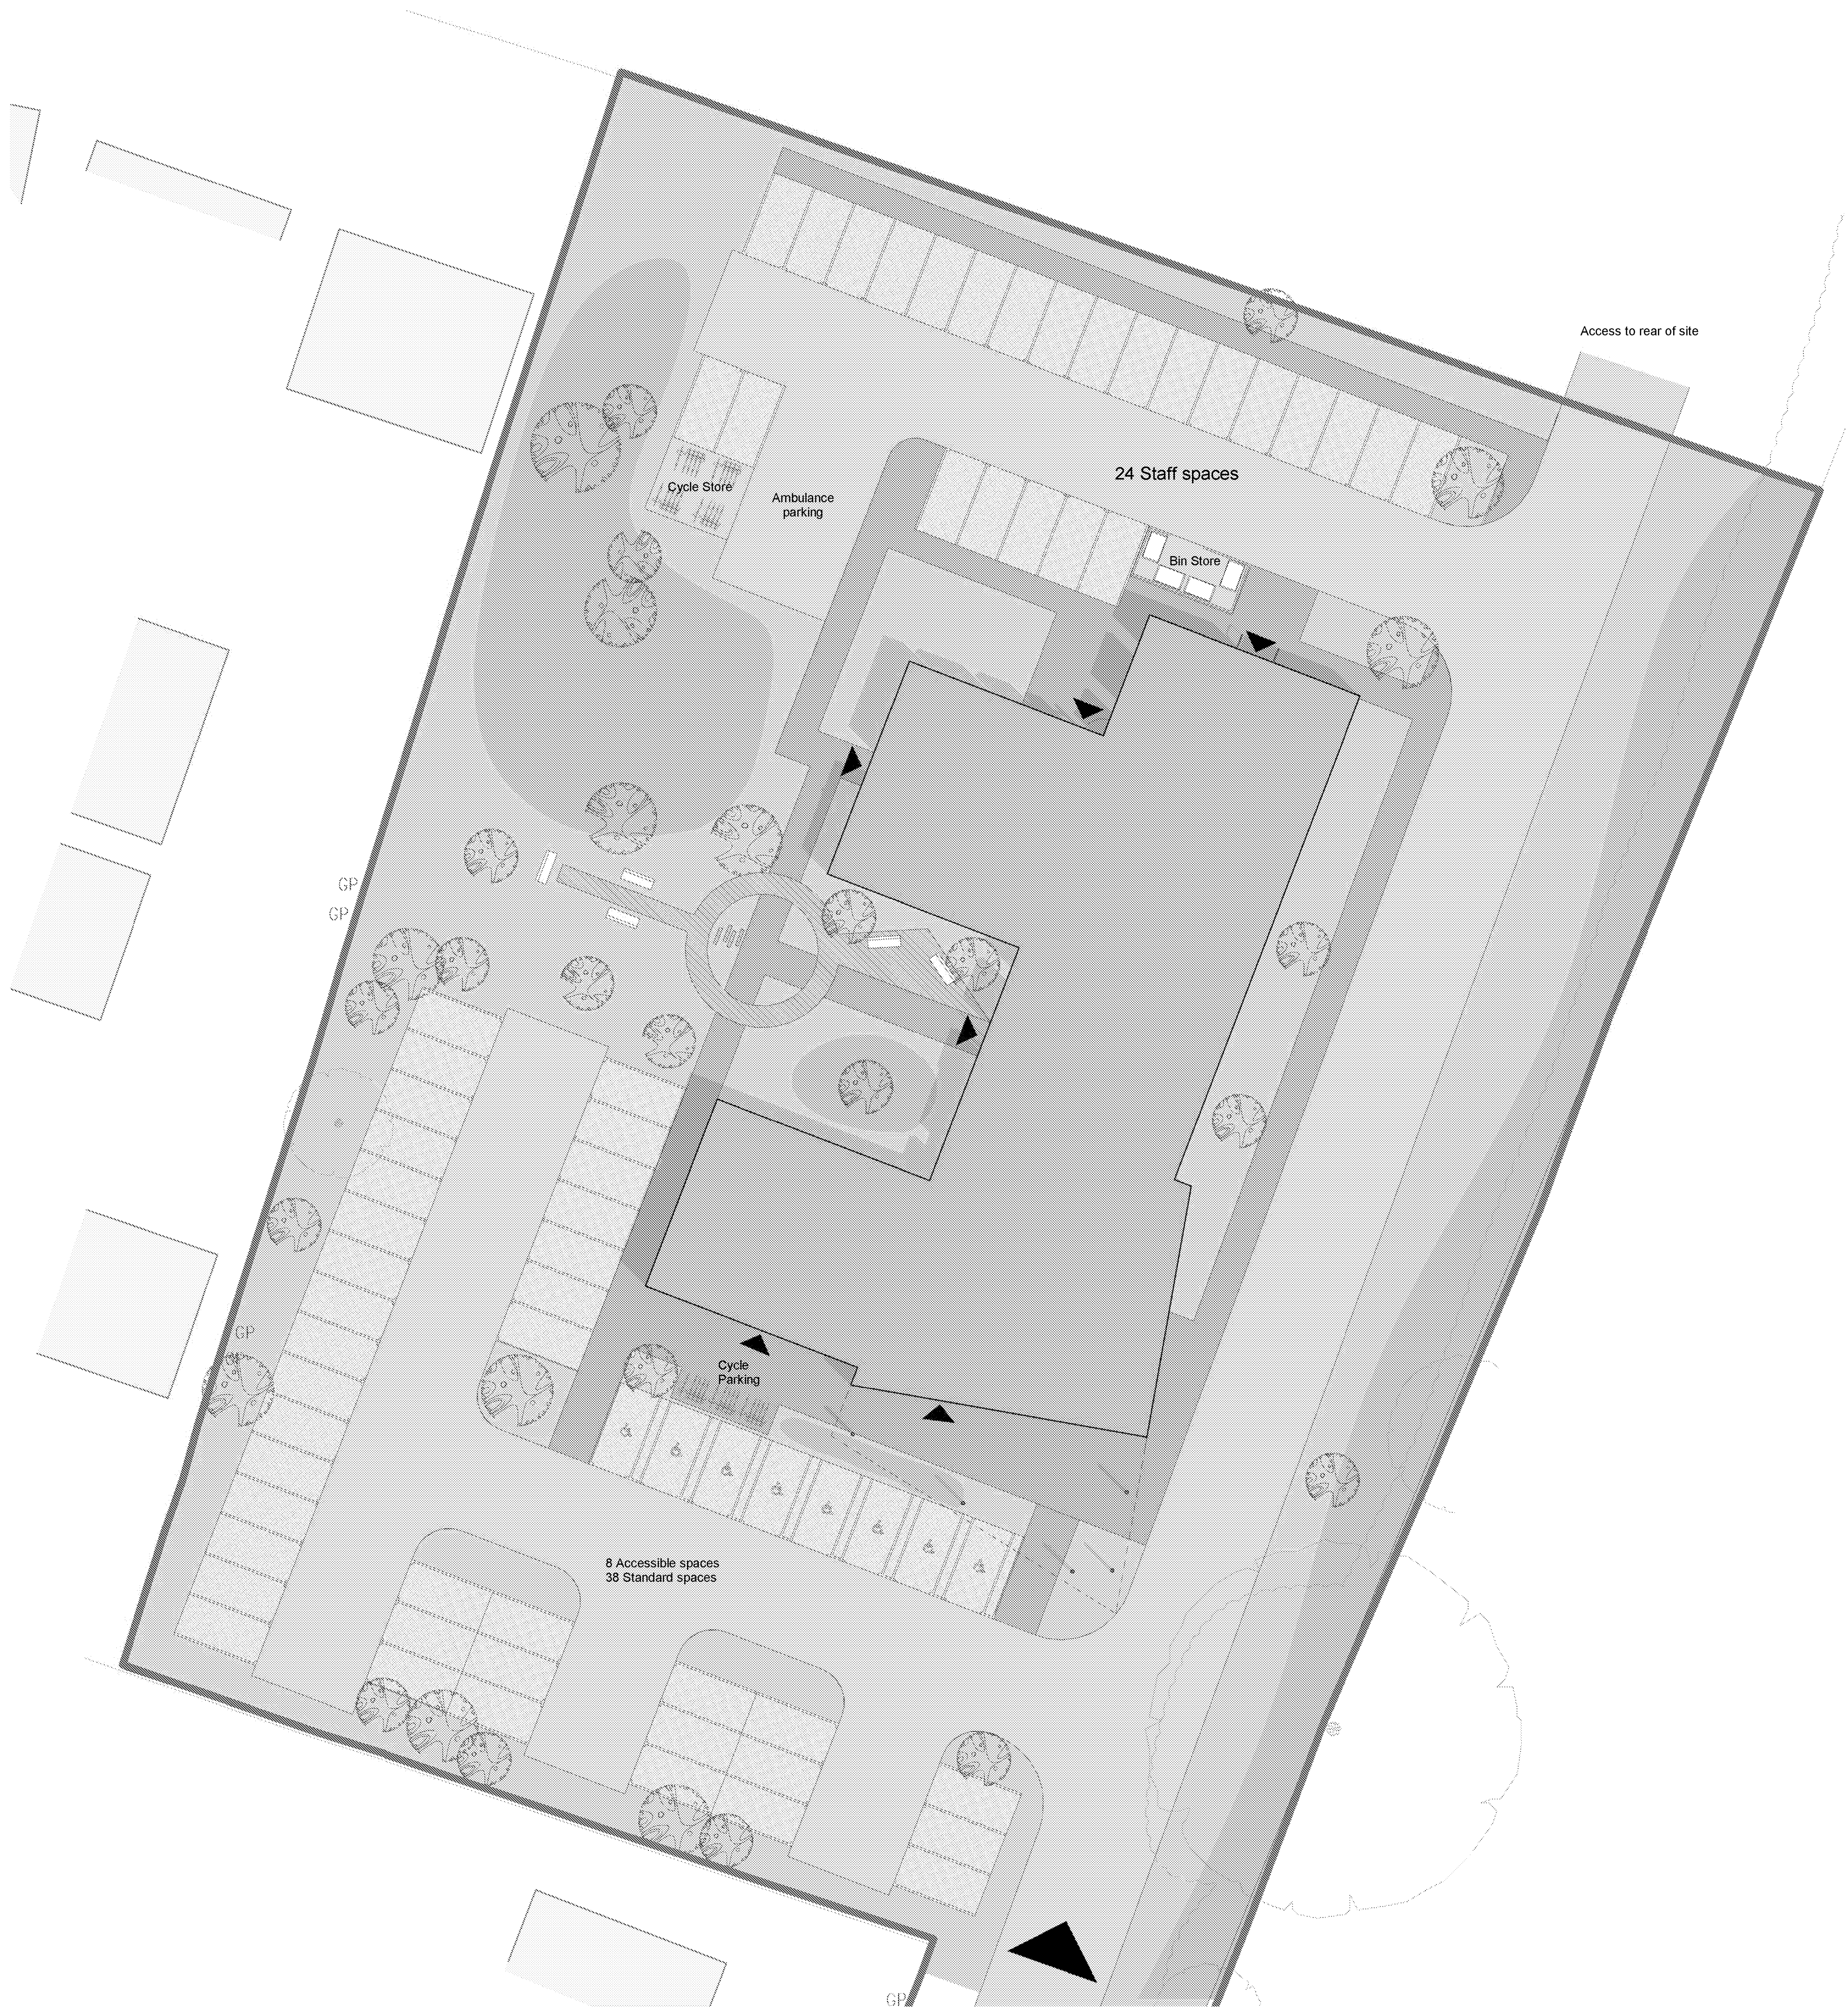
Drawing No. 9226-P004 Revision:

Proposed Site Plan  
1 : 200

In compiling this report reliance was placed on drawings 9226.P004 - Proposed Site Plan and 9226.P005 - Proposed Floor Plans, dated June 2020 and were prepared by Simpson Hilder Associates Limited. The recommendations provided within this report are made exclusively in relation to the scheme outlined above and must not be applied to any other scheme without further consultation with Soils Limited. Soils Limited must be notified about any change or deviation from the scheme outlined.
