## Preliminary Ecological Appraisal

Land at Bexstone House  
Eastergate, West Sussex

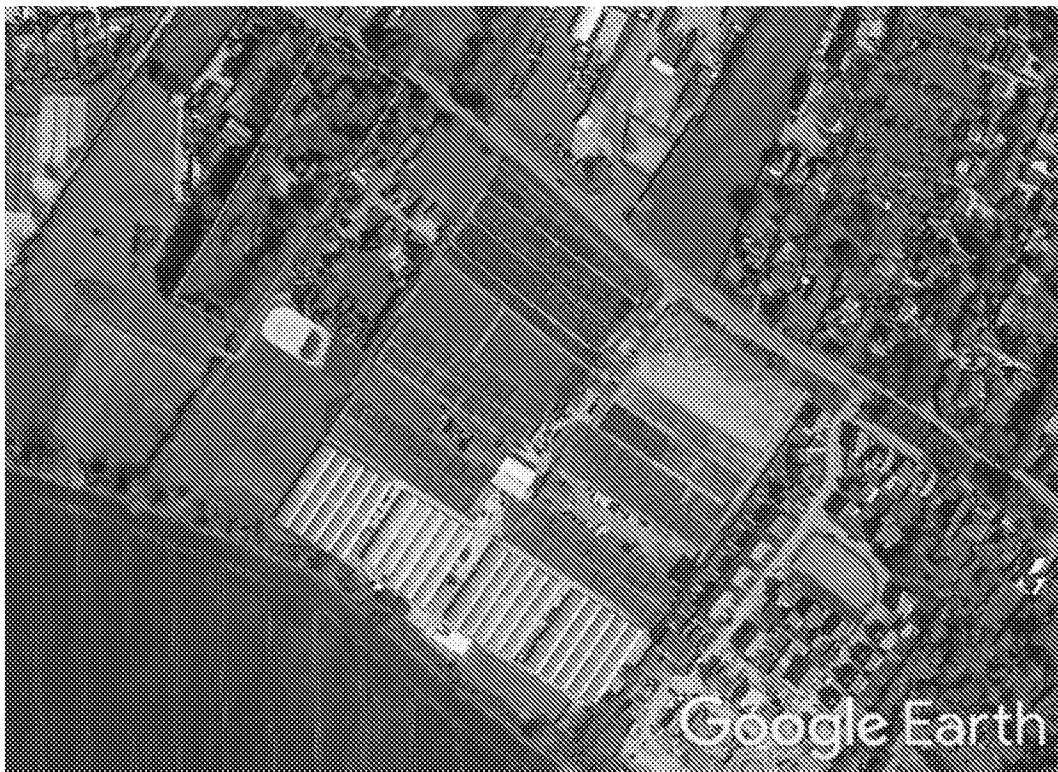
- 3.16 There were no ponds on site and the only waterbody in close vicinity to the red line boundary is a pond approximately 200m southeast. This could not be accessed at the time of the survey as it is located on private property. However, it should be noted that there are a number of glasshouses between the pond and the site which may act as barriers to dispersal.

*Figure 3: Pond within a 250m radius of the red line boundary*

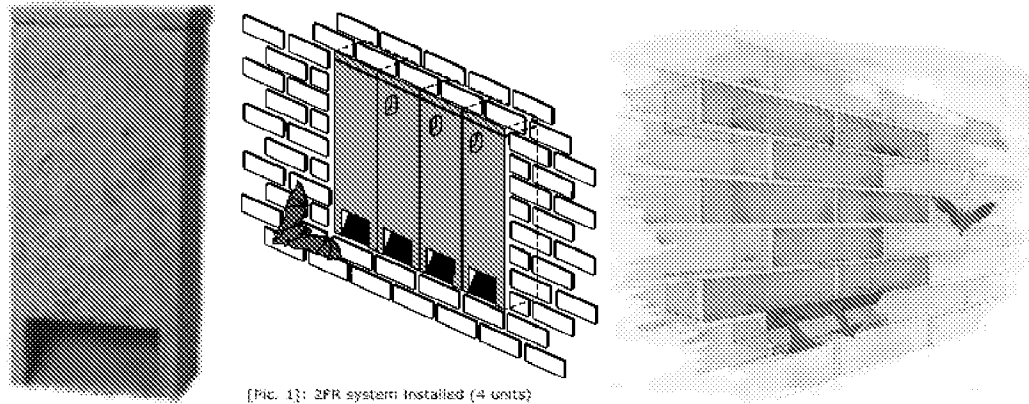
*Figure 4: Bat tubes incorporated into the wall of a building to provide roosting space*

4.12 To enhance the local bat population and provide roosting opportunities within the new development, it is recommended that integrated bat boxes/tubes be incorporated into the structure of the new buildings (Figure 4). These provide good opportunities for crevice-dwelling species such as pipistrelles. The opening of the bat box/tube will be the only section visible and they are designed so that they require little to no maintenance. Several of these tubes can be established in a row together providing a good-sized roost space. The bat tubes should be inserted as high up as possible in the brickwork. Habitat, in association with the Bat Conservation Trust, provide a range of boxes which are unfaced for render or designed to match the brickwork of the building.

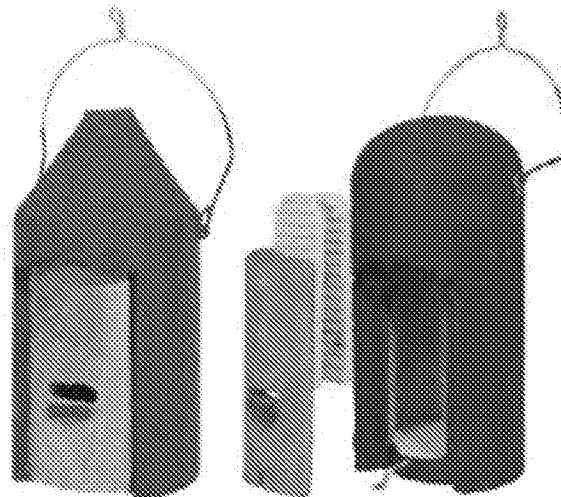
*Figure 5: Schwegler 2F (left) and 1FD (right) bat boxes*

- Schwegler 2F Bat Box – These boxes are attractive to small bats such as pipistrelles and long-eared bats and can be hung on trees (Figure 5).
- Schwegler 2FN Bat Box – This is slightly larger than the 2F and provides opportunities for the larger bats such as noctules. These should be hung on mature trees.
- Schwegler 1FD Bat Box - This box has been designed specifically for smaller bats and provides opportunities as a maternity roost (Figure 5).

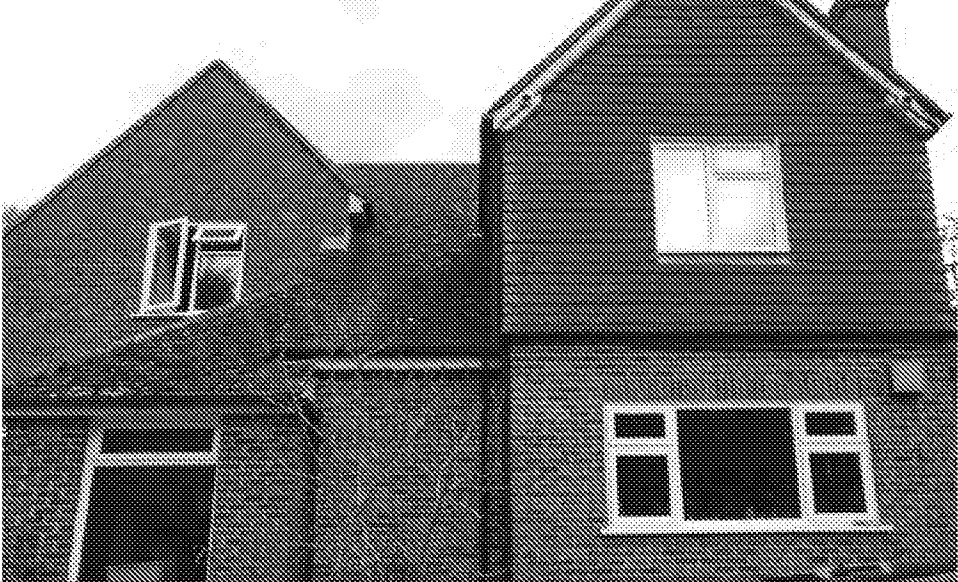
| <p><b>Photograph 1:</b><br/>Back of<br/>Bexstone<br/>House</p> | |

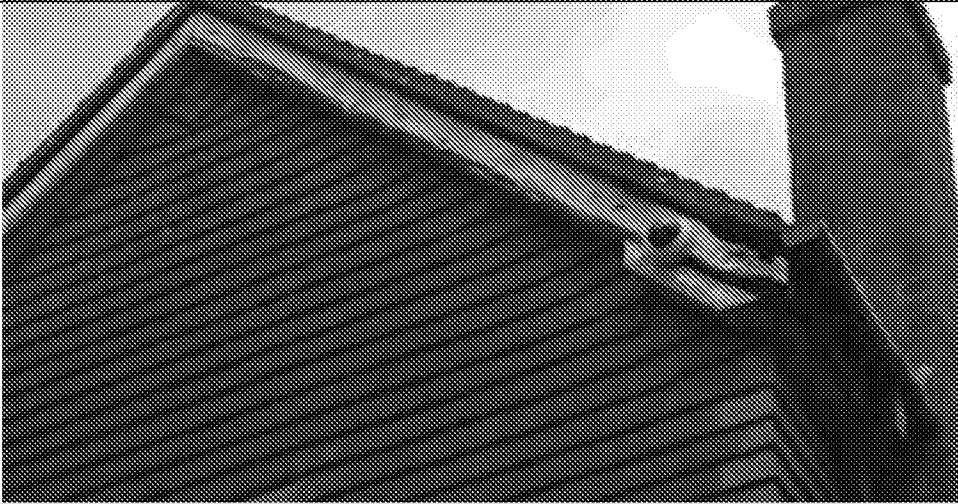
| <p><b>Photograph 2:</b><br/>Broken part of<br/>soffit boarding<br/>at back of<br/>house</p> | |

- 4.5 Both the house and the outbuilding were considered to have low roosting bat potential due to the presence of a small number of external features which may be used opportunistically by a small number of bats. As a precautionary approach, it is recommended that a single bat emergence/re-entry survey be carried out in order to determine if any of the features identified are being used. The Bat Conservation Trust guidelines (2016) recommended that this survey be carried out between May and August in suitable weather conditions.

- 5.3 The house and outbuilding were considered to have low roosting bat potential due to a small number of suitable external features present. As a precautionary approach, a single emergence/re-entry survey has been recommended to determine if any of the identified features are being used by bats.

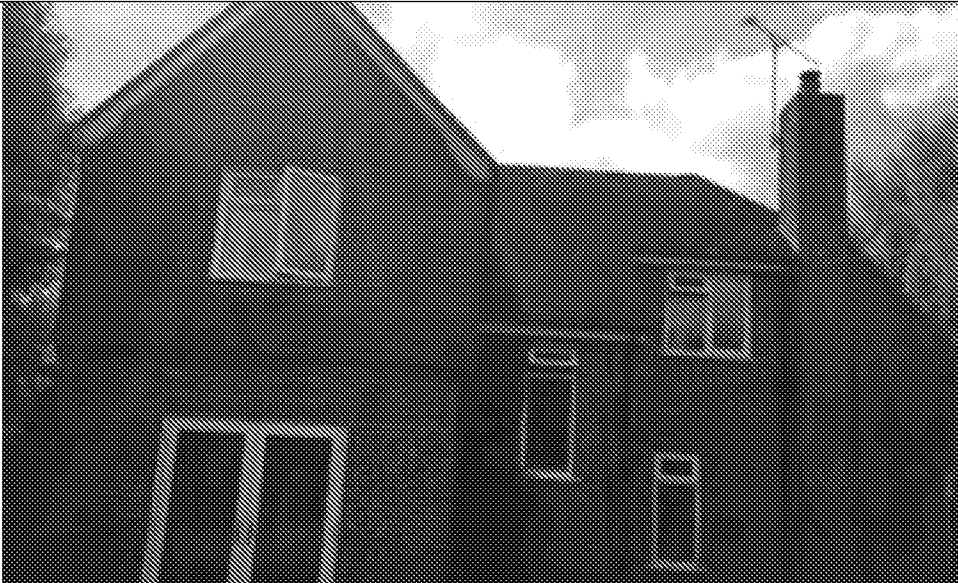
| <p><b>Photograph 3:</b><br/>Front of<br/>Bexstone<br/>House with<br/>intact soffit<br/>boarding</p> | |

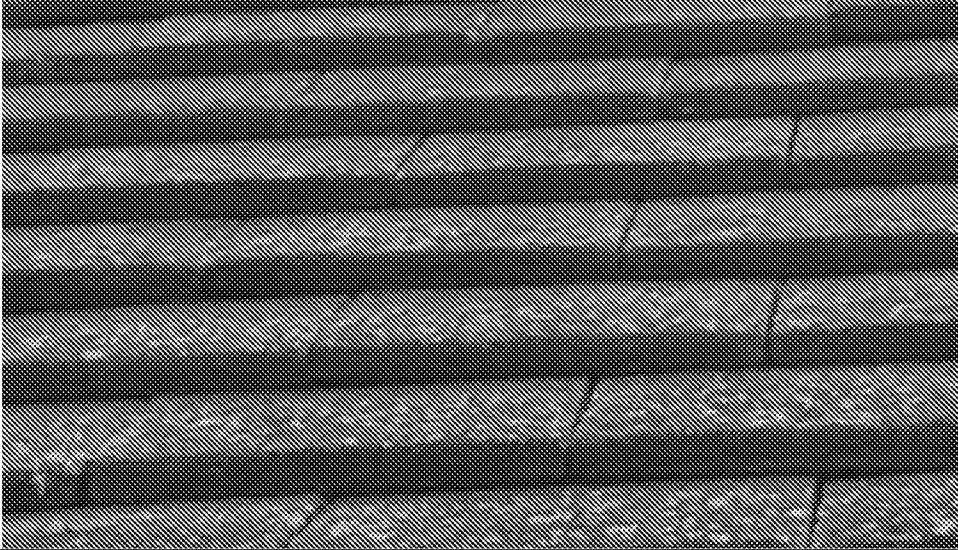
| <p><b>Photograph 4:</b><br/>Hanging tiles<br/>flush at the<br/>front of the<br/>house</p> | |

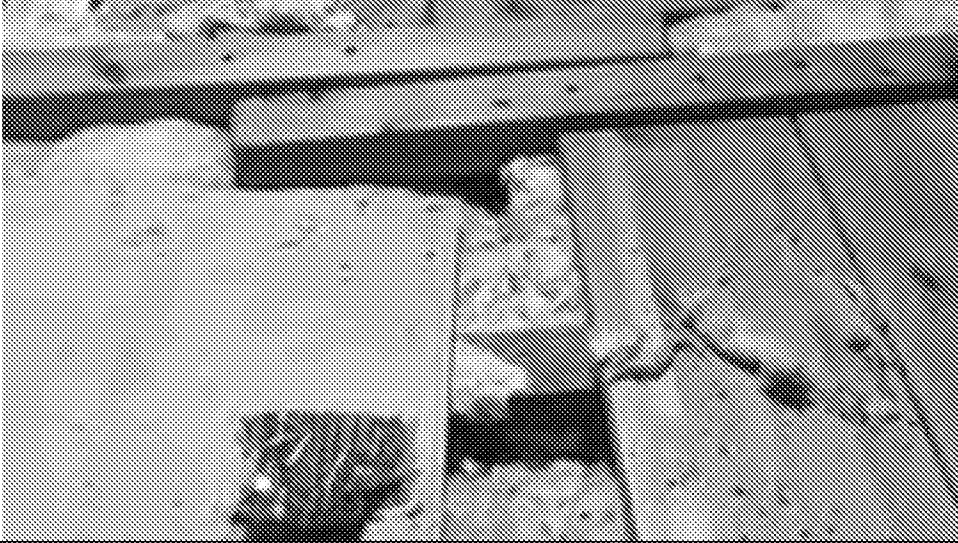
- 3.11 Internally, there was one roof void with intact felt lining and insulation along the base of the void only. No evidence of bats was found in the void, only mouse droppings and there were no potential access points observed. The building was considered to have low roosting bat potential.

| <p><b>Photograph 5:</b><br/>Mouse<br/>droppings in<br/>void of<br/>Bexstone<br/>House</p> | |

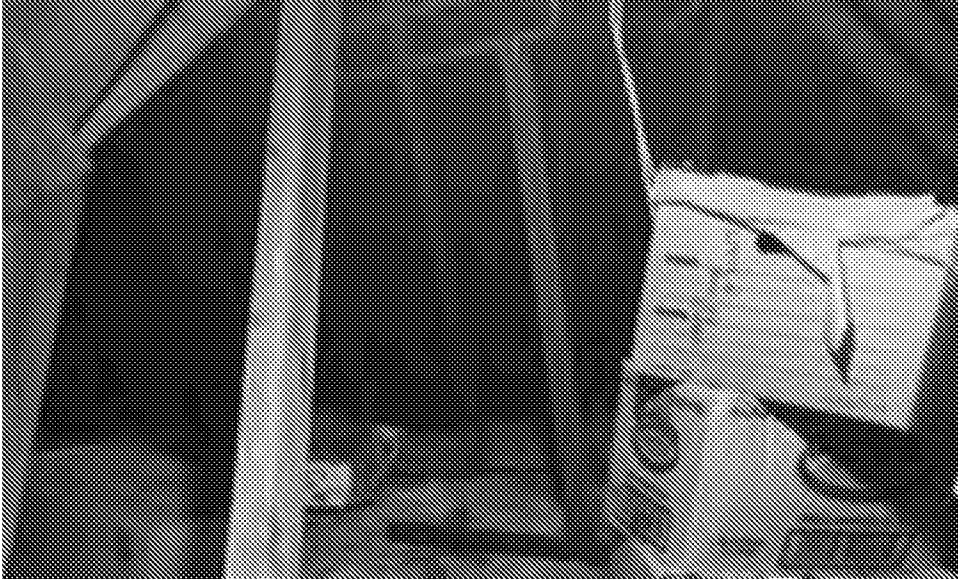
| <p><b>Photograph 6:</b><br/>One end of the<br/>void in<br/>Bexstone<br/>House used<br/>for storage</p> | |

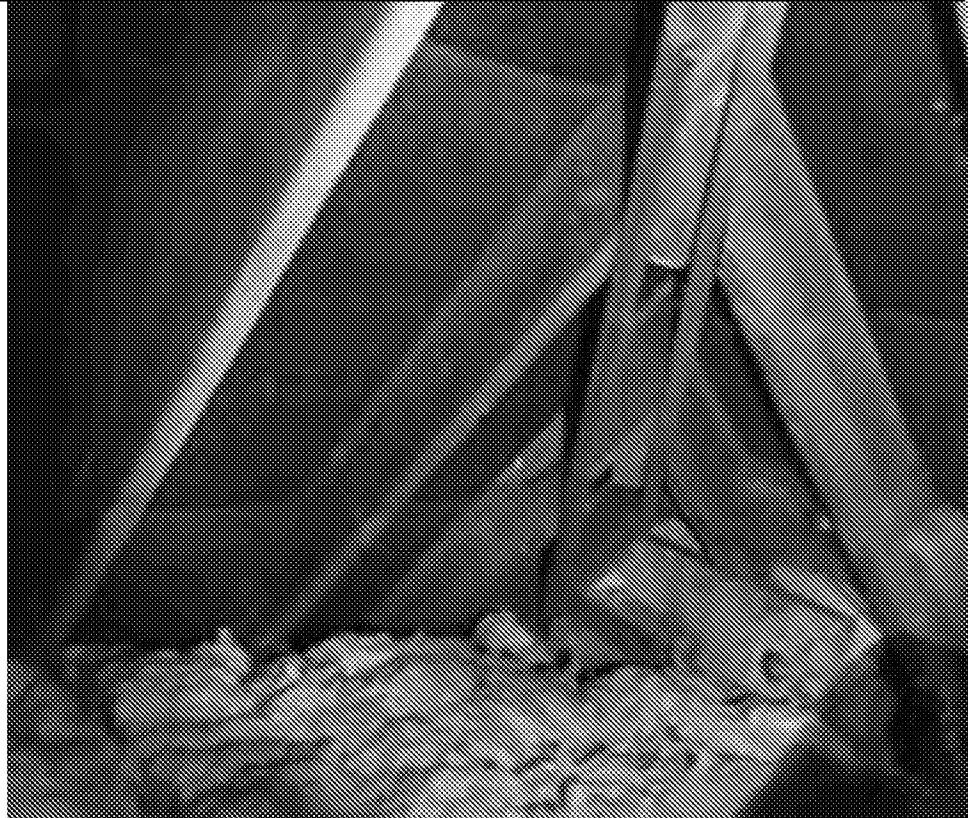
**Photograph 7:**  
Well-sealed  
lining of roof  
void

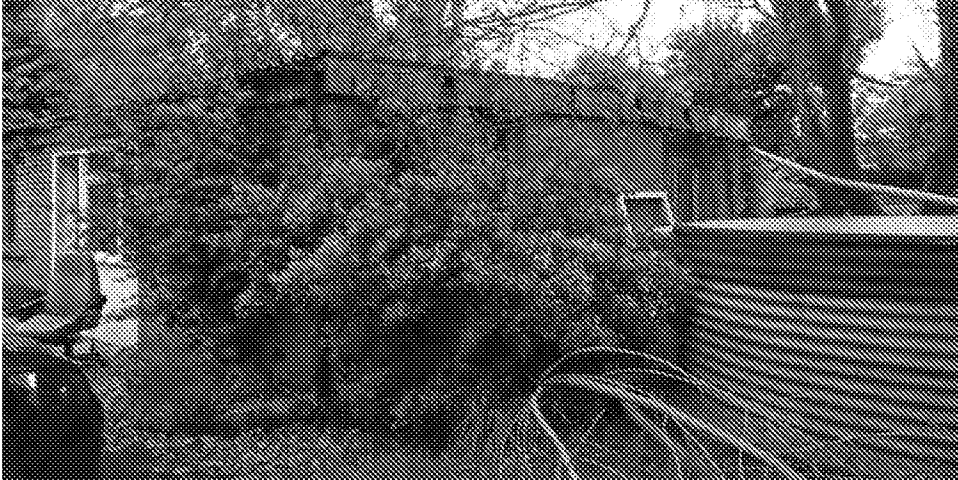
| <p><b>Photograph 9:</b><br/>Outbuilding<br/>next to house</p> | A black and white photograph showing a small outbuilding with a corrugated metal roof and walls, partially obscured by dense foliage and trees. A window is visible on the side of the building. |

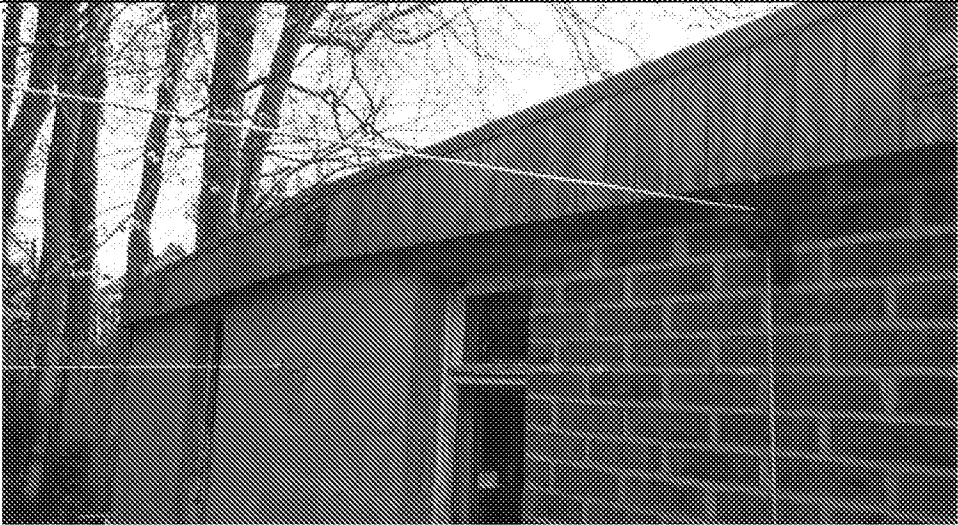
| <p><b>Photograph 10:</b> Wooden<br/>cladding intact<br/>on northern<br/>aspect</p> | A black and white photograph of a building's exterior. The lower portion shows a brick wall, while the upper portion features wooden cladding. A window is visible in the brick section. Bare trees are in the background. |

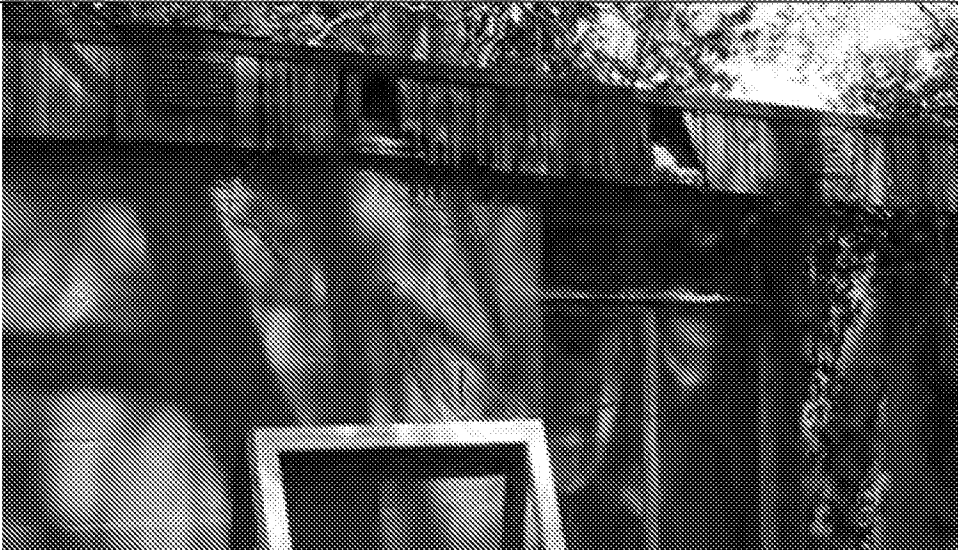
| <p><b>Photograph 11:</b> Holes in<br/>cladding of<br/>outbuilding<br/>on southern<br/>aspect</p> | A black and white photograph showing the exterior of an outbuilding. The wooden cladding is in poor condition, with several large holes and missing sections. A window is visible in the lower part of the frame. |

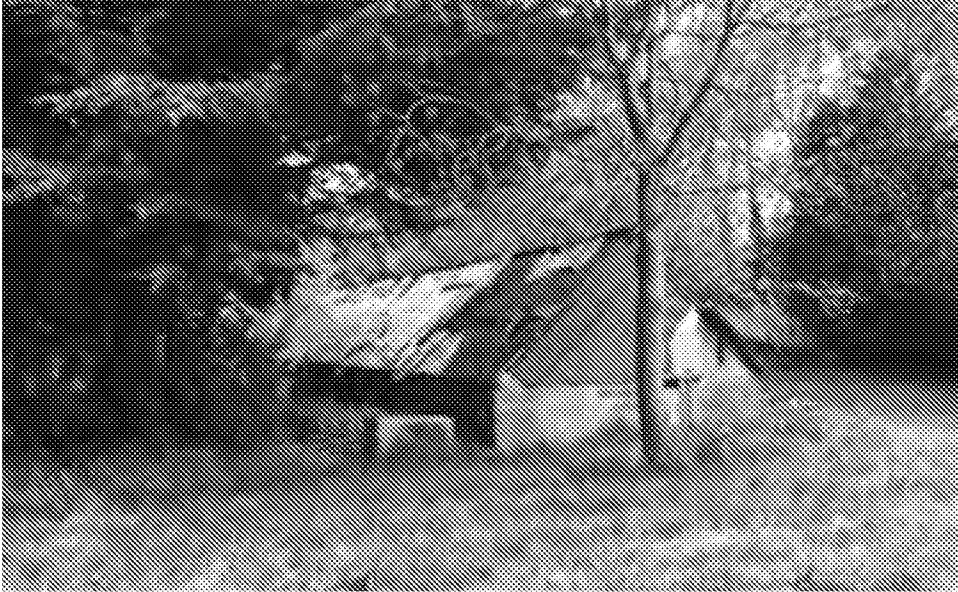
| <p><b>Photograph</b><br/><b>12:</b> Disused glasshouse in back garden</p> | |

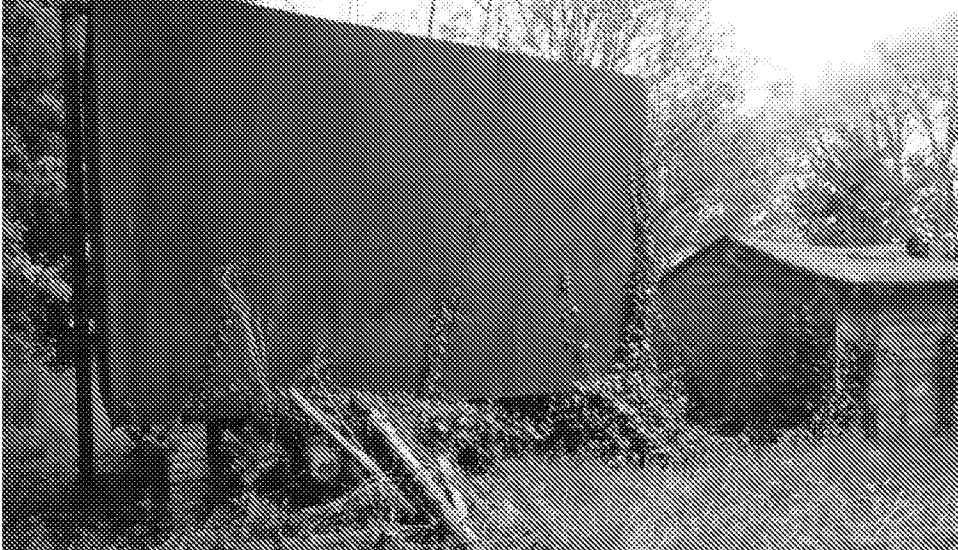
| <p><b>Photograph</b><br/><b>13:</b> Shed and old water tank and shed in back garden</p> | |

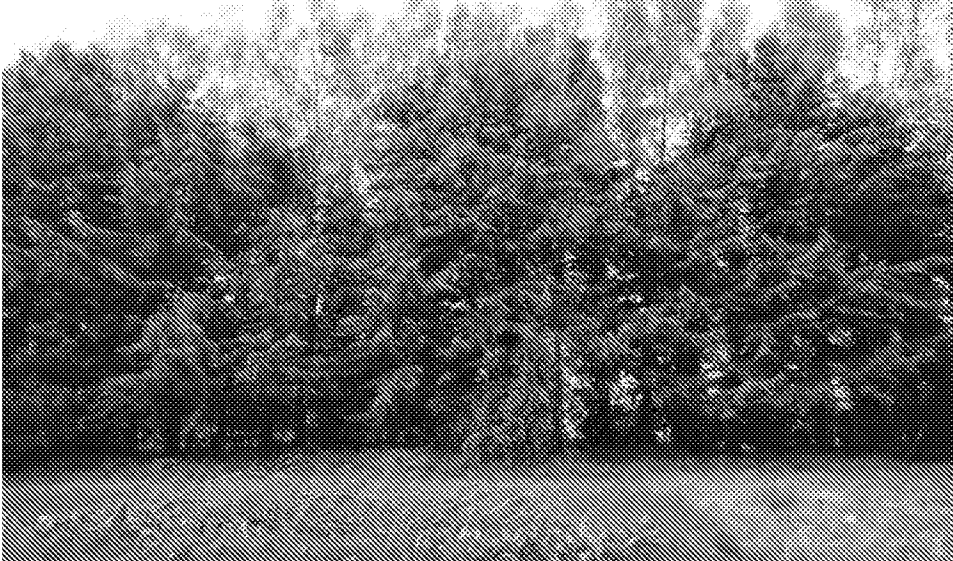
| <p><b>Photograph</b><br/><b>15:</b> Western<br/>tree line in<br/>back garden</p> | A black and white photograph showing a dense line of trees and shrubs in a garden. The foliage is thick and varied in height, creating a dark, textured wall of vegetation. |

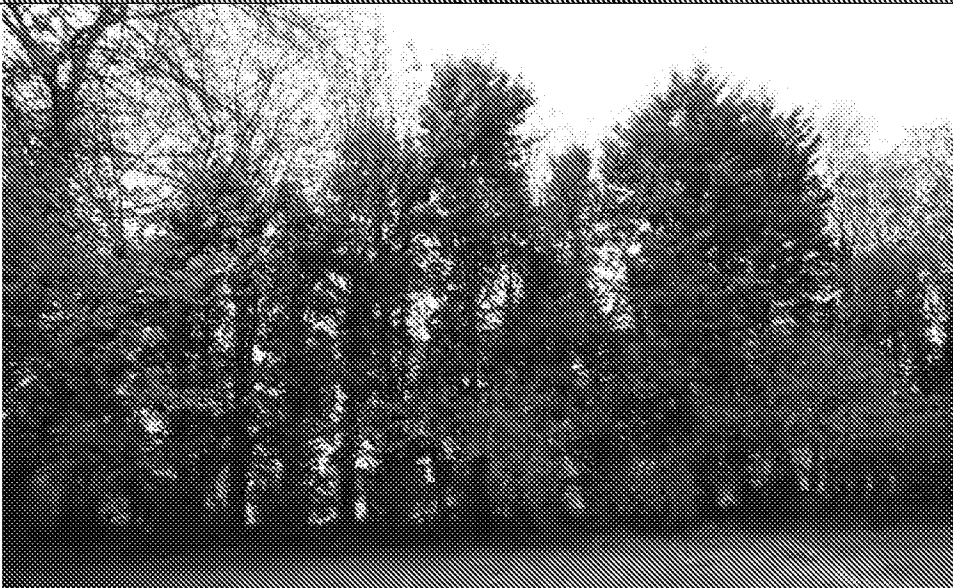
| <p><b>Photograph</b><br/><b>16:</b> Southern<br/>tree line of<br/>back garden</p> | A black and white photograph of a row of tall, slender trees, possibly pines or cypresses, standing in a line. They are set against a lighter background, and their shadows are cast on the ground in front of them. |

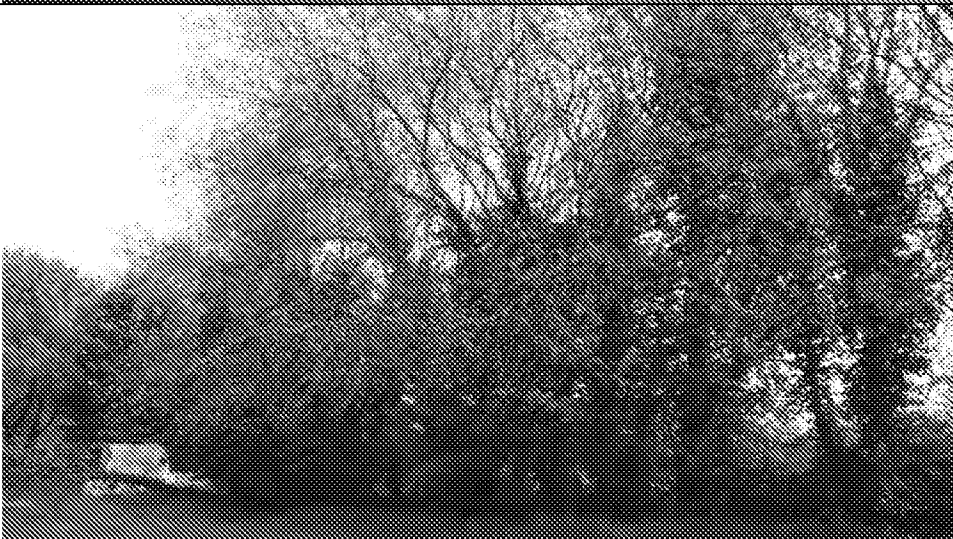
| <p><b>Photograph</b><br/><b>17:</b> Eastern<br/>tree line of<br/>back garden</p> | A black and white photograph showing a dense thicket of trees and bushes. The view is somewhat obscured by the branches and leaves, giving it a sense of being deep within a wooded area. |
