# **Road Safety Answers**

## **Road Safety Audit Stage 1**

**Bexstone House, Eastergate, West Sussex**

**Road Safety Answers reference no: RSA172**

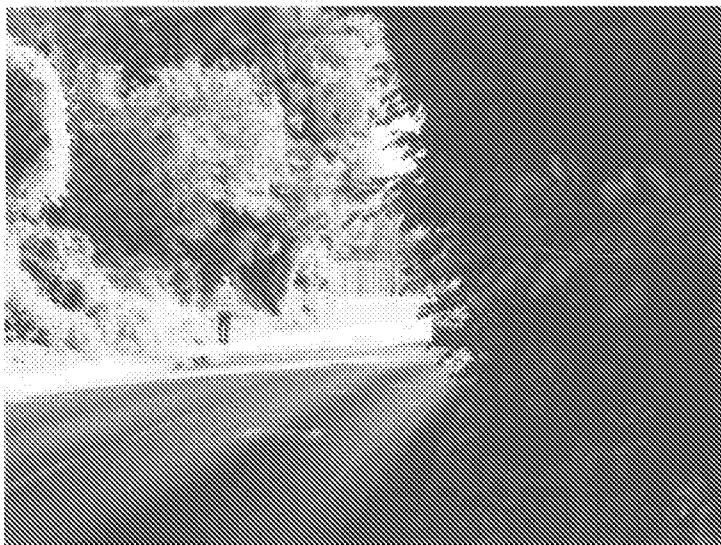
**Photo 2: Looking west from the southern side of Barnham Road at the proposed crossing location**

**Location:** B – East of the eastern pedestrian refuge.

**Summary:** Risk of vehicle/pedestrian collisions.

Due to the bend in Barnham Road to the east of the site and vegetation alongside, visibility for a pedestrian, stepping from the southern kerb to use the uncontrolled crossing, will be poor (photo 2), increasing the risk of vehicle/pedestrian collisions.

On the southern side of Banham Road, to the east of the eastern crossing point, the trees and vegetation should be cut back to achieve adequate visibility to approaching vehicles for a pedestrian waiting to cross from the southern tactile paving.

Trees and vegetation will be cut back to achieve adequate visibility to approaching vehicles for a pedestrian waiting to cross from the southern tactile paving.

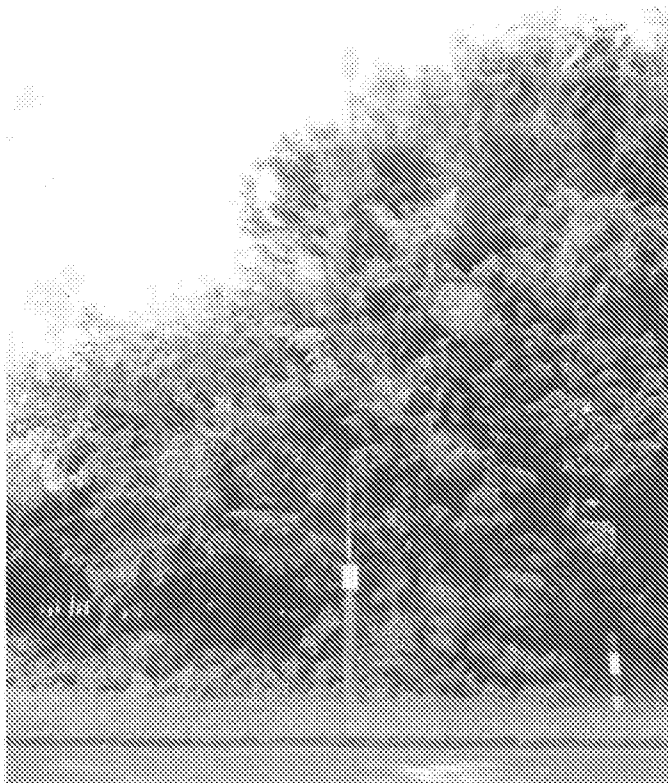
**Photo 4: Lamp column on the south side of Barnham Road, just west of the site access**

Location: E – South side of Barnham Road, west of the site access.

Summary: Risk of darkness related collisions.

There are two lamp columns that will require relocating further into the verge to accommodate the carriageway widening. One of these, approximately 10m west of the site access, is already located within the canopy of the mature trees on the southern side of Barnham Road (photo 4), obstructing its illumination of the carriageway at night. This will only get worse once it is relocated further to the south, increasing the obstruction of illumination and the consequent risk of darkness related collisions.

The tree branches should be cut back so that the illumination from the relocated lamp columns is not obstructed.

Tree branches will be cut back so that the illumination from the relocated lamp columns is not obstructed
