**SOAKAGE TESTING AND GROUNDWATER MONITORING**

**WAYSIDE, EASTERGATE LANE**

**G6483**

Report Title: Soakage Testing and Groundwater Monitoring  
Wayside, Eastergate Lane

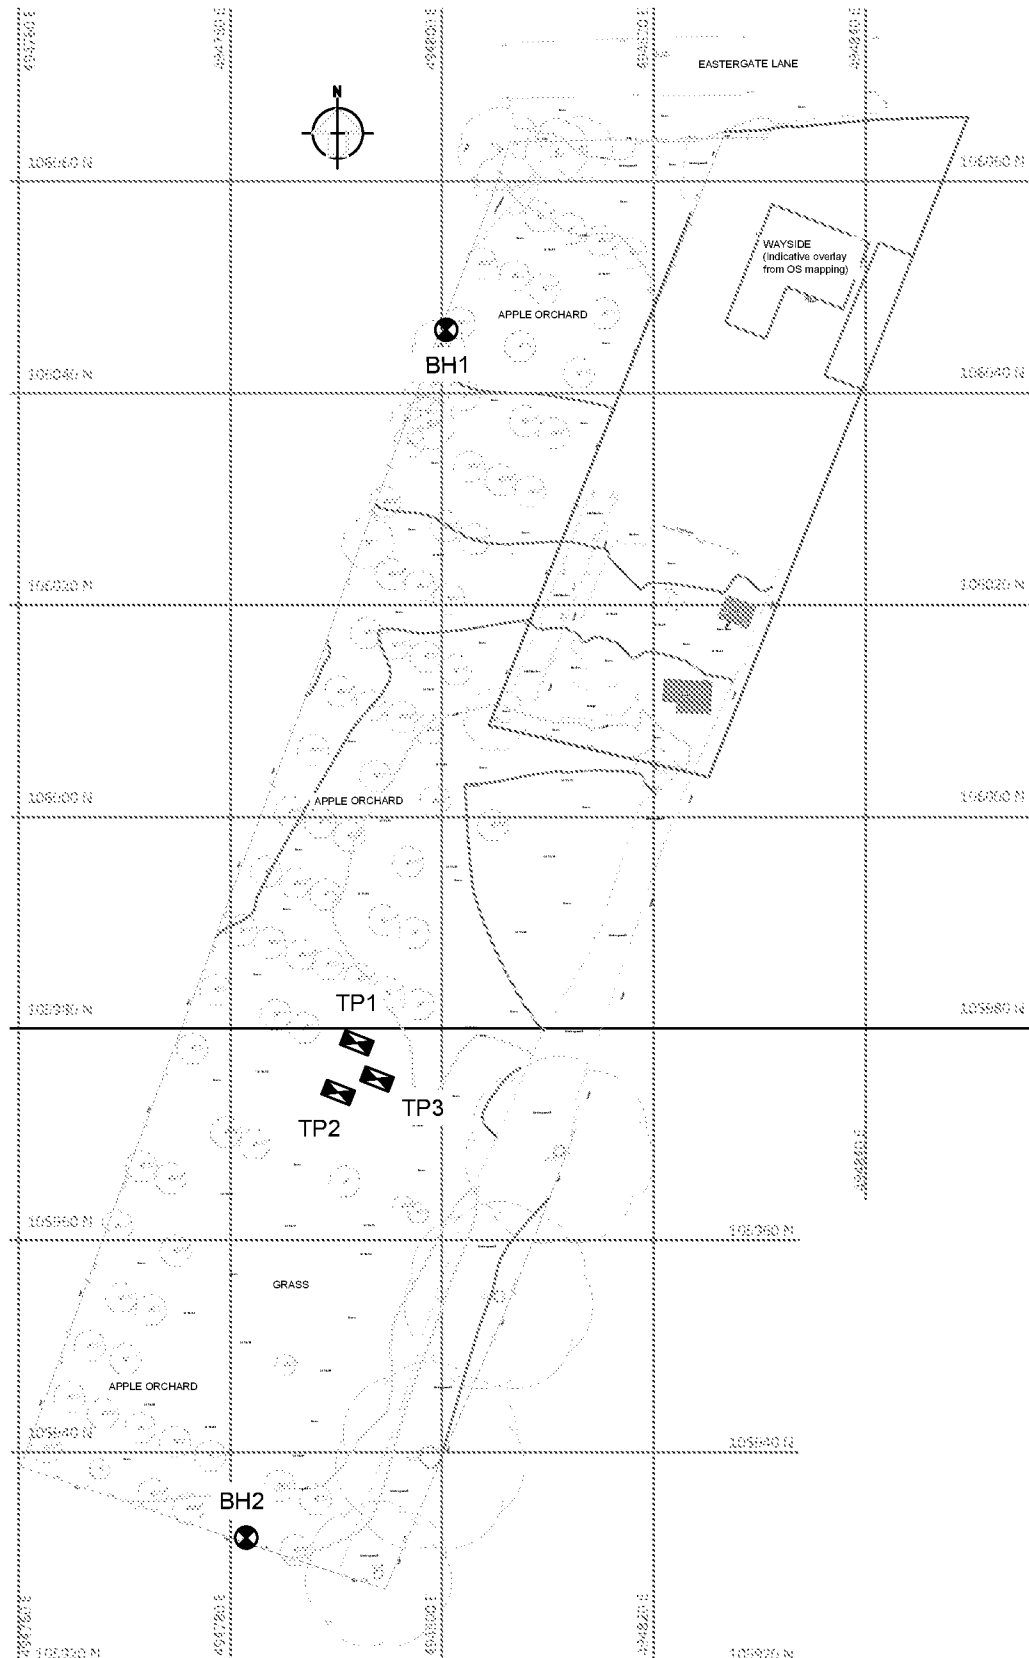
FIGURE REF: Figure 4

TITLE: Exploratory Hole Location Plan

HOLE LOCATIONS ARE INDICATIVE ONLY UNLESS DIMENSIONED

- 5.1 Fieldwork commenced on 22 December 2022 with the excavation of two boreholes, referenced as BH1 and BH2, at the locations indicated on the attached Figure 3 using handheld window sampling equipment.
