Drainage Statement

Land Off Canal Mews,  
Barnham, West Sussex

## DRAINAGE STATEMENT

Project No. SPR032

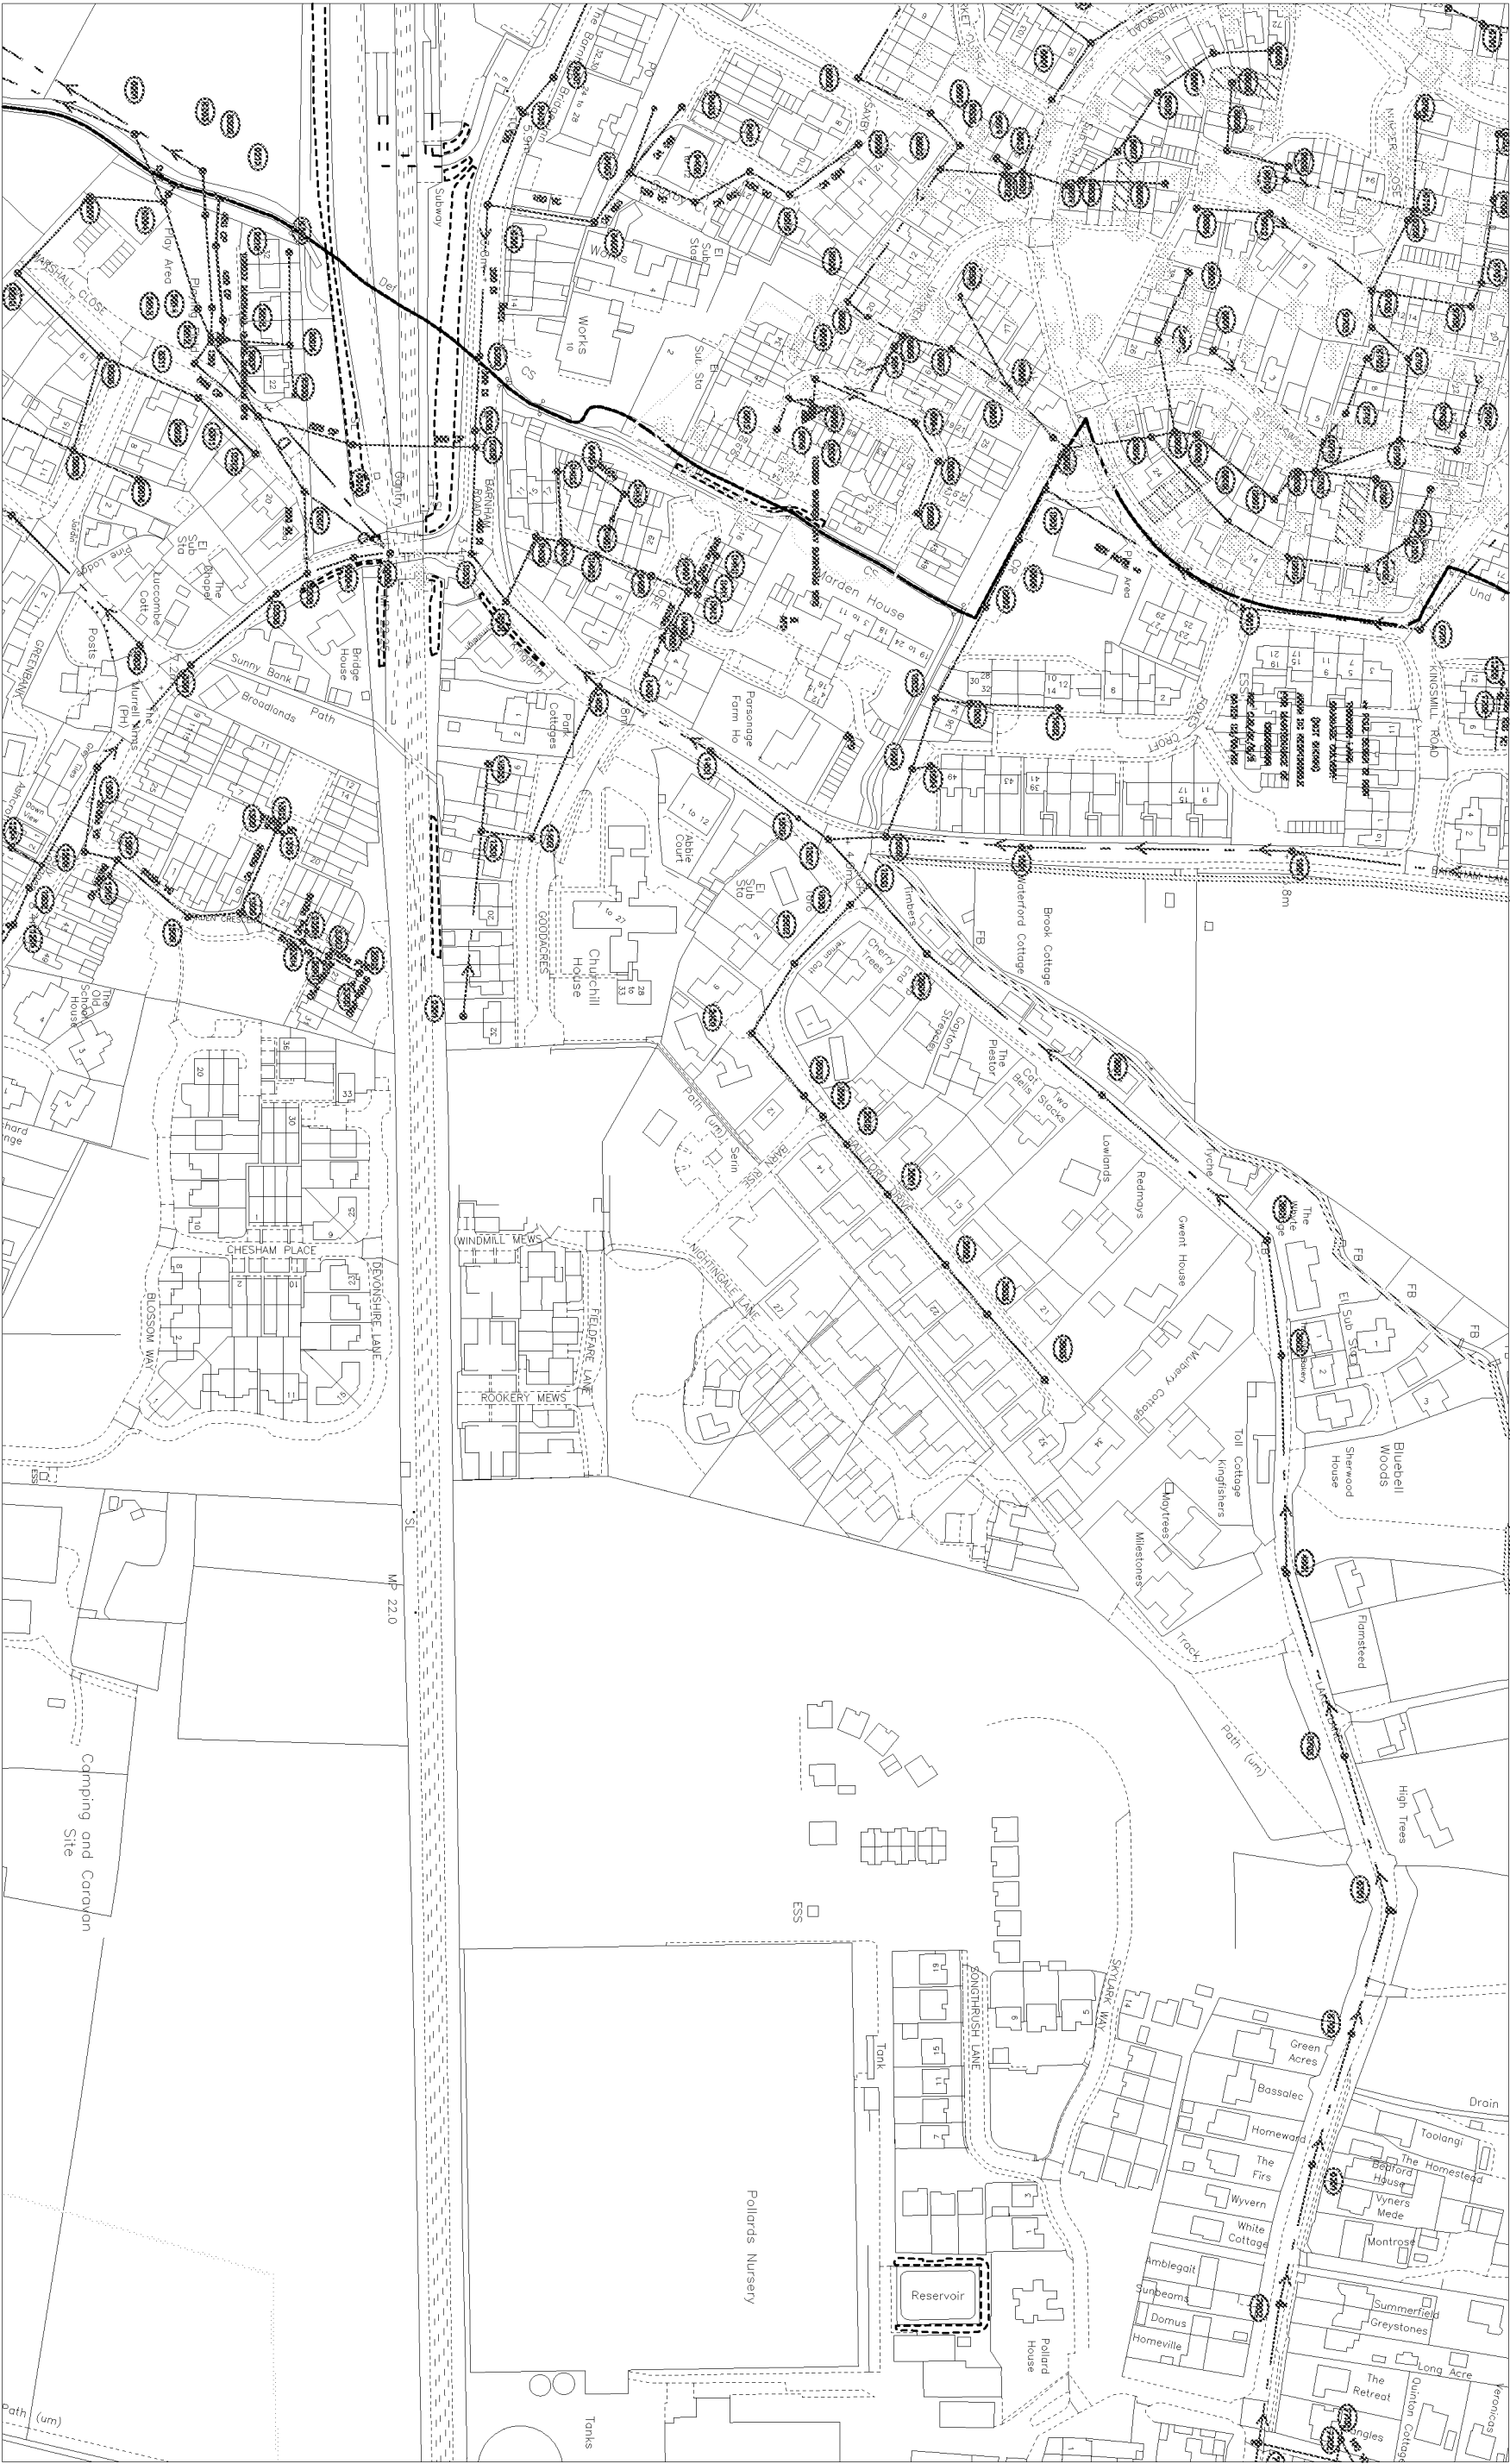
### **Southern Water Sewer Plan**

Review of the Southern Water asset plan confirms that there is an existing 150mm diameter foul water sewer in Halliford Drive running in north to south-westerly direction, with the nearest manhole being manhole ref. 2501 located at the T-junction with Barn Rise to the west of the site. There are no existing public surface water sewers presented within the vicinity of the site on the Southern Water asset location plans. Refer to the Southern Water asset plan in **Appendix 2**.

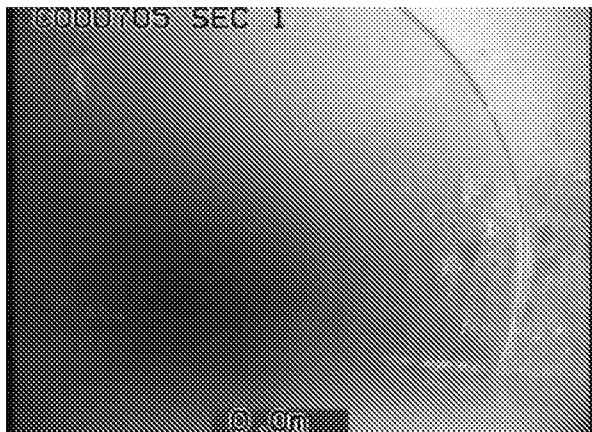
FW1X\_0d76fe4c-d64b-4dff-a029-d21ec7f79804\_20180110\_193300\_411.jpg, 0.00m  
Start node type, manhole, reference number: FW2

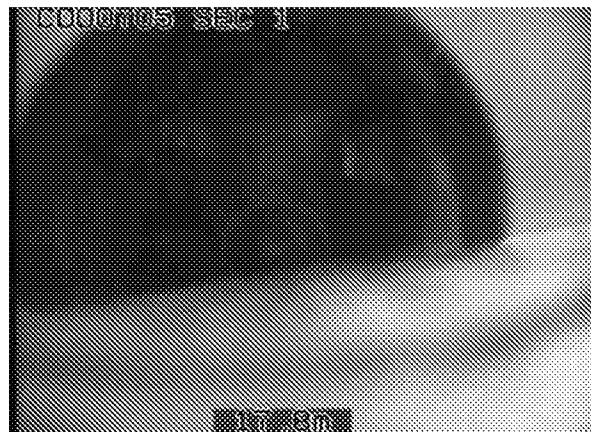
FW1X\_ae57d161-f9c4-4092-a28d-53740de2bdf6\_20180110\_193636\_768.jpg, 17.80m  
Finish node type, manhole, reference number: FW1 / NO

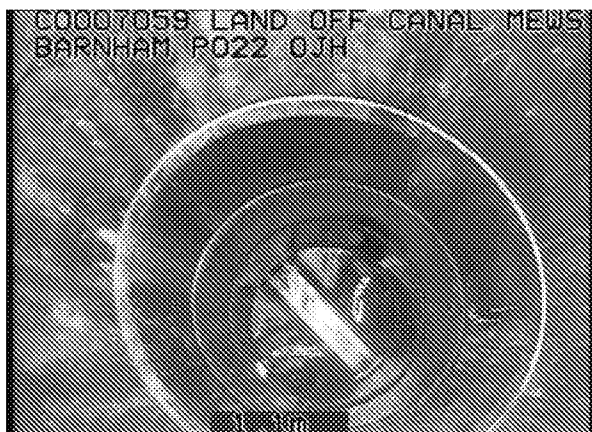
FW1X\_94c783ad-9477-49a7-978e-bf66089f40ef\_20180110\_193136\_514.jpg, 00:00:00, 0.00m  
General photograph taken at this point / OVERVIEW

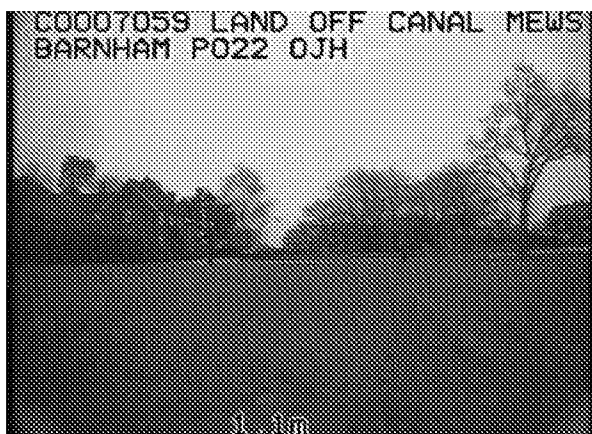
FW1X\_7f90da61-620c-44cc-a96b-bed728392652\_20180110\_193059\_014.jpg, 00:00:00, 0.00m  
General photograph taken at this point / OVERVIEW

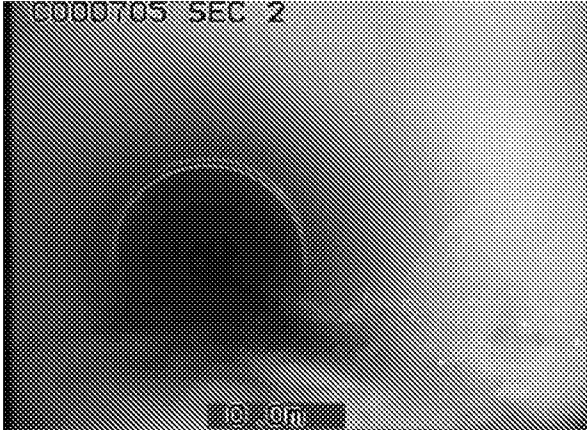
FW2X\_3e2d9e45-481b-4e36-b275-d35d78e19be5\_20180110  
\_194004\_497.jpg, 00:00:00, 0.00m  
Start node type, manhole, reference number: FW2

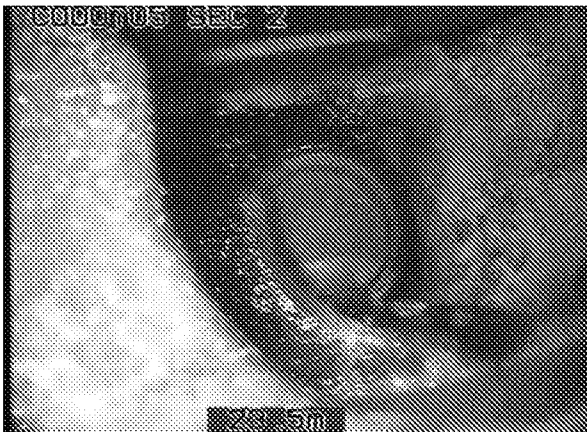
FW2X\_123d7814-9d39-47bc-8a50-48c4b4c2e600\_20180110  
\_194216\_024.jpg, , 23.50m  
Finish node type, manhole, reference number: FW4

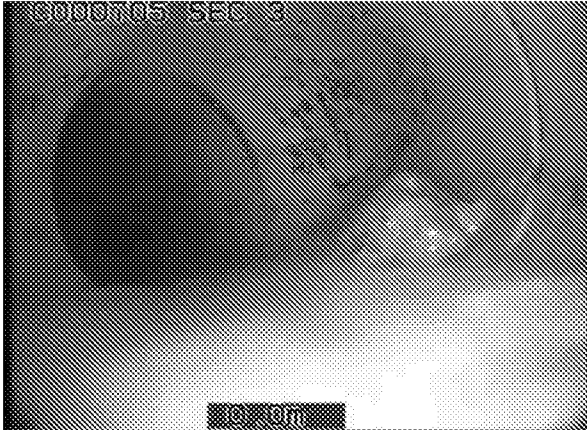
FW3X\_ec21d8f3-e28e-4486-895b-98986cc3c2d7\_20180110\_194747\_359.jpg, 00:00:00, 0.00m  
Start node type, manhole, reference number: FW3

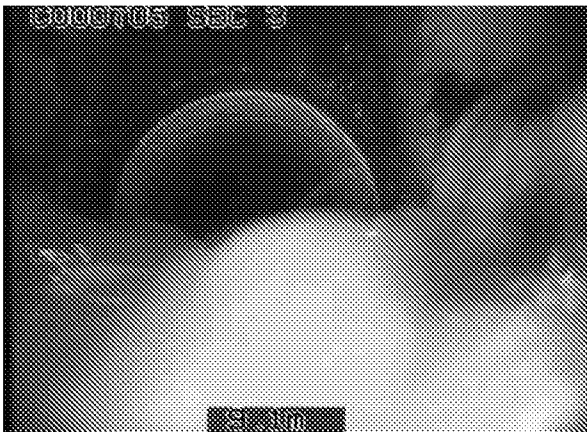
FW3X\_87f3fb8b-06d2-4f23-9bf1-9e042a1563d5\_20180110\_194933\_042.jpg, 00:00:00, 9.10m  
Finish node type, manhole, reference number: FW4

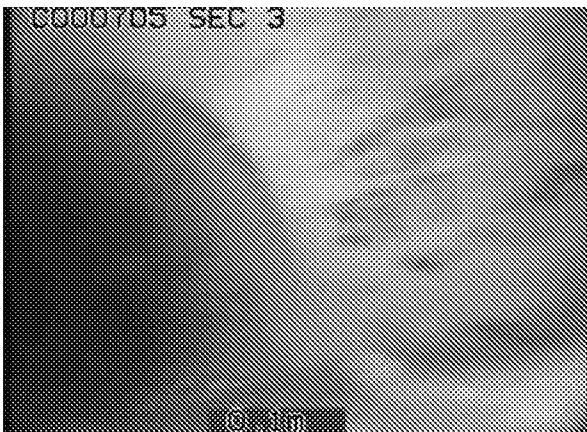
FW3X\_31ec5b81-d325-4d26-9daa-c960a3abd43a\_20180110\_194828\_893.jpg, , 0.01m  
Line deviates left

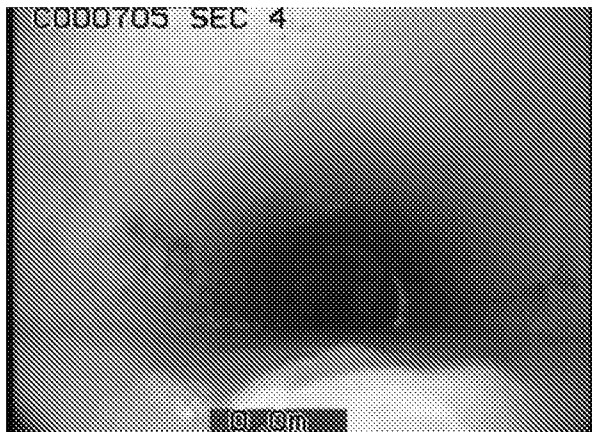
FW4X\_94e5ead6-dc09-4da9-acc3-f3e4d655e641\_20180110\_195351\_931.jpg, 00:00:00, 0.00m  
Start node type, manhole, reference number: FW4

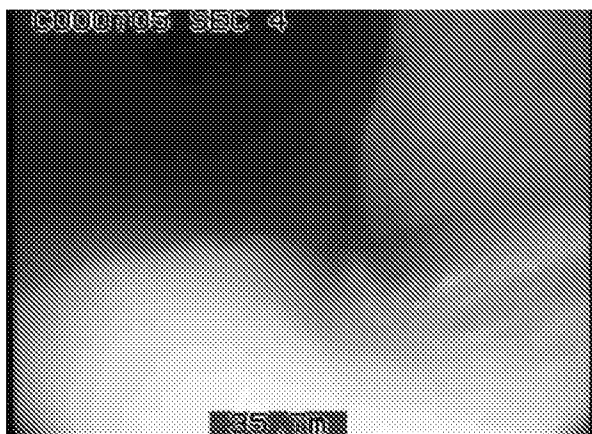
FW4X\_e9b28669-9564-4422-bd69-d97c942bd698\_20180110\_200309\_751.jpg, 00:07:43, 35.70m  
Finish node type, manhole, reference number: FW5 /

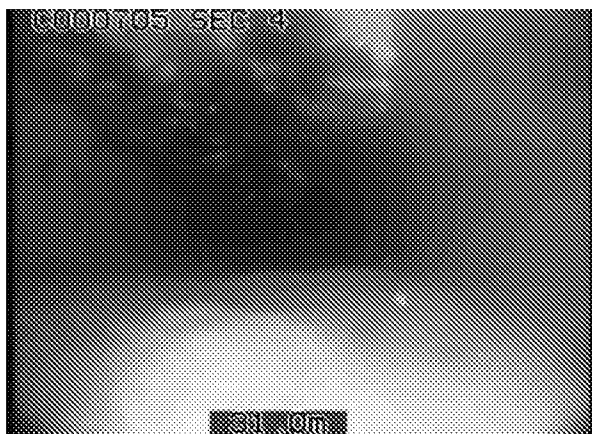
FW4X\_d168865b-8a15-48a5-abc0-75b79300f2b4\_20180110\_200004\_508.jpg, 00:08:06, 31.00m  
Attached deposits, grease at 12 o'clock, 5% cross-sectional

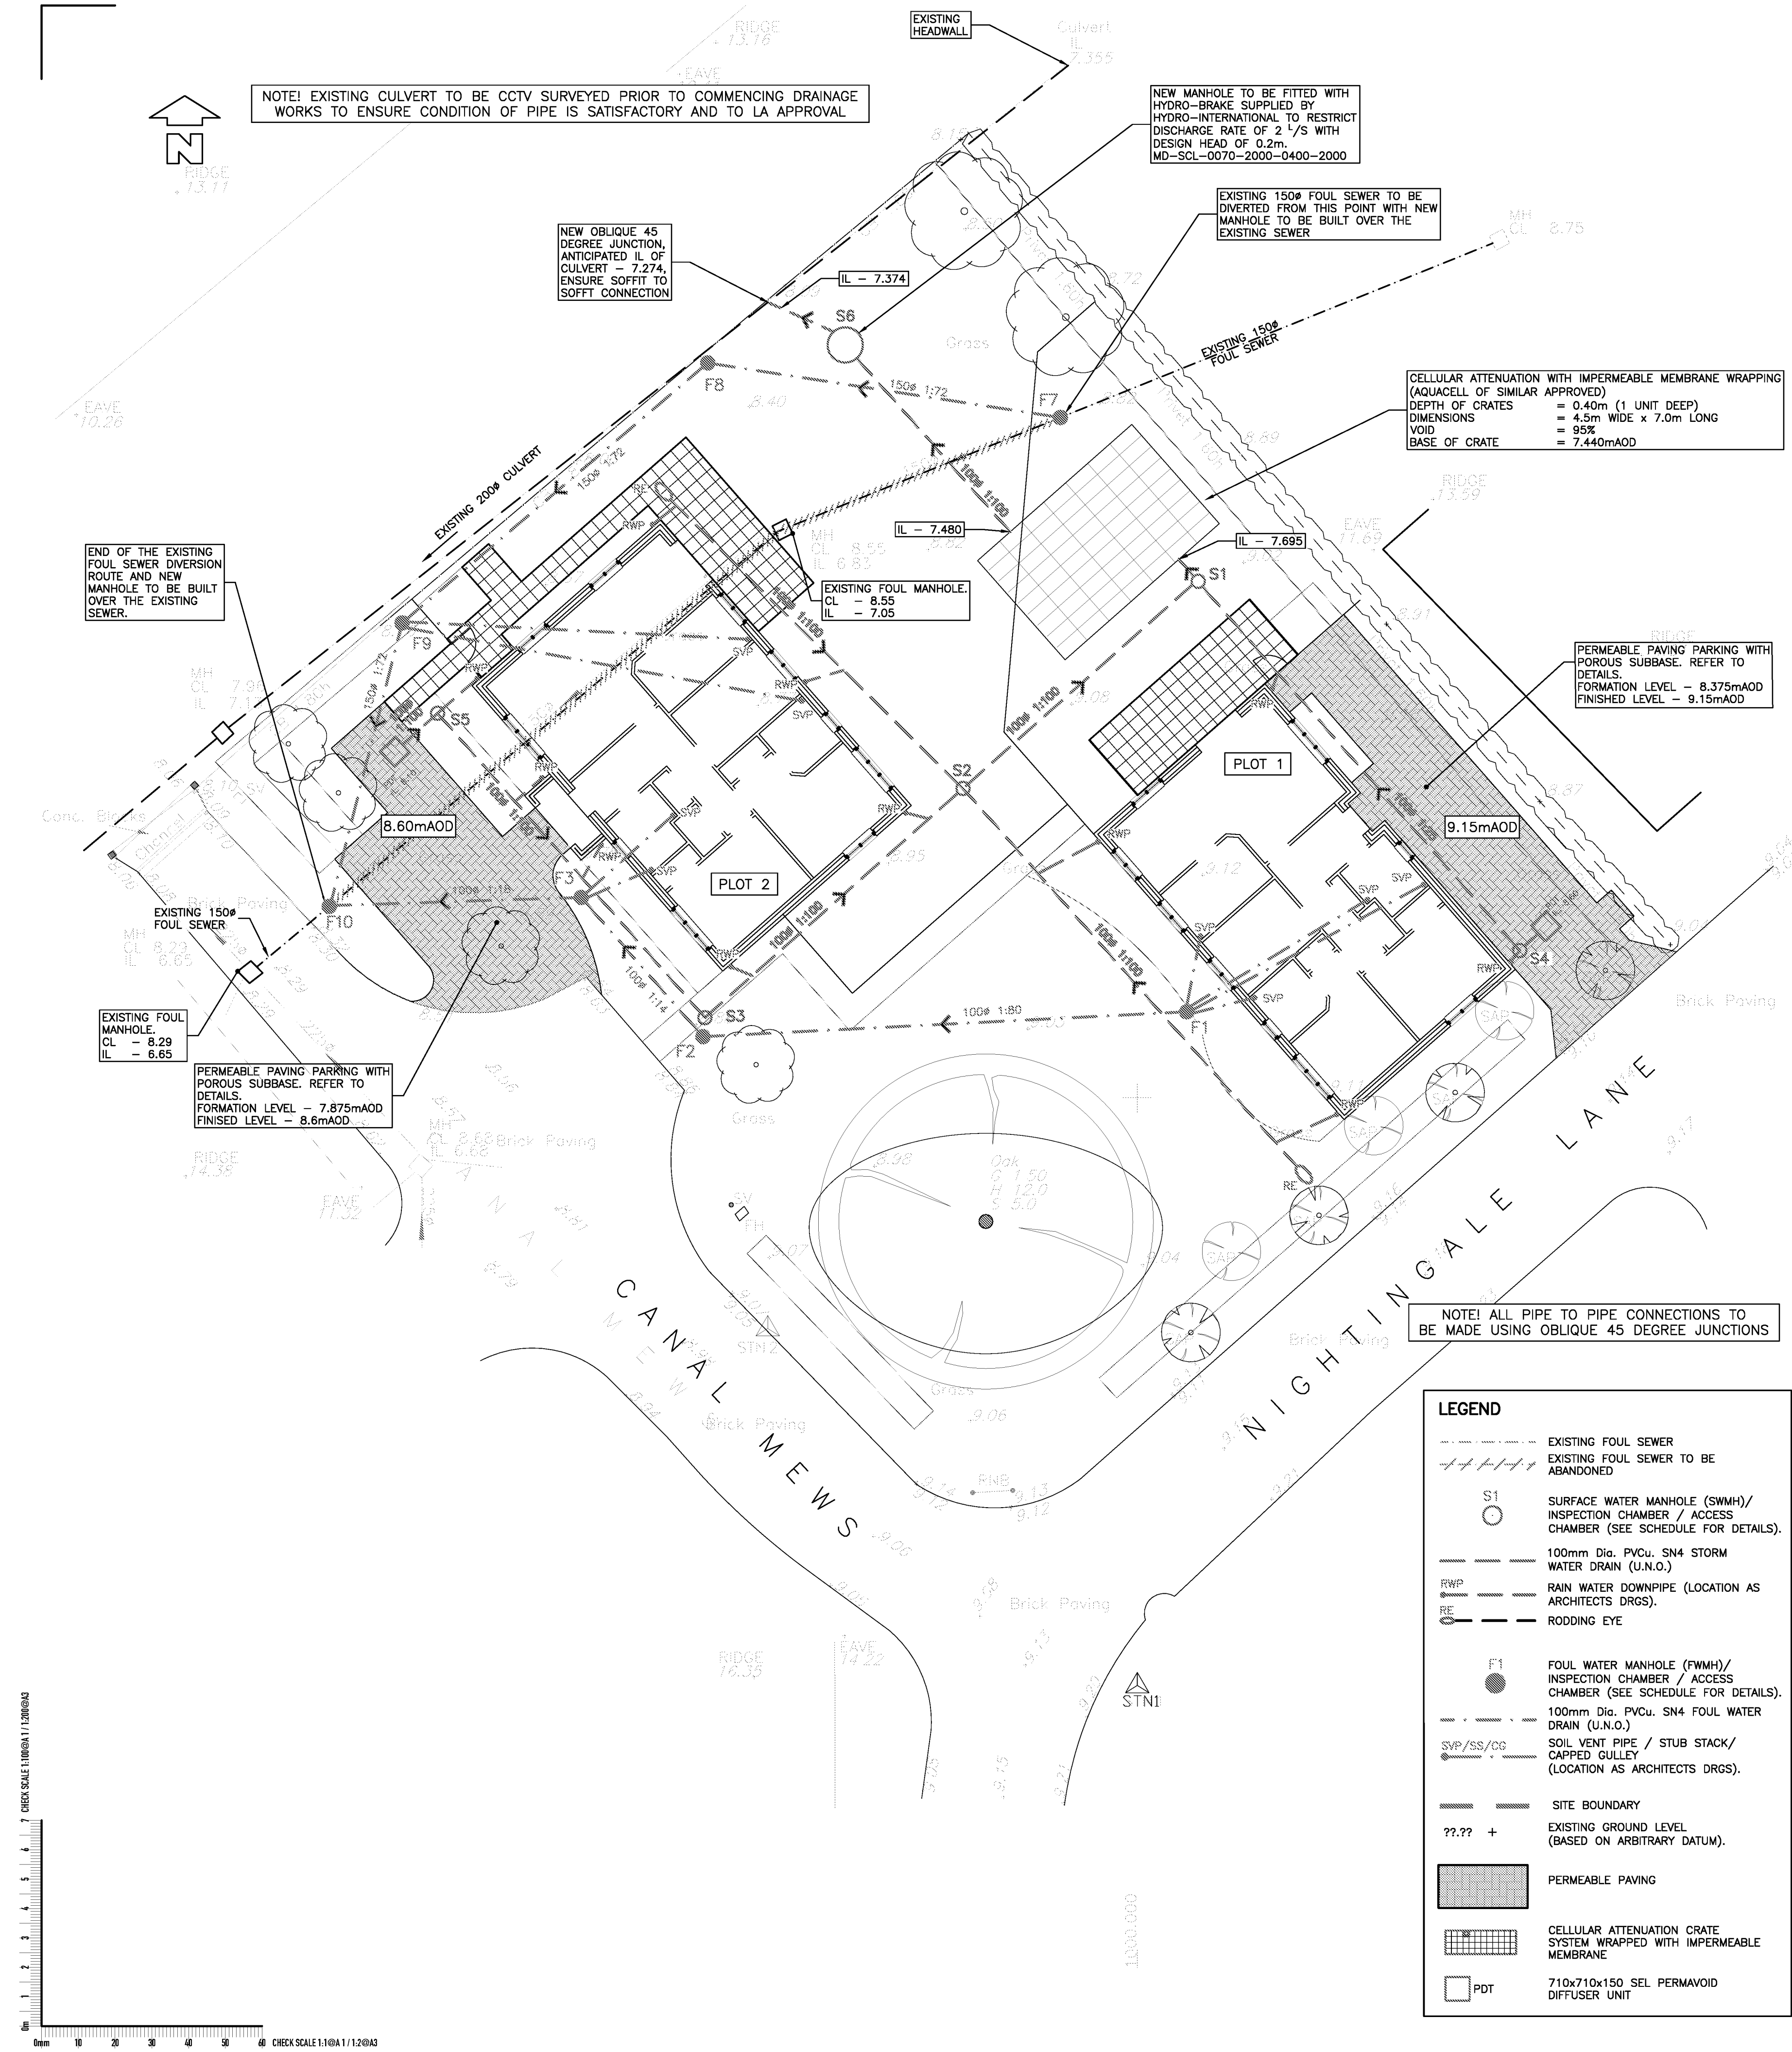
### **Drainage Strategy Drawing & Details**

It is proposed to discharge the foul water run-off from the site into the existing 150mm diameter foul sewer located to the south-west of the site, via a new foul network gravity system. The proposed foul water drainage strategy has been designed in accordance with the Sewers for Adoption 7<sup>th</sup> Edition and Part H of the Building Regulations. Refer to **Appendix 7** – Drainage Strategy Drawing for details.

The length of the existing sewer that runs across the site will need to be diverted in order to accommodate the proposed development site layout. Any new connections and alterations in drainage flows to the existing sewers will have to be agreed with Southern Water and Third Parties under the Water Industry Act (WIA) Section 106 Agreement.

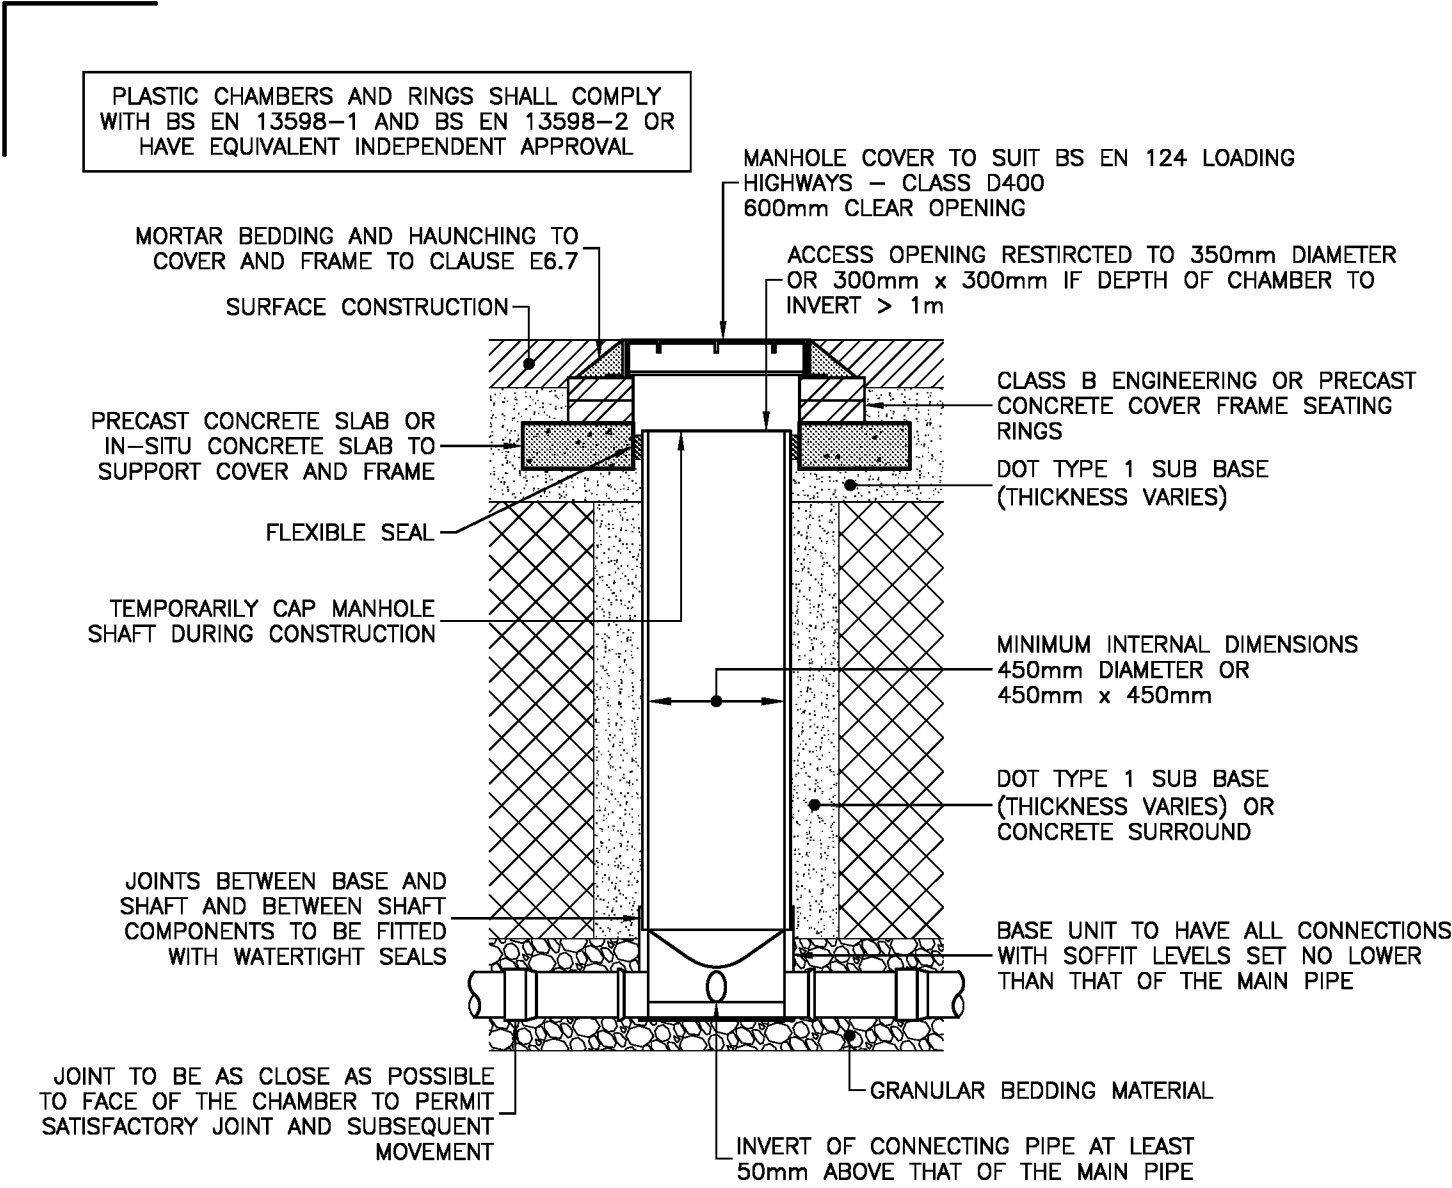
**TYPICAL ACCESS CHAMBER DETAIL – TYPE 3 (FLEXIBLE MATERIAL DETAIL)**  
MAXIMUM DEPTH FROM COVER LEVEL TO SOFFIT OF PIPE IN AREAS SUBJECT TO VEHICLE LOADING 3m, NON ENTRY  
(1:25)

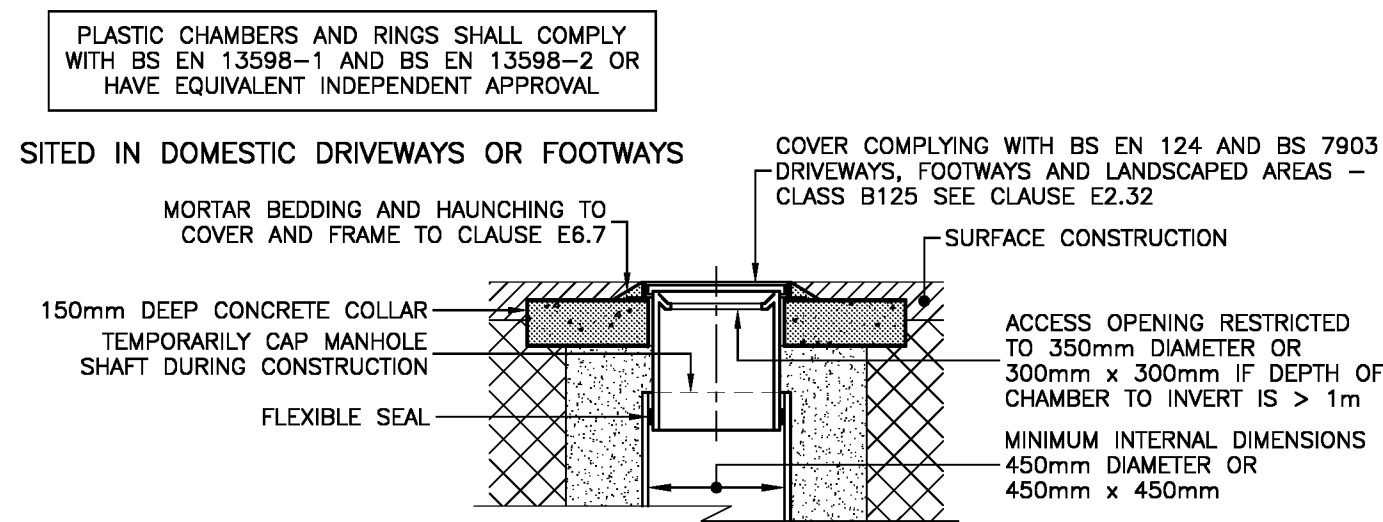
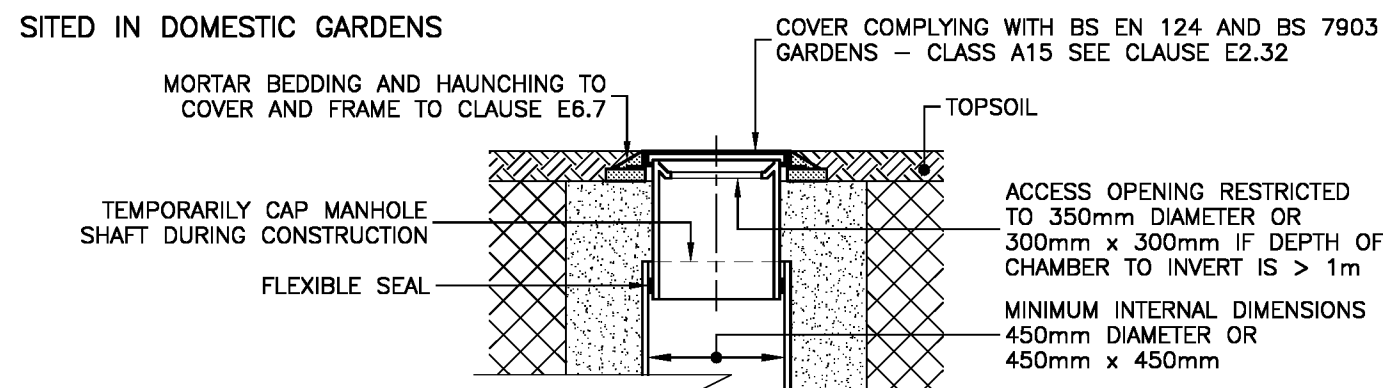
**ALTERNATIVE TOP DETAILS FOR LIGHT VEHICLE LOADING AND LANDSCAPED AREAS – TYPE 3**  
(1:25)

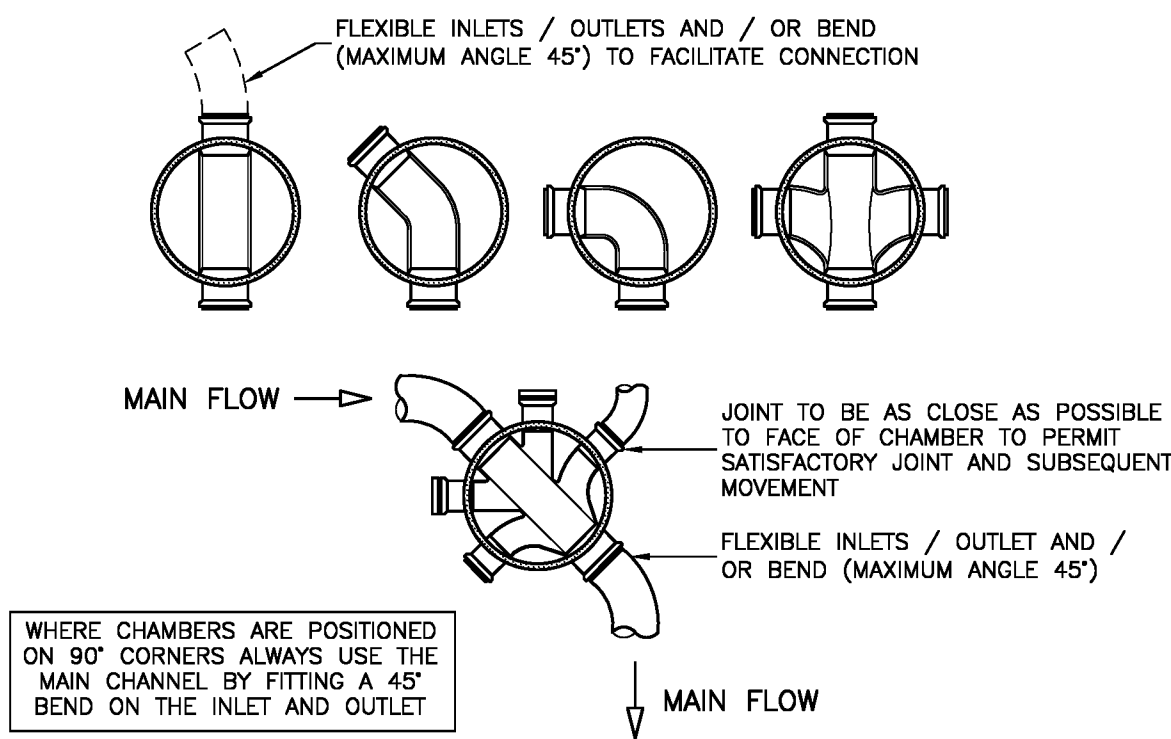
**ALTERNATIVE BASE LAYOUTS FOR TYPE 3 CHAMBERS**  
(1:25)

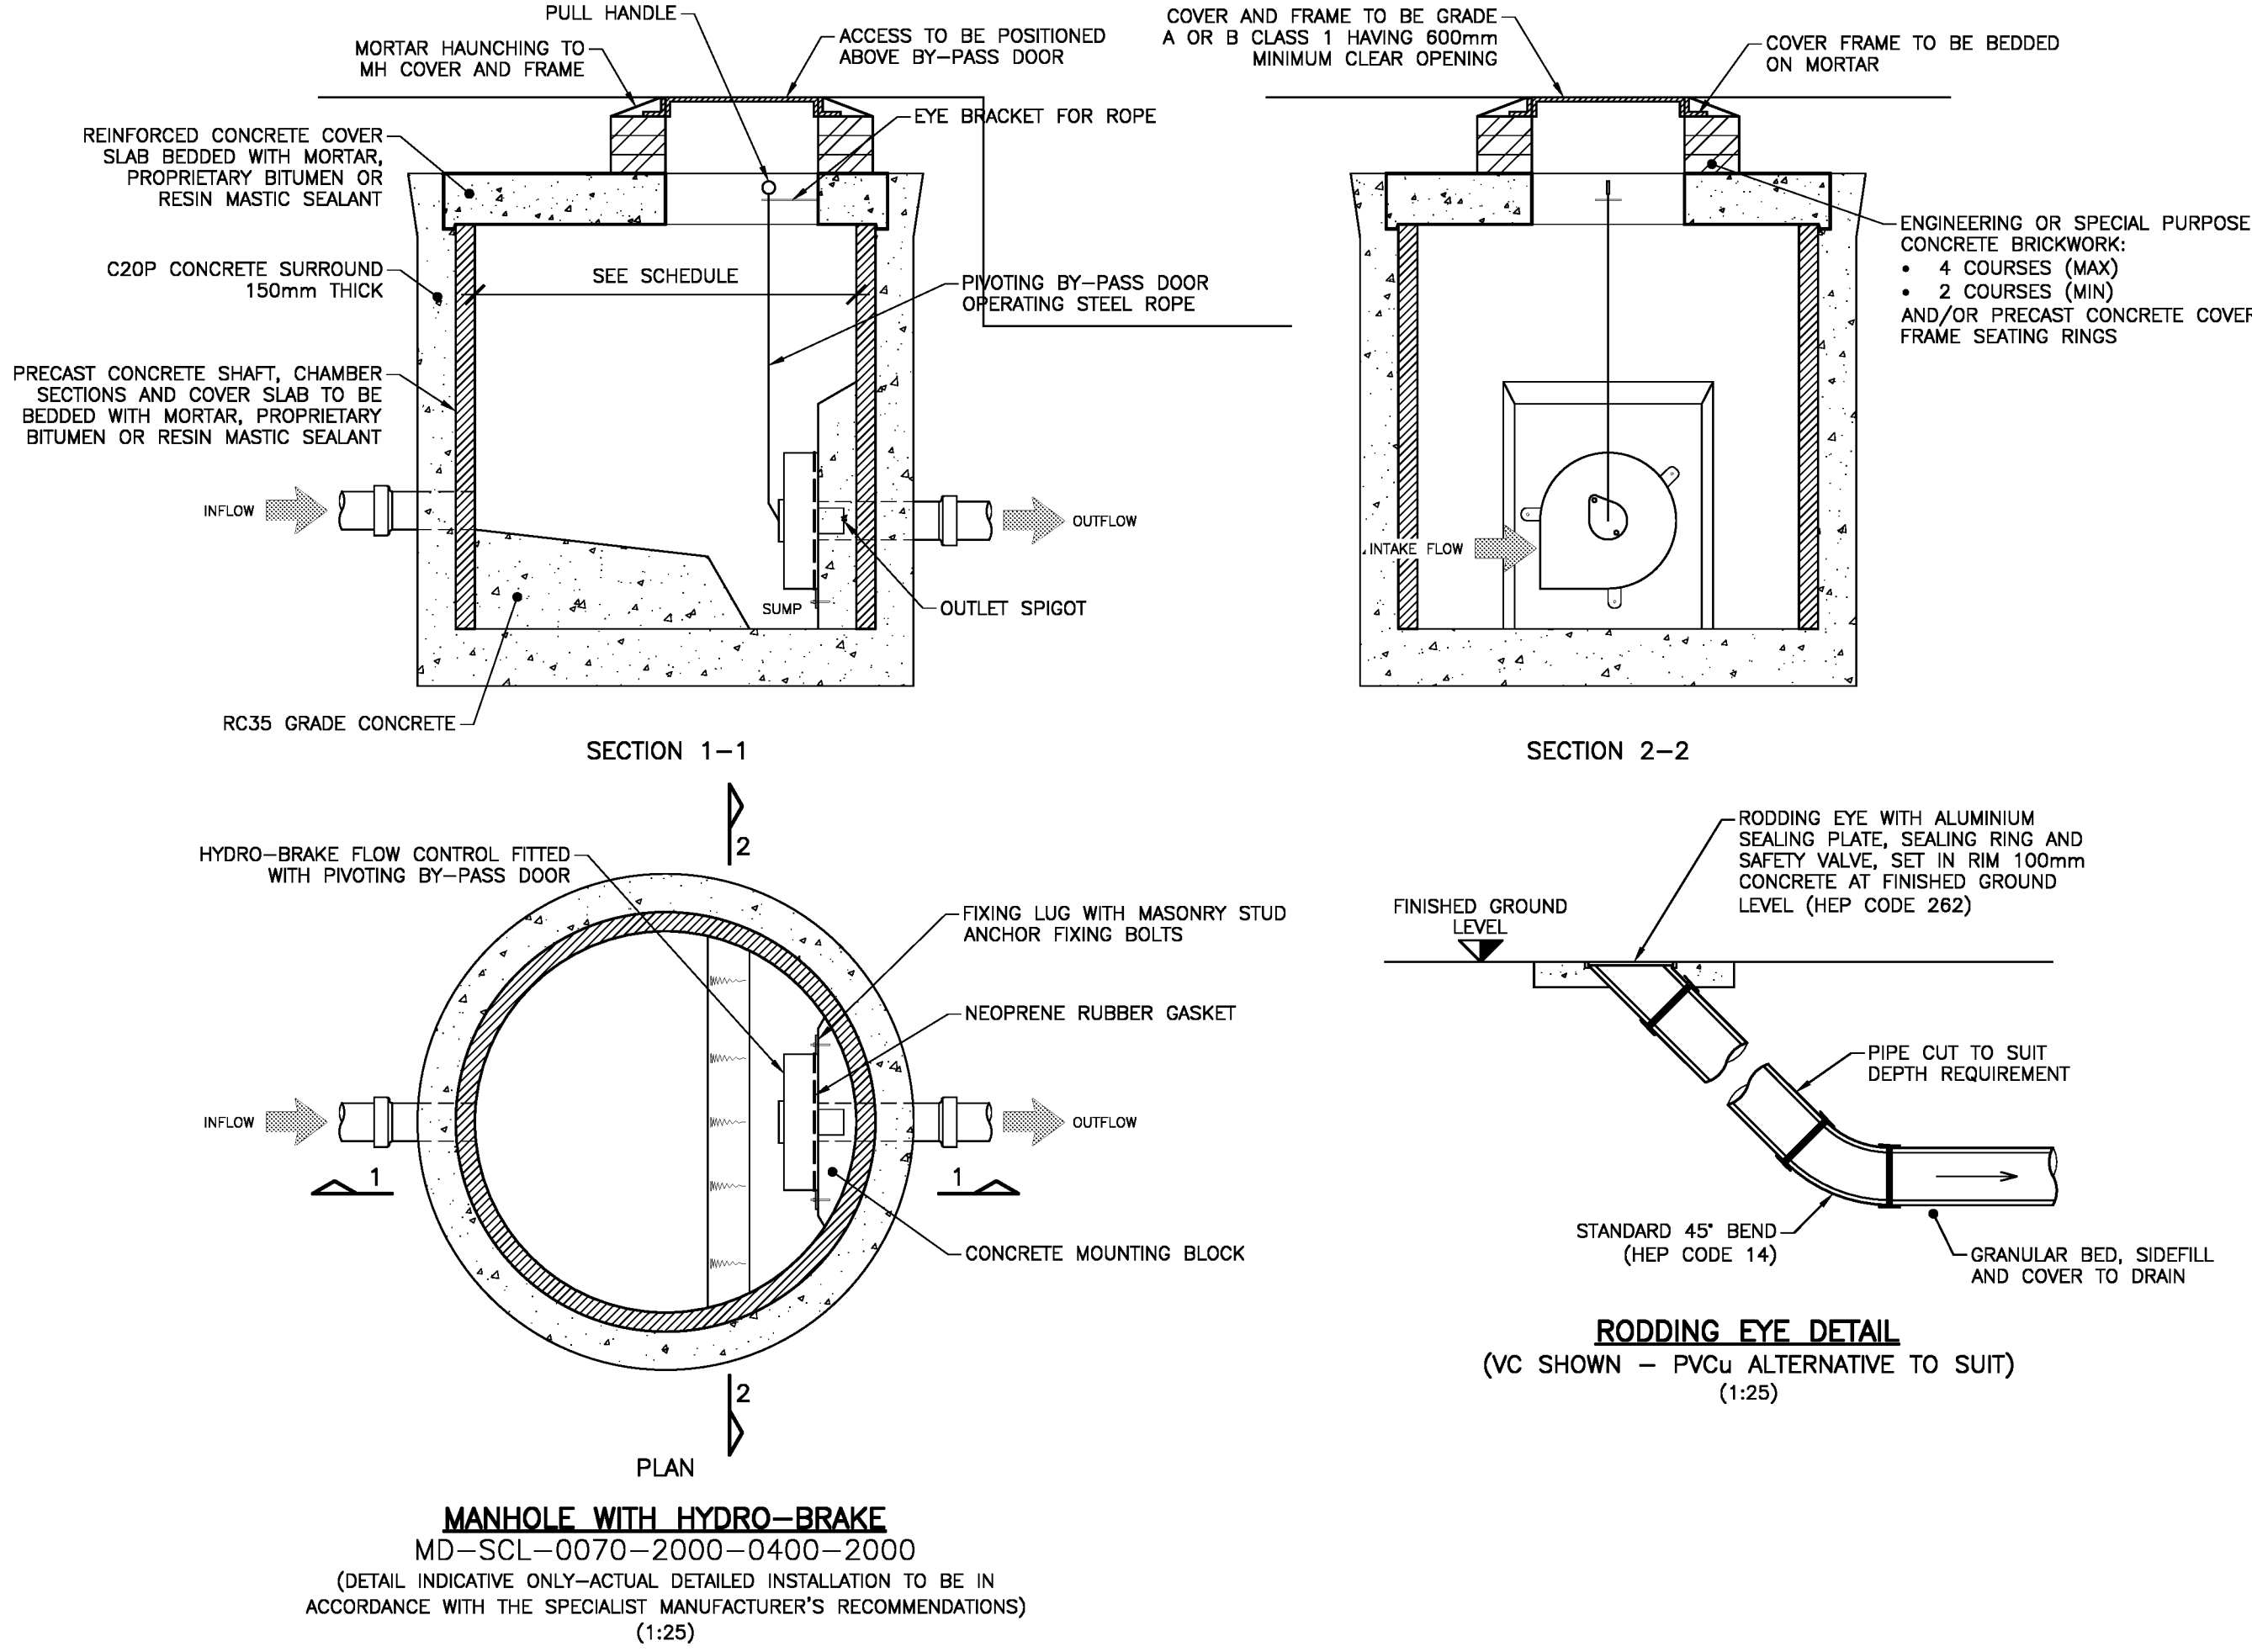
**MANHOLE WITH HYDRO-BRAKE**  
MD-SCL-0070-2000-0400-2000  
(DETAIL INDICATIVE ONLY-ACTUAL DETAILED INSTALLATION TO BE IN ACCORDANCE WITH THE SPECIALIST MANUFACTURER'S RECOMMENDATIONS)  
(1:25)

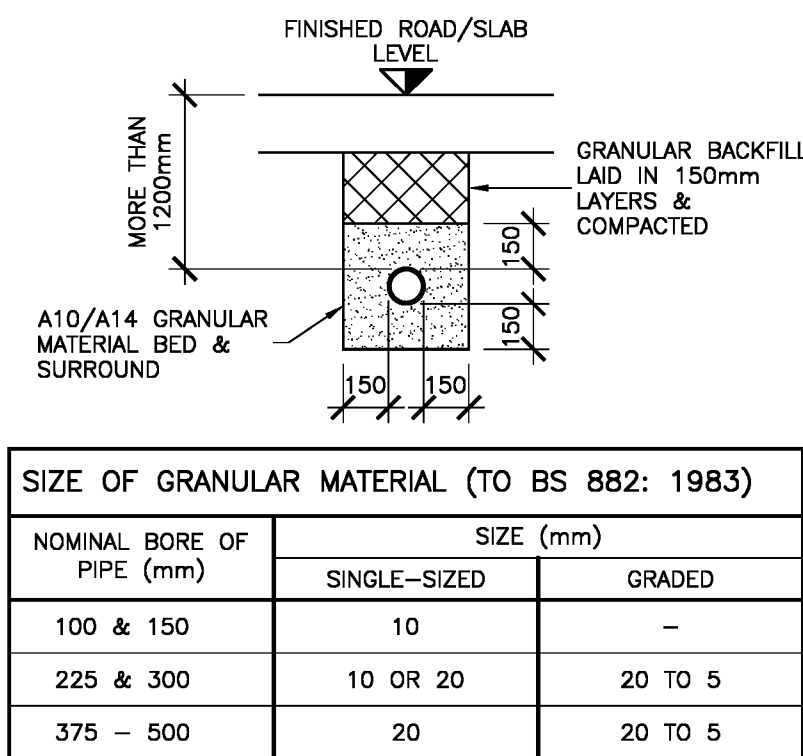
**PIPE BED & SURROUND DETAIL (CLASS S)**  
(1:25)

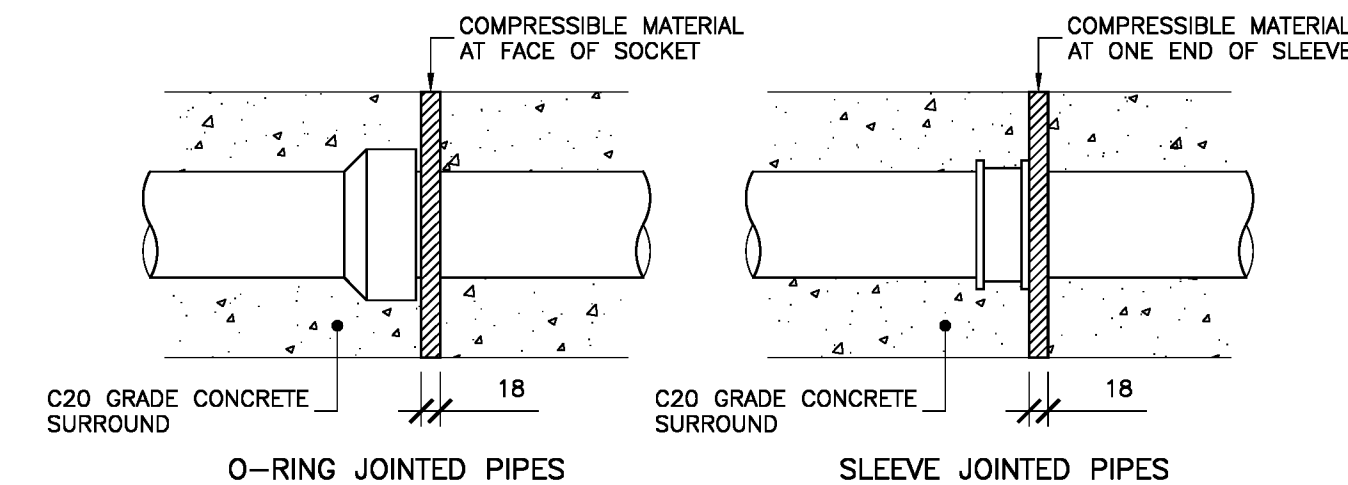
THE FLEXIBILITY OF A PIPELINE BEDDED ON, OR SURROUNDED WITH, CONCRETE SHOULD NORMALLY BE MAINTAINED BY THE PROVISION OF FLEXIBLE CONSTRUCTION JOINTS THROUGH THE CONCRETE AT PIPE JOINTS. THESE SHOULD BE MADE FROM BITUMEN IMPREGNATED INSULATING BOARD COMPLYING WITH B.S. 1142 PART 3, OR OTHER EQUALLY COMPRESSIBLE FILLER MATERIAL SUCH AS EXP&D POLYSTYRENE. THE BOARD SHOULD BE CUT TO FIT THE PIPES & PLACED AT THE FACE OF THE PIPE SOCKETS OR AT ONE END OF SLEEVE JOINTS. THE JOINT MATERIAL SHOULD BE AT LEAST 18mm THICK PLACED AT 5.0m CENTRES MAX.

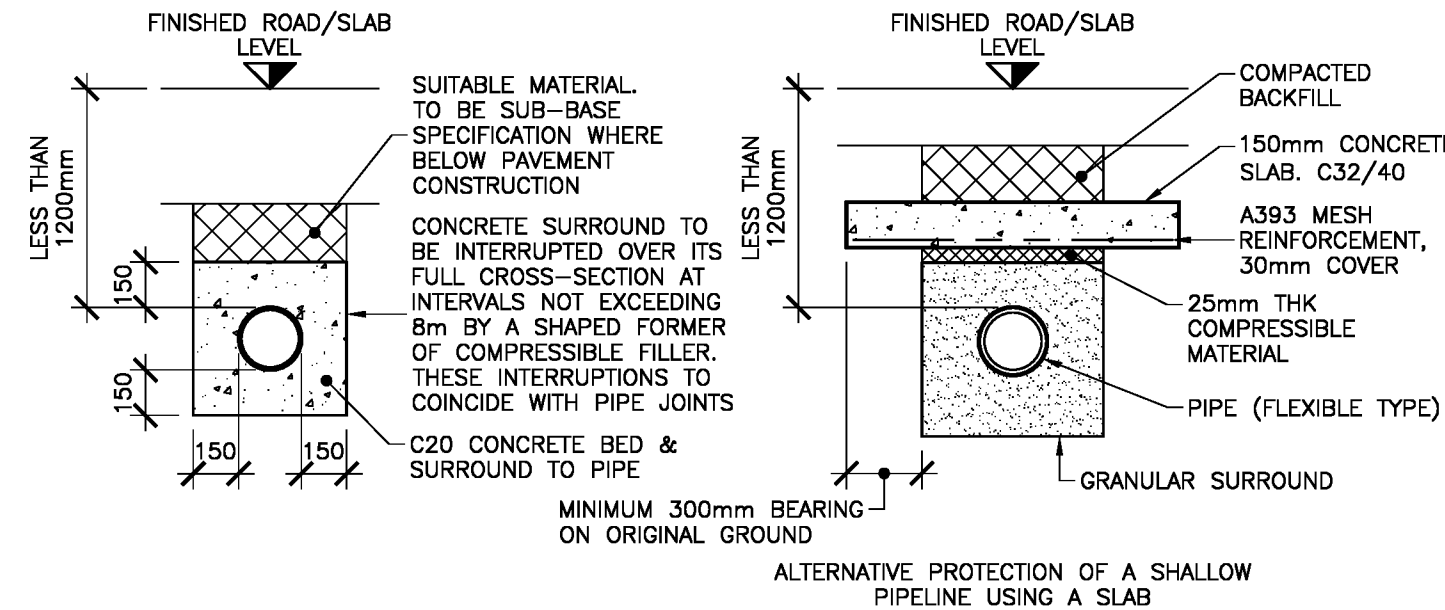
**PROTECTION TO PIPELINES WITH LESS THAN 1200mm COVER**  
(1:25)
