Drainage Statement

Land Off Canal Mews,  
Barnham, West Sussex

## DRAINAGE STATEMENT

Project No. SPR032

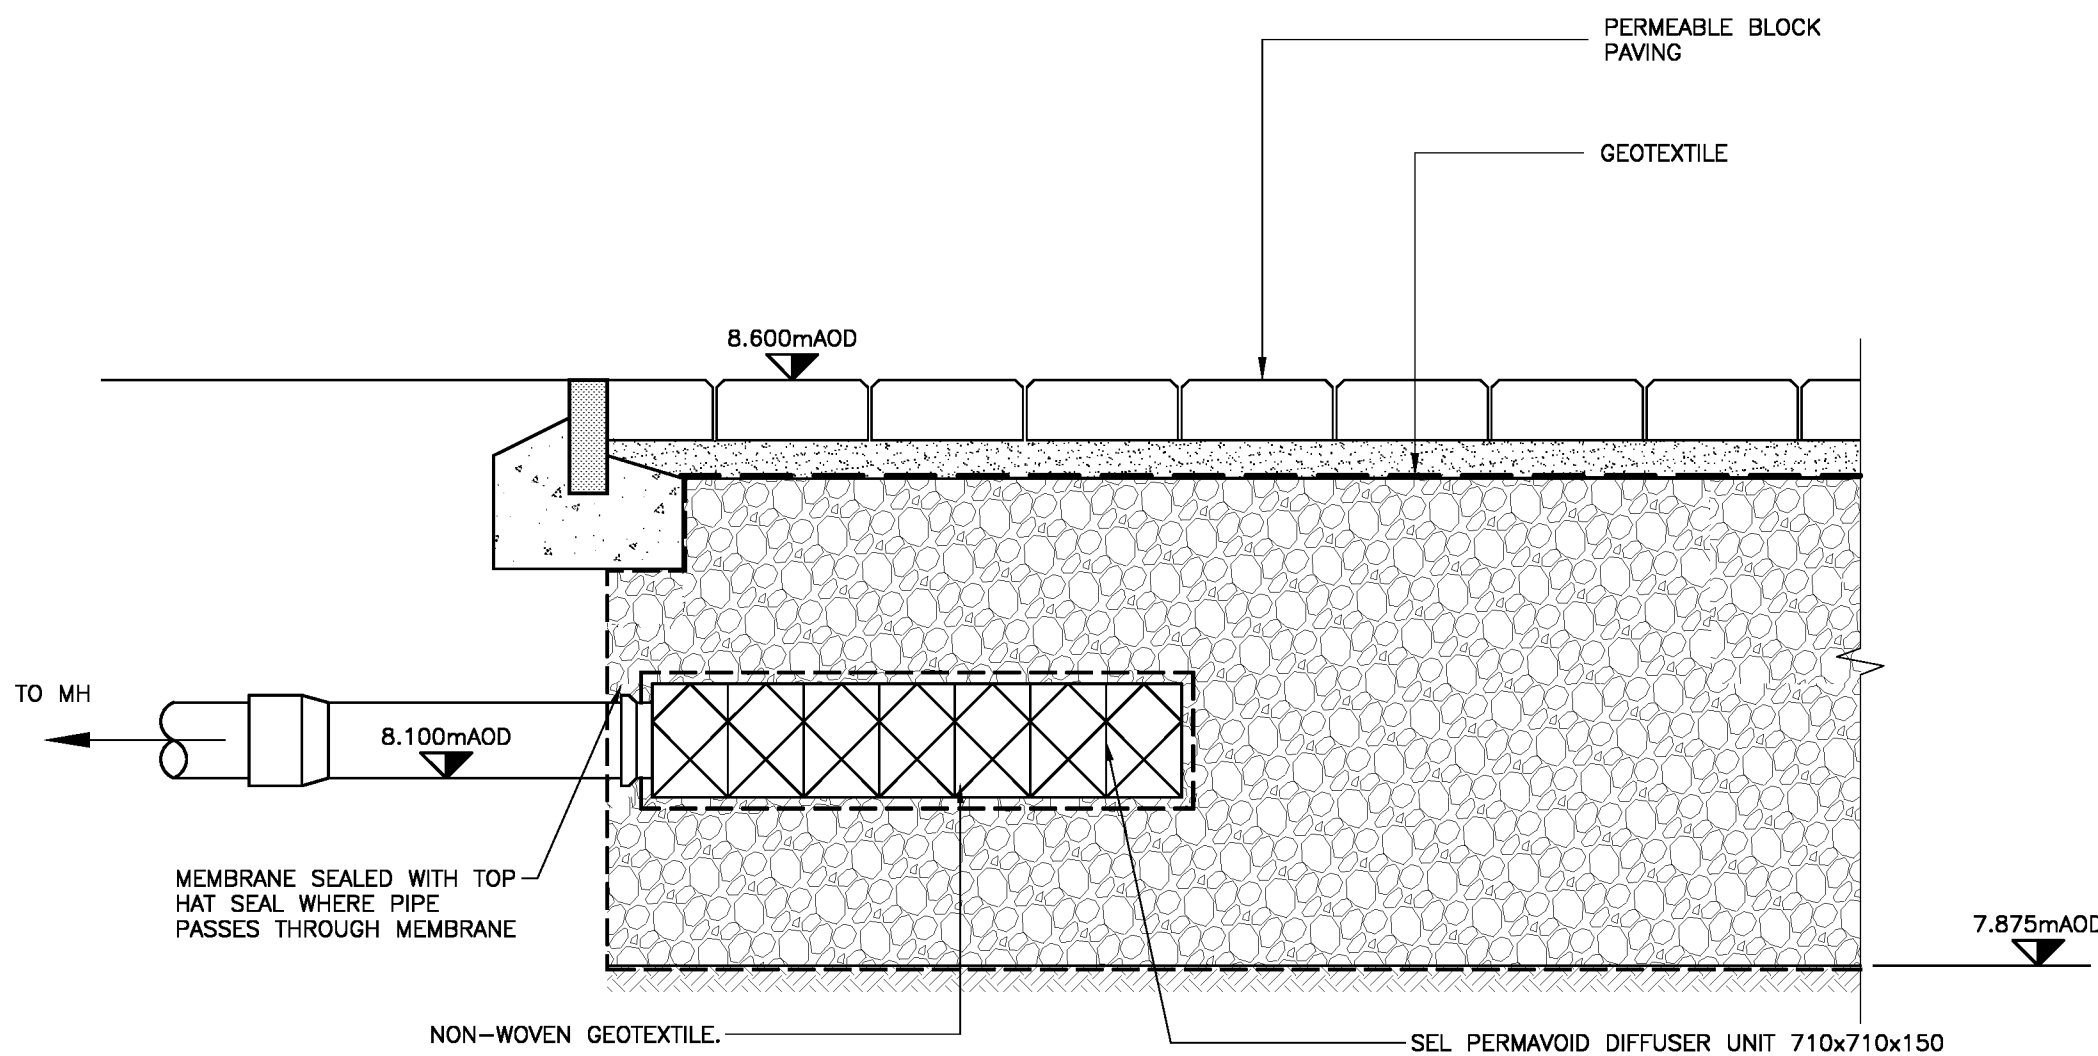
**S.E.L. PERMAVOID DIFFUSER UNIT DETAIL FOR PLOT 2**  
(SCALE 1:25@A1)

The run-off from the roof areas is to be diverted via gravity into a shallow crate storage unit within the rear soft landscaping where it will be allowed to infiltrate where possible using a permeable geotextile wrapping. However, infiltration will not be accounted for in the calculations and therefore the tank will be designed for attenuation storage only. Refer to Appendix 9 for Calculations.

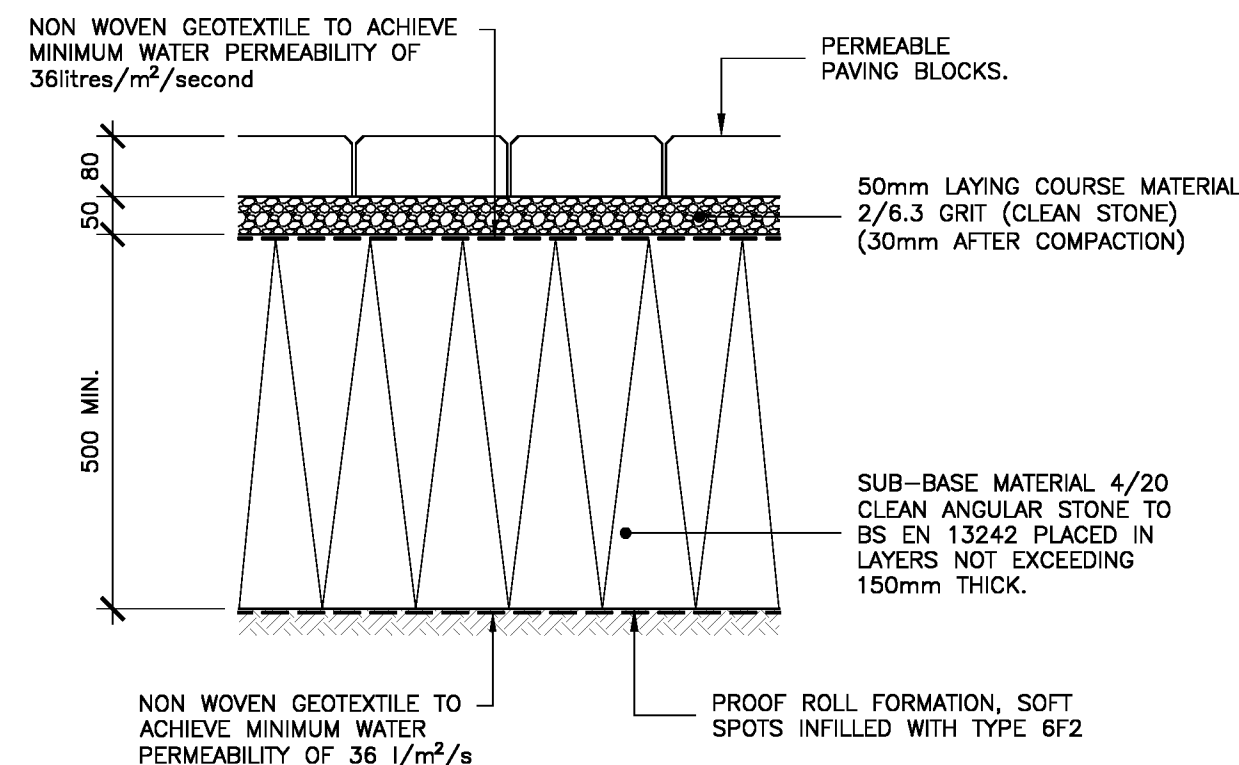
**PARKING AREAS PERMEABLE BLOCK PAVING  
CONSTRUCTION DETAIL**  
(SCALE 1:10@A1)

Permeable paving with a porous subbase and permeable geotextile is proposed for the driveways of both plots so that high level infiltration can be

used to drain the hardstanding. However, as the target half drain down time will not be achieved, an overflow will be provided in the wider surface water drainage system. The attenuation tank will therefore be designed to cater for the car park areas and the storage within the subbase will not be accounted for in the tank calculations for conservatism.

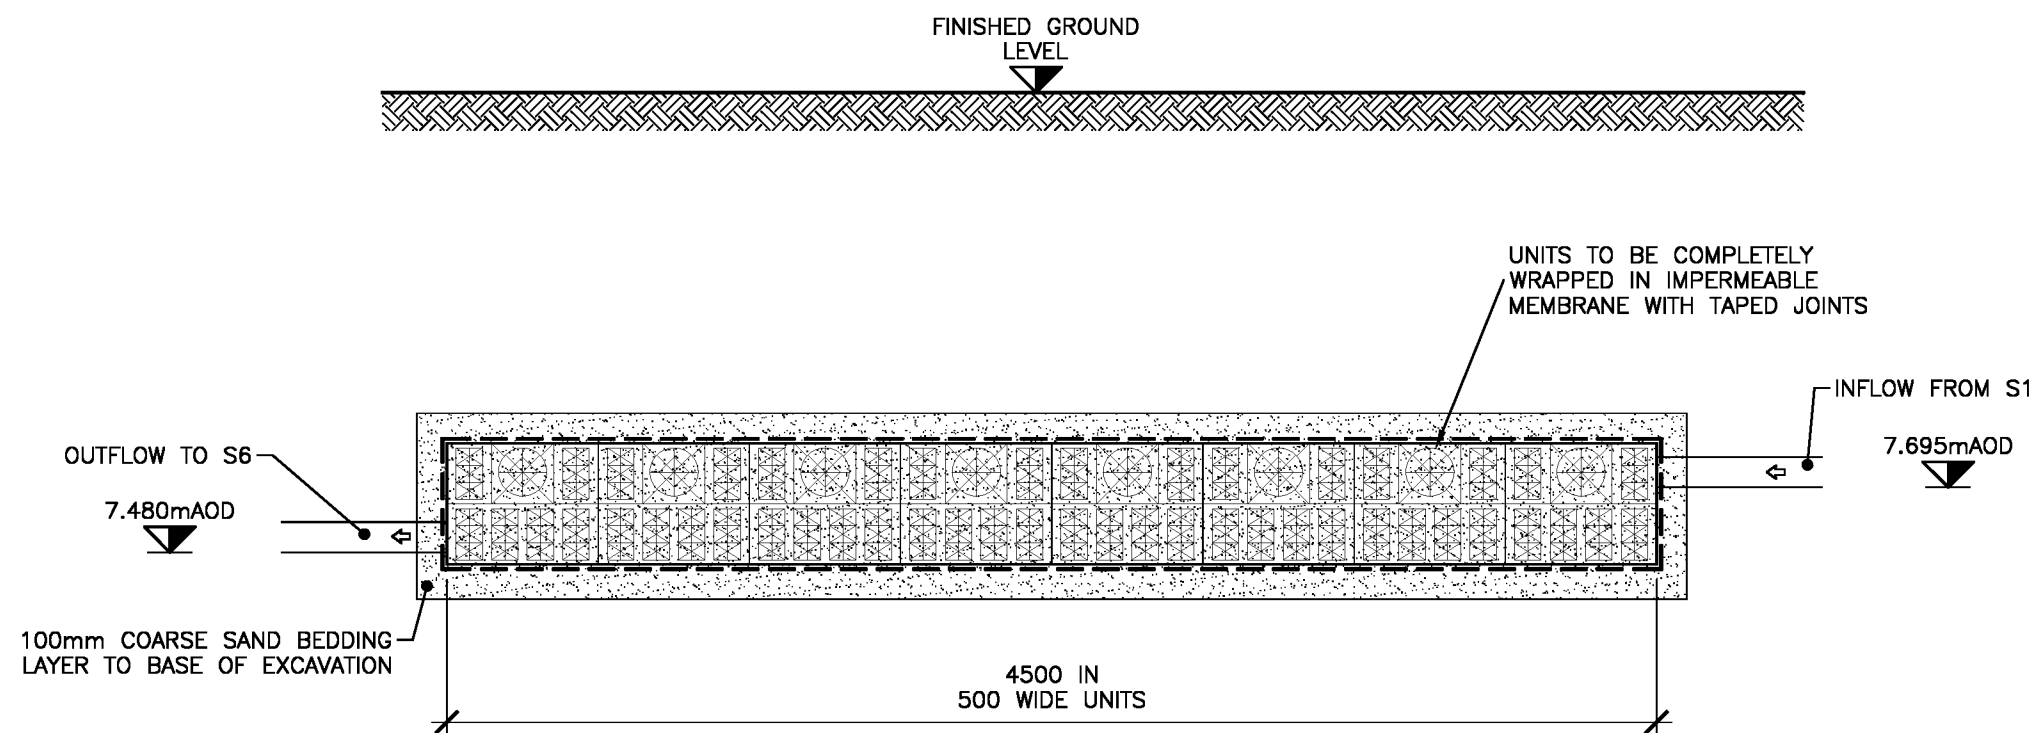
**ATTENUATION TANK**  
[OUT OF WAVIN / INTESIO 'AQUACELL' CRATES OR  
SIMILAR APPROVED PROPRIETARY MODULAR SYSTEM]  
(SCALE 1:25@A1)

Total Area Draining into Attenuation Tank = 297m<sup>2</sup>
