Our Ref: 1921454L01/nba  
12 May 2021

**THE LILIES, YAPTON ROAD, BARNHAM – WINTER GROUNDWATER MONITORING 2020/2021**

A total of 6 window sample holes (Locations 1 to 6) were sunk on 20<sup>th</sup> October 2020 for the purpose of measuring groundwater levels over a period of time within the development area. The locations are shown on Figure 1.

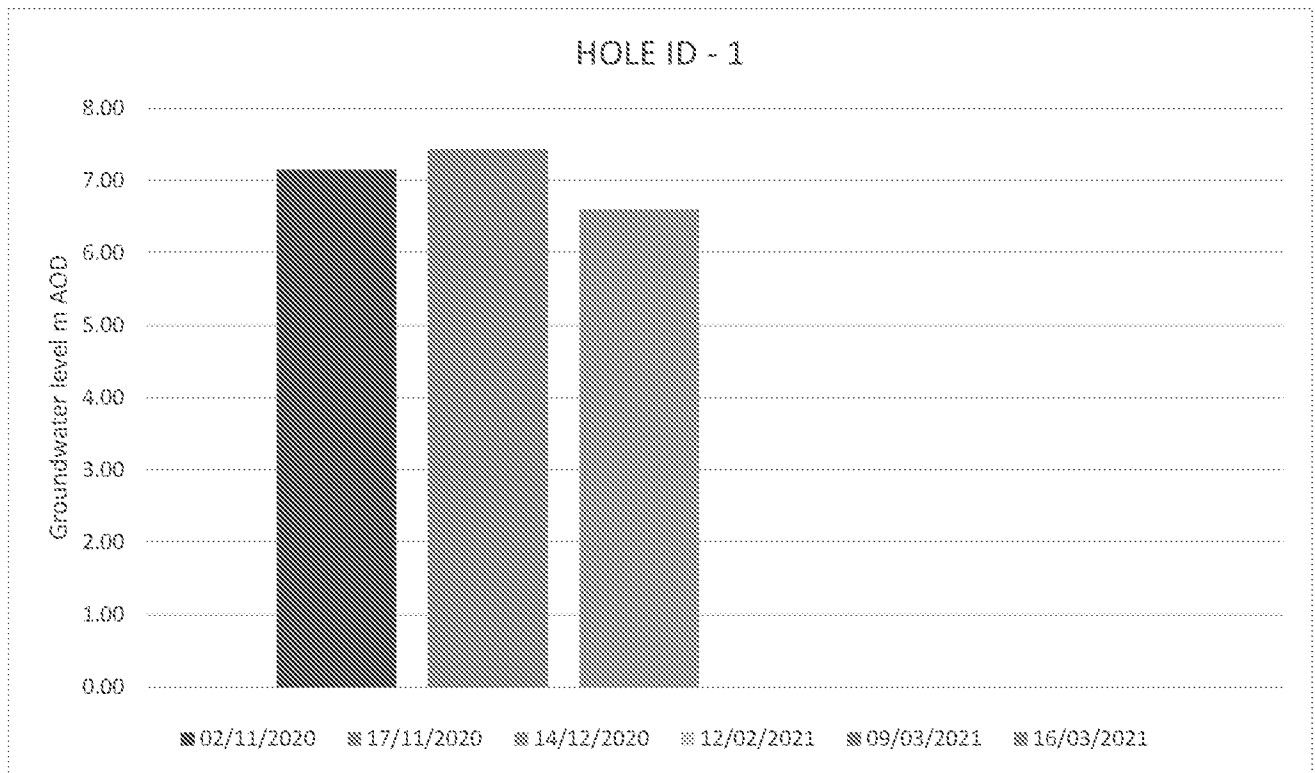
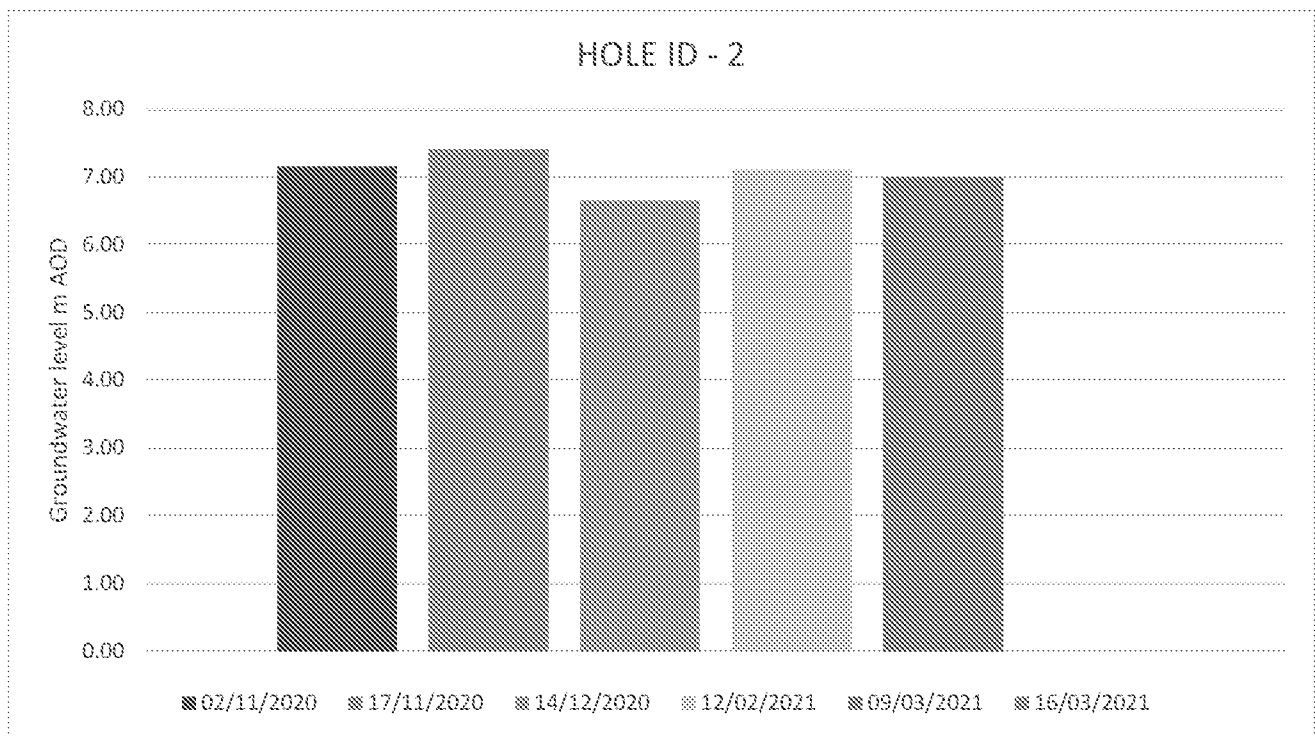
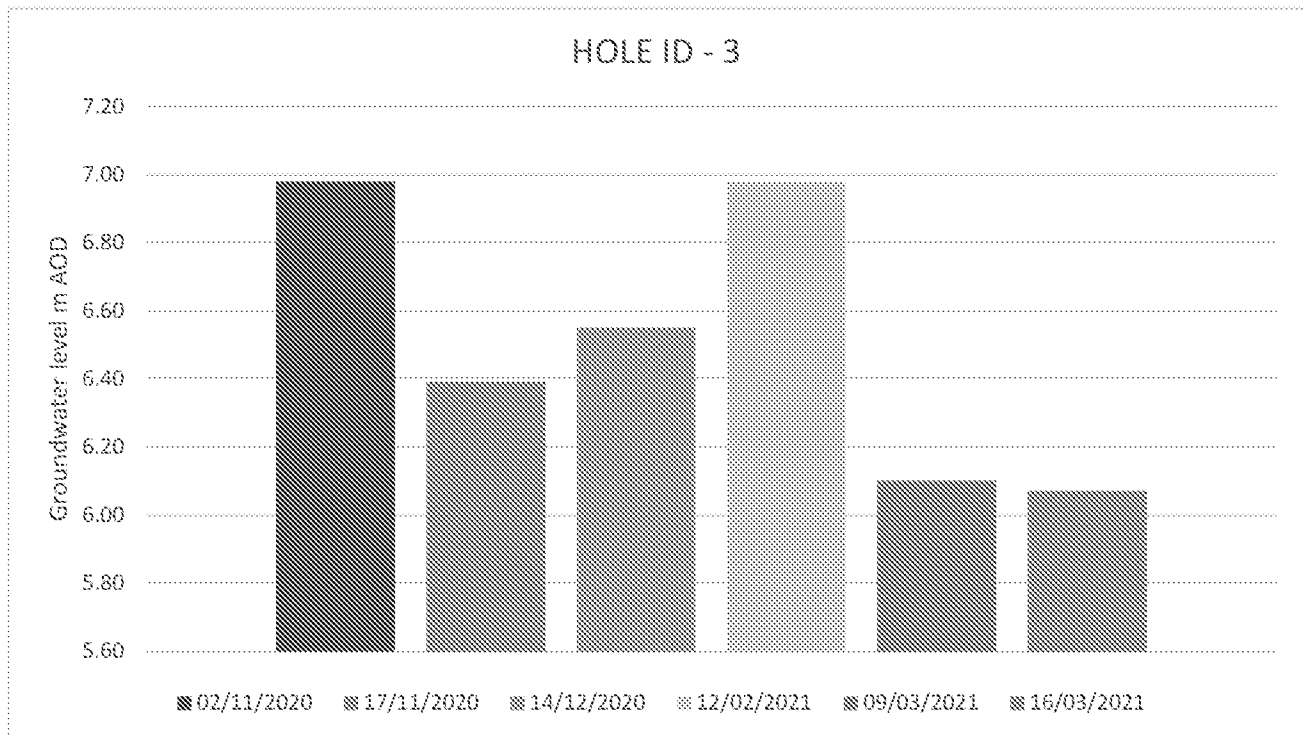
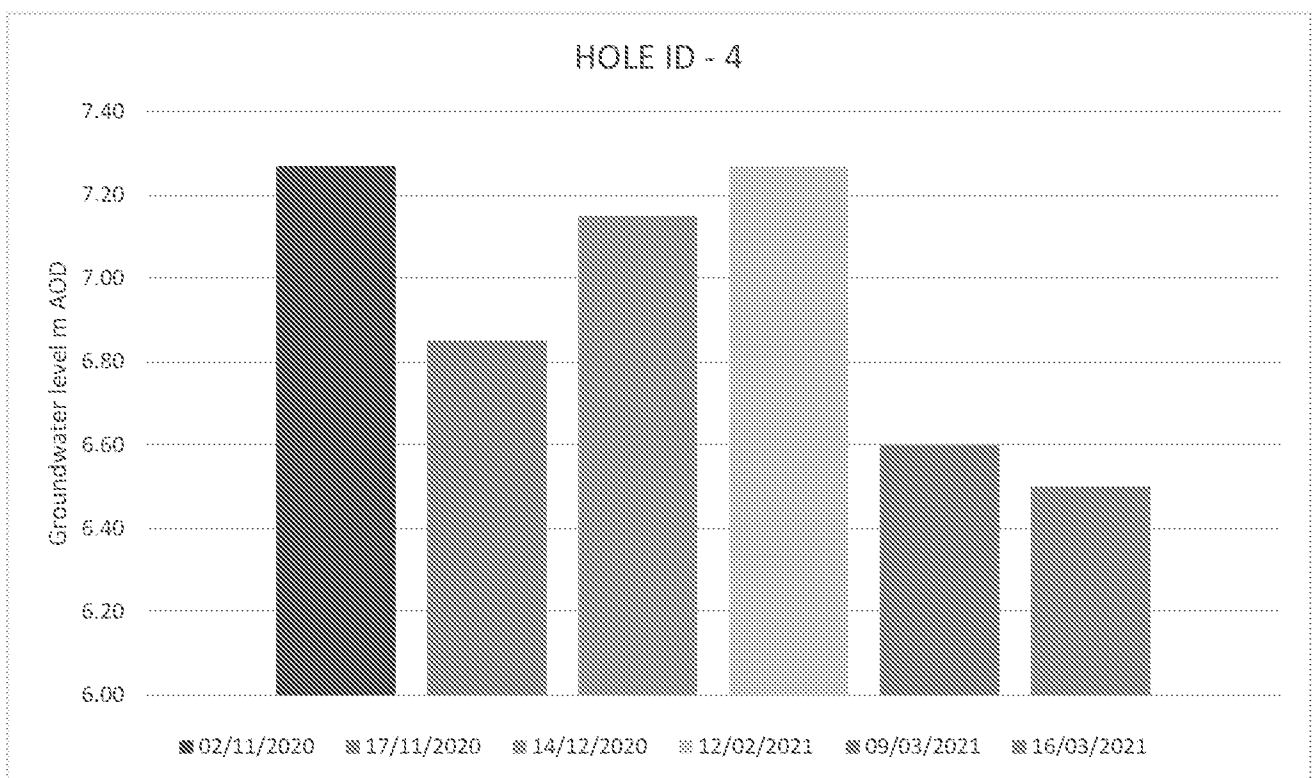
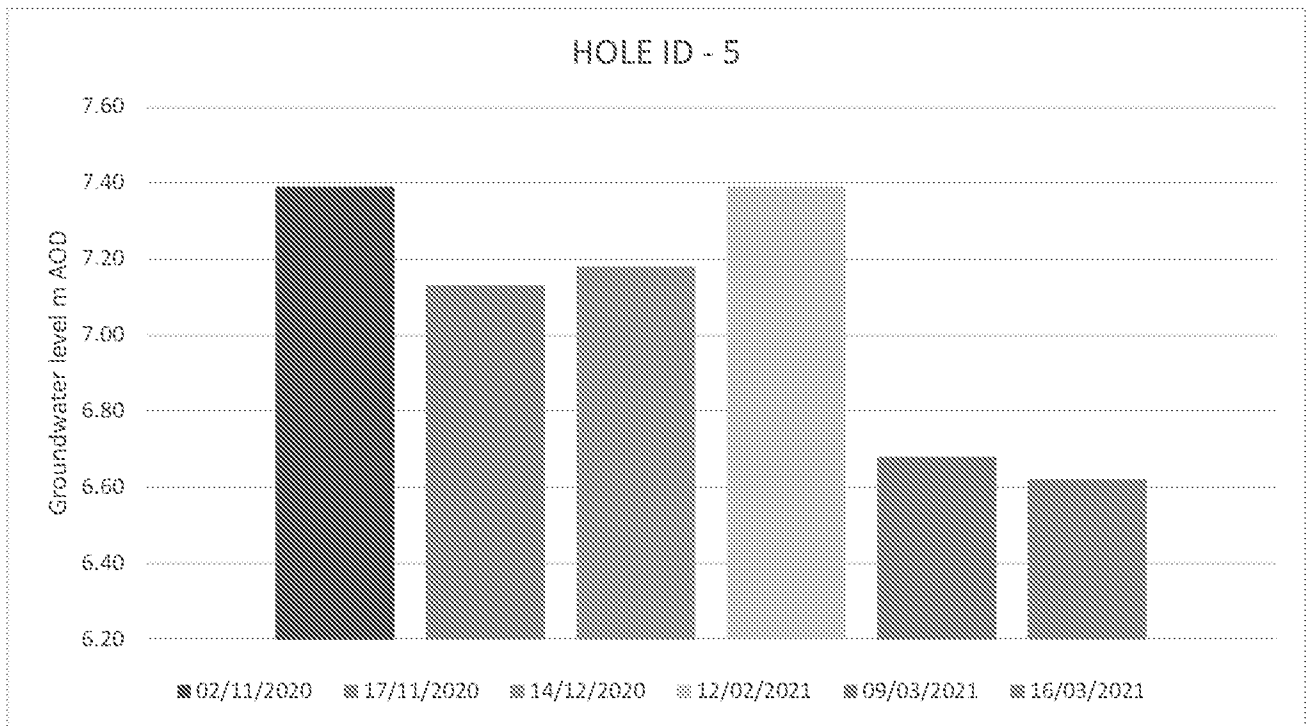
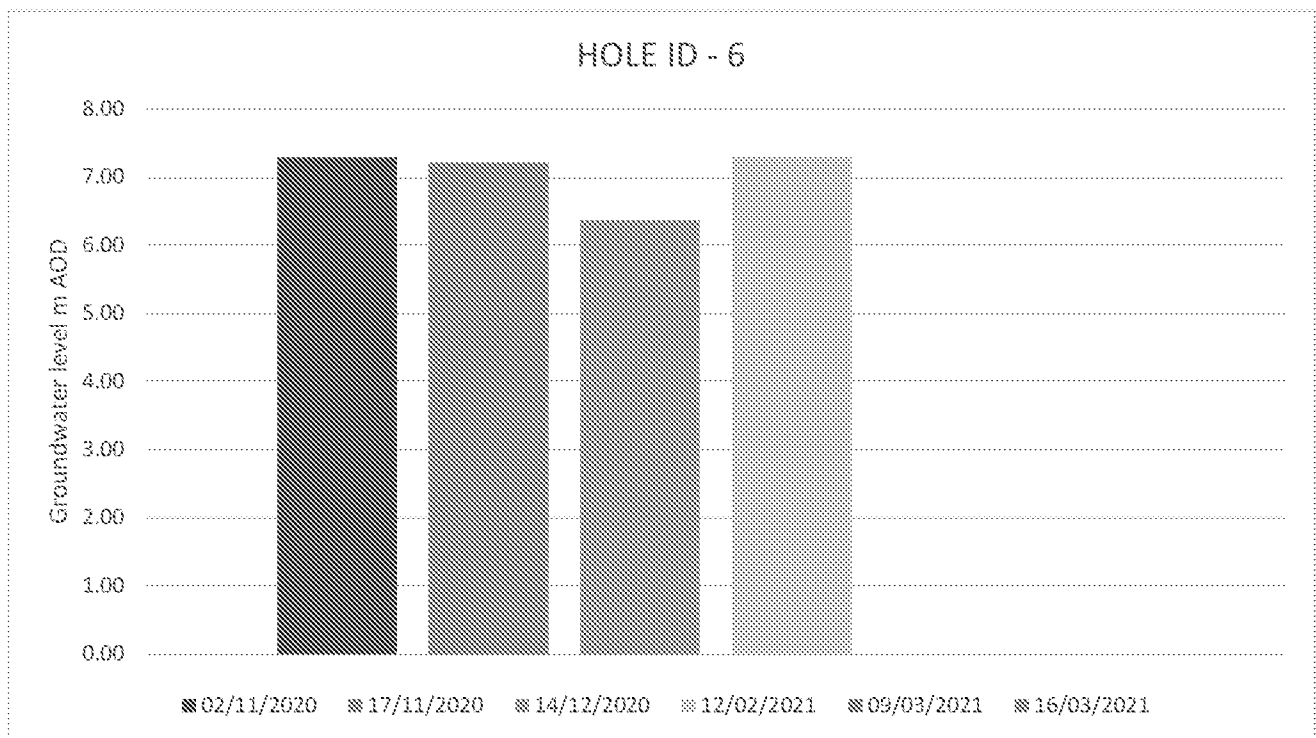
# **RSK GROUNDWATER MONITORING**

Groundwater monitoring was carried out by RSK on 6 occasions (2/11/2020 to 16/03/2021) and the results are attached. Some of the standpipes were lost on the later monitoring rounds as development has proceeded through the site, however it is considered that there is sufficient data to inform design of the drainage system.

The monitoring was carried out during one of the wettest October to February periods in recorded history. In summary when these levels are compared to the existing topographical levels on site, the highest northern level recorded was in Hole 1 on 17 November 2020 was at 7.43 mAoD and the southern location WS4 was at 6.98 mAoD on 2 November 2020.

14/12/2020 - Holes 1, 2 and 6 affected by localised dewatering
