NO.65 (CHARLOTTE HOUSE),  
NOS.67 & 69 AND 71 UPPER  
BOGNOR ROAD, BOGNOR  
REGIS, WEST SUSSEX

HERITAGE STATEMENT  
(including Archaeological Desk Based Assessment)

A report to inform the refurbishment and alteration  
of existing Grade II listed buildings and the  
construction of new buildings within their setting  
and within a designated conservation area

**Document Title:** Heritage Statement – Alterations to Grade II listed building and development within setting of Grade II listed building and within a conservation area

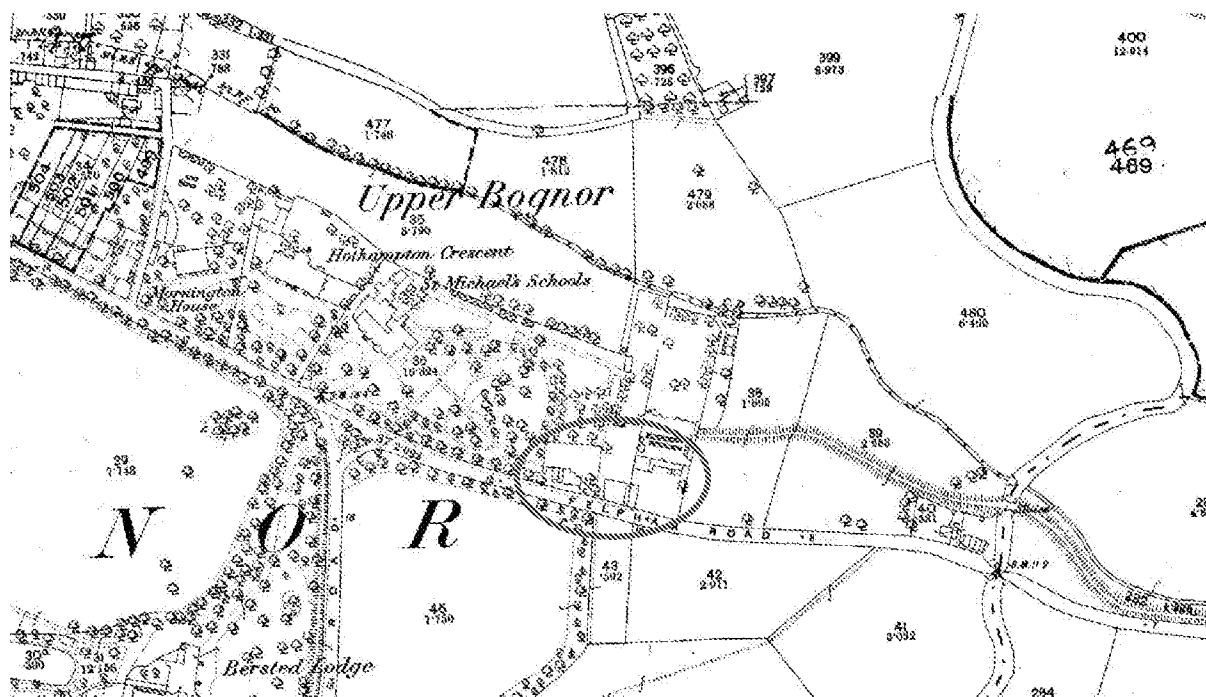
**Figure HM4:** Ordnance Survey 1 to 25 inch 1877 (Site outlined in red)

- 2.12 The Ordnance Survey map of 1877 (**Figure HM4 Appendix B**) shows Nos. 67 and 69 and No.65 Charlotte House, with a significant garden uptake to the rear. The rear garden space for No.67 and 69 are also shown as is the rear outshut to these two properties. There is also a number of enclosures shown to the west of Charlotte House as well as the extension to the west at this time and the plan of the building is as seen presently. It is notable that there are long glass houses shown to the north of No.71 Upper Bognor Road between the house and its serpentine wall to the north. The outbuildings to No.71 at this time extend almost to the boundary wall to the east. The sequence of boundary walls which survive presently are shown on this map extract and continue to be present thereafter.

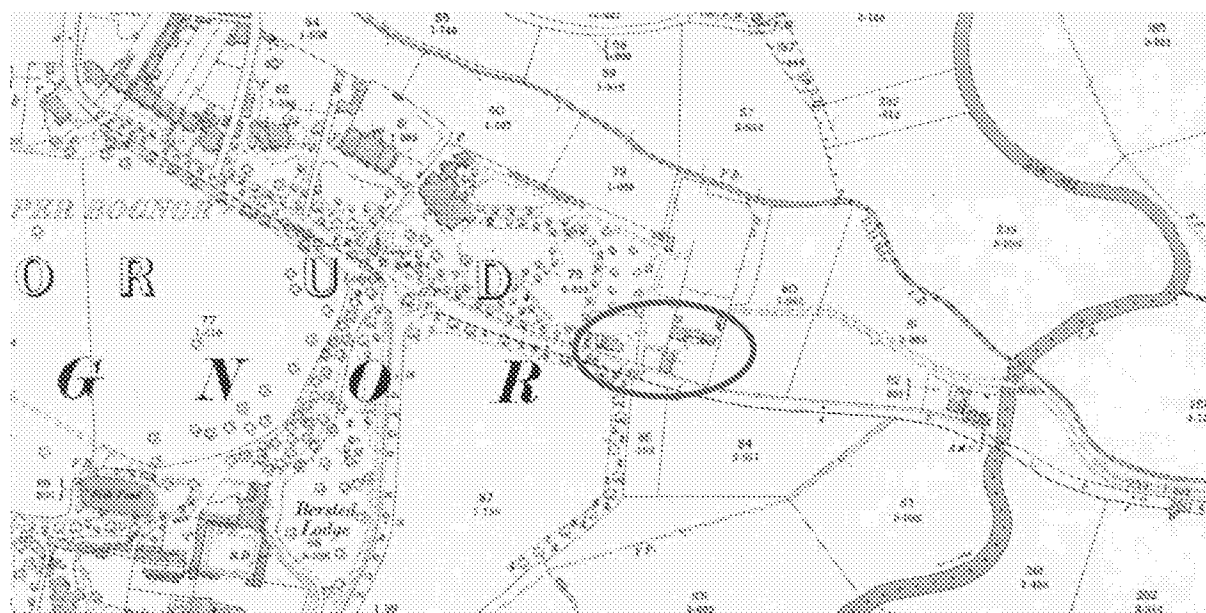
**Figure HM5:** Ordnance Survey 1 to 25 inch 1898 (Site outlined in red)

- 2.14 By the second edition 1898 25 inch Ordnance Survey mapping (**Figure HM5 Appendix B**) the glasshouses have been demolished with the rest of the site as previously depicted. Of note is a linking path between No.71 and No 67 and 69 which then continues west into the next plot.

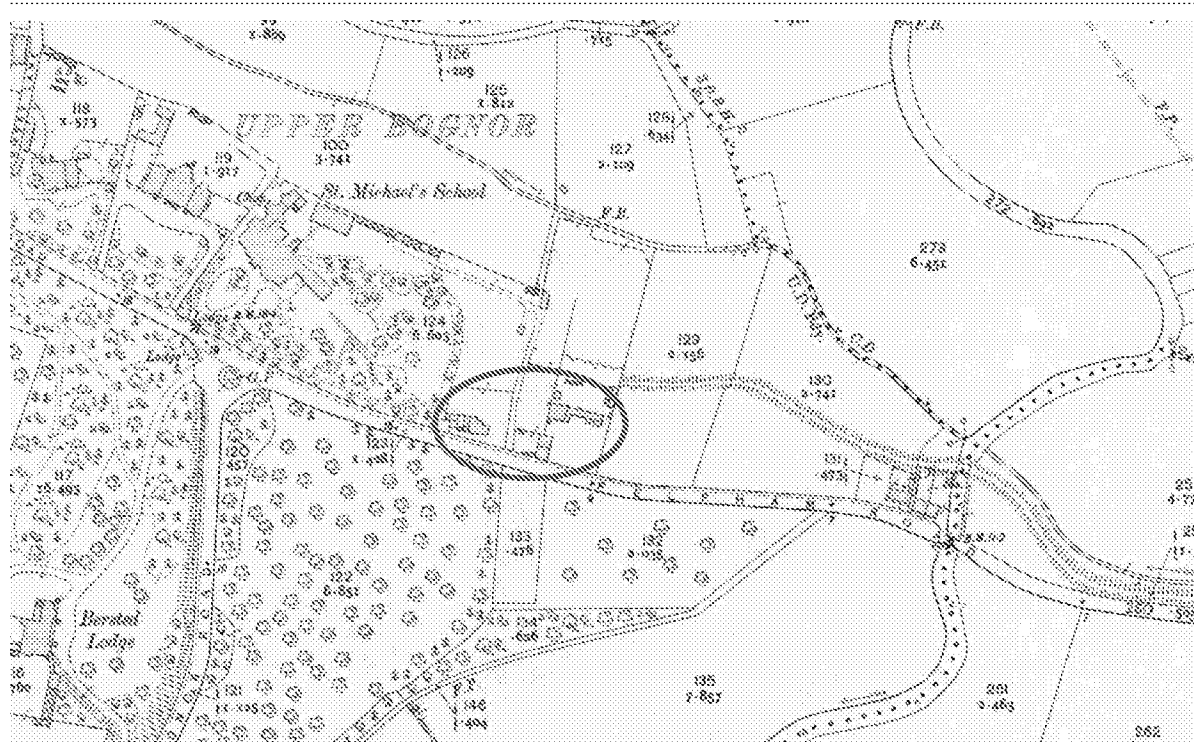
**Figure HM6:** Ordnance Survey 1 to 25 inch 1912 (Site outlined in red)

- 2.15 By 1912 (**Figure HM6 Appendix B**), a new wing appears to St Michael's School to the east and a new building built adjacent to the northern boundary wall. The boundary wall to No.71 clearly shows pig/animal pens to the west side in the same position shown on the 1877 and 1898 maps. No.71 shows buildings extending towards the boundary wall to the east but not linked. There is a smaller glasshouse to the rear garden.

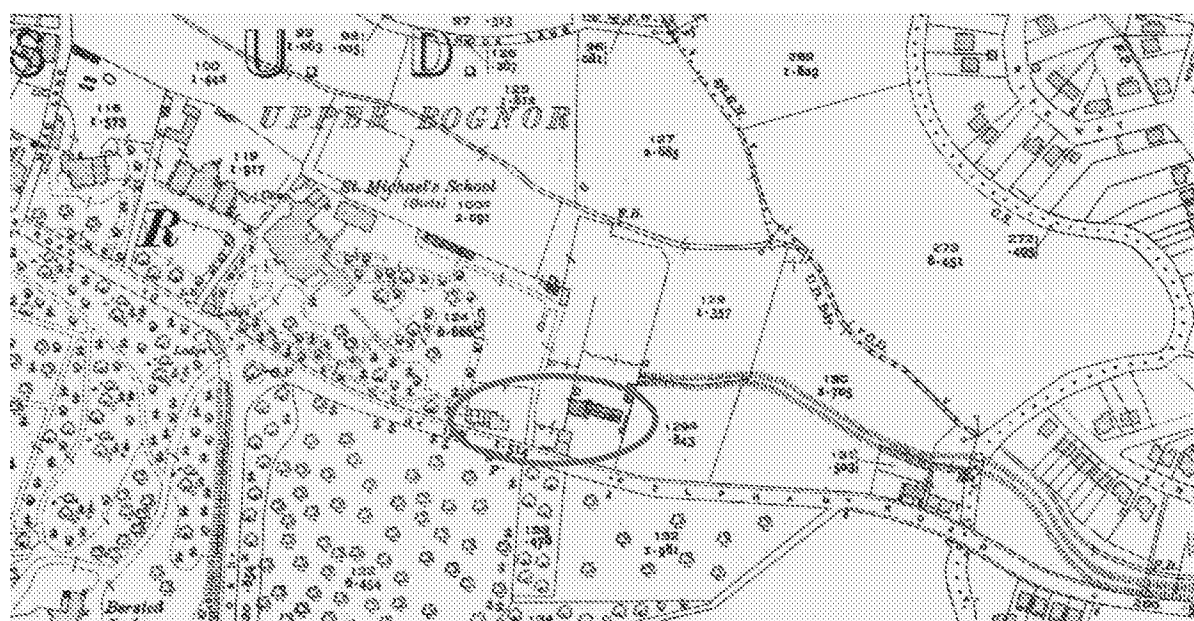
**Figure HM7:** Ordnance Survey 1 to 25 inch 1932 (Site outlined in red)

- 2.16 The 1932 Ordnance Survey map (**Figure HM7 Appendix B**) shows a playing field, including tennis courts, having been laid out and landscaped to the north of St Michaels School, annotated as a school for girls. There are no glasshouses to the rear of No.71. To the boundary wall of No.71, the animal pens remain and there are further enclosures shown to the east of the outbuildings adjacent to the wall.

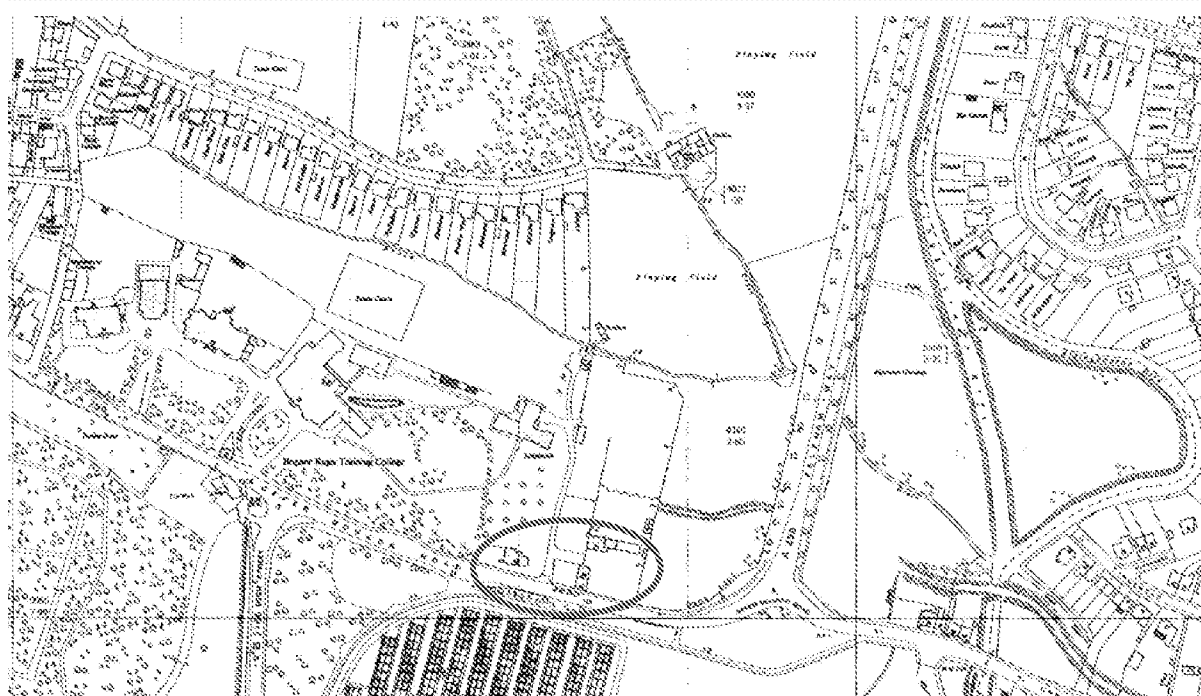
**Figure HM8:** Ordnance Survey 1 to 25 inch 1963 (Site outlined in red)

- 2.17 The 1961 Ordnance Survey mapping (**Figure HM8 Appendix B**) shows that in the post-war era to the north the Assembly Hall and Longbrook had been built, new paths and circulation routes laid out replacing and remodelling much of the previous landscaping associated with St Michael's House. The structure formally mapped as the Bognor Golf Club House is now shown as a Pavilion and Builder's Yard. A second pavilion, to the south, no longer extant is also shown and an existing field boundary extending north-west - south-east across the site is now mapped as a drain extending towards to the newly built Felpham Way and beyond, to discharge into the Aldingbourne Rife. The map shows an almost continuous line of built form (boundary wall) to the boundary on the east of No.71. There is limited change to the 1970 Ordnance Survey map (not illustrated) although Charlotte House appears to have lost its garden to the west with more regular landscape planting shown to the north.

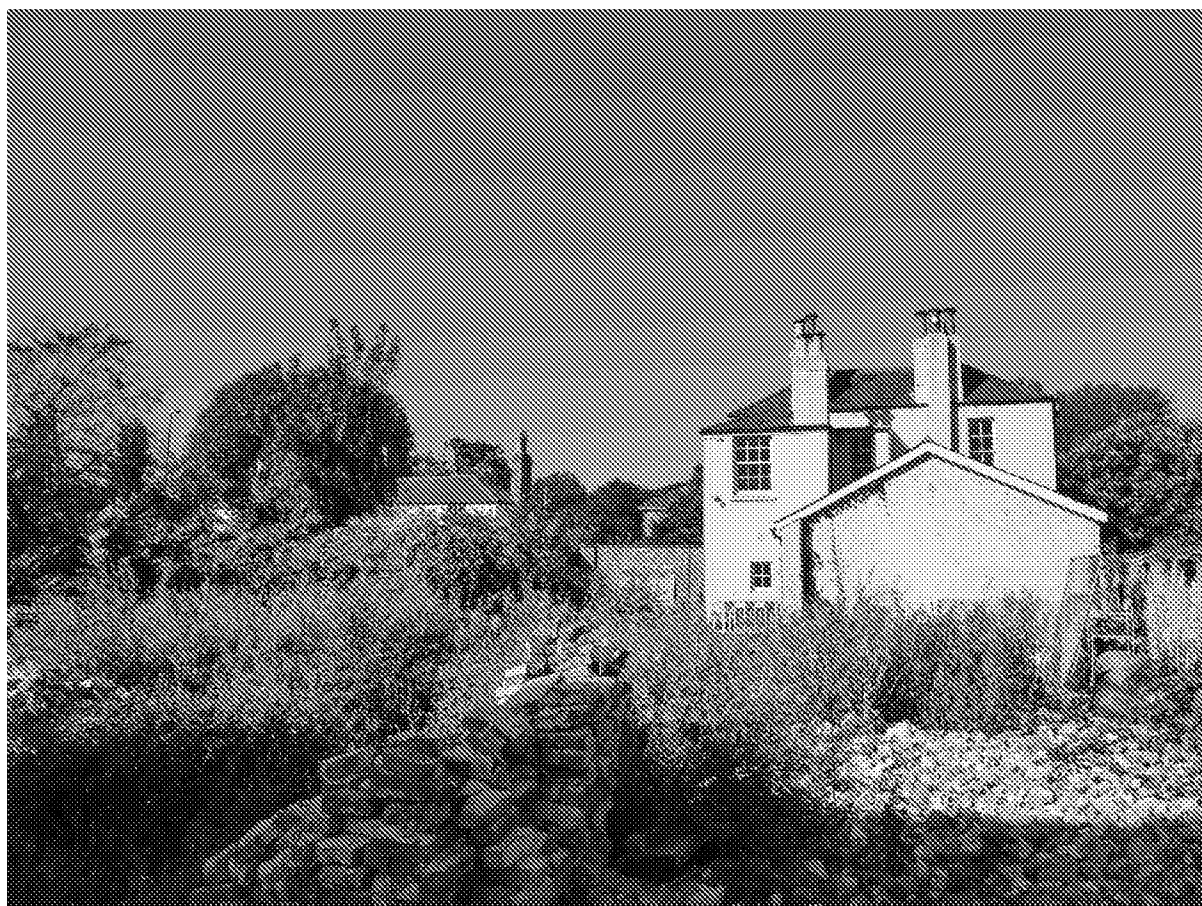
**Figure 5:** The 'site' for proposed new buildings

- 3.2 The site (**Figure 5 Appendix C**) lies immediately to the east of the Grade II listed Nos 67 and 69 Upper Bognor Road (see description below). To the east beyond the Grade II listed stone boundary wall is the recently completed Engineering and Digital Technology Park of Chichester University (Bognor campus). To the north of the site is No.71 Upper Bognor Road (see description below). To the south is the Grade II listed stone boundary wall fronting Upper Bognor Road. The site itself has various self seeded shrubs, plants and small to medium trees. Due to the high boundary walls to Upper Bognor Road and historic built form, the site cannot be easily seen from the public realm.

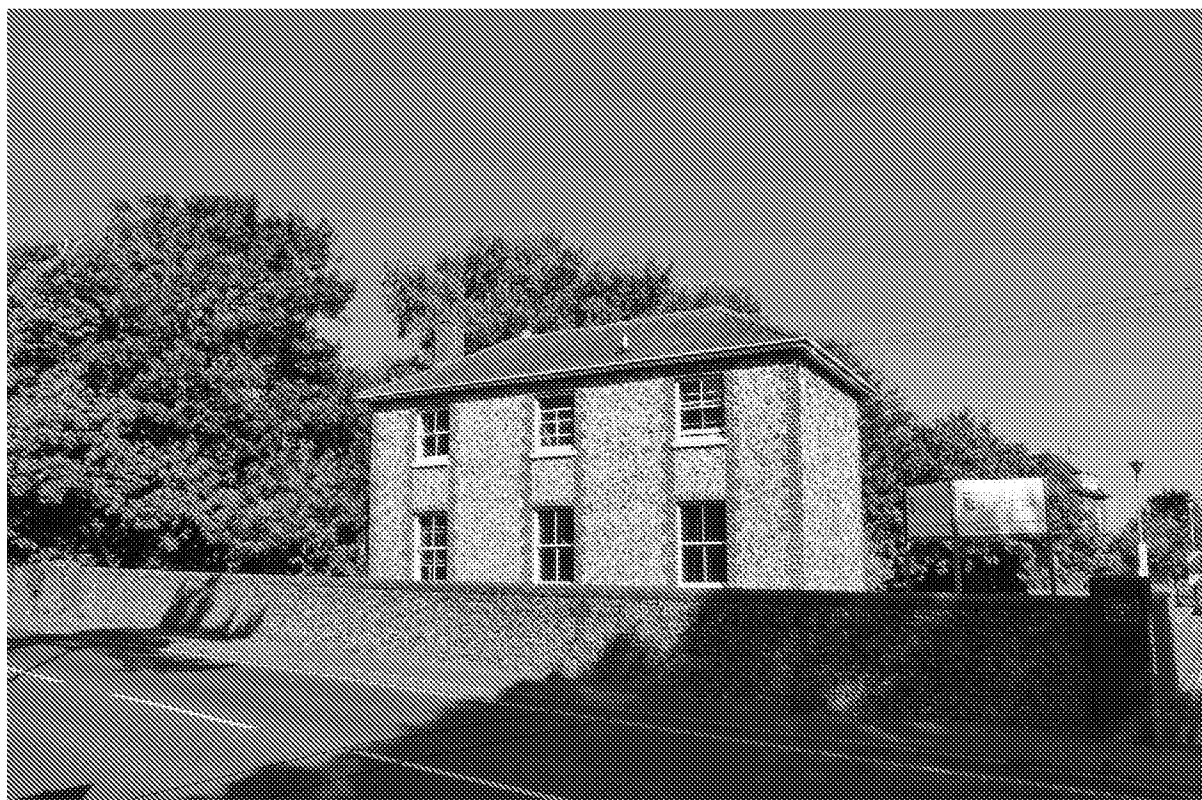
**Figure 6:** Charlotte House, No.65 Upper Bognor Road – south elevation

- 3.3 Charlotte House (**Figure 6 Appendix C**) sits to the west of the rear flint and brick garden boundary enclosure to Nos.67 and 69 Upper Bognor Road to the west side of a tarmac access road to the university campus. The house is separately Grade II listed and was constructed some time between 1842 and 1877. The list description describes the building as an estate house. Charlotte House is two-storey with unknapped and knapped flint with later cementitious pointing to the external walls with brick quoins and dressings to windows which unusually rise continuously through ground and first floor. The south elevation comprises three bays each with a single vertical sliding timber framed sash window with single central glazing bar to each sash. The windows are modern. It is not clear whether they replicate earlier windows but they differ from earlier windows to the rear wing.

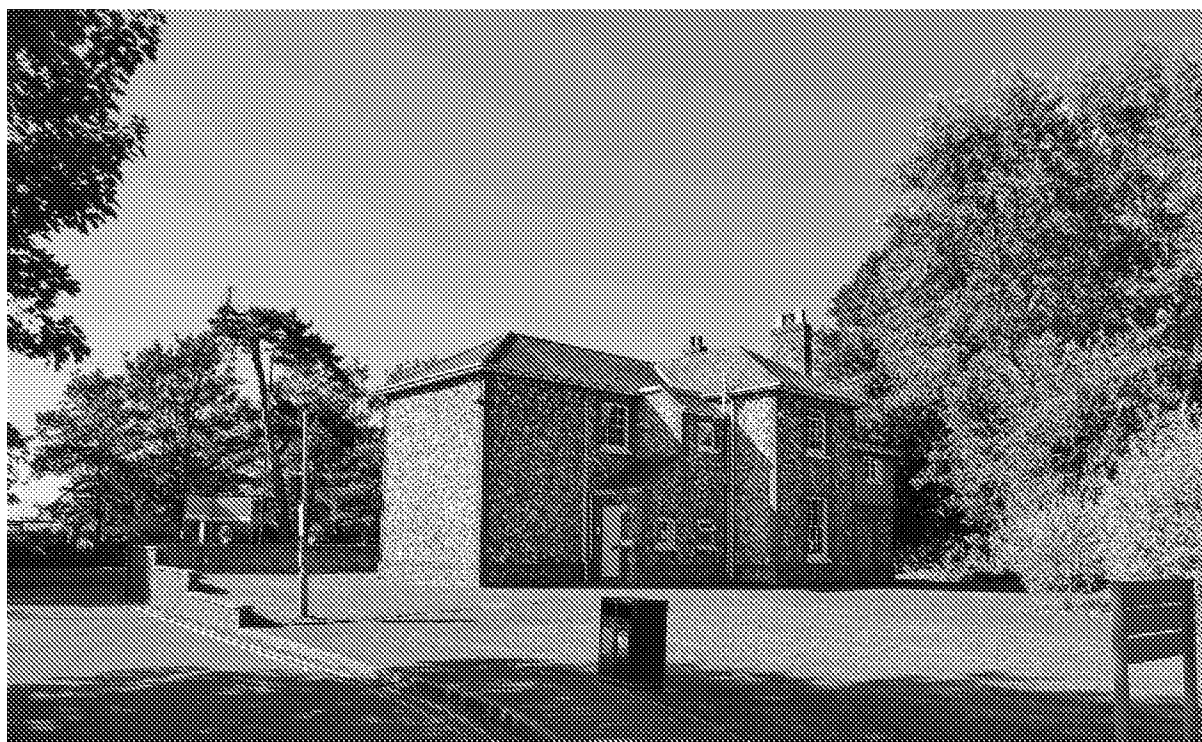
**Figure 7:** North elevation of Charlotte House, No.65 Upper Bognor Road

- 3.4 The main entrance is to the north elevation (**Figure 7 Appendix C**) and extends at single storey with pent natural slate roof to a further two storey extension extending from the north elevation and set in the junction between the main range and projecting rear wing (the service wing). This small extension has a modern top-light window to ground floor and a small sash to the first floor. The entrance has a 19<sup>th</sup> century two panel door with mouldings. The panels are set vertically. The principal roof is hipped with a low pitched natural slate covering. The projecting rear wing has a single sash to each floor. The upper sash is smaller than the lower but both have glazing bars in a six over six configuration. These windows are 19<sup>th</sup> century.

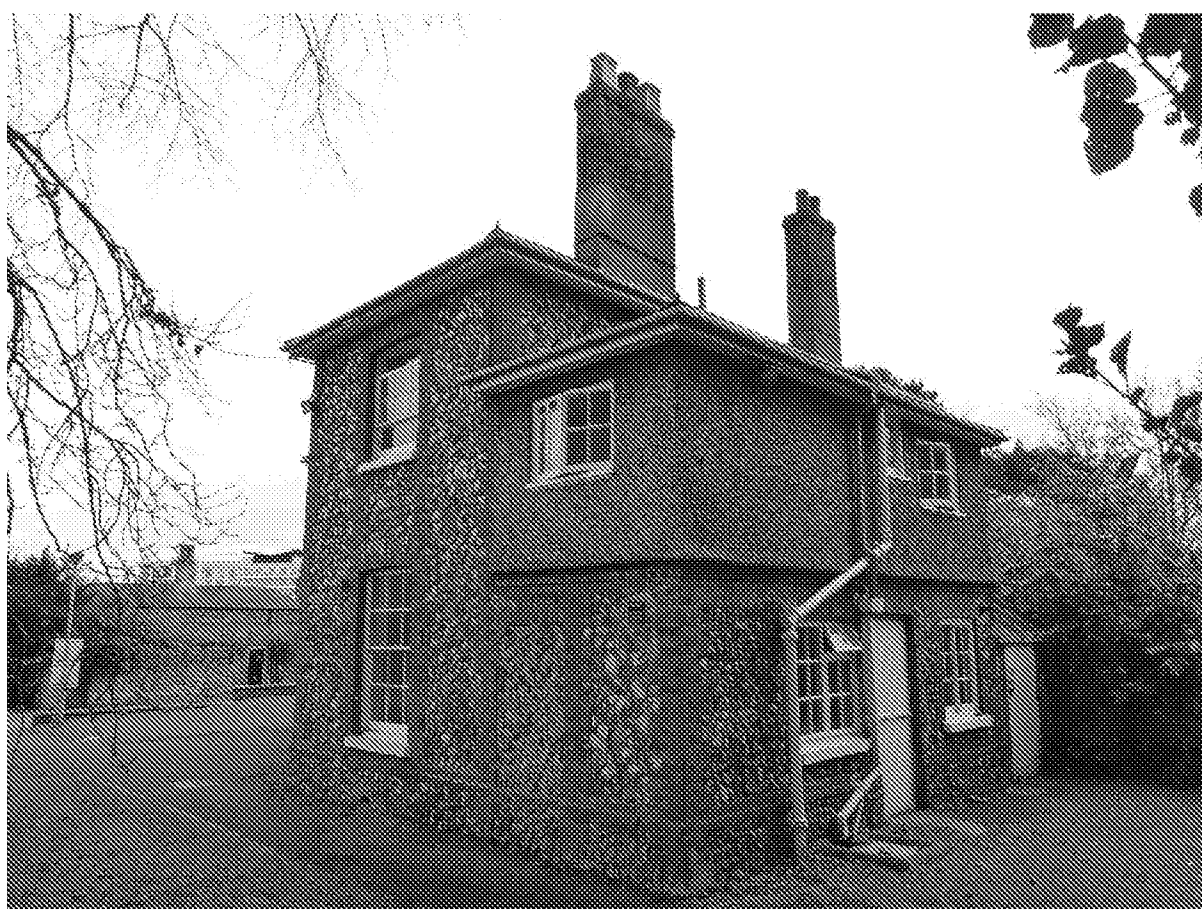
**Figure 8:** Part north and part west elevation to Charlotte House, No.65 Upper Bognor Road

- 3.5 There is a two storey extension to the west in two build phases (**Figure 8 Appendix C**). The ground floor is unknapped flint and has not been repointed to the lower sections but has ribbon pointing to upper sections of flint. There is a blocked door to the north elevation of the extension. The west elevation has two casement windows, one modern and one probably original 19<sup>th</sup> century Yorkshire sliding sash (with a glazing bar missing to the lower section) (**Figure 9 and 16 Appendix C**) and a modern boarded painted timber door between the windows. To the south of this is a single storey brick built store with cement fibre corrugated pent roof (**Figure 10 Appendix C**). The first floor is pebbled-dash rendered with early 20<sup>th</sup> century casements with glazing bars. The roof to this section is natural slate in a low hip.

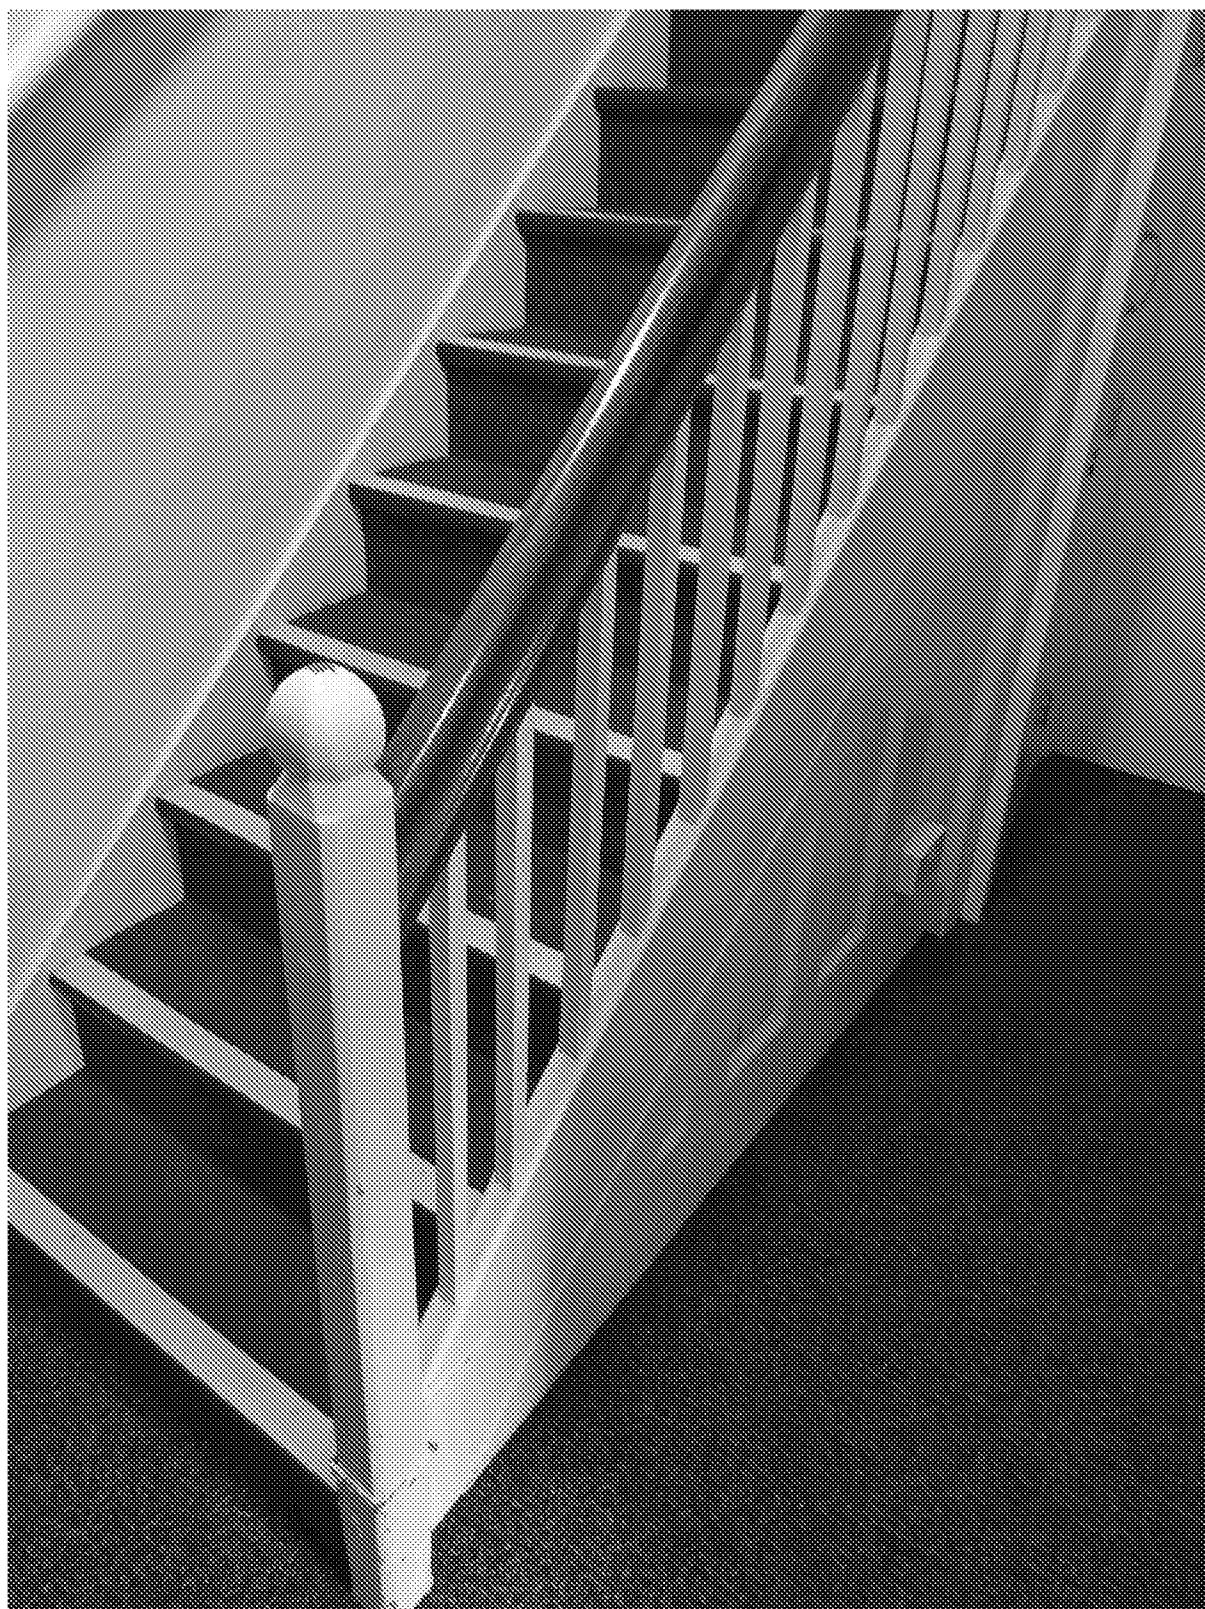
**Figure 11:** Newel post and part of lower flight to staircase to Charlotte House, 65 Upper Bognor Road

- 3.7 The building currently provides living accommodation for students and is subdivided into separate rooms each with their own sink. The entrance lobby enters onto the stair compartment. Whilst the stairs appear modern, the newel posts may be earlier and possibly original. The stair (**Figures 11, 12 and 13 Appendix C**) is probably in its original position given the proportions of the remaining rooms at ground and first floor appear original. There is a 19<sup>th</sup> century four panel door to the ground floor WC (**Figure 14 Appendix C**).

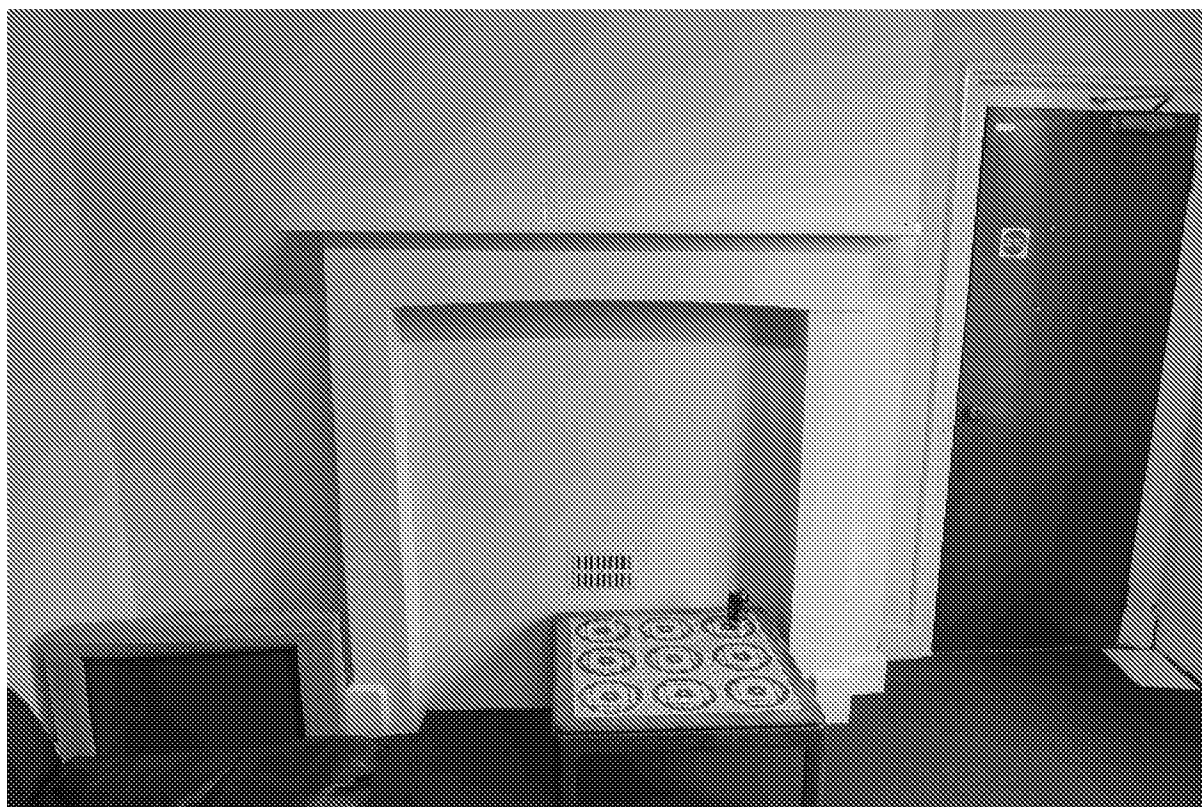
**Figure 15:** Former kitchen range fire surround, Charlotte House, 65 Upper Bognor Road

- 3.8 Generally, all chimney breasts survive and that to the rear wing would appear to be a kitchen range (**Figure 15 Appendix C**). Floors were not inspected. Skirtings are present, they are painted timber and moulded but probably replica 20<sup>th</sup> century in date. There are no fireplaces or chimney pieces surviving (**Figure 17 Appendix C**). Most rooms have a picture rail, some moulded, some plain. It is suspected these are all replacements. There are no original doors except that to the ground floor WC which is a moulded four panel door (**see Figure 14 Appendix C**) and probably original to the building. The only later intervention to the plan appears to be the insertion of a corridor to the rear room (to the wing) to facilitate access to the raised west extension.

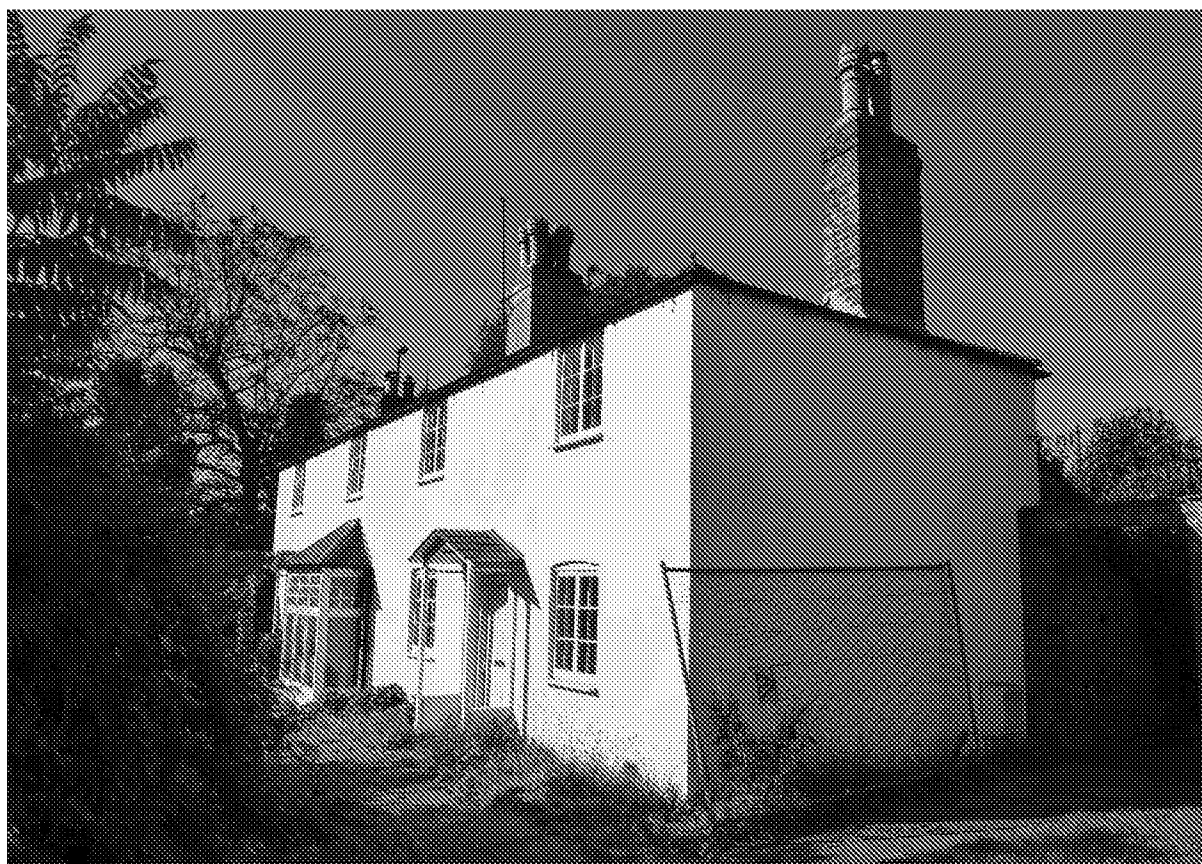
**Figure 18:** Nos.67 and 69 Upper Bognor Road – east and north elevations

- 3.9 Nos.67 and 69 Upper Bognor Road a semi-detached pair of mid-19<sup>th</sup> century cottages (**Figure 18 Appendix C**). They are listed at Grade II. No.67 is particularly prominent in the street scene with a projecting oriel canted bay window to the street and stuccoed walls interrupting the galletted rubble stone and brick wall fronting Upper Bognor Road and running up to the edge of the undeveloped section of the site to the east and along to the secondary entrance to the site adjacent to No. 65 Upper Bognor Road.

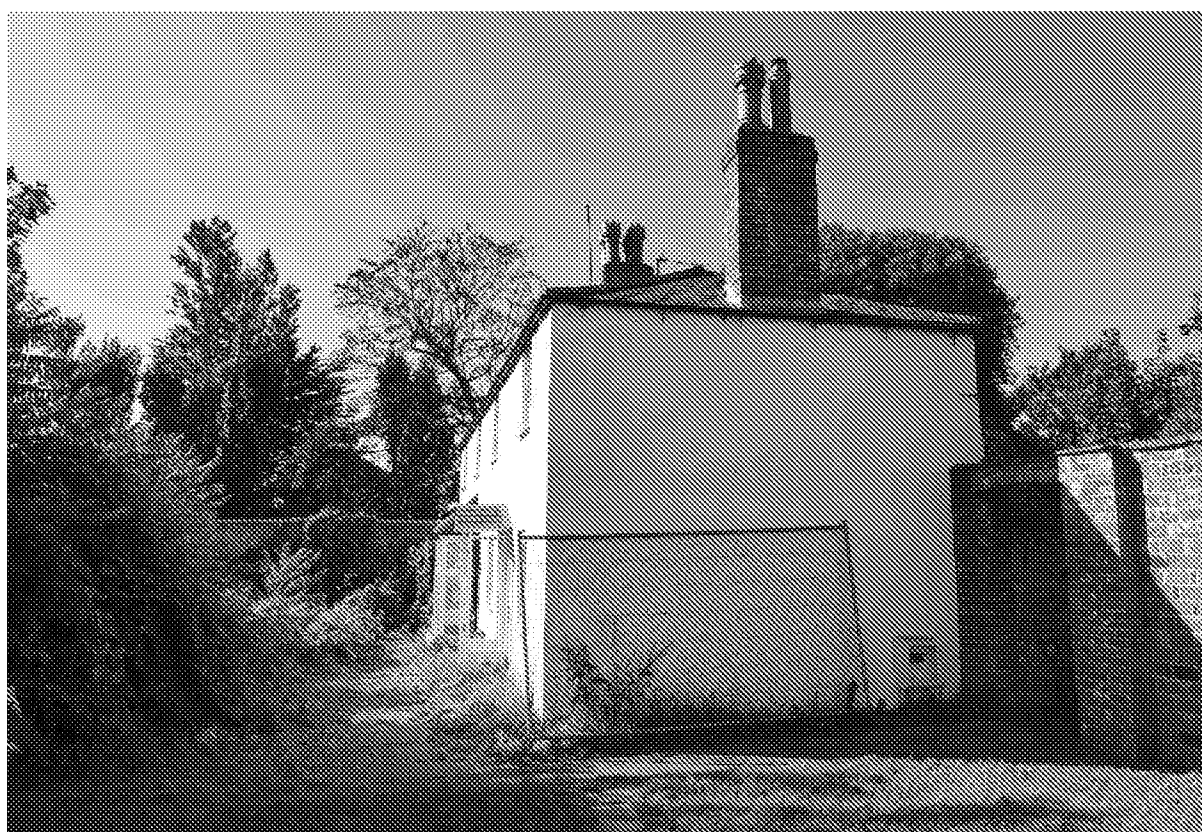
**Figure 19:** North elevation of No.69 Upper Bognor Road

- 3.10 The pair of cottages, formerly known as Anne's Cottages have principal façades facing east. These comprise painted stucco over brick. The north elevation is also stucco on brick (**Figure 19 Appendix C**). The south elevation (to No.67) is brick built (at first floor) onto a continuation of the stone with brick dressings wall which continues to the west and east of the south façade (forming the boundary walls to enclosed gardens). This south elevation (**Figure 22 Appendix C**) appears to have been built up from the wall. The roof is a shallow hipped pitched natural slate with a continuous single storey lean-to rear extension with pent roof. The rear elevation is exposed brick. The brick is a random bond with some stone components and was probably intended to be rendered (or has lost its render) (**Figure 20 Appendix C**).

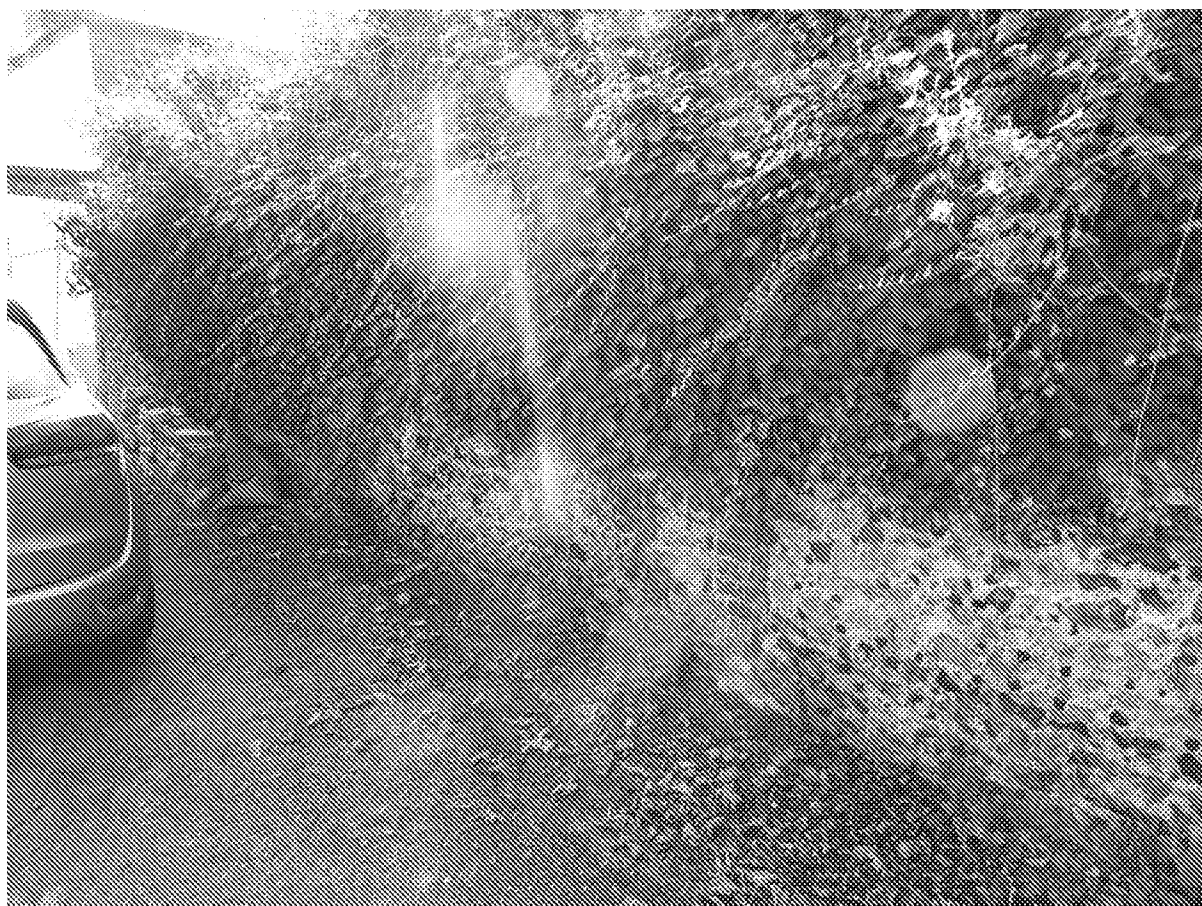
**Figure 21:** Part of flint and brick boundary wall to gardens of 67 and 69 Upper Bognor Road

- 3.28 There is a rear garden wall to Nos.67 and 69 (**Figure 21 Appendix C**). This is heavily obscured by vegetation but comprises a mix of coursed brick, unknapped and knapped flint cobble and small stone components (Bognor Rock) with red brick dressings and copings.

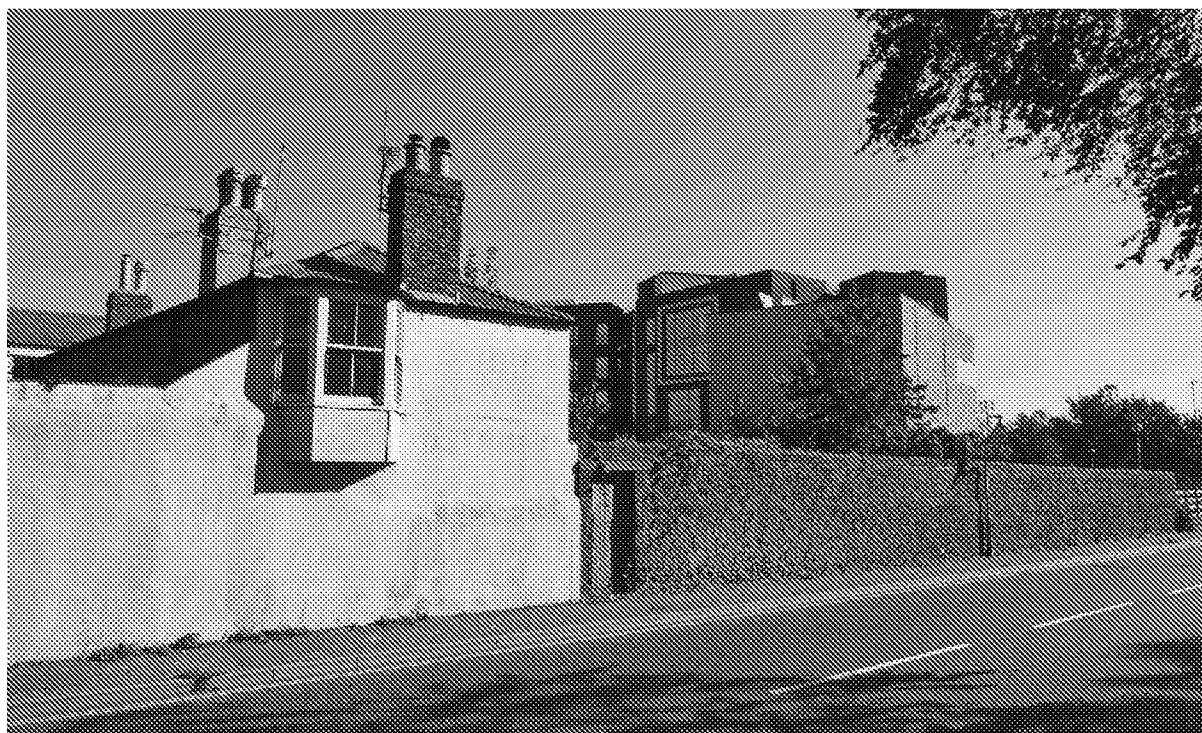
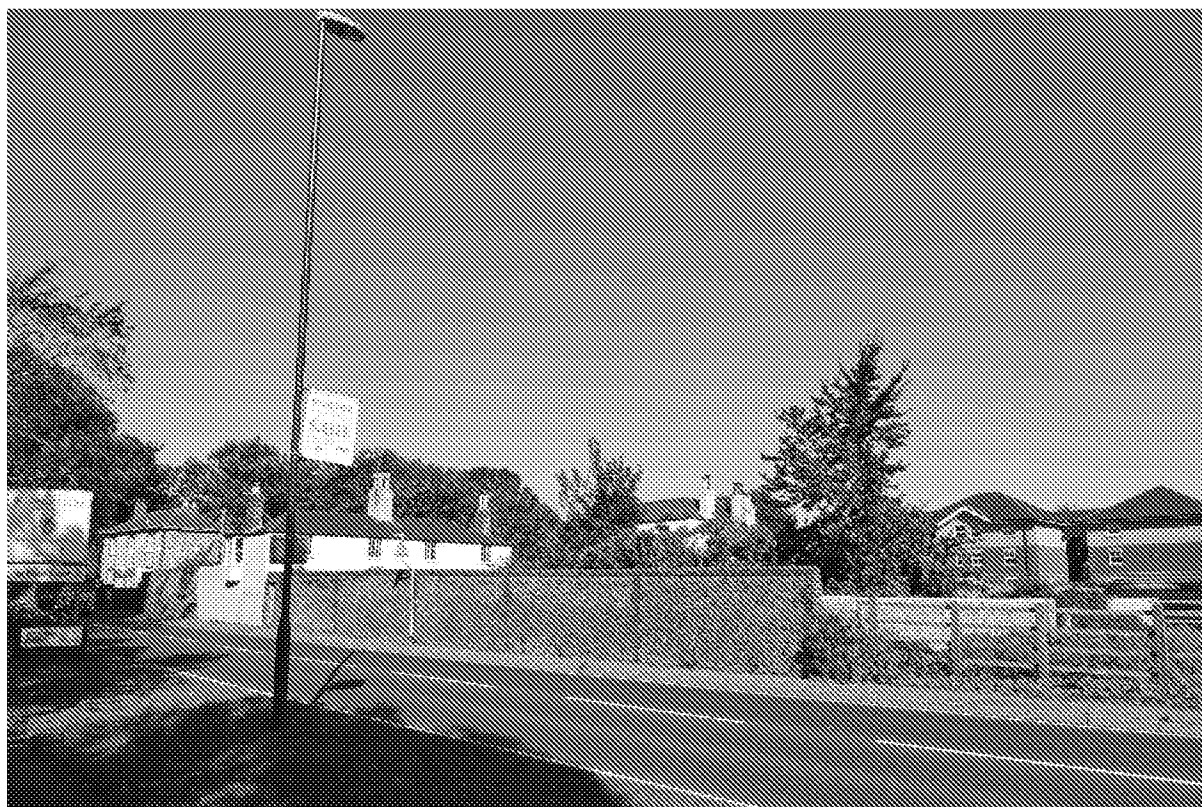
- 3.30 There are boundary walls to the east and south of Nos.67 and 69 (**Figures 22 and 39 Appendix C**). These are constructed in Bognor Rock with brick dressings and are separately Grade II listed. These walls enclose the proposed development site and form the present setting of the listed group.
